Mount Thorley Warkworth

2023 Annual Review

Mount Thorley Warkworth (MTW) is an integrated operation of two open cut coal mines, Warkworth Mining Limited (WML) and Mount Thorley Operations (MTO). This Annual Review reports on the environmental performance of MTW for the period 1 January 2023 to 31 December 2023.

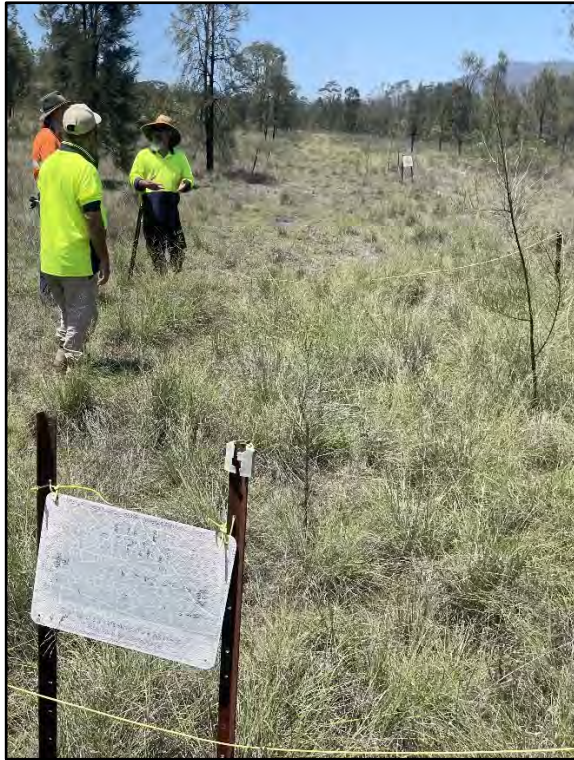
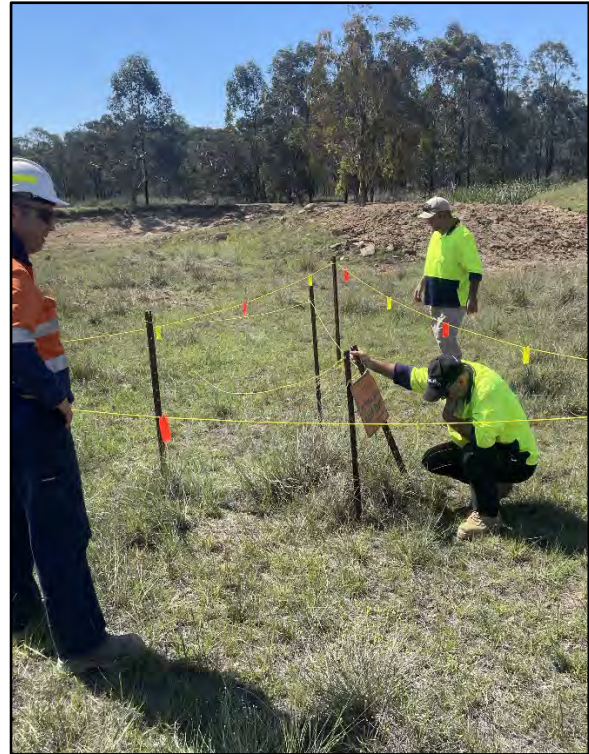
Examples of barricading in need of repair (left) and newly reinstated (right)

Barricading should consist of hi-vis string line and signage delineating the area as an ACH site to be avoided. There are some areas, however, where hi-vis delineation posts minus string line are an appropriate demarcation method.

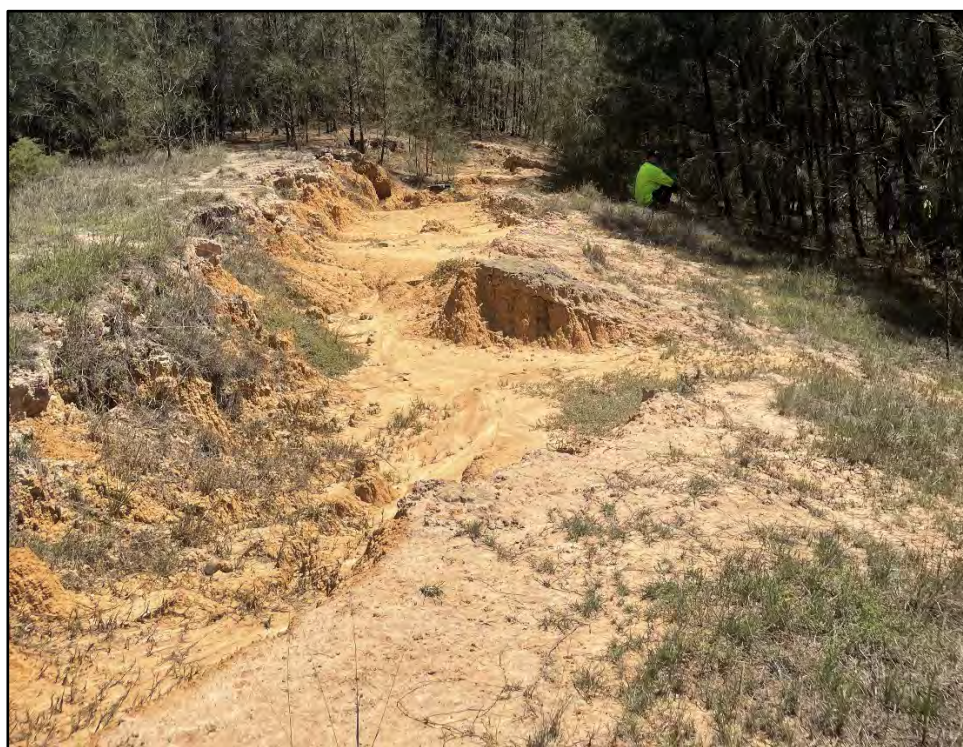
Erosion scour along Loder Creek

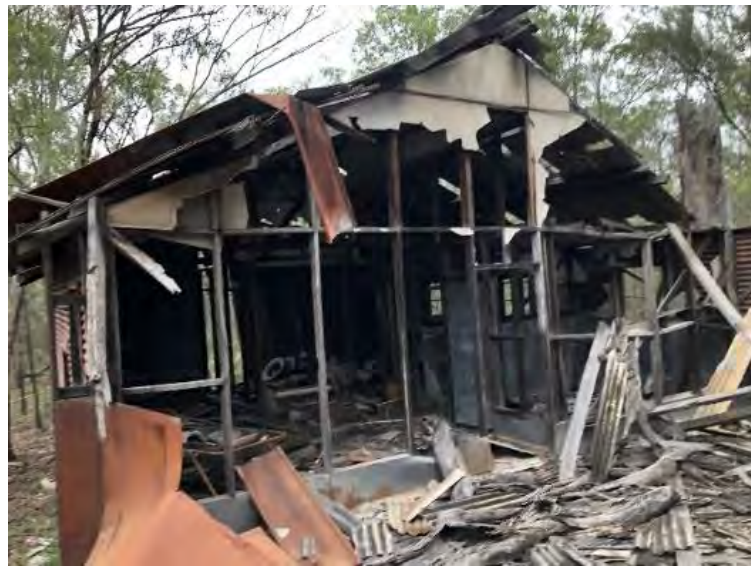
2021	2022	2023	<p><u>View to interior of south end of building, view from east</u></p> <p>2012-18: shows increased collapse over open kitchen area.</p> <p>2018-20 (Mar): shows further minor deterioration of asbestos panelling.</p> <p>Mar 2020 – Dec 2020: no discernible change.</p> <p>Dec 2020 – 2021: no discernible change.</p> <p>2021-2022: no discernible change</p> <p>2022-2023: some movement of fallen timbers</p>

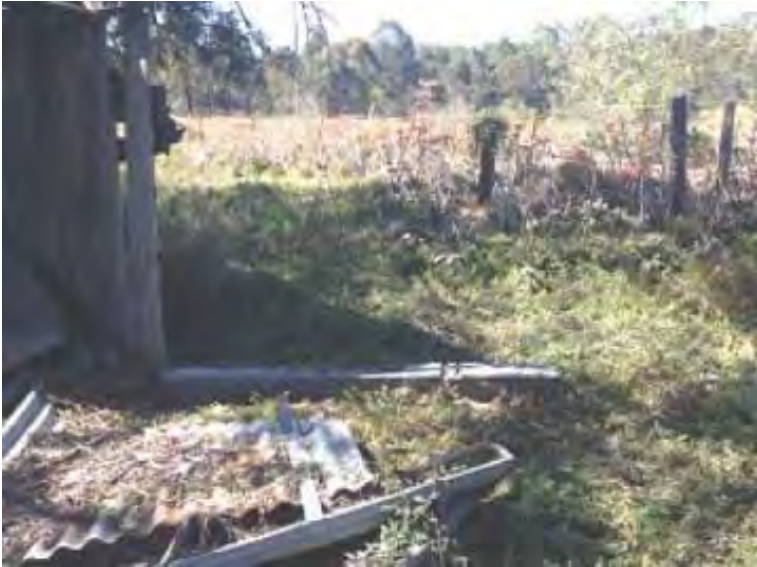
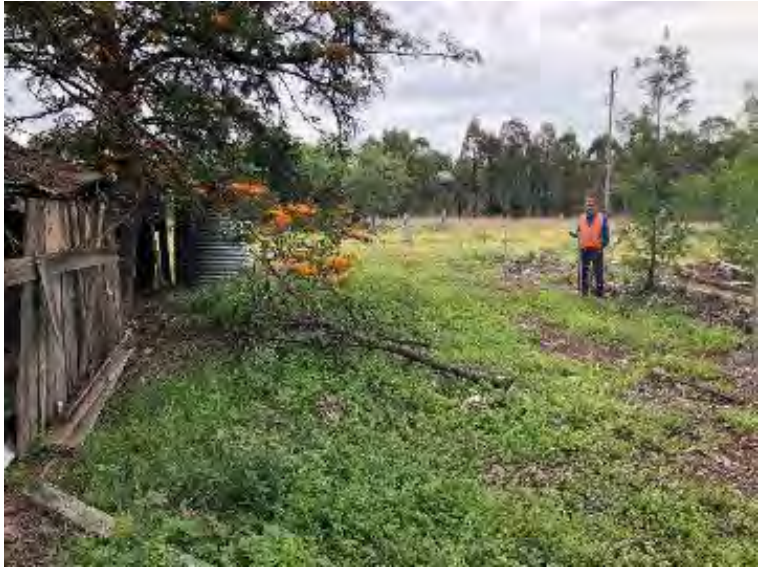
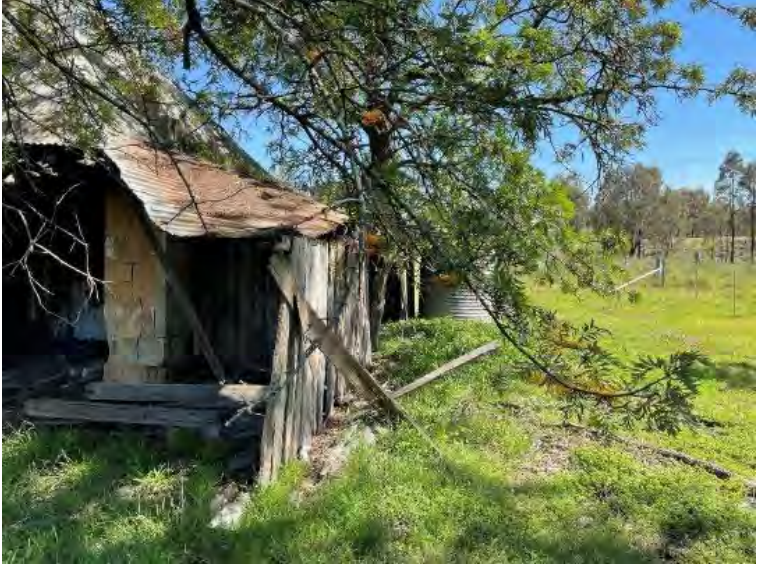
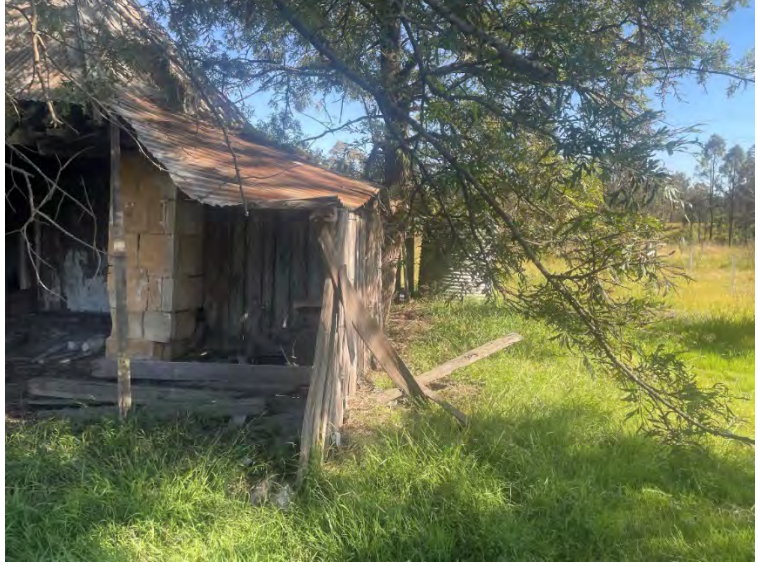
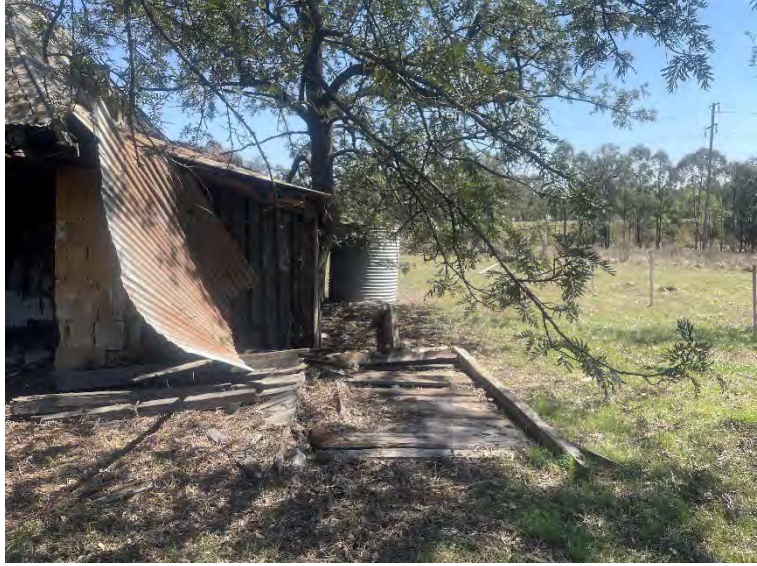
2021	2022	2023	<p><u>Eastern side</u></p> <p>2014-8: debris has been cleaned and stored and a weed removal program conducted. The house area has also been fenced.</p> <p>2018-20 (Mar): further deterioration of eastern wall and regrowth of weeds.</p> <p>Mar 2020-Dec 2020: no discernible change.</p> <p>Dec 2020 – 2021: no discernible change.</p> <p>2021-2022: apparent increased deformation of eastern roof line.</p> <p>2022-2023: south-east wall and skillion roof collapsed</p>

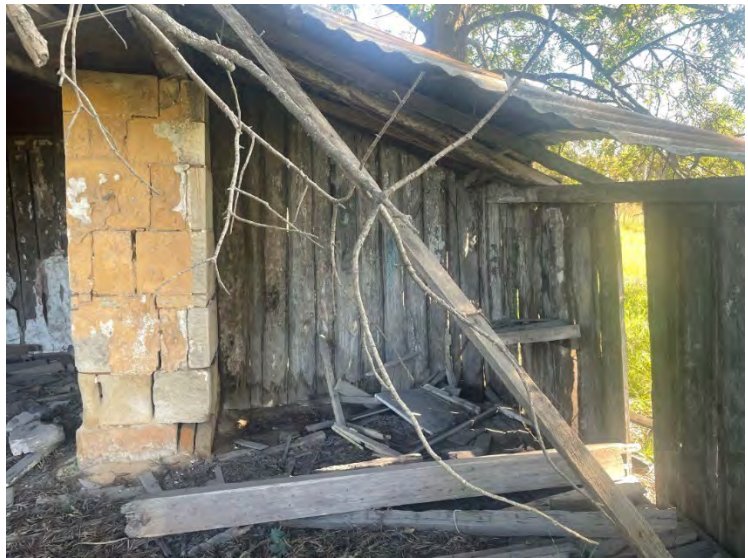
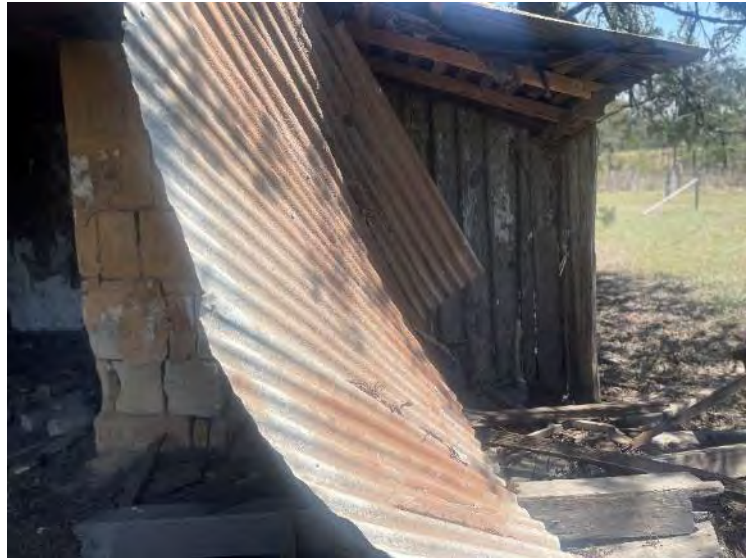
<p>2014-8: shows removal of vertical slabs from southern wall, and some from eastern wall, and further collapse of roof.</p> <p>2018-20 (Mar): further roof slumping and deterioration of eastern wall.</p> <p>Mar 2020-Dec 2020: no discernible change.</p> <p>Dec 2020 – 2021: further deterioration of eastern wall.</p> <p>2021-2022: movement of roofing timbers, subsidence in chimney blocks, bottom left corner.</p> <p>2022-2023: total collapse of side wall and roof</p>

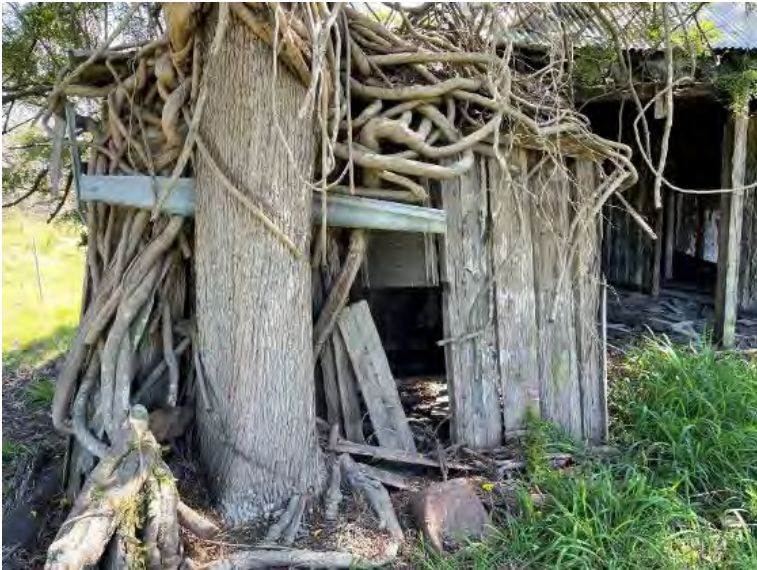
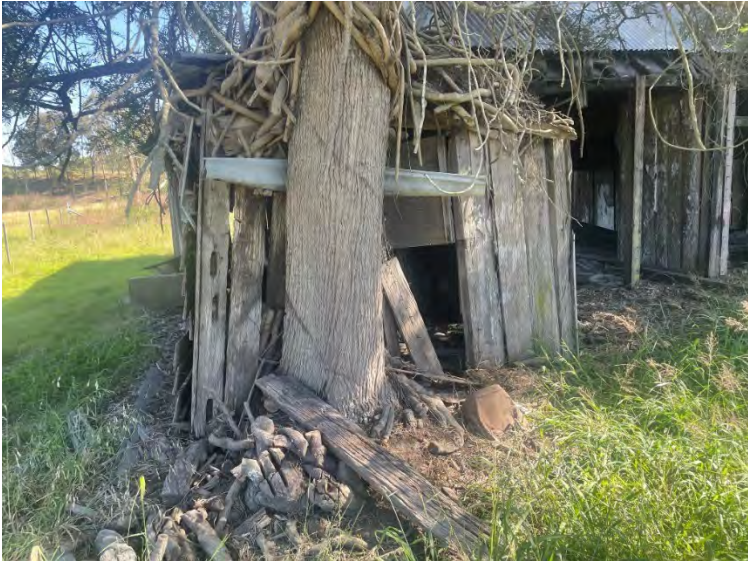
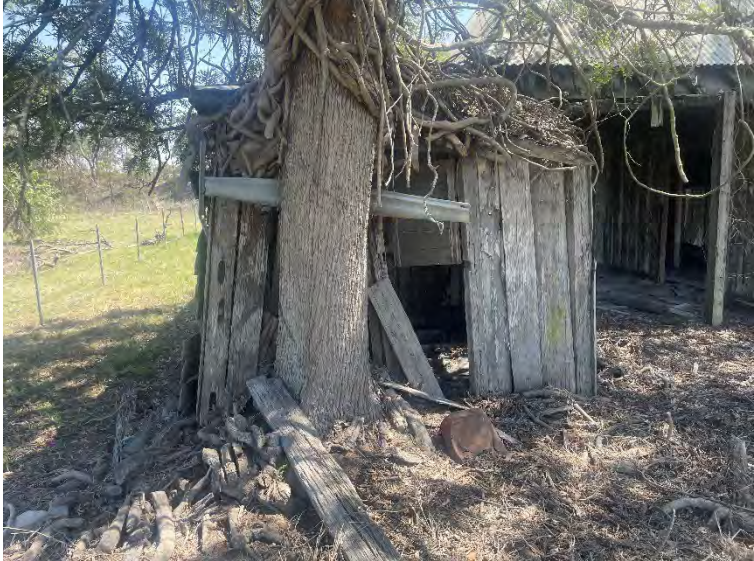
<p>2014-8: shows removal of vertical slabs from southern wall as well as some increase in vegetation growth.</p> <p>2018-20 (Mar): no discernible change but continuing vegetation impacts.</p> <p>Mar 2020-Dec 2020: apparent increased vine growth.</p> <p>Dec 2020 – 2021: continued impacts on south-west corner.</p> <p>2021-2022: vine has been chopped near ground and killed, some resultant movement of timbers.</p> <p>2022-2023: no discernible change but continuing vegetation impacts.</p>

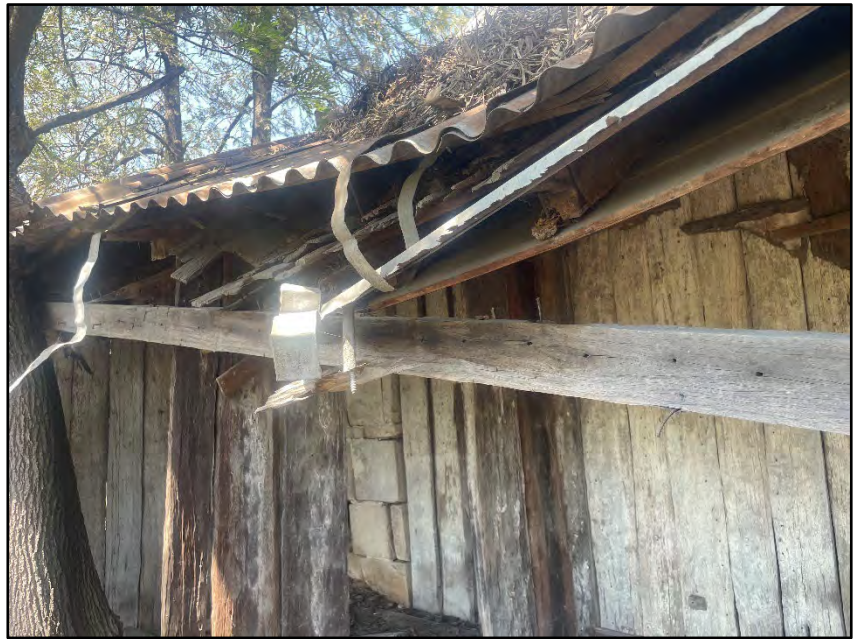
Additional northern verandah upright affected by termites and/or rot

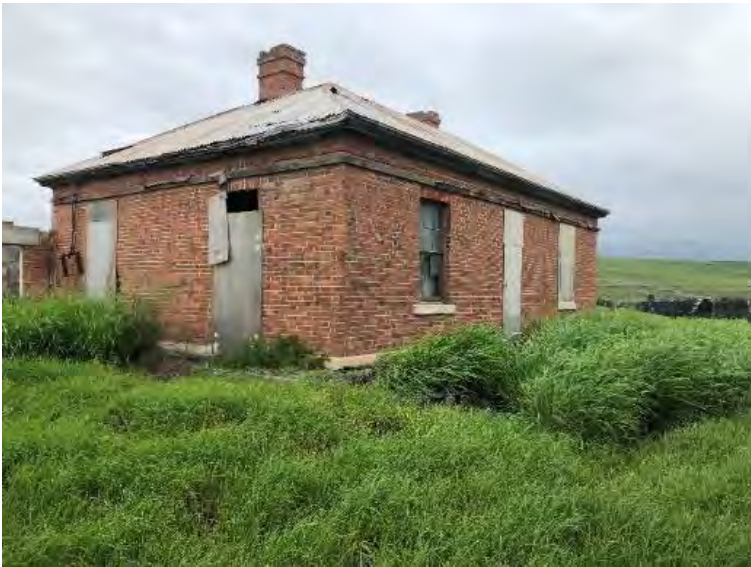
2021	2022	2023	<u>View of north-west side</u>
 	 	 	<p>2015-8: veranda removed and stored inside building, vegetation has been managed.</p> <p>2018-20 (Mar): vegetation has regrown around building.</p> <p>Mar 2020-Dec 2020: vegetation again under control, panel above boarded door requires refixing.</p> <p>Dec 2020 – 2021: vegetation requires management and loose boards re-affixing.</p> <p>2021-2022: panelling fixed or reinstalled on all openings; ruinous electricity board fallen; increased vandal activity at left-most door opening; grass recently mowed.</p> <p>2022-2023: recently mowed and left door barricading bolstered. Guttering deterioration and lifting of roof tin at near corner.</p>

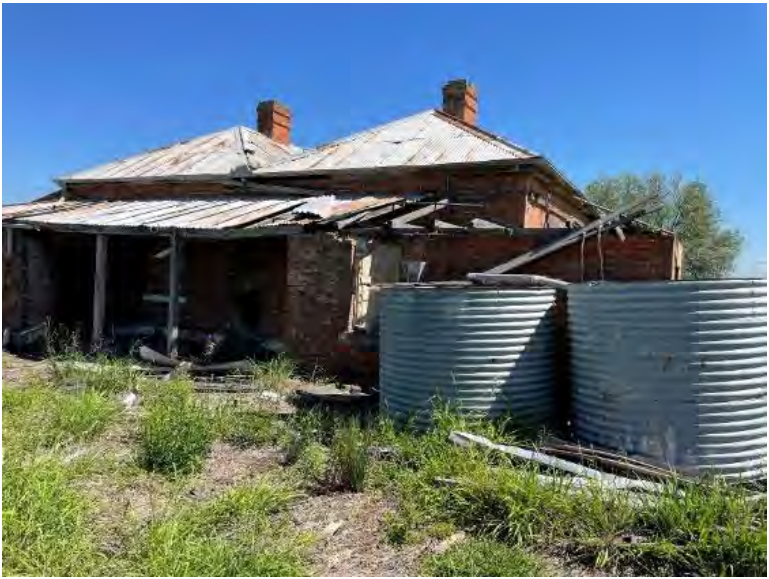
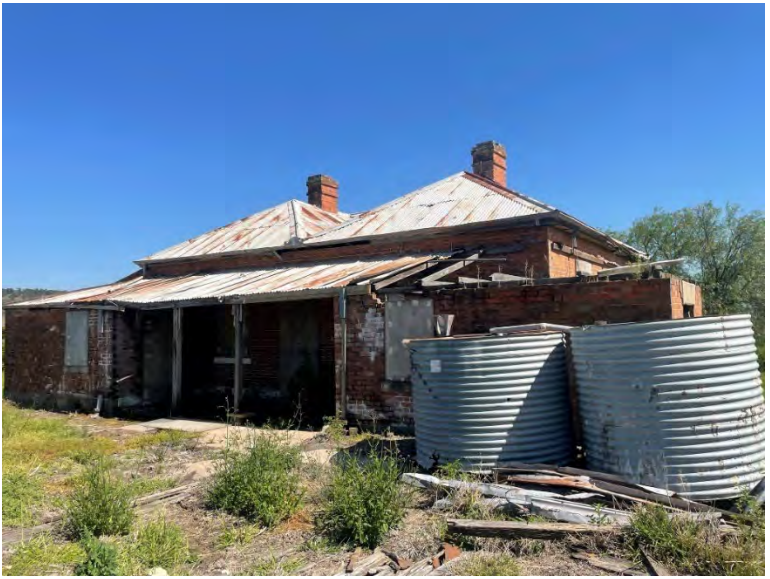
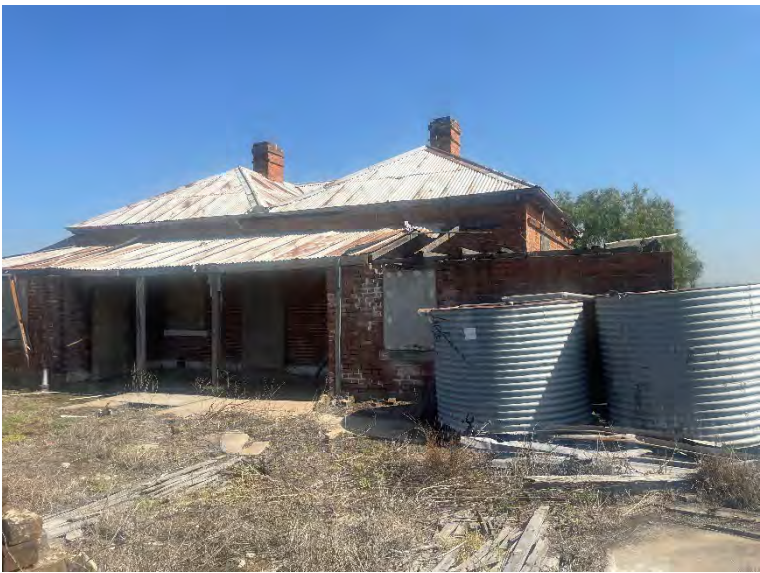
<p>2015-8: skillion roof, guttering and rafters have collapsed; main roof holes repaired.</p> <p>2018-20 (Mar): no discernible change.</p> <p>Mar 2020-Dec 2020: some minor holes in roofing require repair.</p> <p>Dec 2020 – 2021: minor roofing holes remain.</p> <p>2021-2022: veranda uprights propped, loose members tidied; roofing appears patched.</p> <p>2022-2023: shows fallen guttering with lifting of roof sheeting behind.</p>

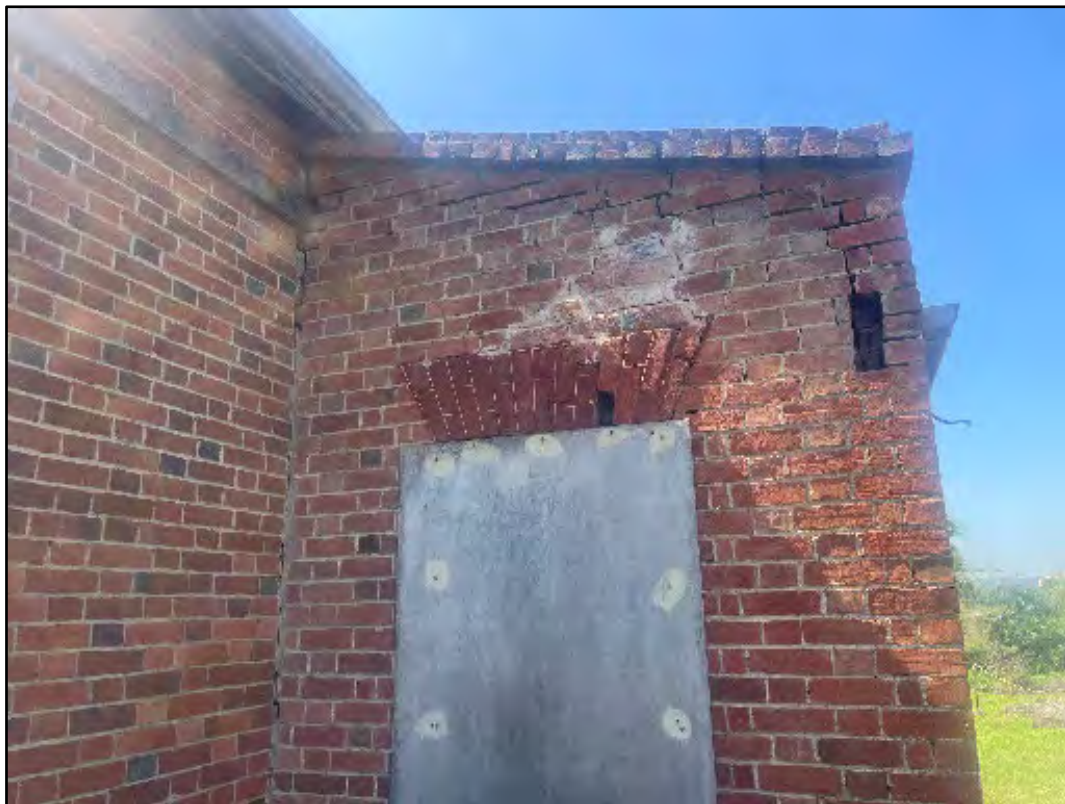
A section of wall at the end of the verandah where it meets Room 5 on the house's south-east corner also requires attention (see picture below). The mortar between the brick work on this wall, particularly on the southern edge, has deteriorated, with fretting on some bricks also apparent. This has created some slight bowing/deformation to the top of the southern side of this wall, which poses a risk of collapse of this section. Repointing attention is required in this area, as it is in other sections of the building.

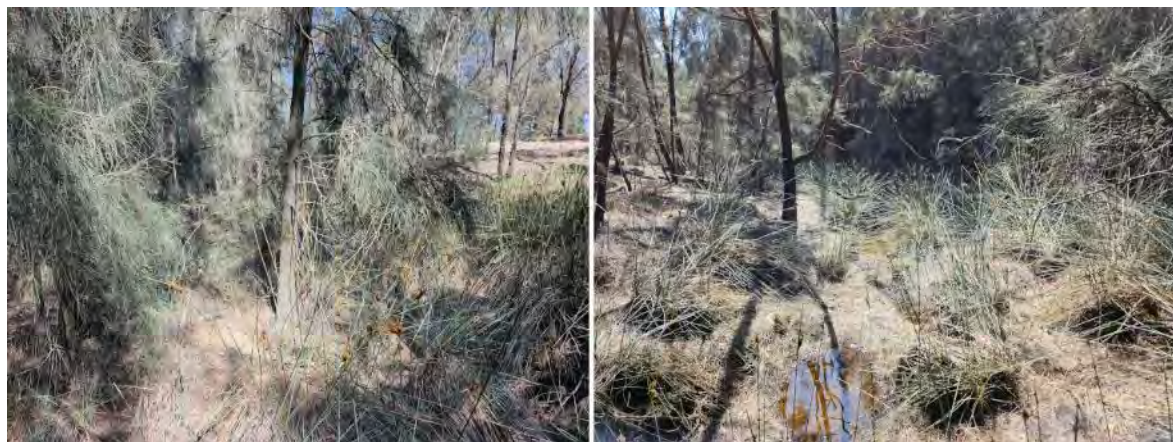
Figure 15: Site LC2 looking upstream (left) and looking downstream (right).

The composition of the vegetation growing on the drainage line walls resulted in an improved category score. There was also an improved category score for ‘Particle size of materials on the drainage floor’ owing to the presence of gravels in the channel basin, and re-assessment of the ‘Shape of drainage line cross-section’ resulted in an improved category score. Overall, there was an improvement in the CSIRO ESA score and rating which shifted from *Active* to *Potentially stable*.

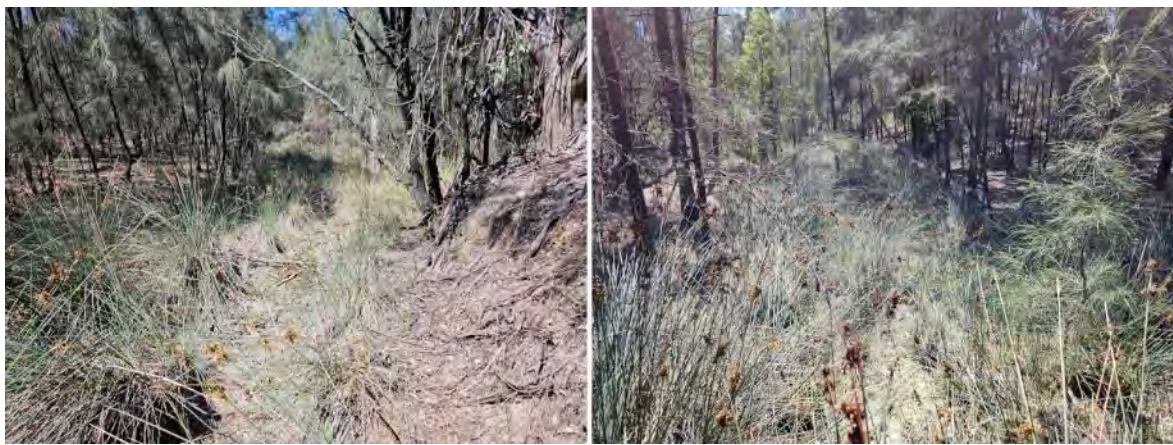
Figure 18: Site LC3 looking upstream (left) and looking downstream (right).

There was an improved category score recorded for 'Particle size of materials on the drainage floor' owing to the presence of gravels in the channel basin, and re-assessment of the 'Shape of drainage line cross-section' and 'Longitudinal morphology' resulted in an improved category score. Overall, there was an improvement in the CSIRO ESA score between 2022 and 2023 which shifted the band rating from *Very Active* to *Active*.

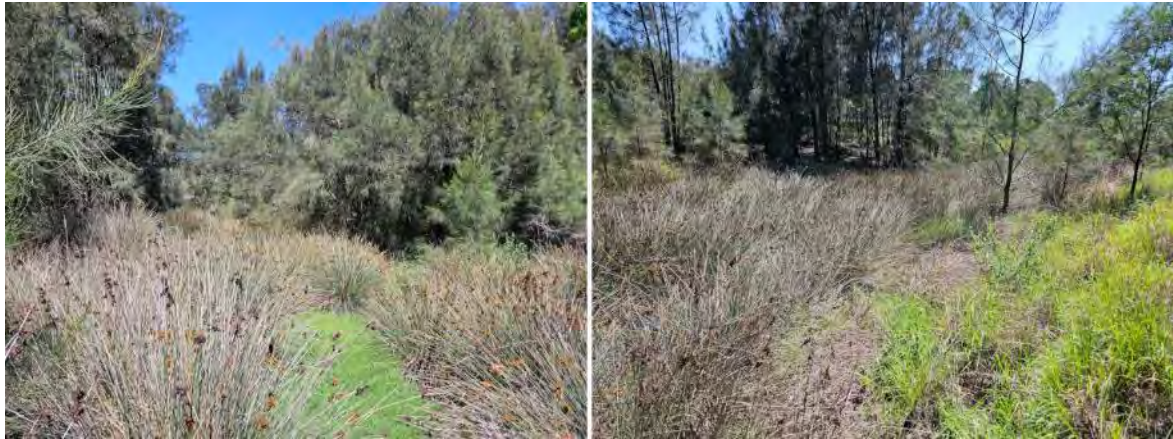
Figure 22: Looking upstream (left) and downstream (right) at LC5.

There was an improved category score recorded for ‘Nature of drainage line wall materials’ owing to reduced estimate of exposed soils along drainage line walls, and re-assessment of the ‘Shape of drainage line cross-section’ and ‘Longitudinal morphology’ resulted in an improved scores their respective categories, resulting in an improved CSIRO rating of *Potentially Stabilising* in 2023.

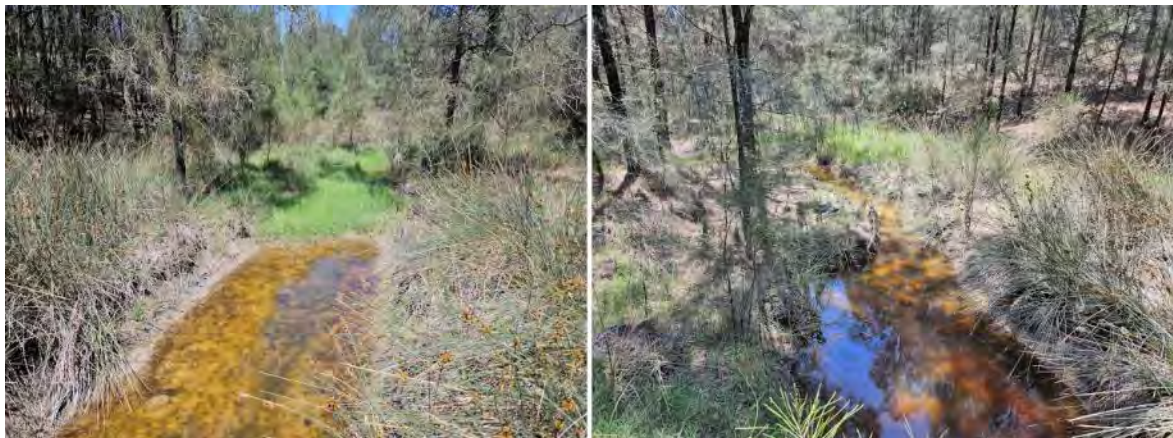
Figure 25: Looking upstream at site LC6 (left) and looking downstream (right).

Notwithstanding, there were no changes to the LC6 site CSIRO ESA rating which remained as *Active* in 2023.

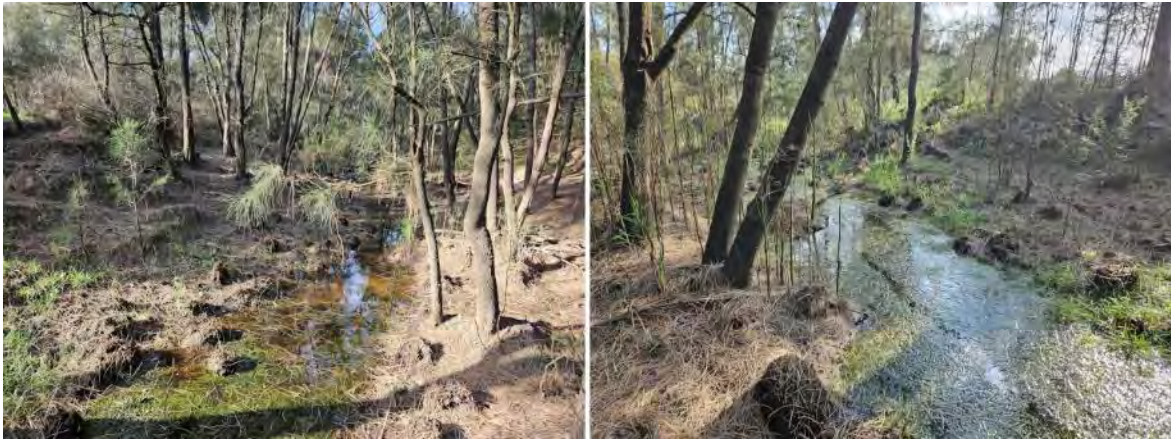
Figure 32: Looking upstream at LC12 (left) and looking downstream (right).

The previous monitoring round in 2022 noted that spiny rushes and common reeds at LC12 had died back, and while there was no indication of recovery for the 2023 survey, the reduction was insufficient to warrant reducing the category score for ‘Vegetation on drainage line floor’. Couch grasses and streaked arrow grass (*Triglochin striatum*) showed signs of localised renewed growth, however much of the drainage line floor and walls comprised bare ground smothered in a layer of swamp-oak needles during the 2023 survey (**Figures 32 and 33**). Cattle access the creekline at LC12 contributes to exposure of soil profiles through trampling, and there was a reduction in category score for ‘Nature of drainage line wall materials’ owing to an increase in the estimate of exposed soils along drainage line walls, and as a result, the LC12 CSIRO ESA score declined, and the overall site rating shifted from the lower limits of *Potentially Stabilising* to the upper limits of *Active* in 2023.

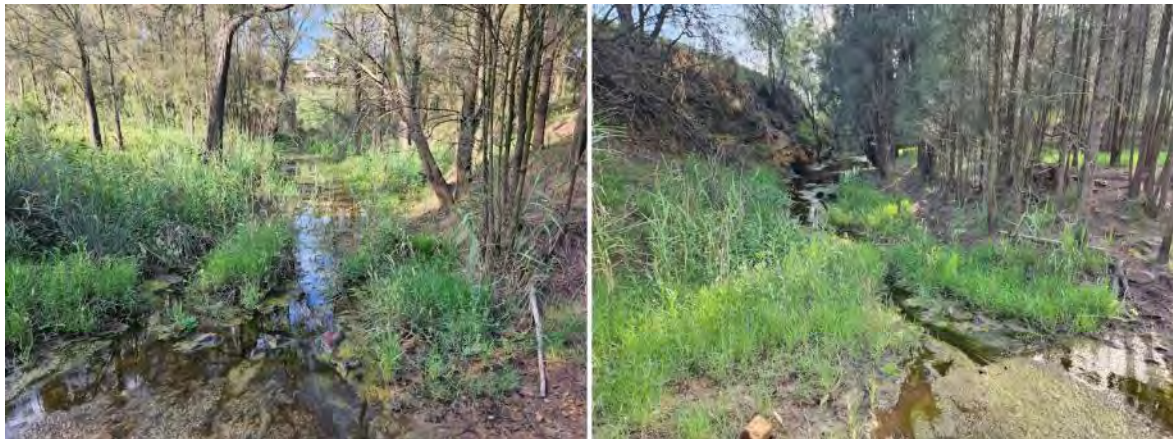
Figure 34: Looking upstream at LC14 (left) and looking downstream (right) in 2023.

Overall, the site drainage channel condition appears consistent with the previous monitoring round and there were no changes to the CSIRO ESA rating, maintaining its rating within the upper limits of *Active* in 2023.

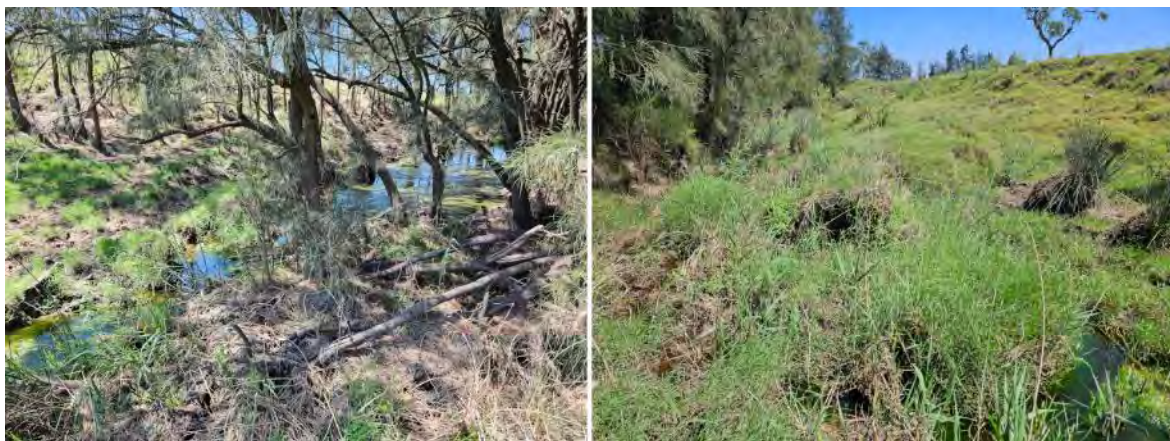
Figure 38: Looking upstream (left) and downstream (right) at LC9.

The creek waters were clear and flowing throughout the site length for the 2023 survey. The instream and edge bank couch grasses, common reed and spiny rush growths showed signs of minor growth since the 2022 survey, and the erosion points along the right-hand bank appeared more vegetated (with pasture grasses) despite signs of recent cattle usage of the area (tracks, scats). The left-hand bank riparian corridor remains in good condition with a dense coverage of small to medium sized swamp-oaks and saplings (<1m height). There were no changes to the LC9 site CSIRO ESA rating which has remained within the upper half of *Potentially Stabilising* since 2018.

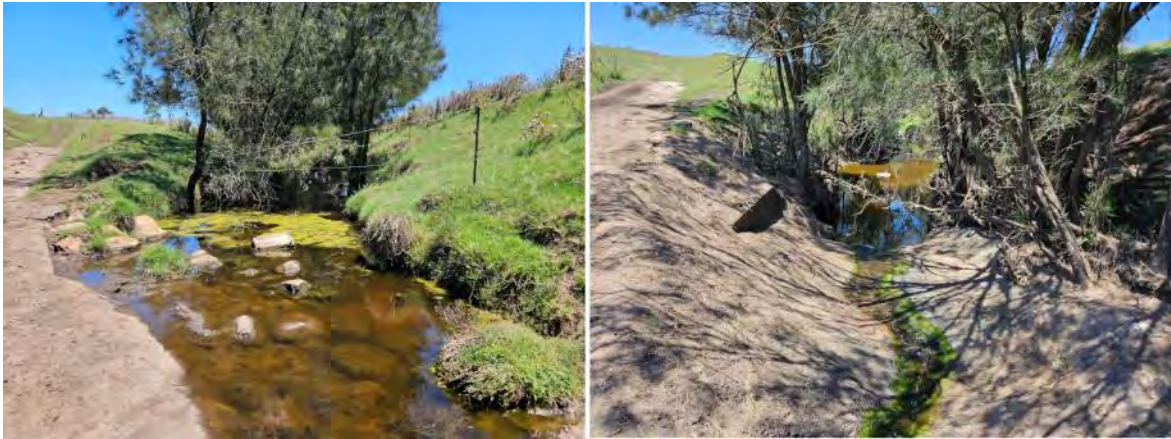
Figure 40: Site LC10 looking upstream from causeway (left) and looking downstream (right).

Surface waters were clear for the 2023 survey and flow was continuous throughout the site length. The condition of the riparian bank vegetation and erosional features (mostly restricted to flow induced bank undercutting and stepped bank profiles from livestock access) remained unchanged from the previous survey. There was an increase in category score for ‘Particle size of materials on drainage line floor’ due to observations made of coarser materials on the substrates up and downstream of the causeway. As a result, the overall LC10 CSIRO ESA rating increased from *Active* to *Potentially Stabilising* for the 2023 survey.

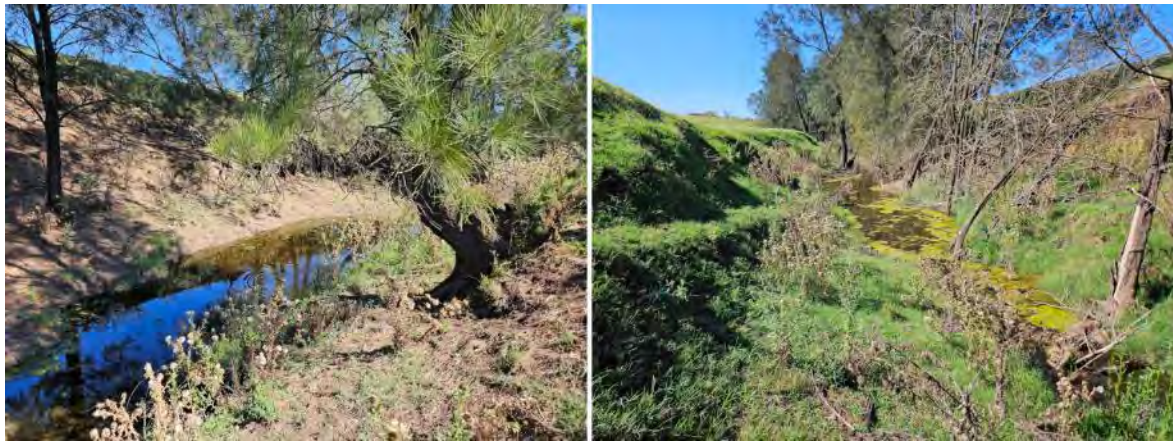
Figure 42: Site LC15 looking upstream (left) and looking downstream (right).

Despite the groundcover vegetation (pasture grasses and weeds) showing a recovery from the degraded condition encountered in 2022, the 'Vegetation on drainage line' category score was reduced for the 2023 survey (from 3 to 2), as the 2023 condition was more suited to the relevant category description. A re-assessment of the 'Shape of drainage line cross-section' resulted in an improved category score, which resulted in an unchanged overall CSIRO ESA score and rating which remained as *Stable* in 2023.
