**RE: MOOLARBEN COAL COMPLEX – UG4 LONGWALLS 401 TO 407 END OF PANEL REPORT**

Secondary extraction of LW407 was completed in January 2026. Accordingly, MCO has prepared a UG4 LW401-407 End of Panel Report (refer to **Enclosure 1**), which presents monitoring data, describes observed impacts during mining of LW401-407 and compares these results to predictions and relevant performance measures and performance indicators as described in the approved UG4 LW401-408 Extraction Plan.

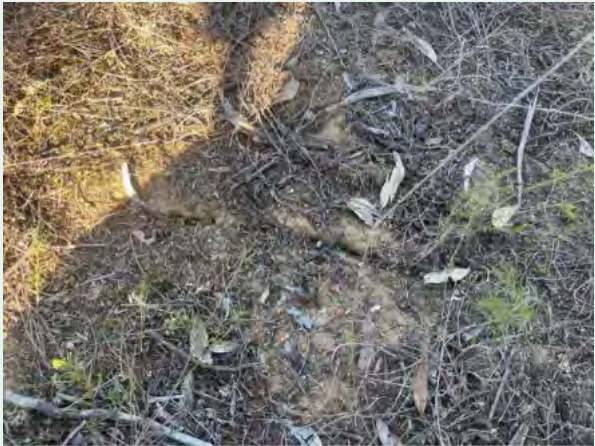
| Study site (undermined) | Year subsidence first observed | Evidence of subsidence | Width of cracking | Length of cracking | Area of plot affected (%) | Location of subsidence | Example Photo |
|---|---|---|---|---|---|---|---|
| UG4_03 | 2023 | Cracking observed (no change from 2023) | 50 mm | 1 m | 0.225 | Small crack observed at 1.5 m on the left hand side (while facing plot end) 1 m from central tape. | |

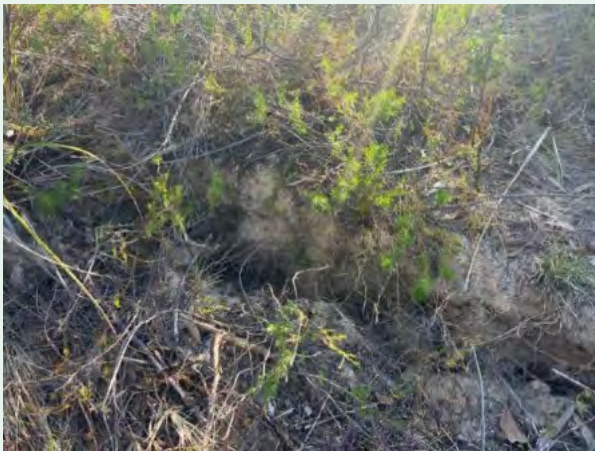
| Study site (undermined) | Year subsidence first observed | Evidence of subsidence | Width of cracking | Length of cracking | Area of plot affected (%) | Location of subsidence | Example Photo |
|---|---|---|---|---|---|---|---|
| | 2023 | | 150 mm | 15 m | | Large crack observed at 49 m spanning across the centre tape. | |

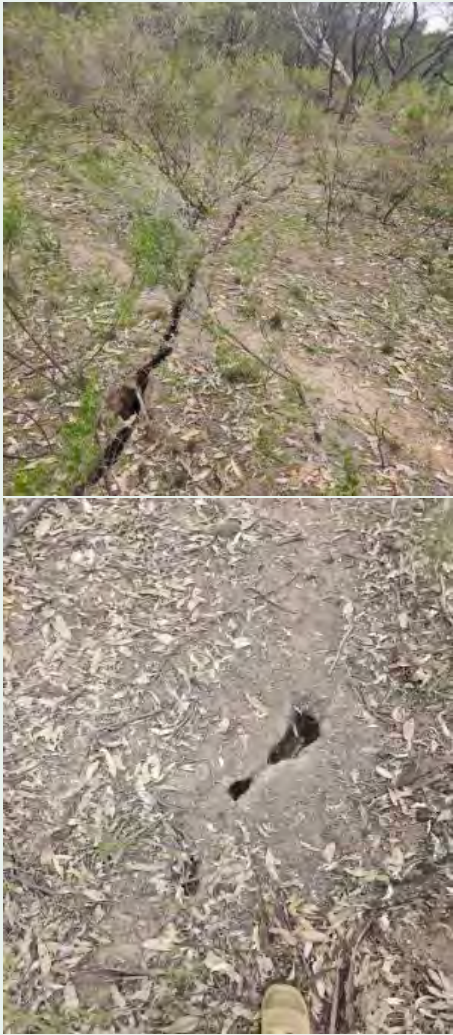
| Study site (undermined) | Year subsidence first observed | Evidence of subsidence | Width of cracking | Length of cracking | Area of plot affected (%) | Location of subsidence | Example Photo |
|---|---|---|---|---|---|---|---|
| UG4_06a | 2025 | Subsiding holes and cracking observed | Holes avg: 200mm; Cracks avg: 50mm | Holes avg: 0.5m; Cracks avg: 5m | Holes (0.03%; avg hole x3); Cracks (0.15%; avg crack x6) | Numerous subsidence holes and long, deep cracks | |

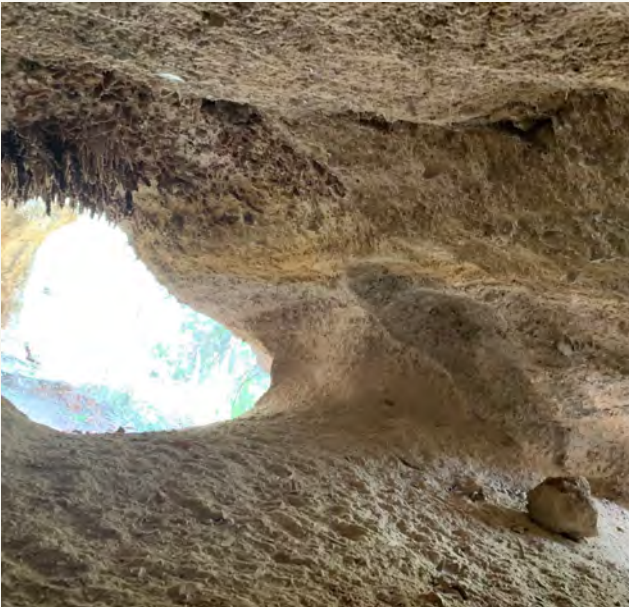
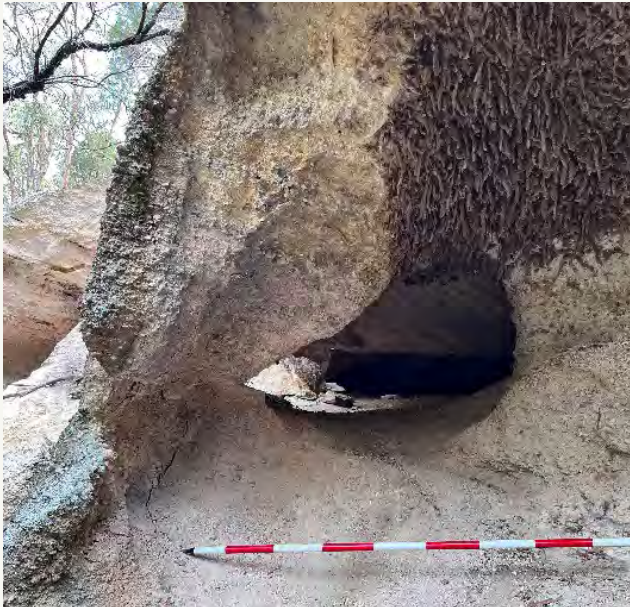
| Baseline recording (Nov 2022) | Post-mining recording (Dec 2025) |
|---|---|
| <p>Plate 5: Detail of rear wall at S1MC358b (AHIMS ID#36-3-3305) with graffiti and fresh exfoliation. Photo taken on 21 November 2022.</p> | <p>Plate 6: Interior of shelter with collapsed block. Photo taken on 11 December 2025.</p> |

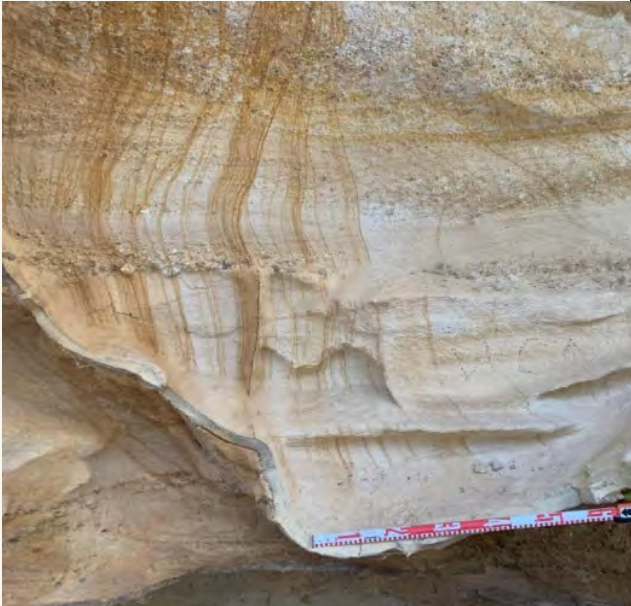
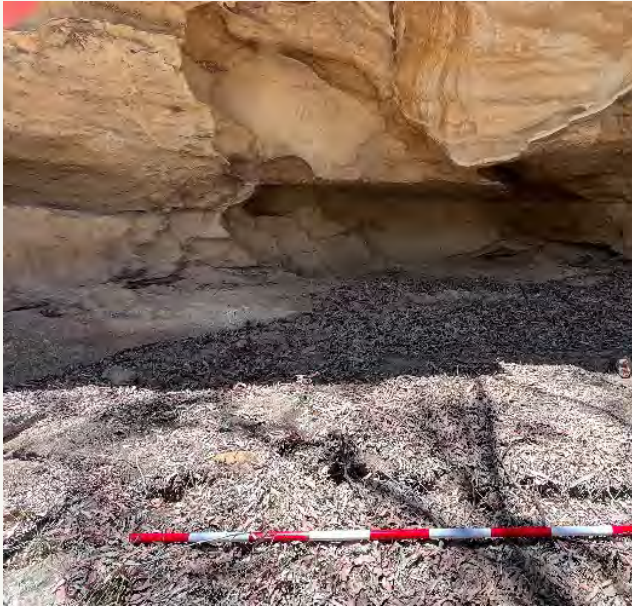
| Baseline recording (Nov 2022) | Post-mining recording (Dec 2025) |
|---|---|
| Plate 59: Graffiti panel 2. Photo taken on 29 November 2022. | Plate 60: Graffiti panel 2 in background with fissure crack in front of shelter in foreground. Photo taken on 9 December 2025. |

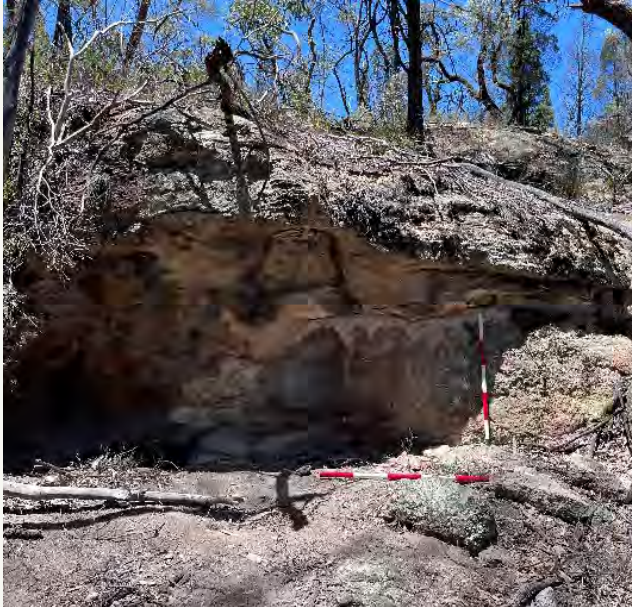
| Baseline recording (Nov 2022) | Post-mining recording (Dec 2025) |
|---|---|
| | Plate 61: Evidence of fissure cracks found on top of the rock that covers the shelter. Photo taken on 9 December 2025. |

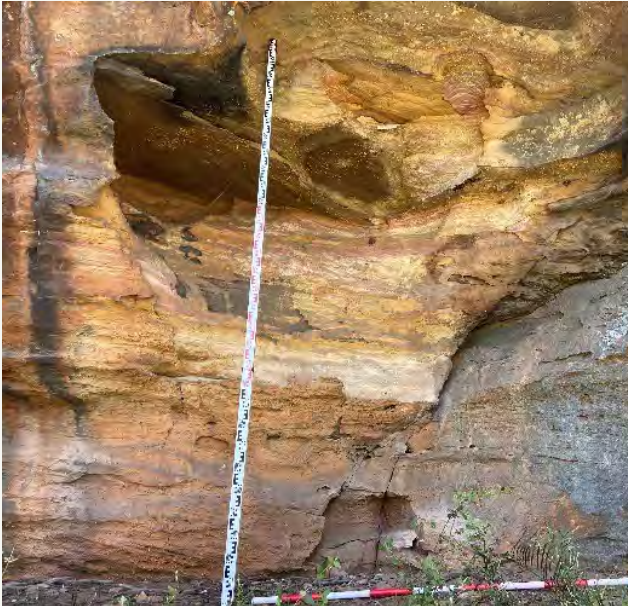
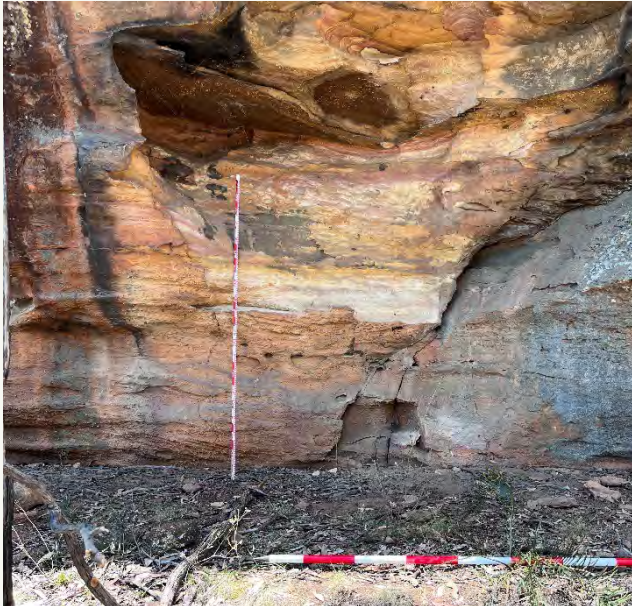
| Baseline recording (Nov 2022) | Post-mining recording (Dec 2025) |
|---|---|
| <p data-bbox="164 1037 794 1115">Plate 71: Midsection of site - floor fissure details. Photo taken on 29 November 2022.</p> | <p data-bbox="810 1037 1444 1115">Plate 72: Midsection of site - floor fissure has not widened or become compressed. Photo taken on 9 December 2025.</p> |

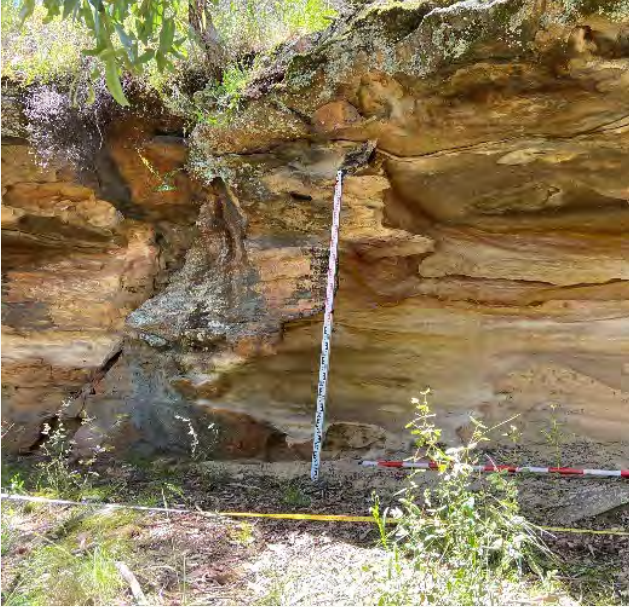
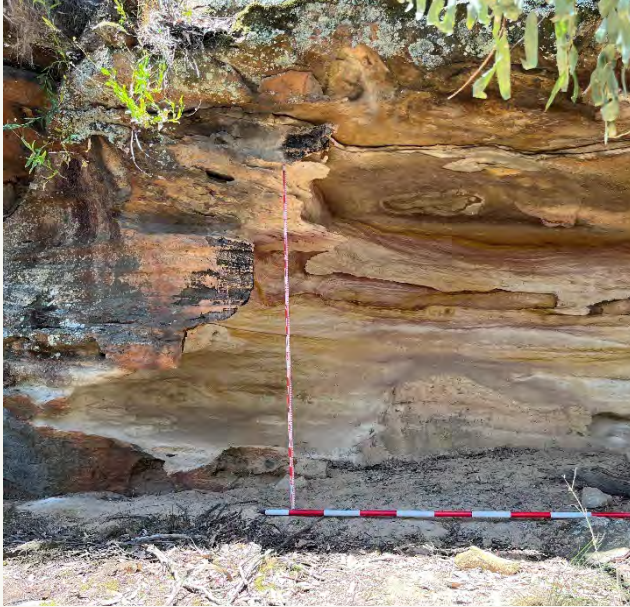
| Baseline recording (Nov 2022) | Post-mining recording (Dec 2025) |
|---|---|
| Plate 75: Eastern section of shelter, view to the north east. Photo taken on 29 November 2022. | Plate 76: Some natural erosion processes continued to remove roof spall in the eastern section of the shelter. Minor cracking was observed in the roof and back wall. Photo taken on 9 December 2025. |

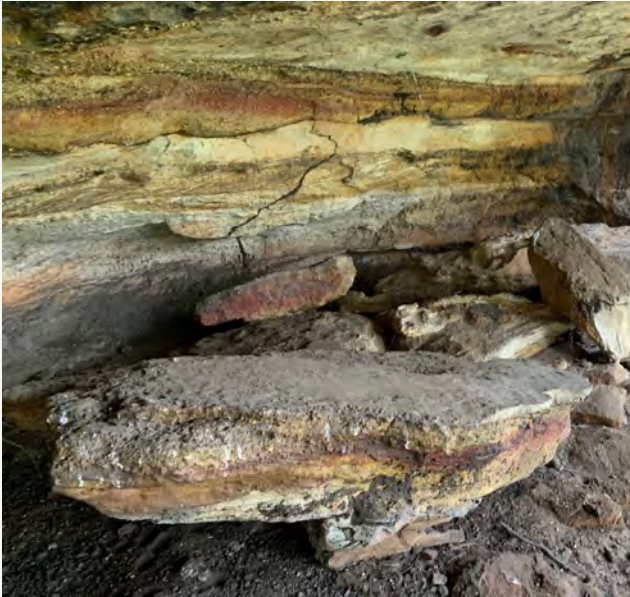
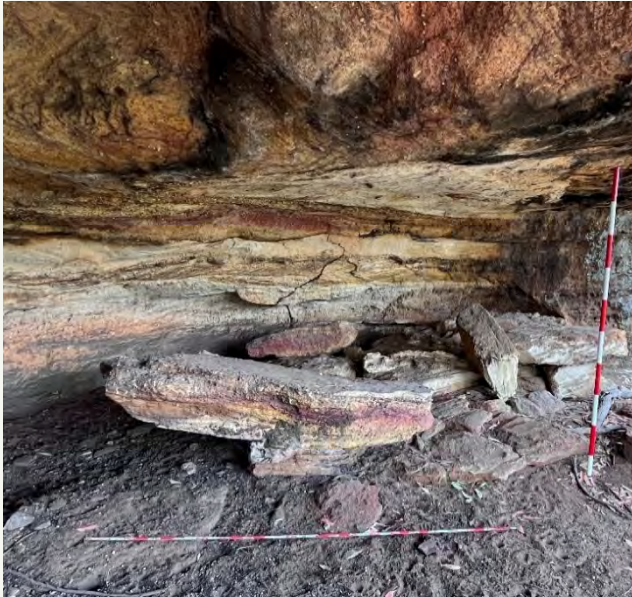
| Baseline recording (Mar 2021) | Post-mining recording (Dec 2025) |
|---|---|
| <p>Plate 85: Detail of southern end of S1MC280 (AHIMS ID#36-3-0042), showing vertical and diagonal cracks through rear wall and blockfall with smooth polish. Photo taken on 17 March 2021.</p> | <p>Plate 86: Detail of southern end of S1MC280 (AHIMS ID#36-3-0042), showing vertical and diagonal cracks through rear wall and blockfall with smooth polish. Photo taken on 11 December 2025.</p> |

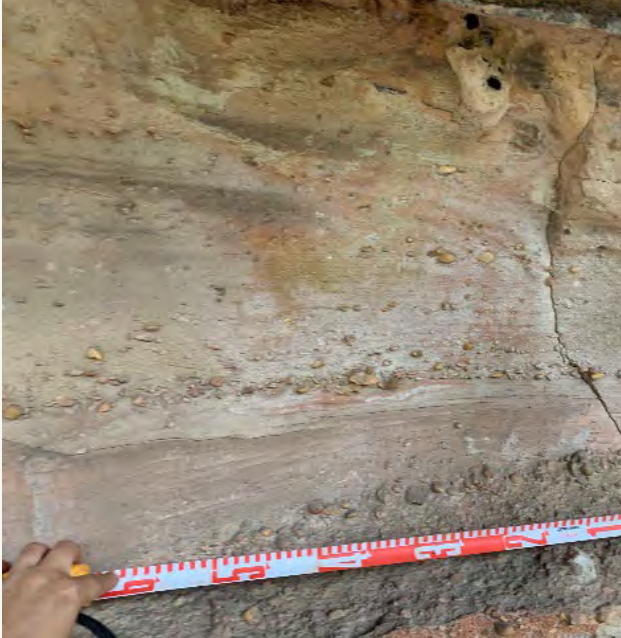
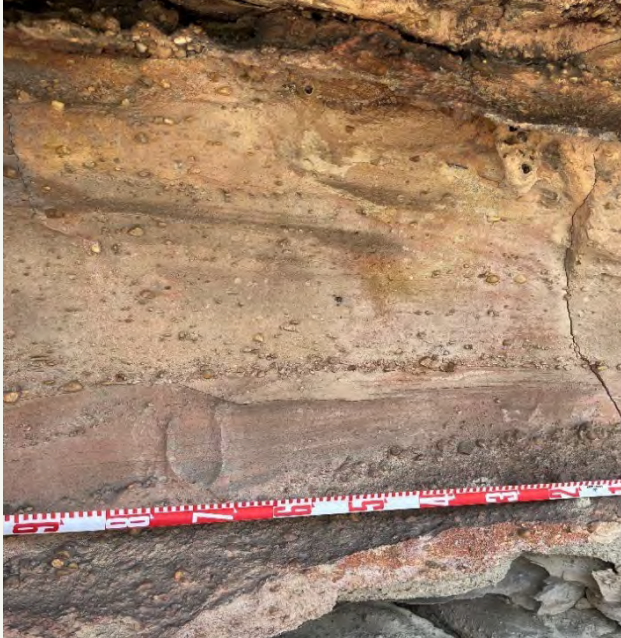
| Baseline recording (Nov 2022) | Post-mining recording (Dec 2025) |
|---|---|
| <p>Plate 99: S1MC472 (AHIMS ID#36-3-3803) fissuring occurring through sandstone banding. Photo taken on 23 November 2022.</p> | <p>Plate 100: S1MC472 (AHIMS ID#36-3-3803) fissuring occurring through sandstone banding has not widened or compressed. Some reddening of profile likely fire or chemical weathering induced. Photo taken on 10 December 2025.</p> |

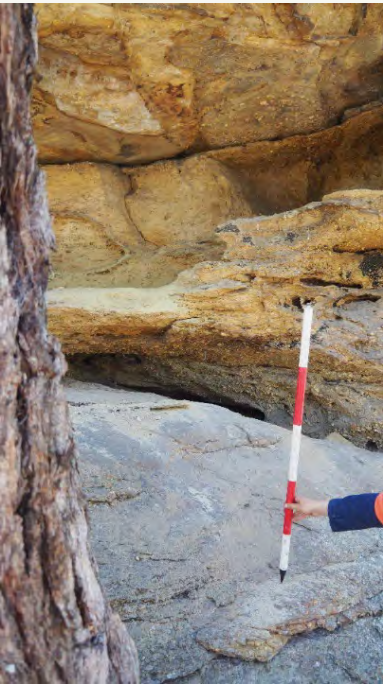
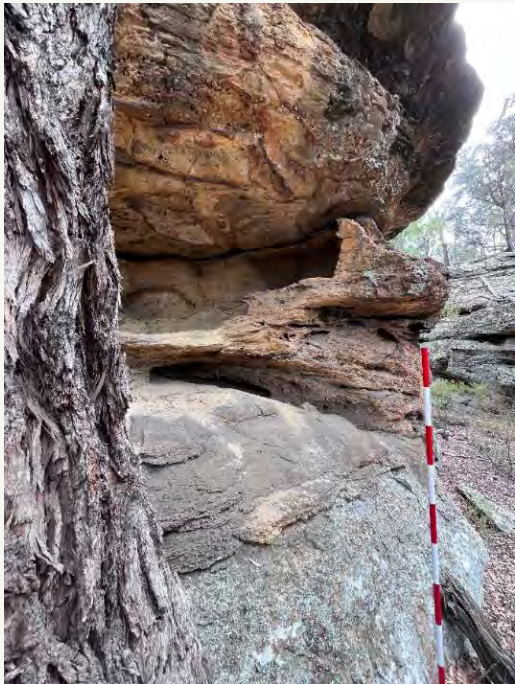
| Baseline recording (Dec 2021) | Post-mining recording (Dec 2025) |
|---|---|
| <p>Plate 129: Close up of shelter at site S1MC491 (AHIMS ID# 36-3-3792), showing the presence of spalling/exfoliation in the rear of the shelter. Photo taken on 2 December 2021.</p> | <p>Plate 130: Close up of shelter at site S1MC491 (AHIMS ID# 36-3-3792), showing the presence of spalling/exfoliation in the rear of the shelter. Photo taken on 10 December 2025.</p> |
