Monthly Environmental Monitoring Report

Yancoal Mt Thorley Warkworth

October 2017

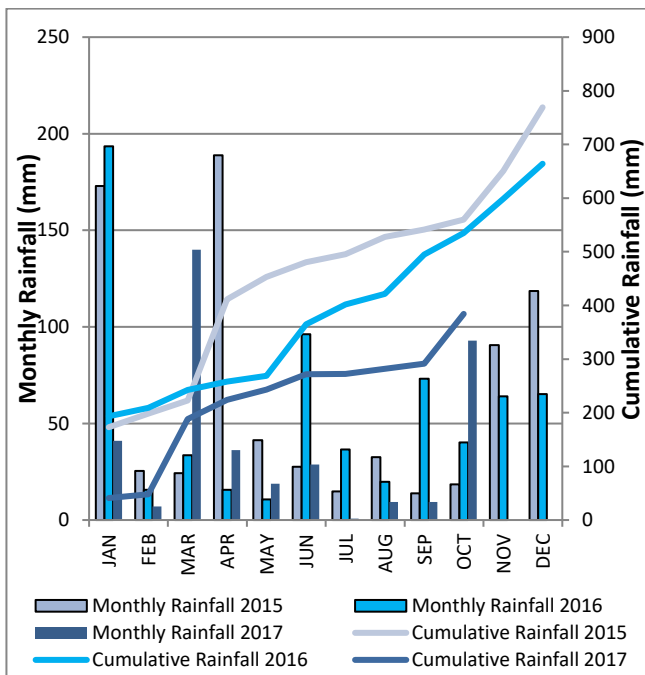
Figure 1: Rainfall Trend YTD

Rainfall for the period is summarised in Table 1, the year-to-date trend and historical trend are shown in **Error! Reference source not found.**

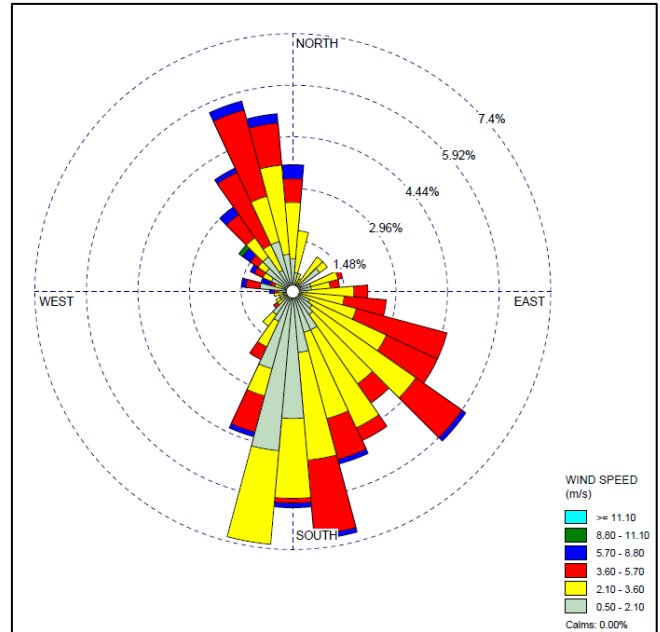
Figure 2: Charlton Ridge Wind Rose – October 2017

Winds from the South and North-West were dominant throughout the reporting period as shown in **Error! Reference source not found.**

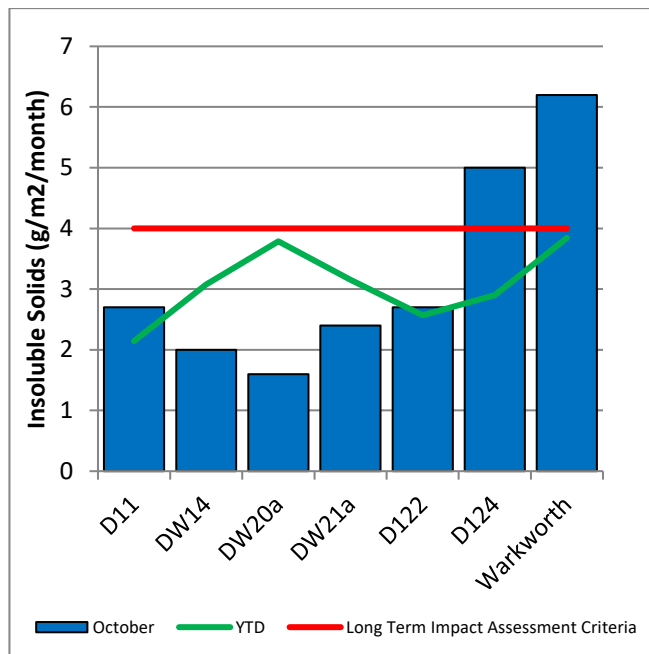
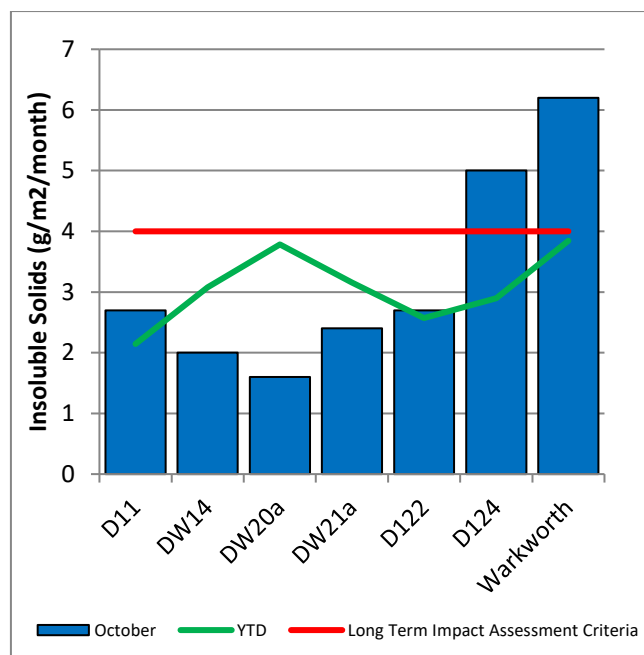
Figure 4: Depositional Dust – October 2017

Figure 4 displays insoluble solids results from depositional dust gauges during the reporting period compared against the year-to-date average and the annual impact assessment criteria.

During the reporting period the D124 and Warkworth monitors recorded a monthly result above the long term impact assessment criteria of 4.0 g/m² per month. Field notes associated with D124 confirm the presence of insects and bird droppings. As such the result is considered contaminated and will be excluded from calculation of the annual average. There is no evidence to suggest that the Warkworth result is contaminated. Accordingly, the result will be included in the annual average calculation.

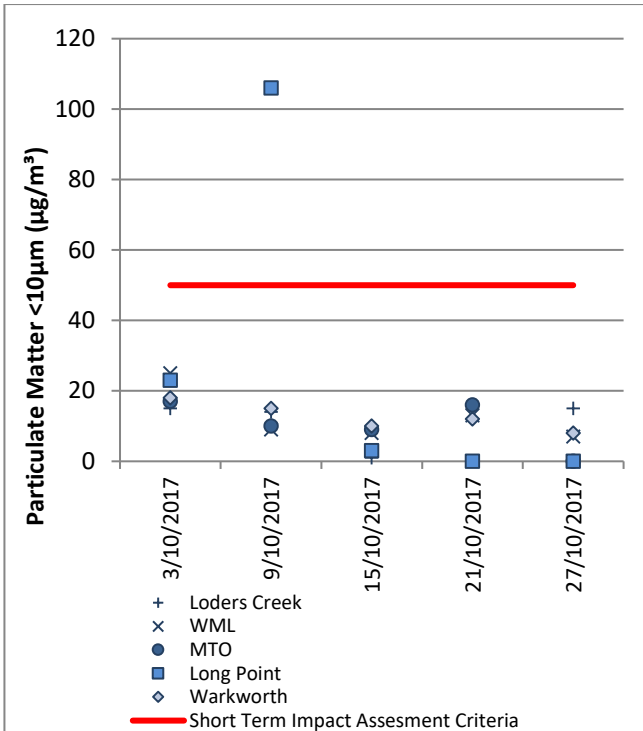
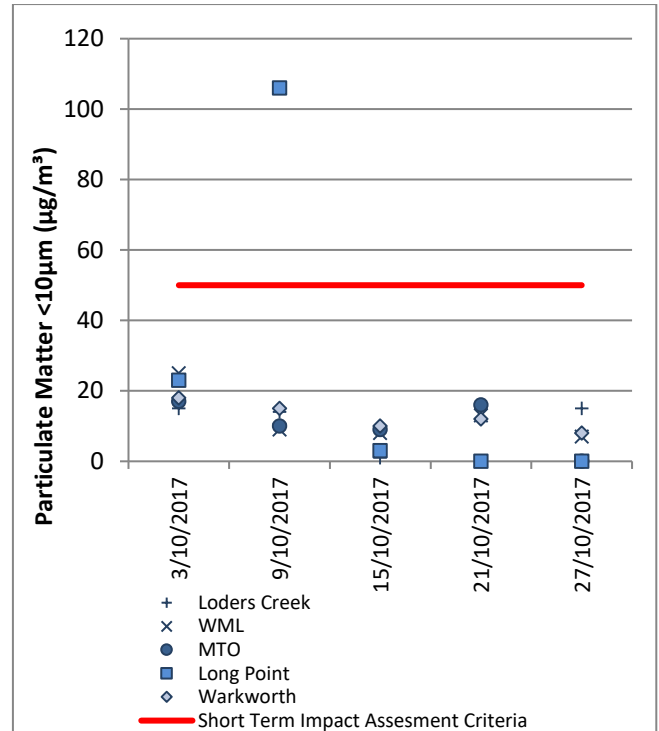
Figure 5: Individual PM₁₀ Results – October 2017

Figure 5 shows the individual PM₁₀ results at each monitoring station against the short term impact assessment criteria of 50µg/m³.

On 09/10/2017 the Long Point HVAS PM₁₀ unit recorded a result of 106µg/m³, which is greater than the short term (24hr) PM₁₀ impact assessment criteria.

Investigation determined that the wind direction was generally not from MTW’s angle of influence at Long Point on the 9th of October. Accordingly, no further action is required.

Data was not available on 21/10/2017 at Long Point due to a power outage and on 27/10/2017 at Long Point or MTO HVAS due to collection of an invalid sample and a power outage, respectively.

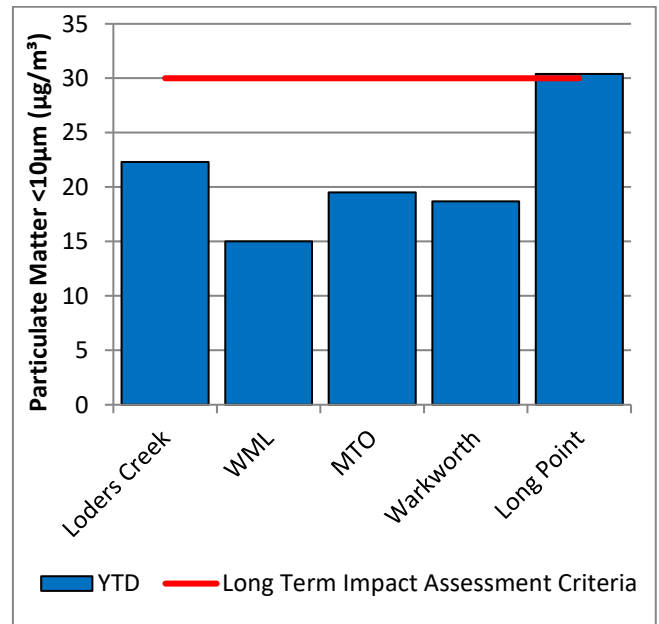
Figure 6: Annual Average PM₁₀ – October 2017

Figure 6 shows the annual average PM₁₀ results against the long term impact assessment criteria.

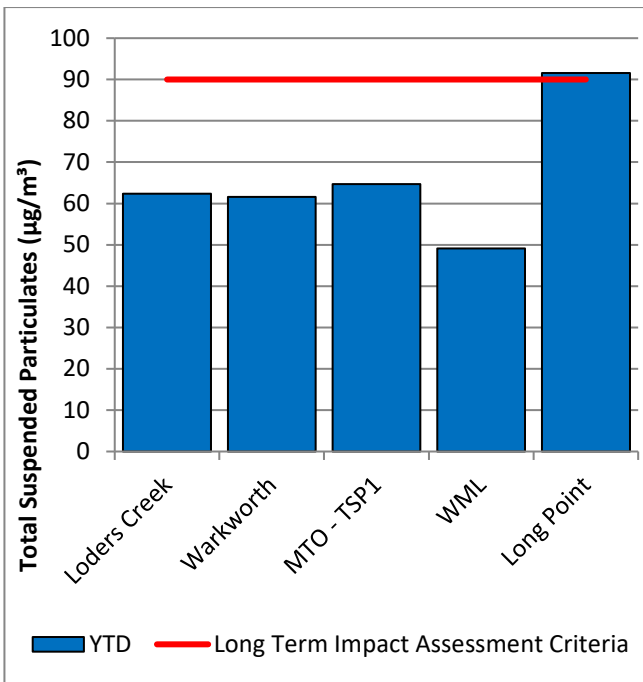
Figure 7: Annual Average Total Suspended Particulates – October 2017

Figure 7 shows the annual average TSP results compared against the long term impact assessment criteria of 90µg/m³.

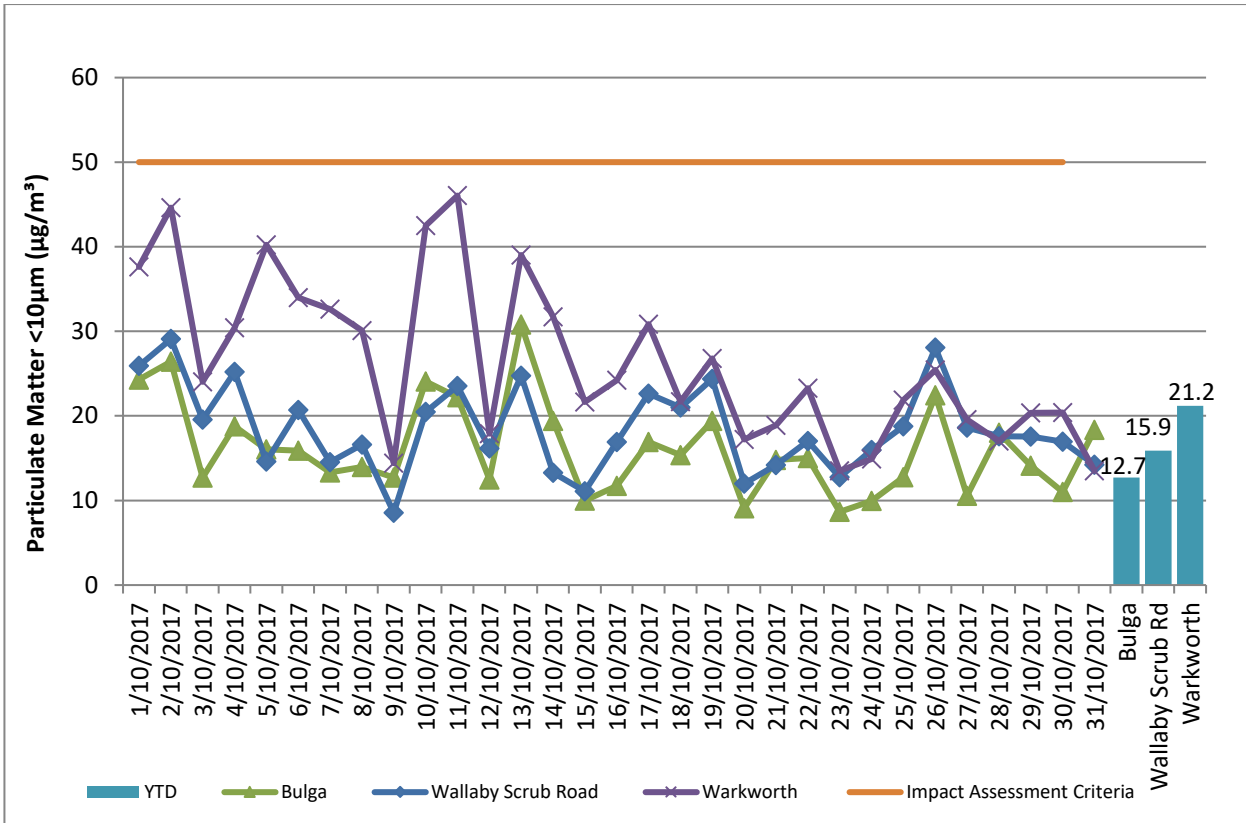
Figure 8: Real Time PM₁₀ daily 24hr average and annual average – October 2017

Results for real time dust sampling are shown in Figure 8, including the daily 24 hour average PM₁₀ result and the annual PM₁₀ average.

During October, the real time monitoring system generated 143 automated air quality related alerts, including 11 alerts for adverse meteorological conditions and 132 alerts for elevated PM₁₀ levels.

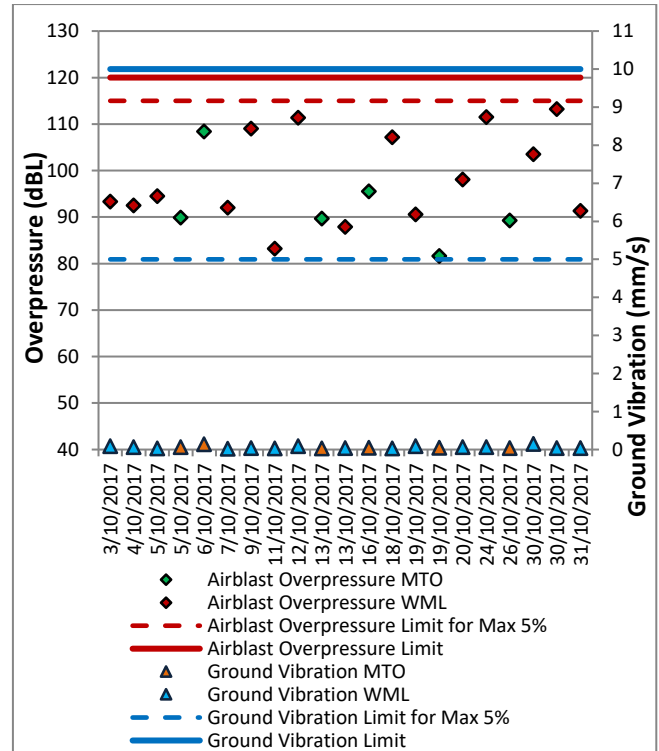
Figure 9: Abbey Green Blast Monitoring Results – October 2017

During the reporting period no blasts exceeded the 115 dB(L) 5% threshold for airblast overpressure or 5mm/s 5% threshold for ground vibration.

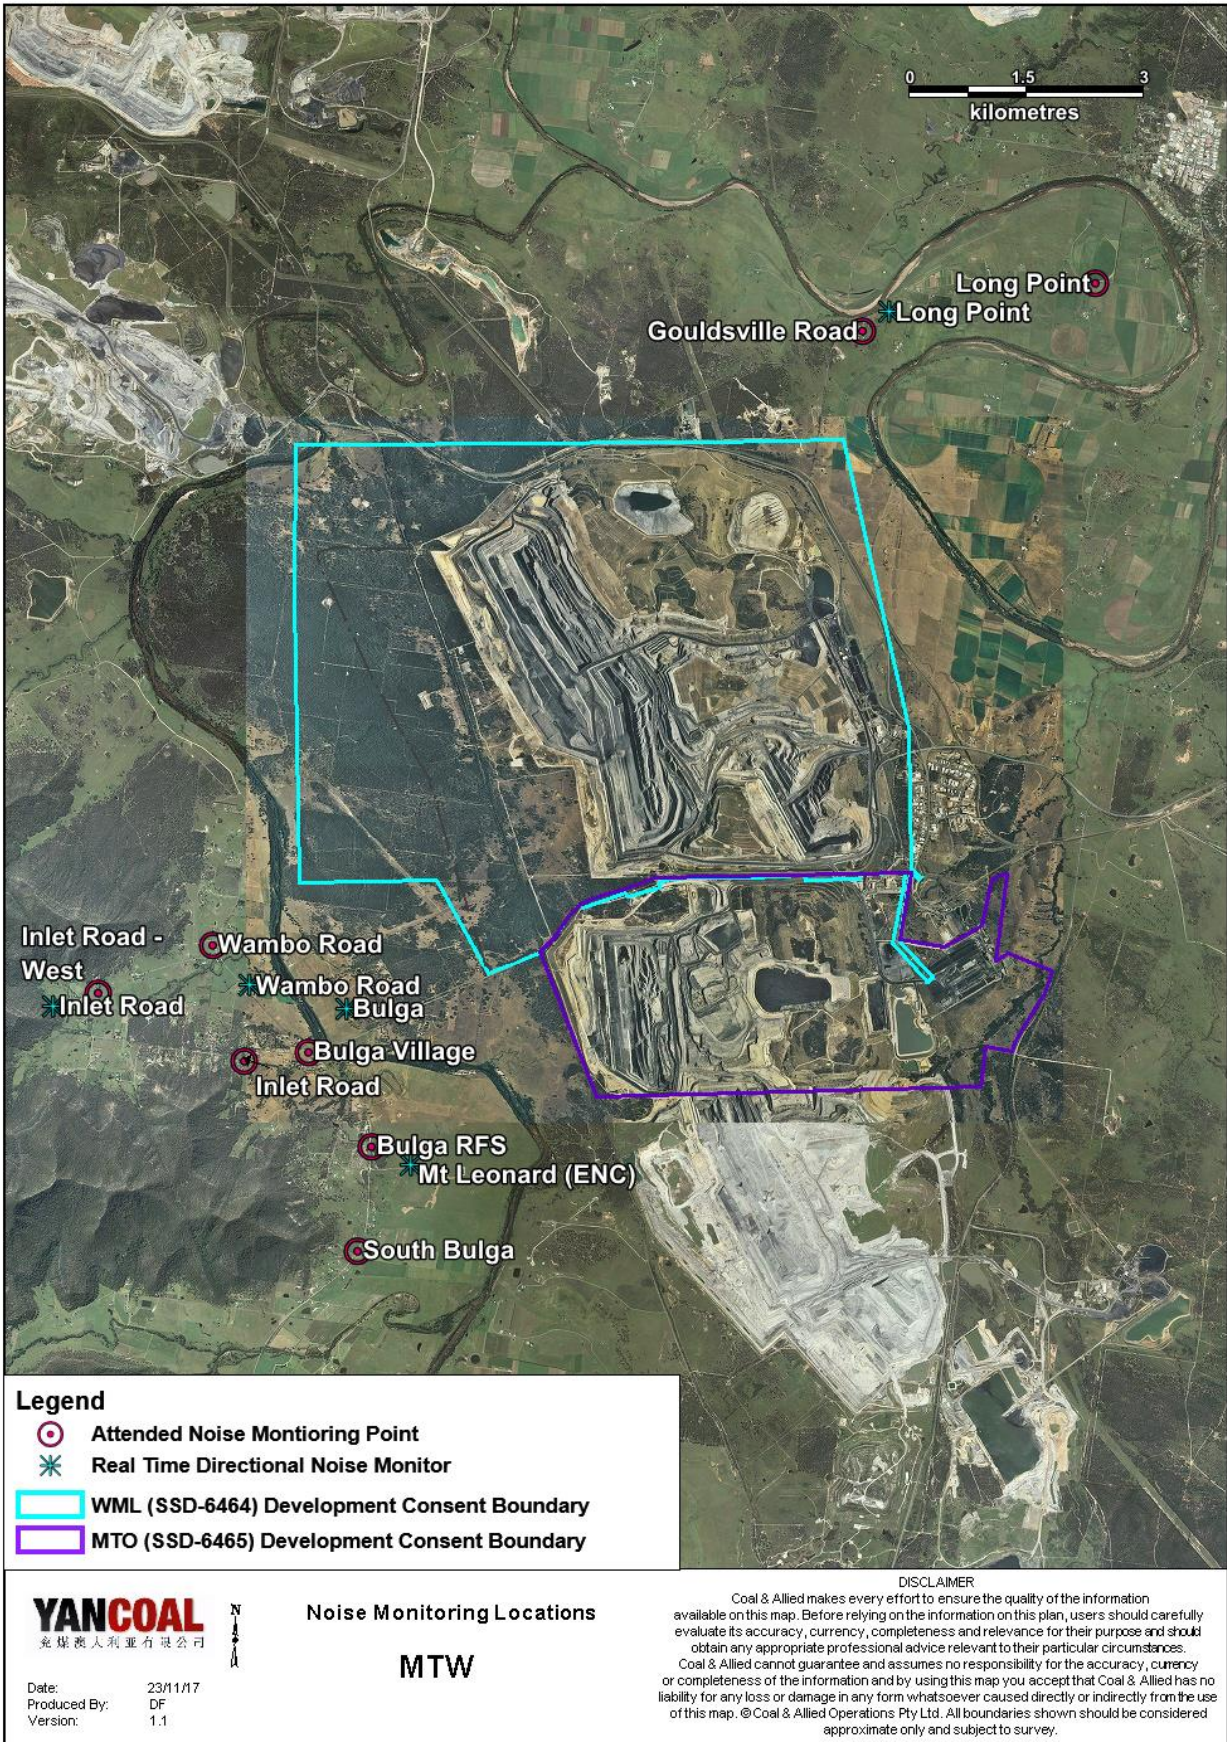
Figure 16: Noise Monitoring Location Plan

Routine attended noise monitoring is carried out in accordance with the MTW Noise Management Plan. A review against EIS predictions will be reported in the Annual Review. The purpose of the noise surveys is to quantify and describe the acoustic environment around the site and compare results with specified limits. Real time noise monitoring also occurs at nine sites surrounding MTW. Noise monitoring locations are displayed in Figure 16.

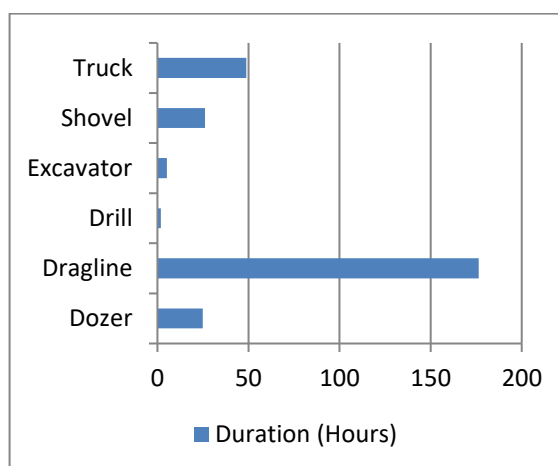
Figure 17: Operational Downtime by Equipment Type – October 2017

During October, a total of 283.3 hours of equipment downtime was logged in response to environmental events such as dust, noise and adverse meteorological conditions. Operational downtime by equipment type is shown in Figure 17.

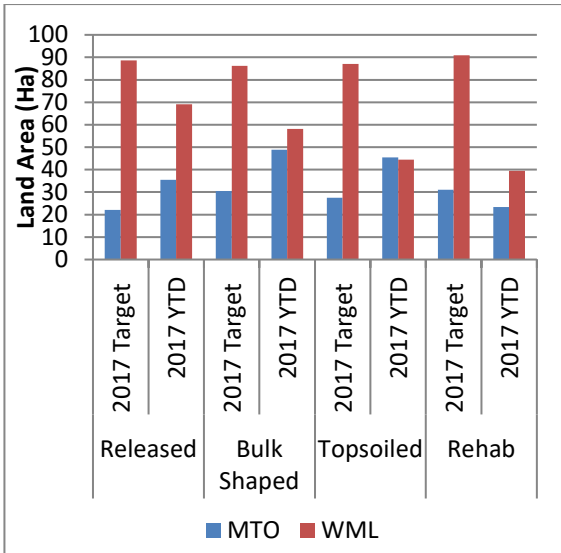
Figure 18: Rehabilitation YTD - October 2017

During October, 11.08 Ha of land was released, 11.75 Ha of land was bulk shaped, 6.57 Ha of land was topsoiled, 24.81 Ha of land was composted and 1.72 Ha of land was rehabilitated.
