Mount Thorley Warkworth

2017 Annual Review

MARCH 2018

Mount Thorley Warkworth (MTW) is an integrated operation of two open cut coal mines, Warkworth Mining Limited (WML) and Mount Thorley Operations (MTO). This Annual Review reports on the environmental performance of Mount Thorley Warkworth (MTW) for the period 1 January 2017 to 31 December 2017.

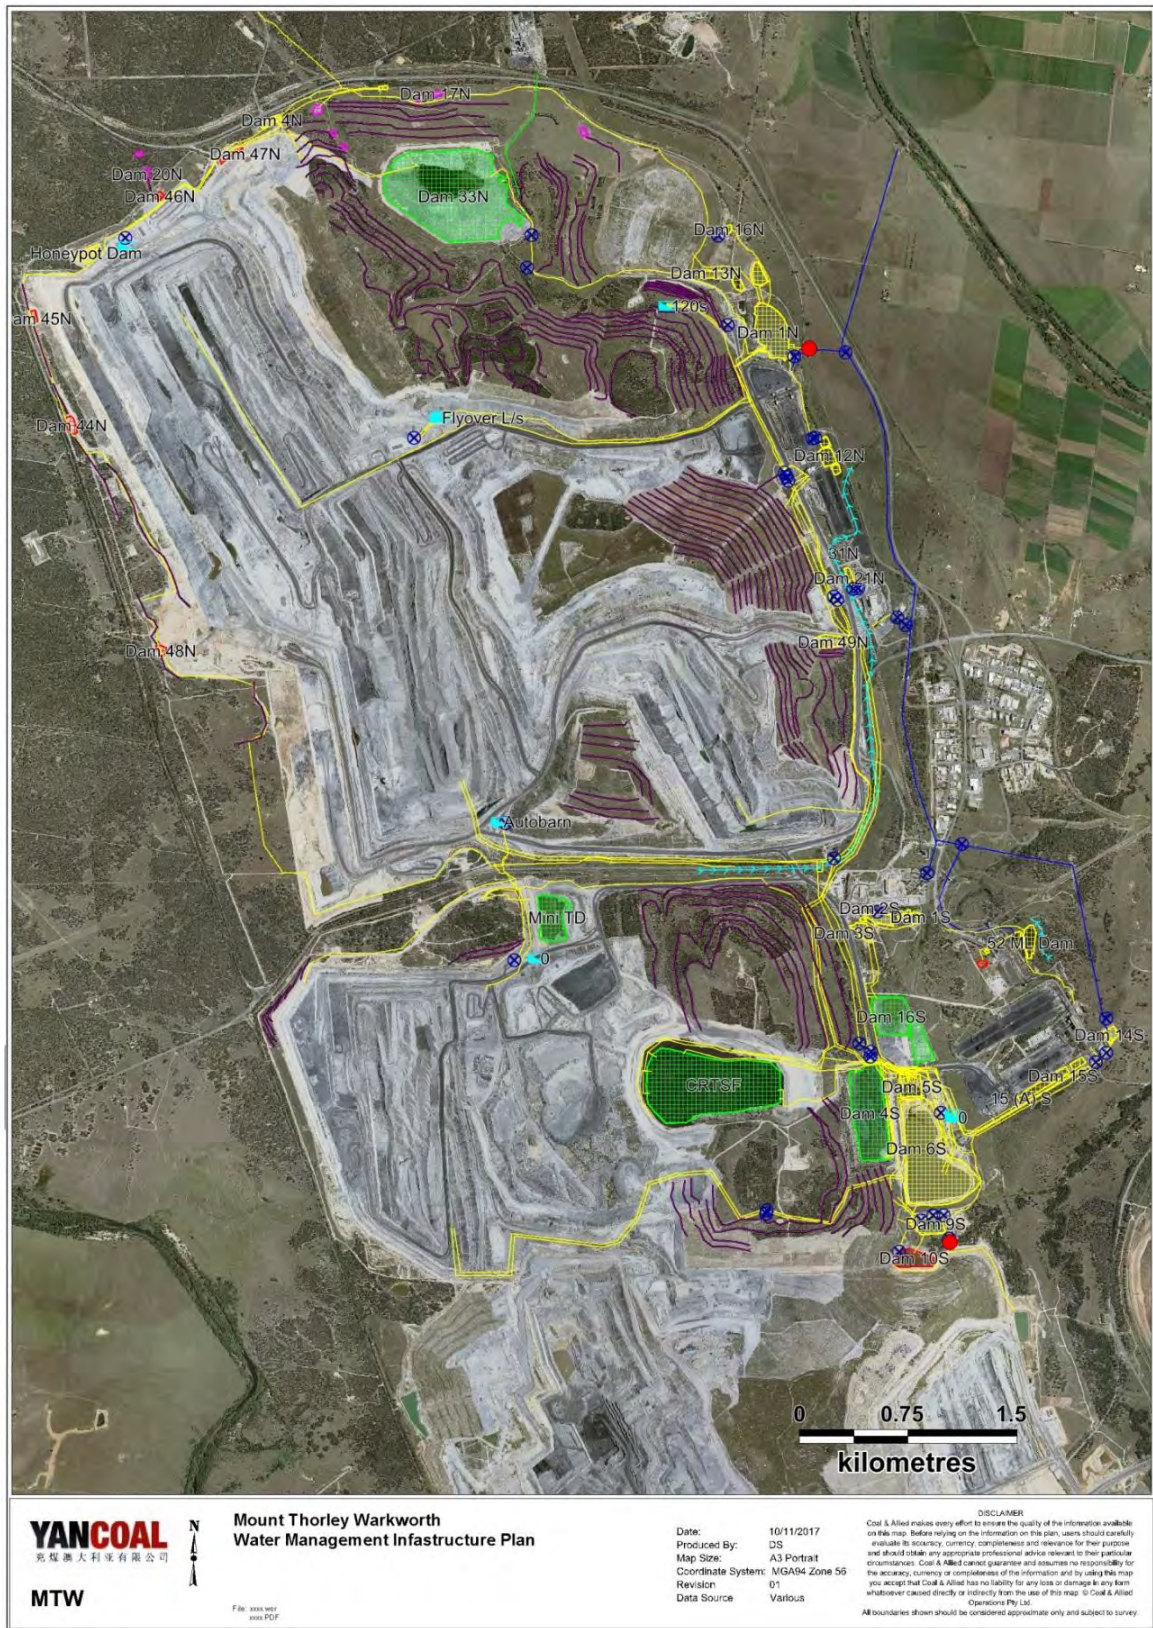
FIGURE 24: WATER MANAGEMENT INFRASTRUCTURE PLAN

Improvements to water management in 2017 have focused on reducing the risk of unauthorised water releases from site. A diversion channel at the base of the Abbey Green rehabilitation area was constructed in 2017. Revegetation of the construction area for the diversion channel is in progress. Other works completed in 2017 include construction of the Dam 48N, and SSD-05 dam to contain runoff from disturbance areas as mining progresses west in Warkworth Pit. MTW gained operational control of Dam 10S sediment dam (Ramp 22 Dam) following its construction by Bulga mine and the **relinquishment of its “Dam Mining Sublease” (sublease part of CL 219)**. MTW is now responsible for ongoing management of the dam as rehabilitation works progress along the common boundary shared with Bulga mine. Dam 10S receives rehabilitation runoff from both Bulga and MTW mine.

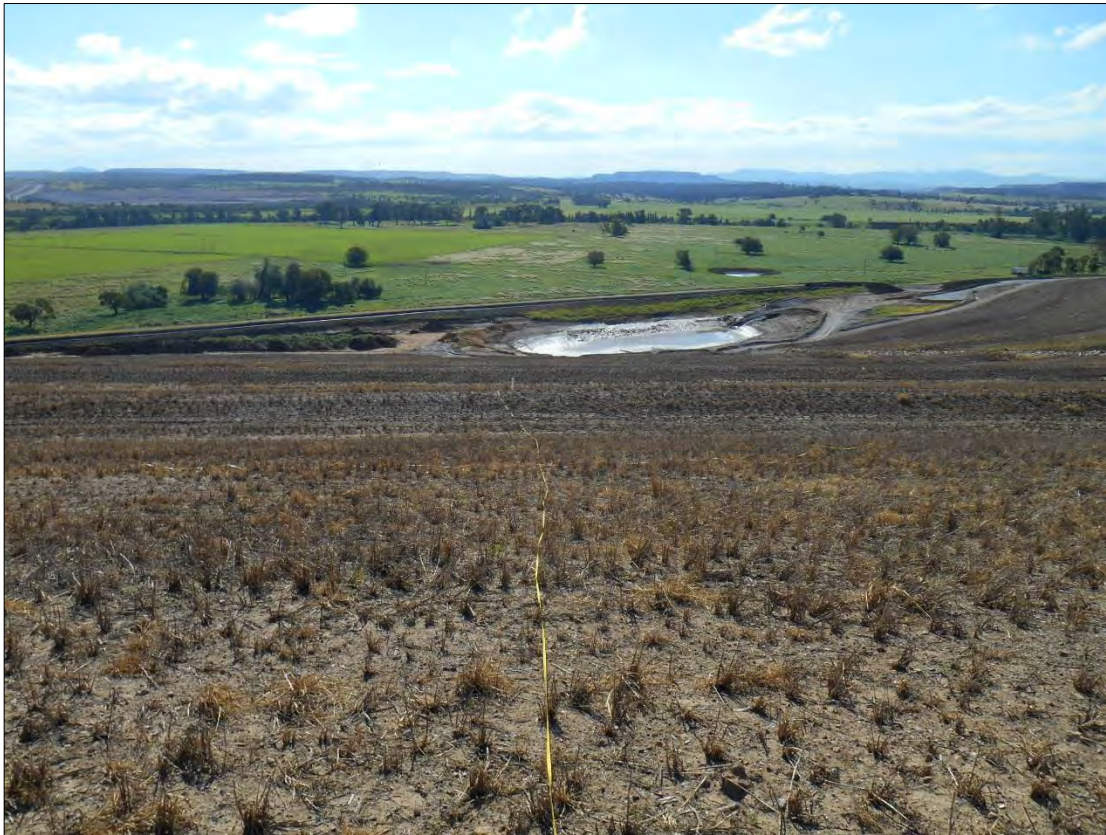
Start position 2017

Disturbance present at rehabilitation site HVOCHE201601 consisted mainly of weeds, and grazing by macropods. No evidence of fire was observed in the rehabilitation area. No areas containing rubbish were observed.

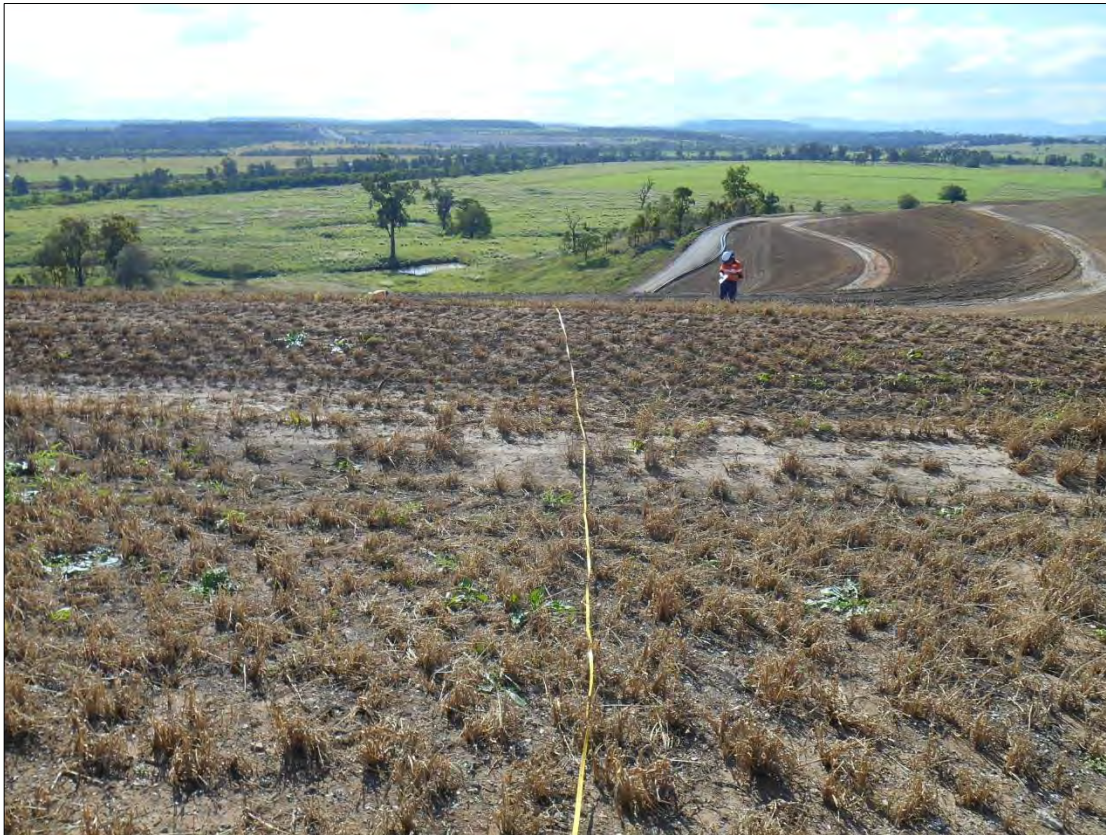
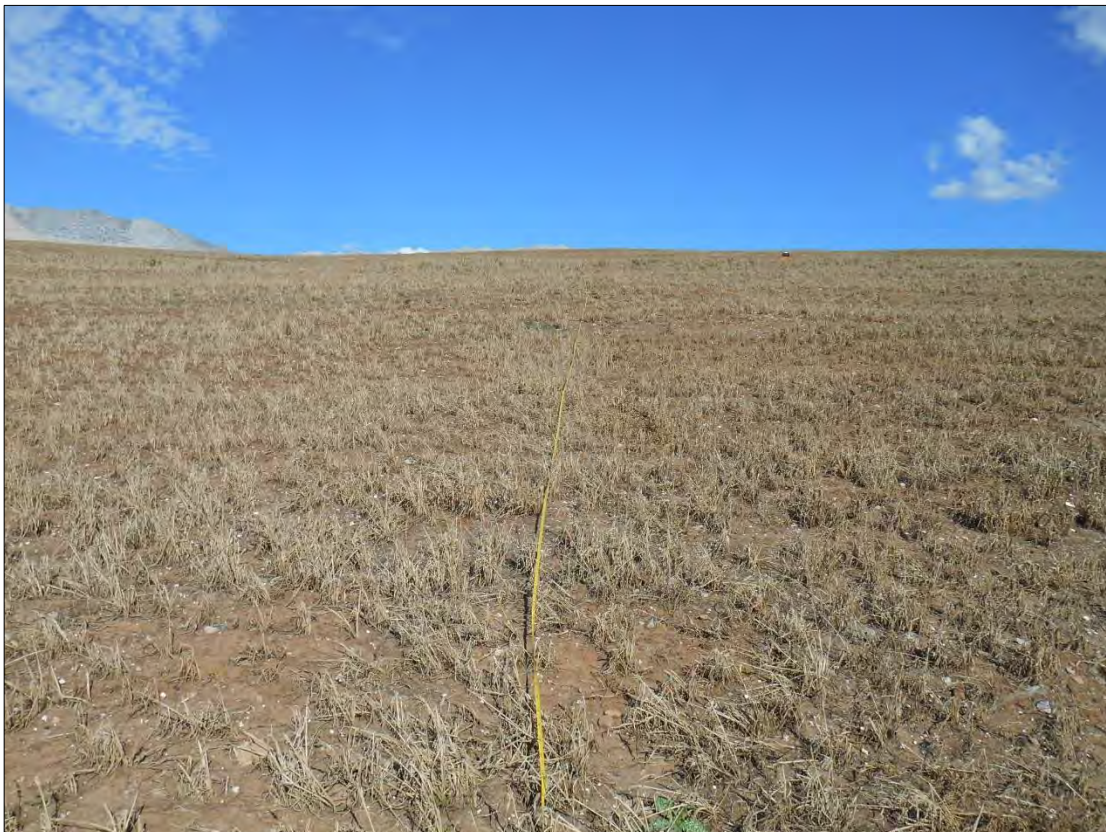
Site photographs at HVOCHE201602

Disturbance present at rehabilitation site HVOCHE201602 consisted mainly of weeds, and grazing by macropods. No evidence of fire was observed in the rehabilitation area. No areas containing rubbish were observed.

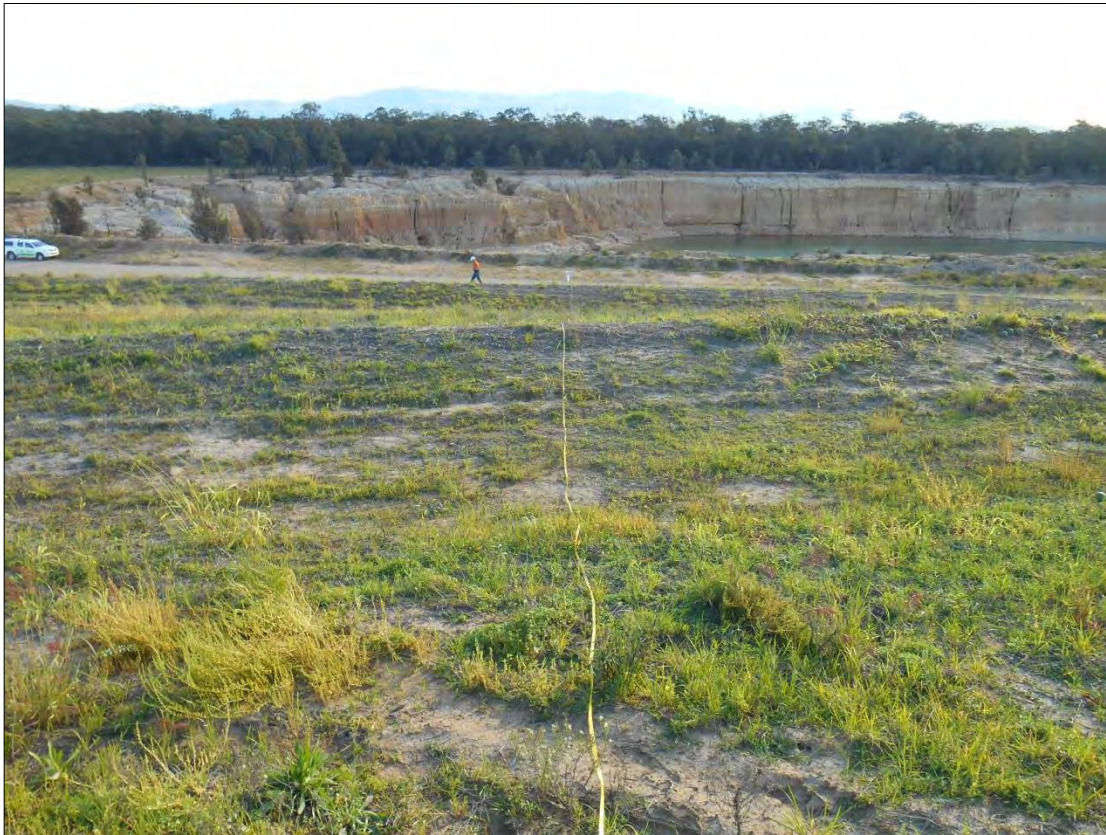
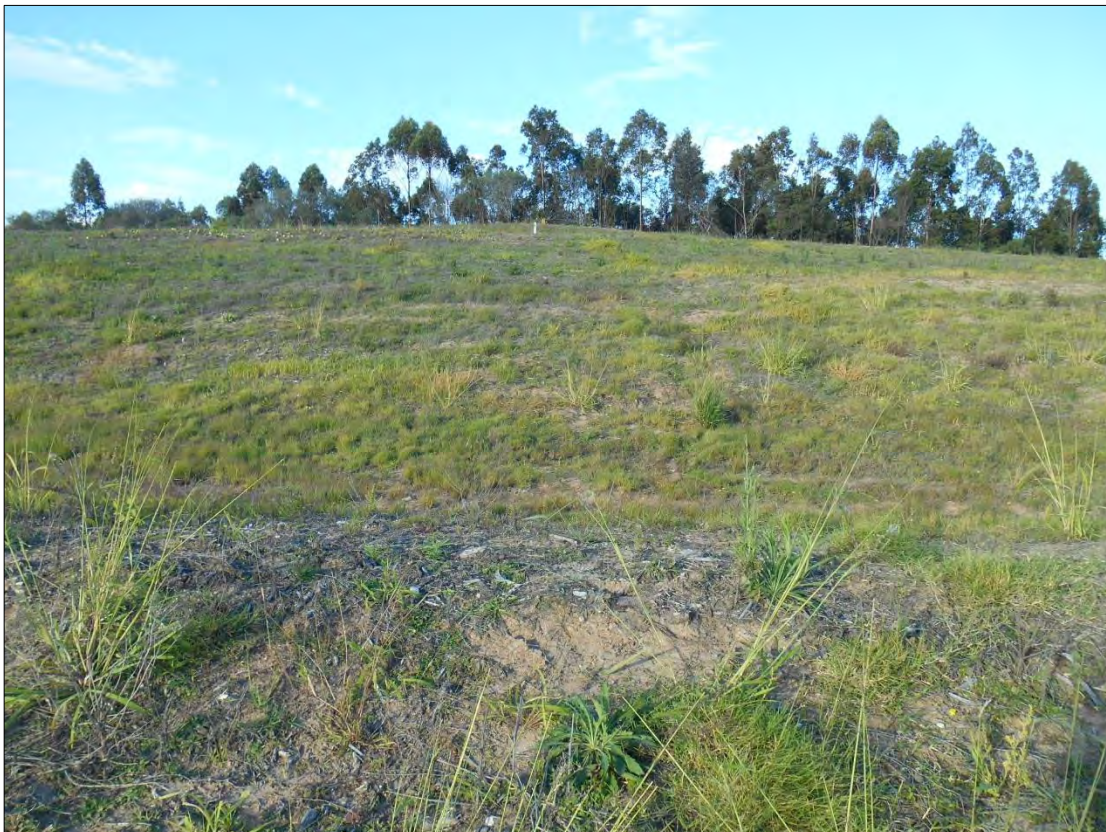
Site photographs at HVOLEM201601

Disturbance present at rehabilitation site HVOLEM201601 consisted mainly of weeds, and grazing by macropods. No evidence of fire was observed in the rehabilitation area. No areas containing rubbish were observed.

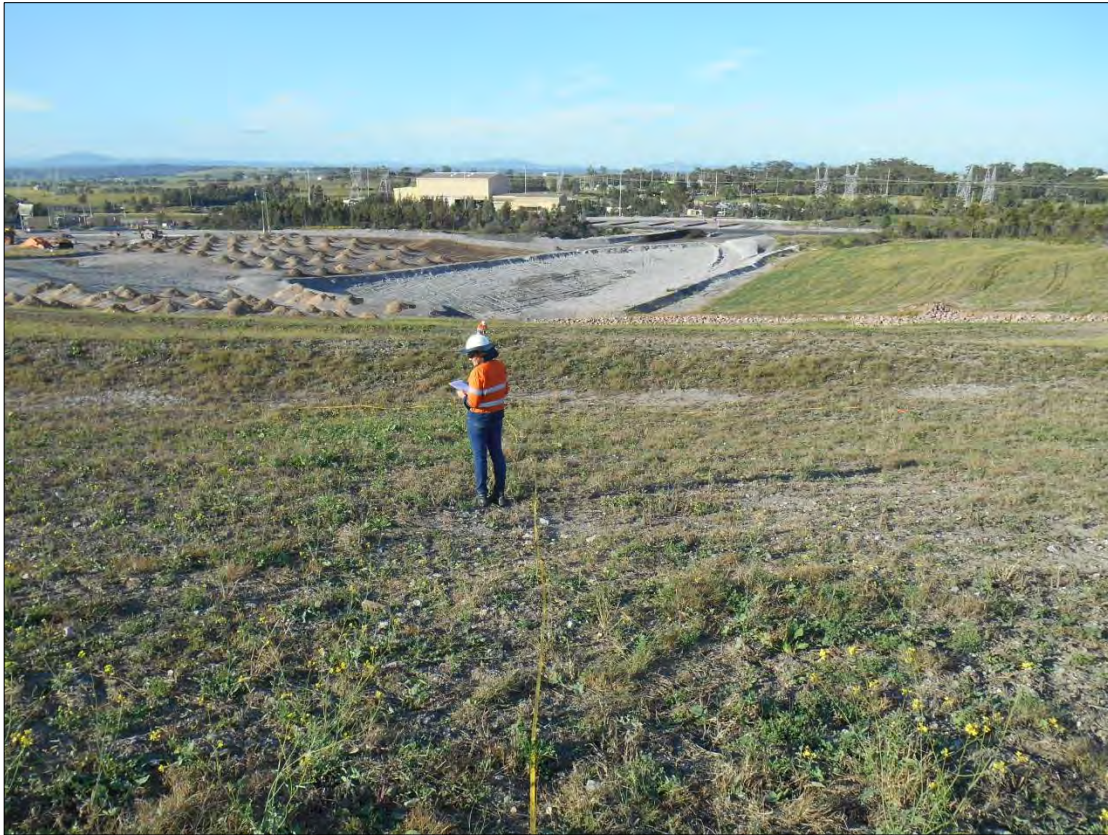
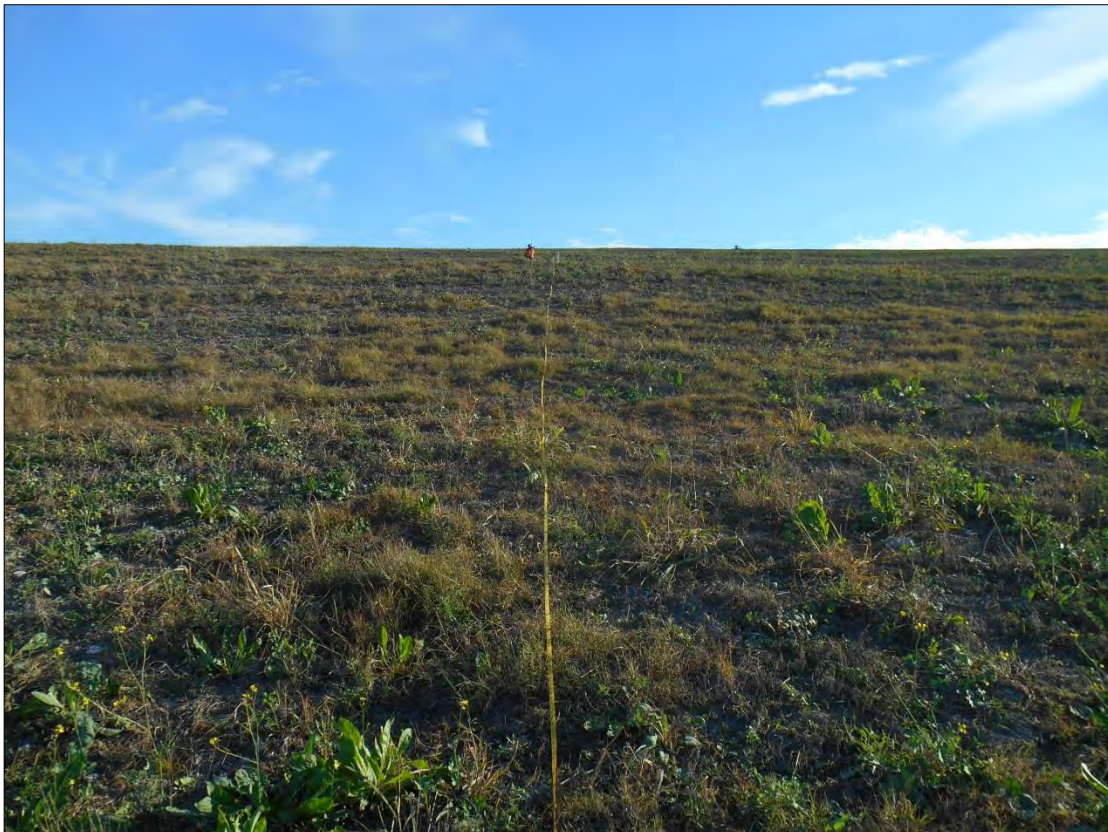
Site photographs at MTWSPS201601

Disturbance present at rehabilitation site MTWSPS201601 consisted mainly of weeds, and grazing by macropods. No evidence of fire was observed in the rehabilitation area. No areas containing rubbish were observed.

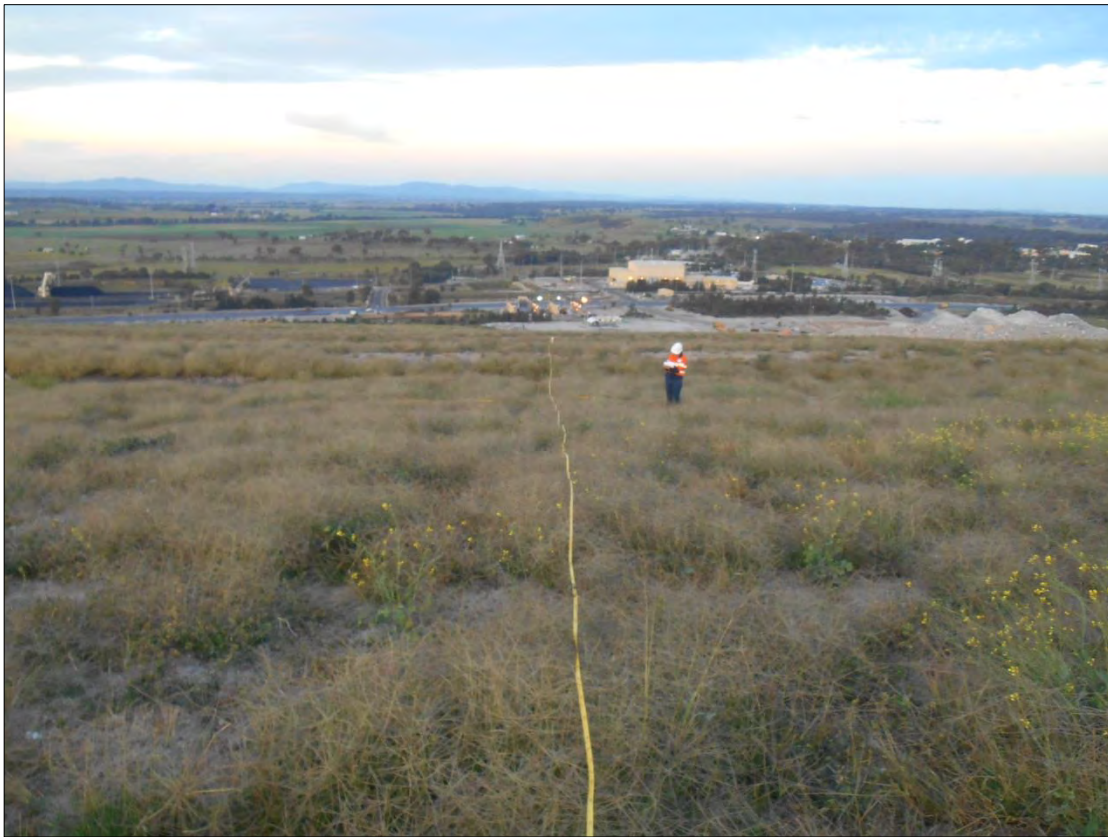
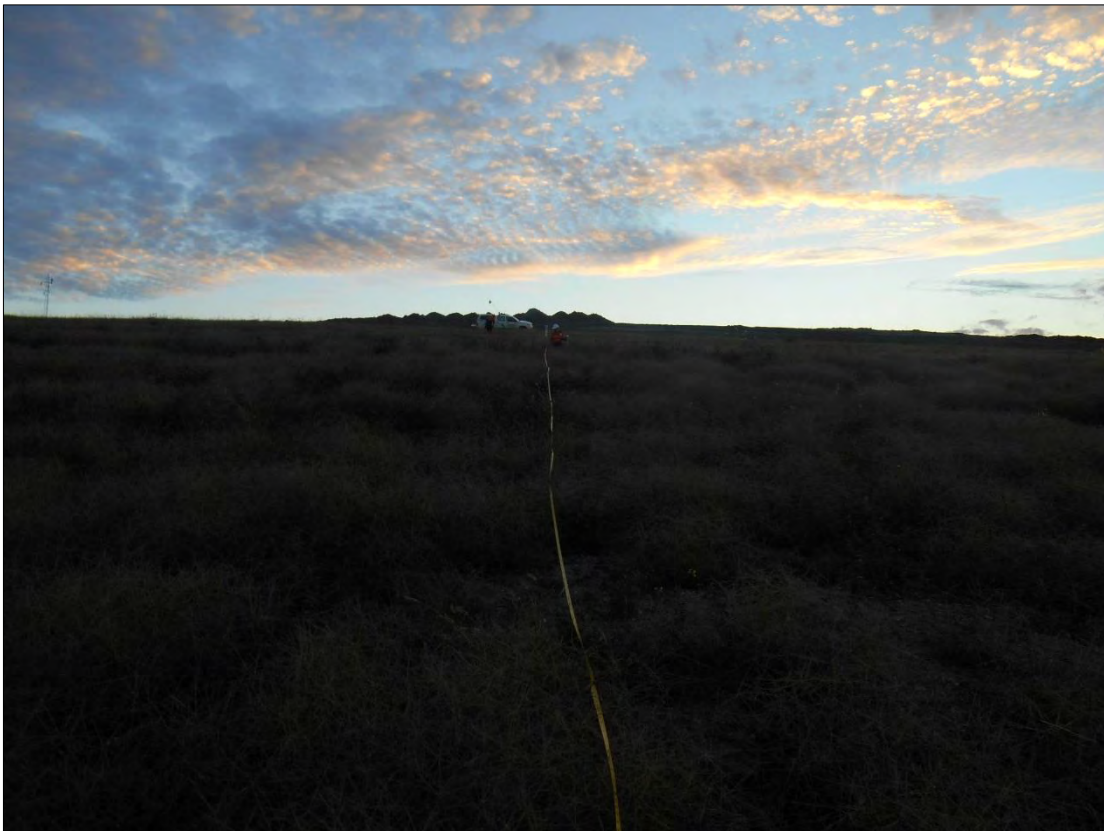
Site photographs at MTWSPN201602

Disturbance present at rehabilitation site MTWSPN201602 consisted mainly of weeds, and grazing by macropods. No evidence of fire was observed in the rehabilitation area. No areas containing rubbish were observed.

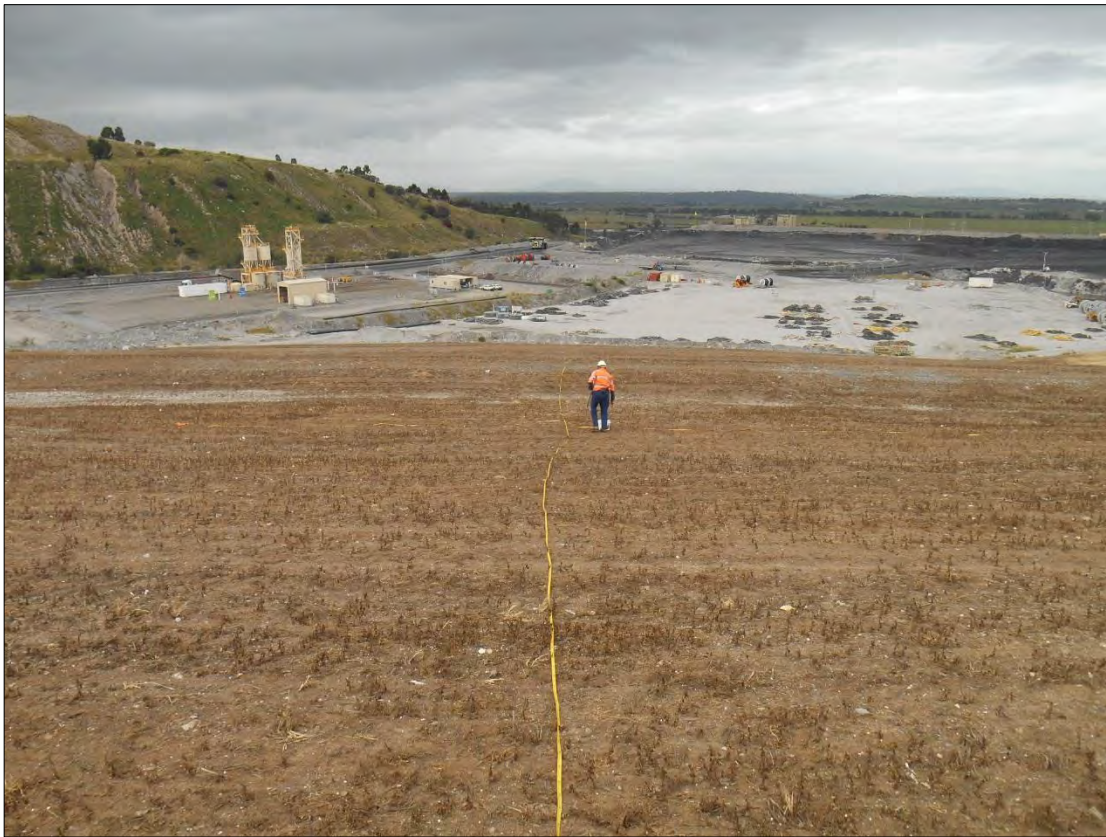
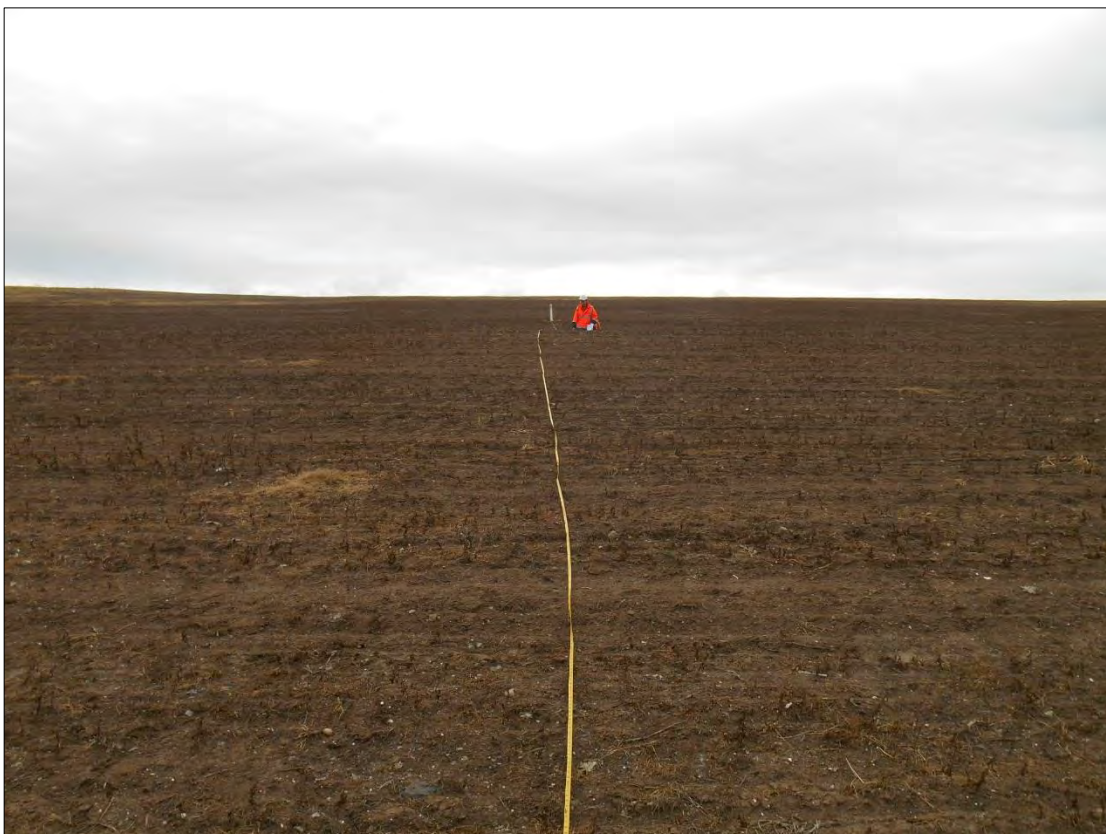
Site photographs at MTWSPN201601

It should be noted no natives or exotic species were recorded at MTWSPN201601.

Disturbance present at the rehabilitation site consisted mainly of weeds, and grazing by macropods. No evidence of fire was observed in the rehabilitation area. No areas containing rubbish were observed.

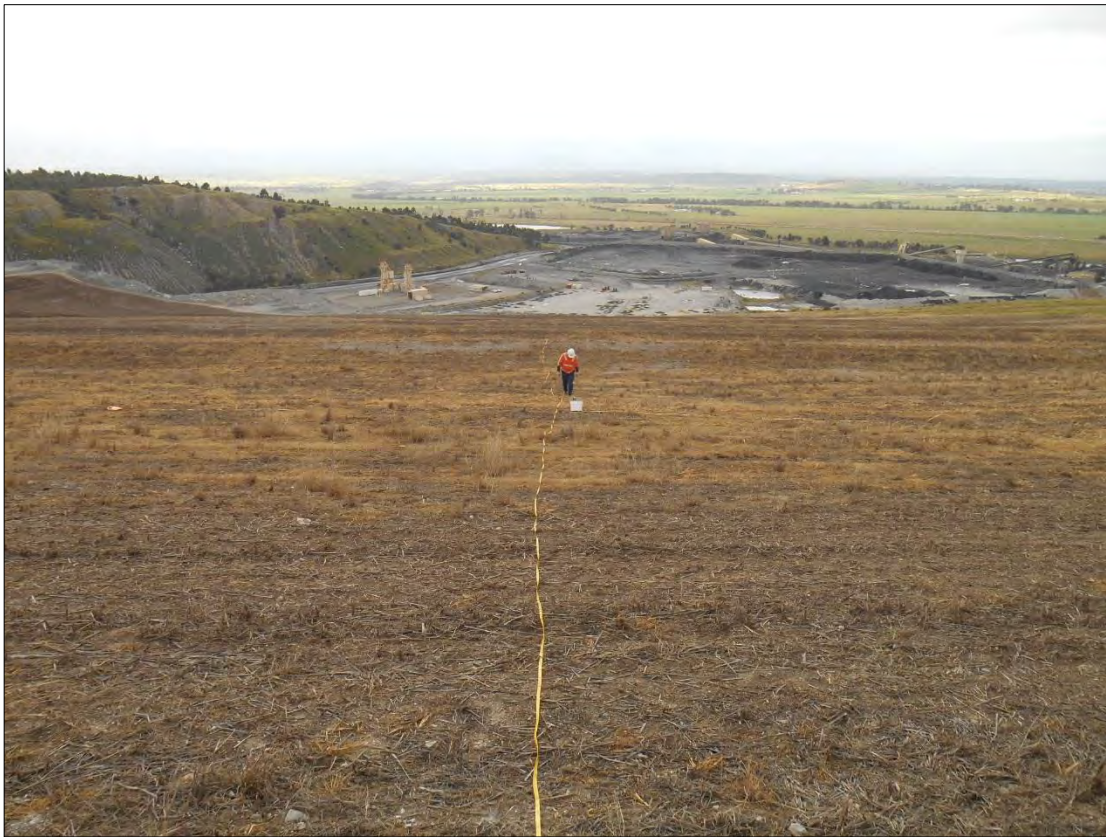
Site photographs at MTWSPN201501

It should be noted no native species were recorded at MTWSPN201501. One native species, *Chloris ventricosa*, was recorded which had been sprayed and was dead.

Disturbance present at the rehabilitation site consisted mainly of weeds, and grazing by macropods. No evidence of fire was observed in the rehabilitation area. No areas containing rubbish were observed.

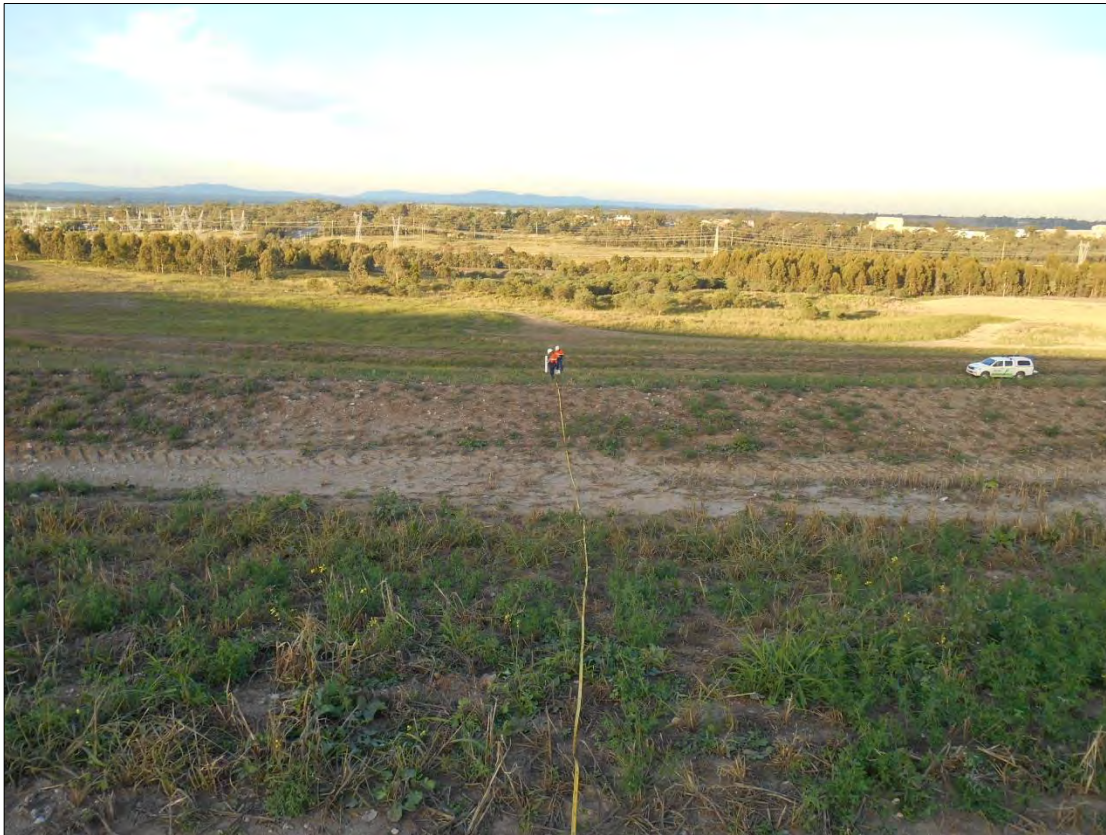
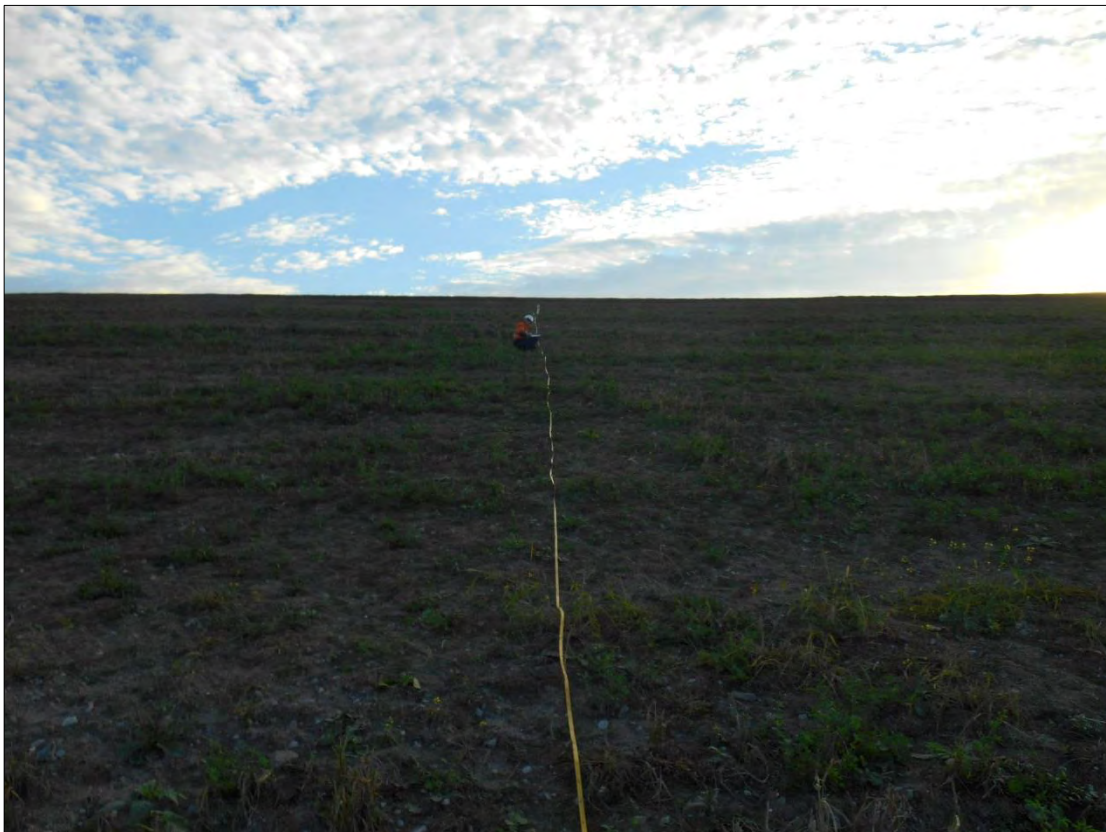
Site photographs at MTWSPS201602

Disturbance present at the site consisted mainly of weeds, and grazing by macropods. No evidence of fire was observed in the rehabilitation area. No areas containing rubbish were observed.

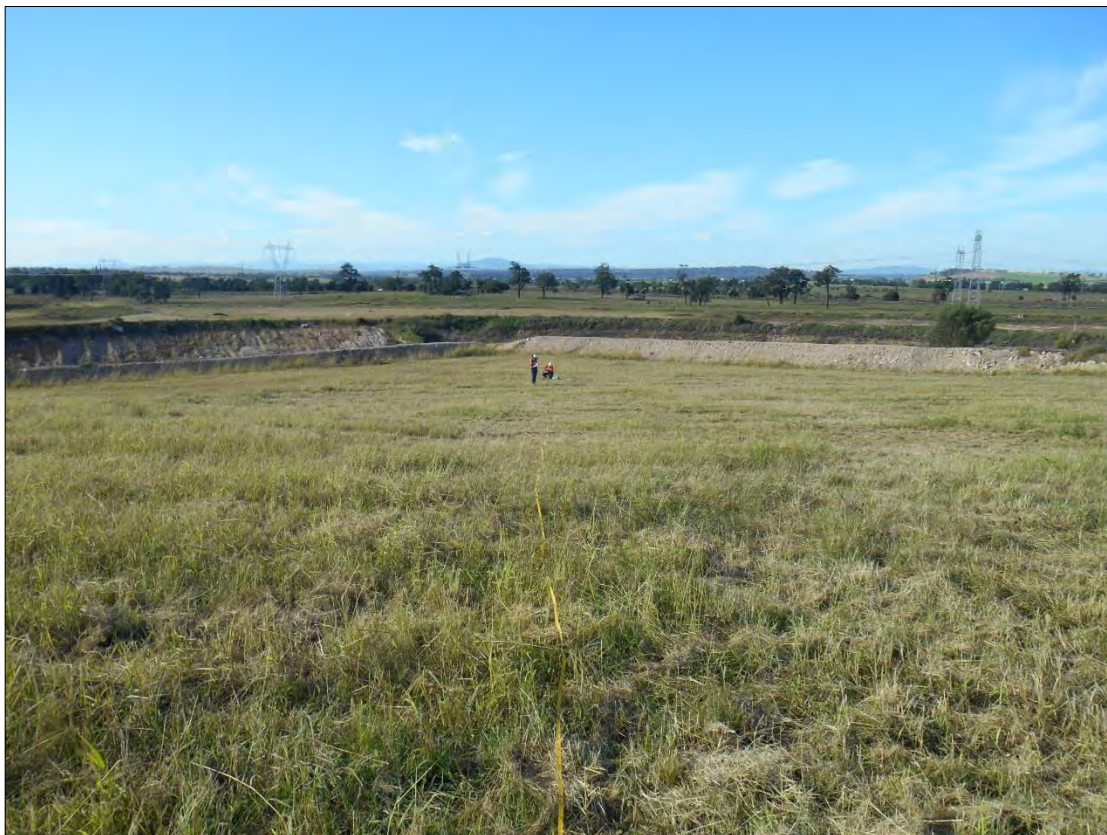
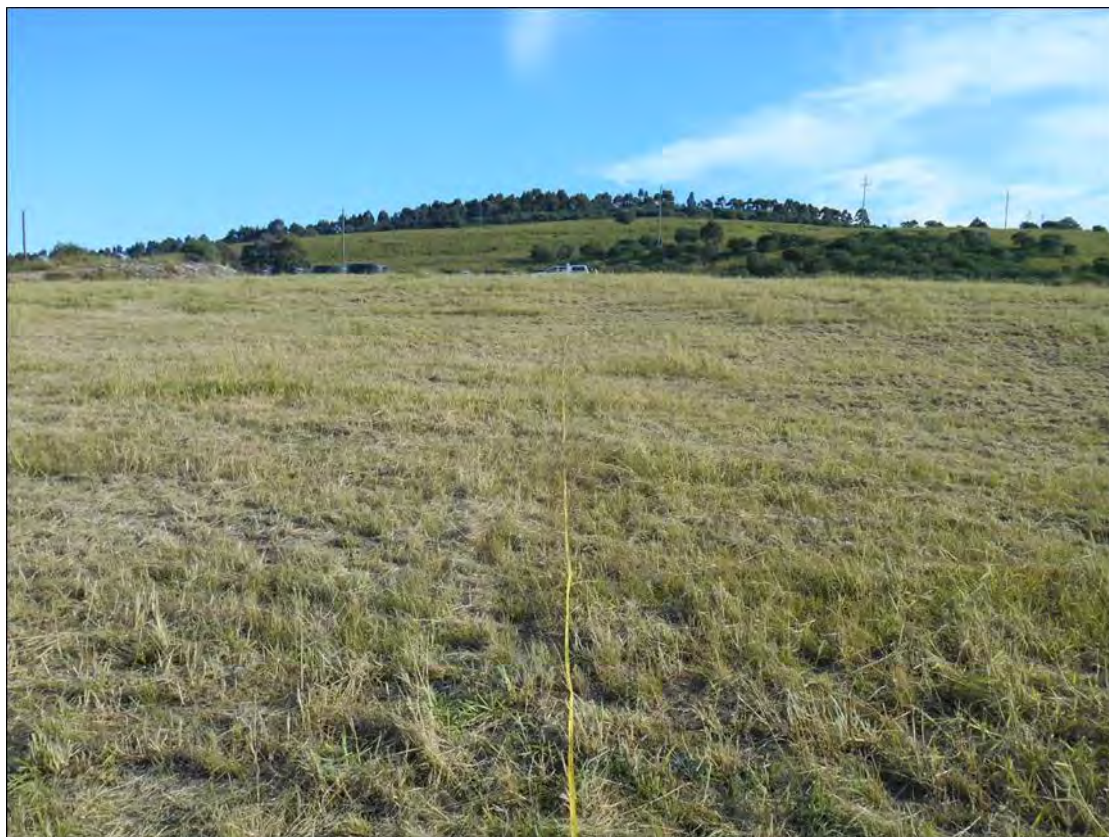
Site photographs at MTWNOO201501

Disturbance present at the rehabilitation site consisted mainly of weeds, and grazing by macropods. No evidence of fire was observed in the rehabilitation area. No areas containing rubbish were observed.

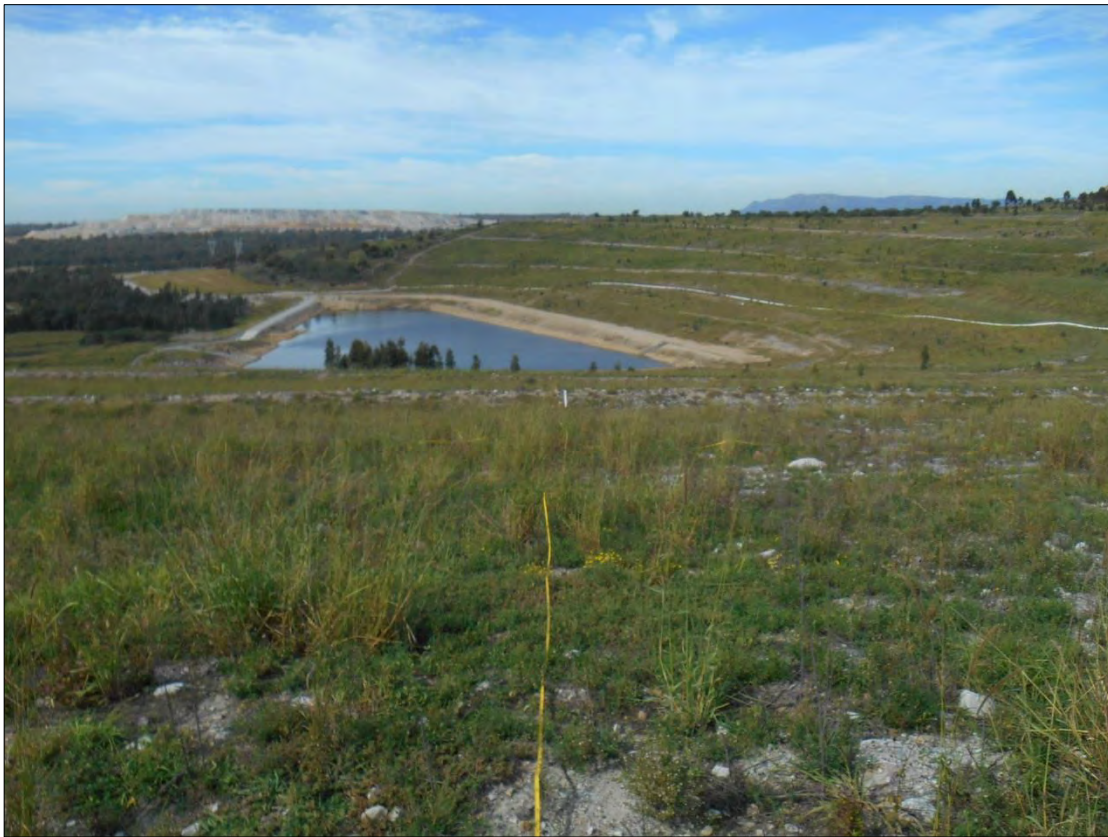
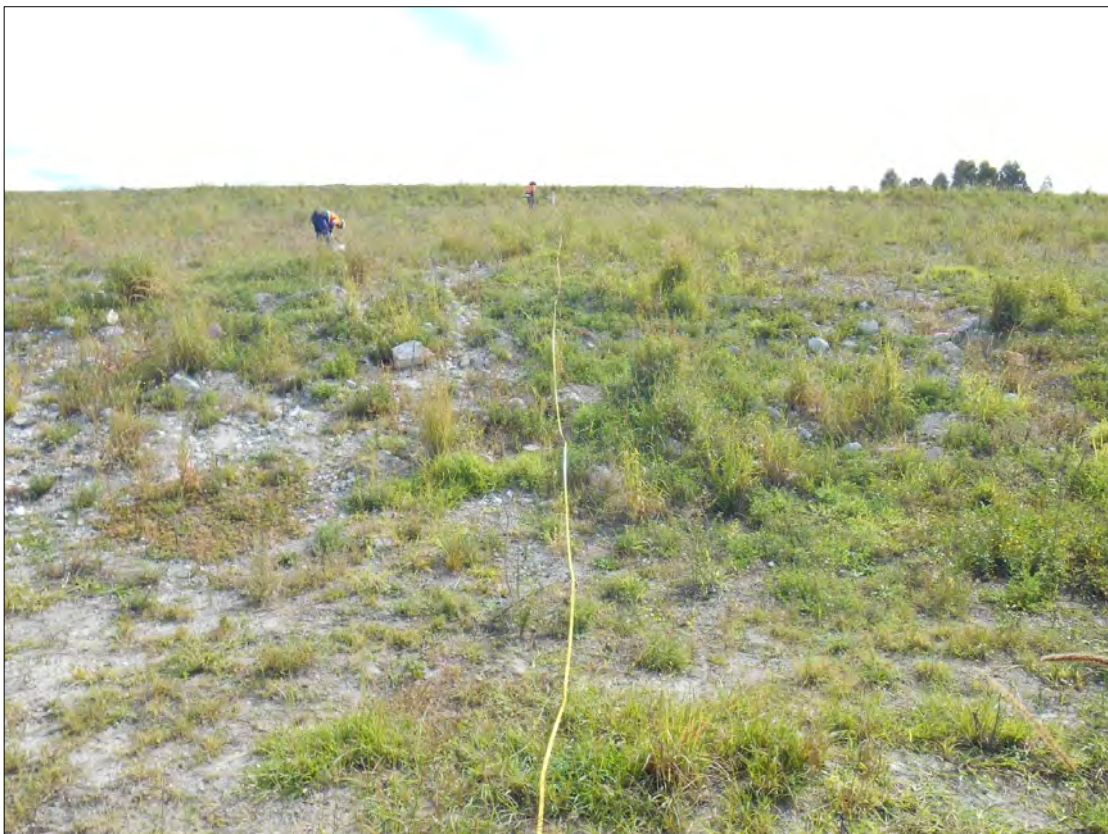
Site photographs at MTWMT0201501

Disturbance present at the site consisted mainly of weeds, and grazing by macropods. No evidence of fire was observed in the rehabilitation area. No areas containing rubbish were observed.

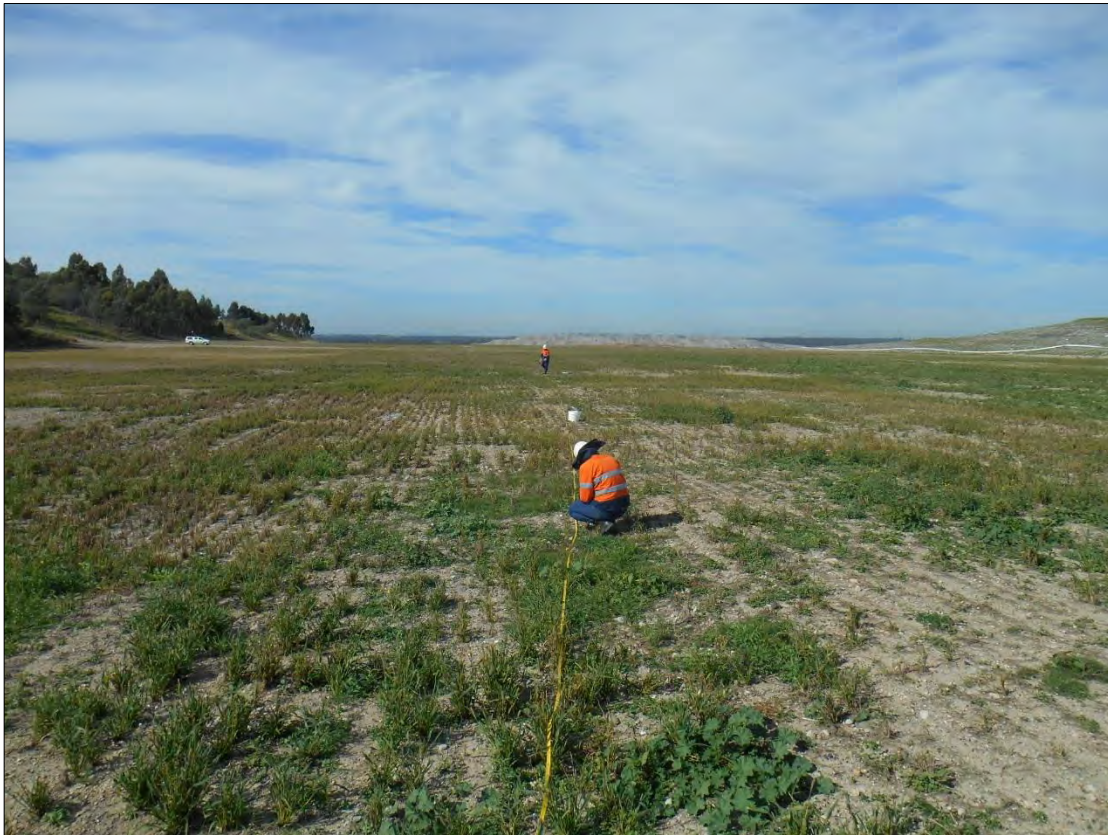
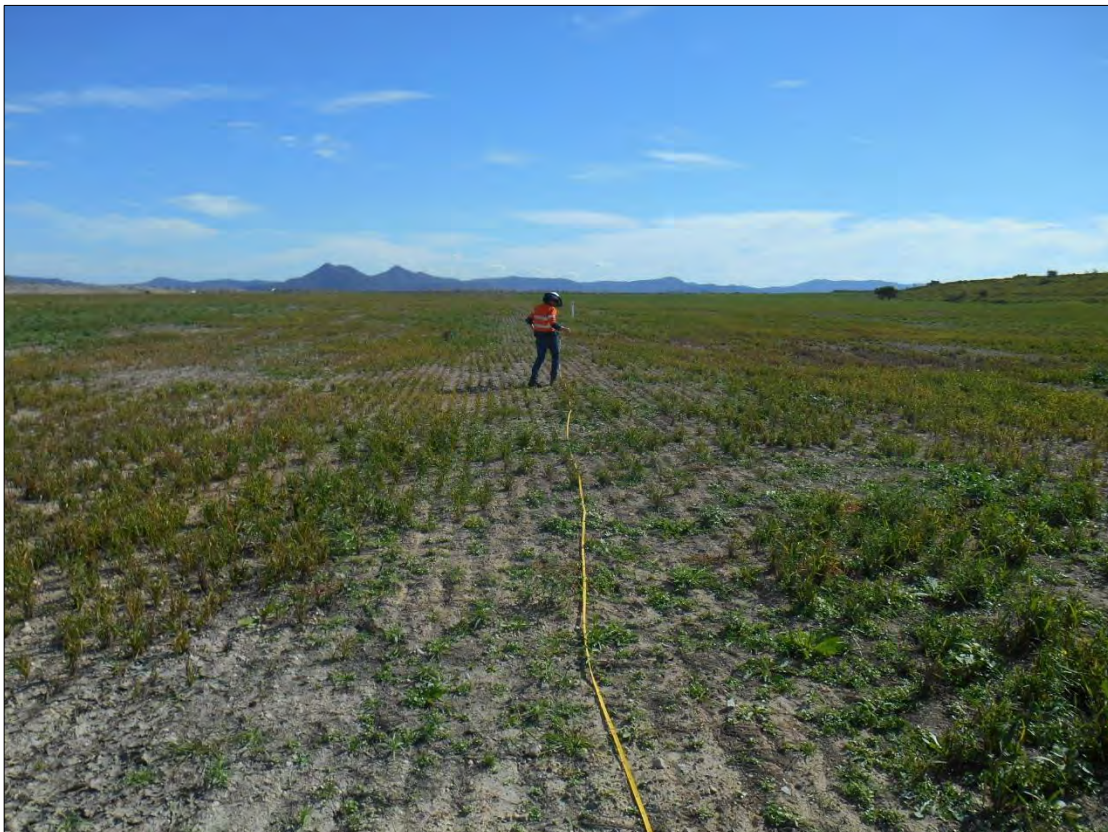
Site photographs at MTWMT0201601

Disturbance present at the site consisted mainly of weeds, and grazing by macropods. No evidence of fire was observed in the rehabilitation area. No areas containing rubbish were observed.
