# Monthly Environmental Monitoring Report

Yancoal Mt Thorley Warkworth

June 2020

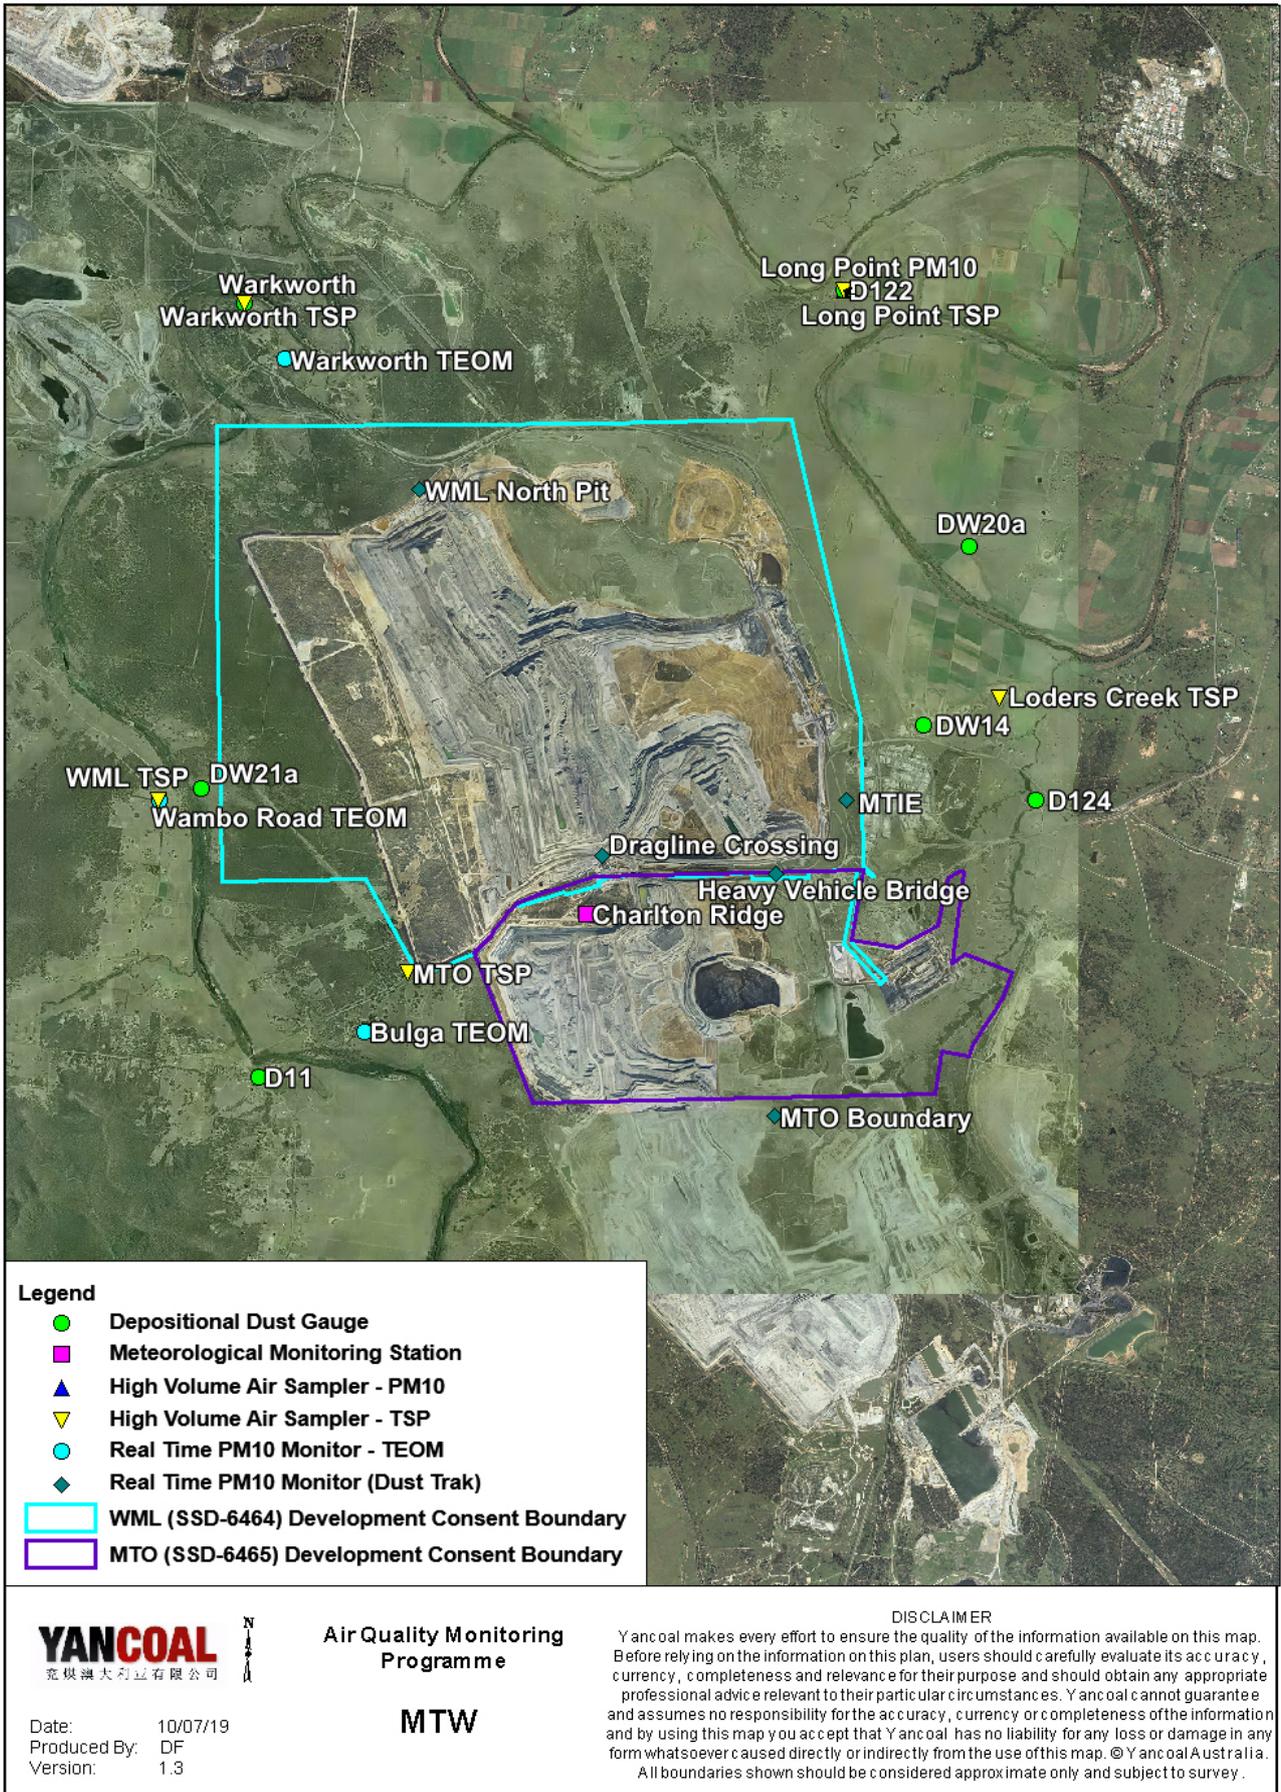
Figure 3: Air Quality Monitoring Locations

Meteorological data is collected at MTW's 'Charlton Ridge' meteorological station (refer to **Figure 3: Air Quality Monitoring Locations**).

Suspended particulates are measured by a network of High Volume Air Samplers (HVAS) measuring Total Suspended Particulates (TSP) and Particulate Matter <10µm (PM<sub>10</sub>). The location of these monitors can be found in **Figure 3**. Each HVAS was run for 24 hours on a six-day cycle in accordance with EPA requirements.
