ASHTON LONGWALL 5 – END OF PANEL SUMMARY REPORT

1 INTRODUCTION

This report has been prepared in conjunction with the SCT Operations Pty Ltd (SCT) Longwall 5 – End of Panel Subsidence Report and the Aquaterra Longwall 5 End of Panel Summary Report.

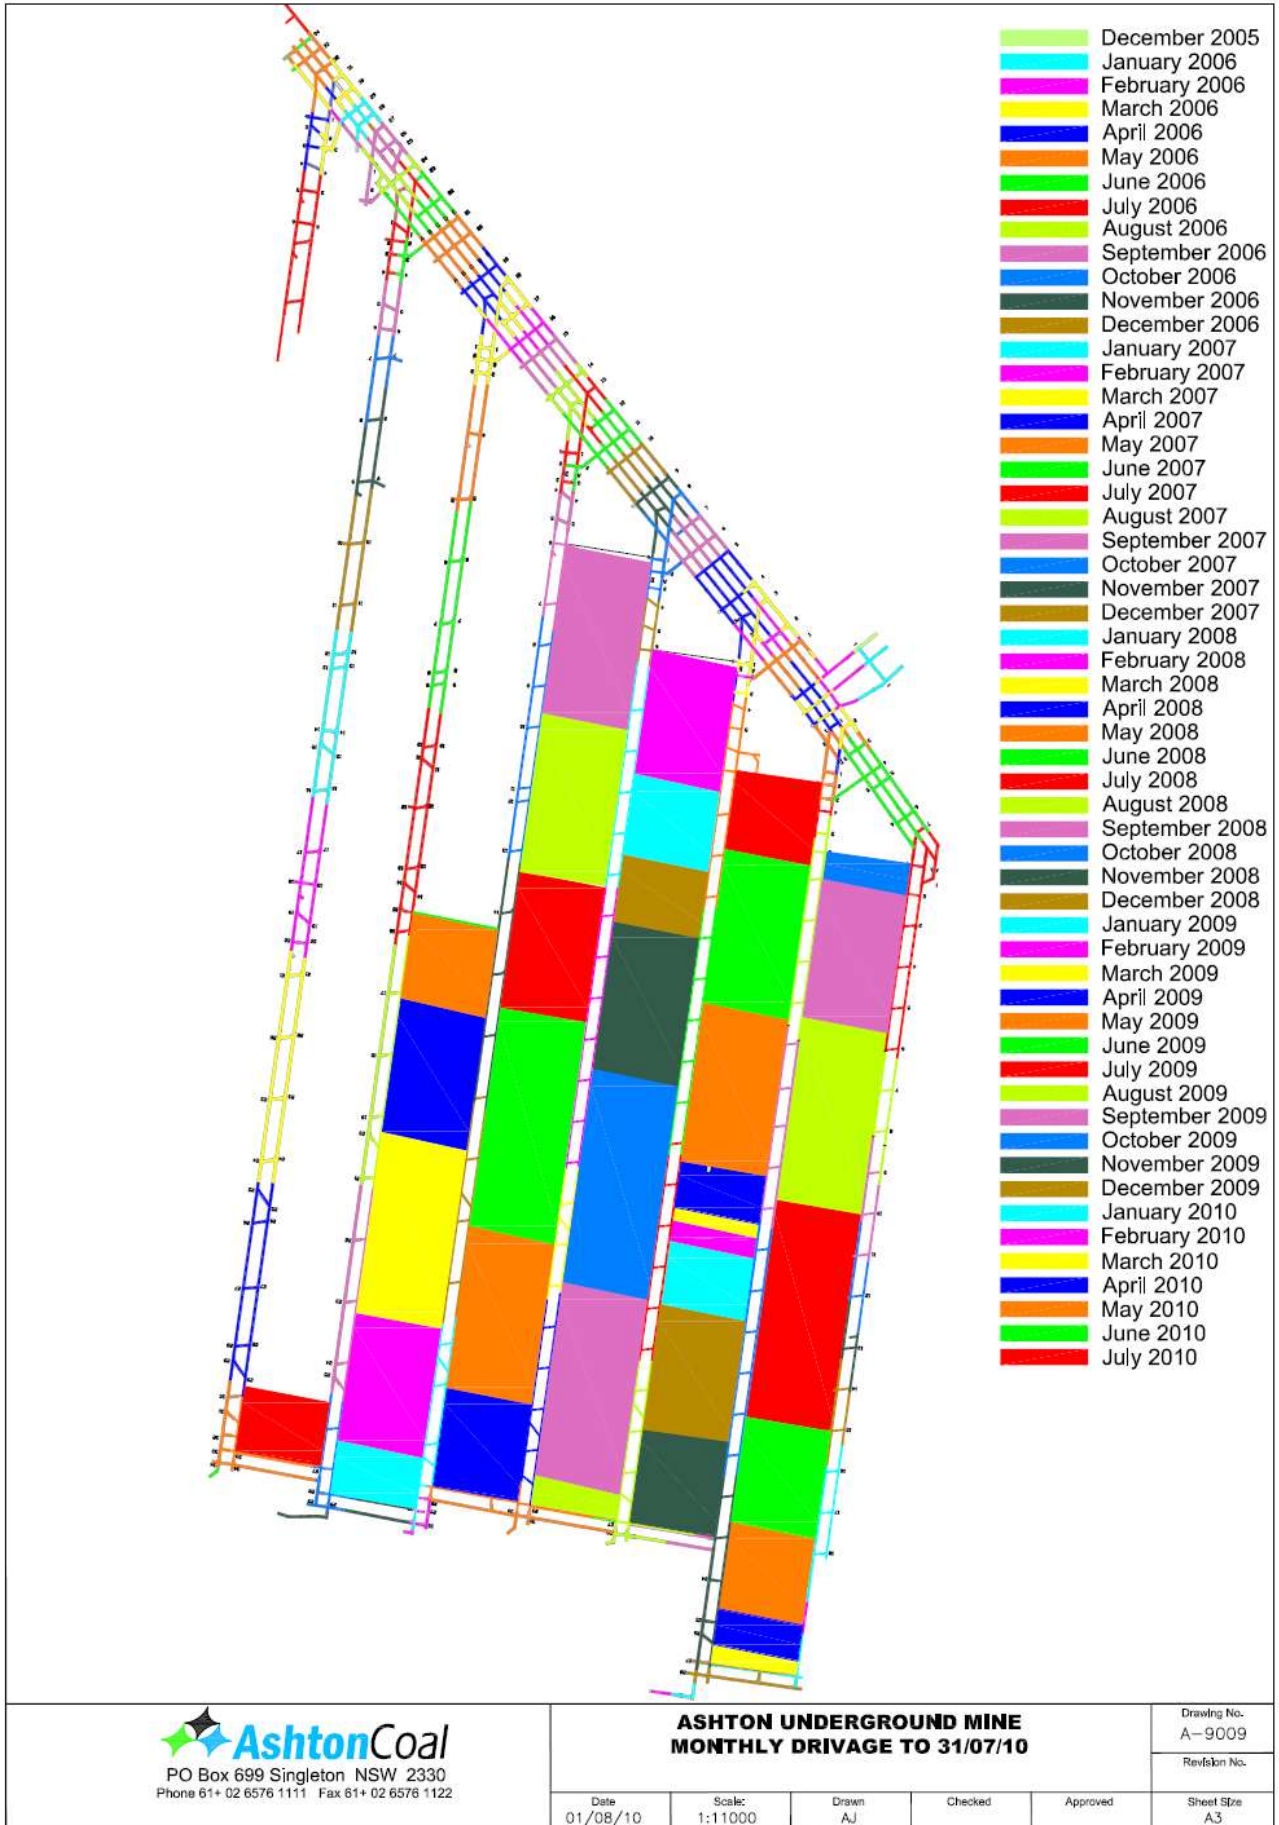
Figure 1: Progression of Longwall Extraction

Ashton's longwall mining operation commenced in February 2007. Since then 5 panels have been completed with the 6th currently being mined. Longwall 5 was completed in June 2010. The progress of longwall extraction is shown in **Figure 1**.

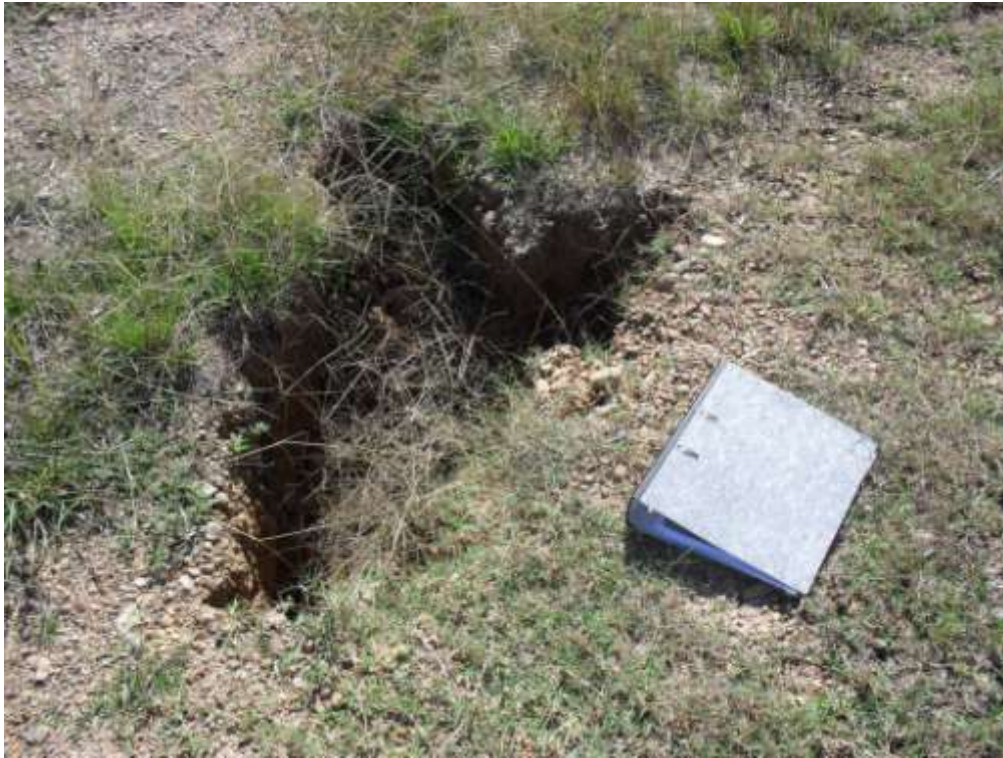
A subsidence hole which was reported in the Longwall 4 EoP Report (see, **Figure 4**) has been remediated and no longer poses a safety risk. **Figure 5** shows this remediation. A cattle yard was undermined during Longwall 5 retreat. No subsidence cracks have been found in the yards and no damage to the yards occurred.

Figure 4: Subsidence in front of Blue House (Chainage 420m)

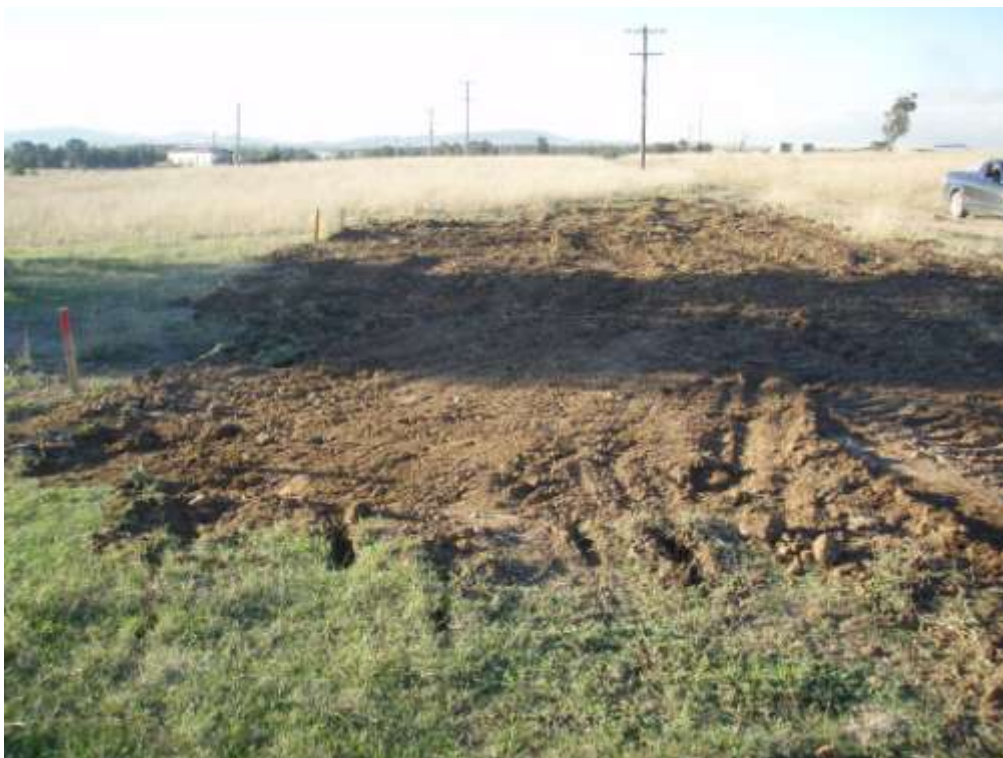
Figure 5: Subsidence Remediation of hole in front of Blue House (Ref: **Figure 4**) looking north from 23/06/10.

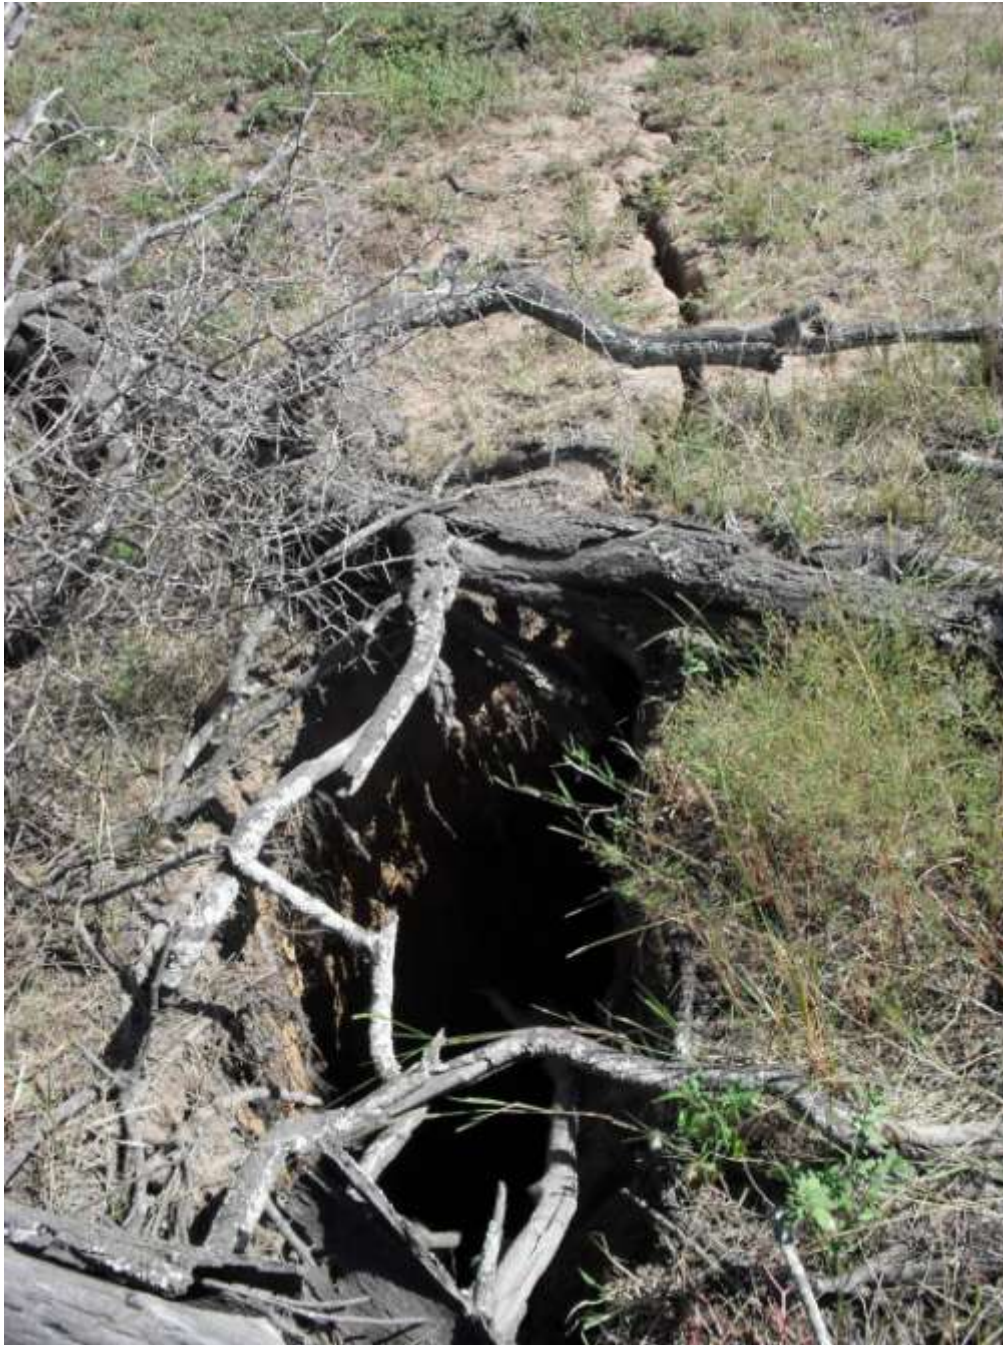
Initial caving over the start of Longwall 5 was typical of the caving behaviour observed elsewhere at ACOL and consistent with predicted subsidence behaviour. **Figure 6** shows the cracking which developed over the Longwall 4 start line. Remediation of this crack was undertaken during Longwall 5 crack remediation with the result being shown in **Figure 7**. All Longwall 5 cracking was remediated using a D6 bulldozer and was completed on the 26 June 2010. Recently cracking has been found over the Longwall 4 take off roadway. This has been pegged and marked with 'caution tape'. Remediation in this area is planned for the future.

Figure 6: LW4 start line crack in drained dam looking to the west. This crack has formed under a tree located in the southern side of the dam wall.

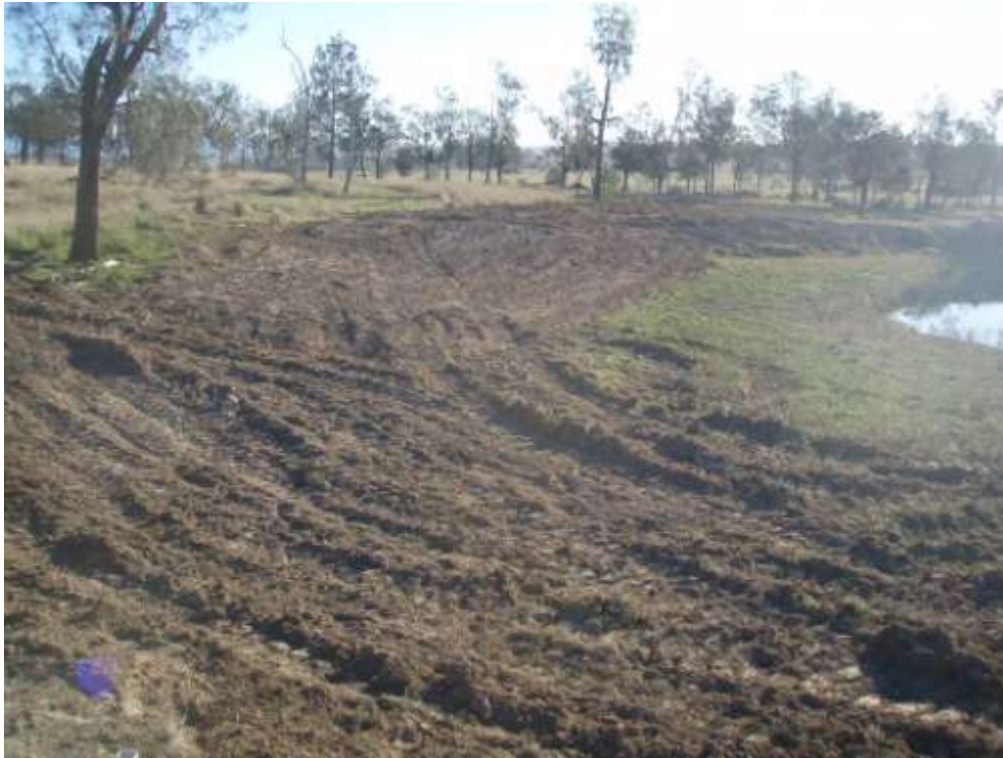
Figure 7: LW4 start line crack (Ref: **Figure 6**) remediated on 25/06/10. Dam re-filling after being drained prior to Longwall extraction.

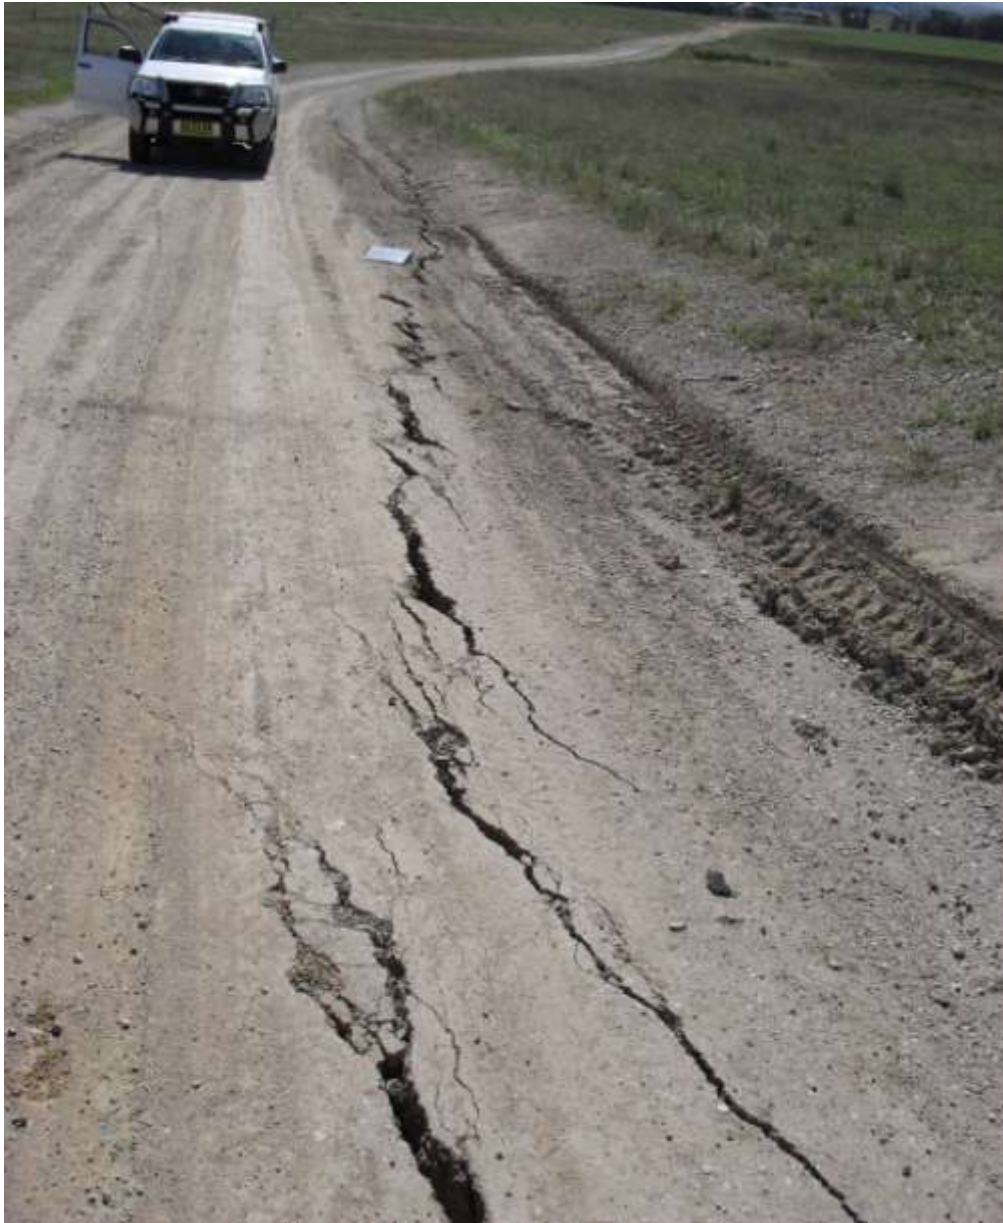
Figure 8: Gateroad cracks in the access road looking north. Remediation required.

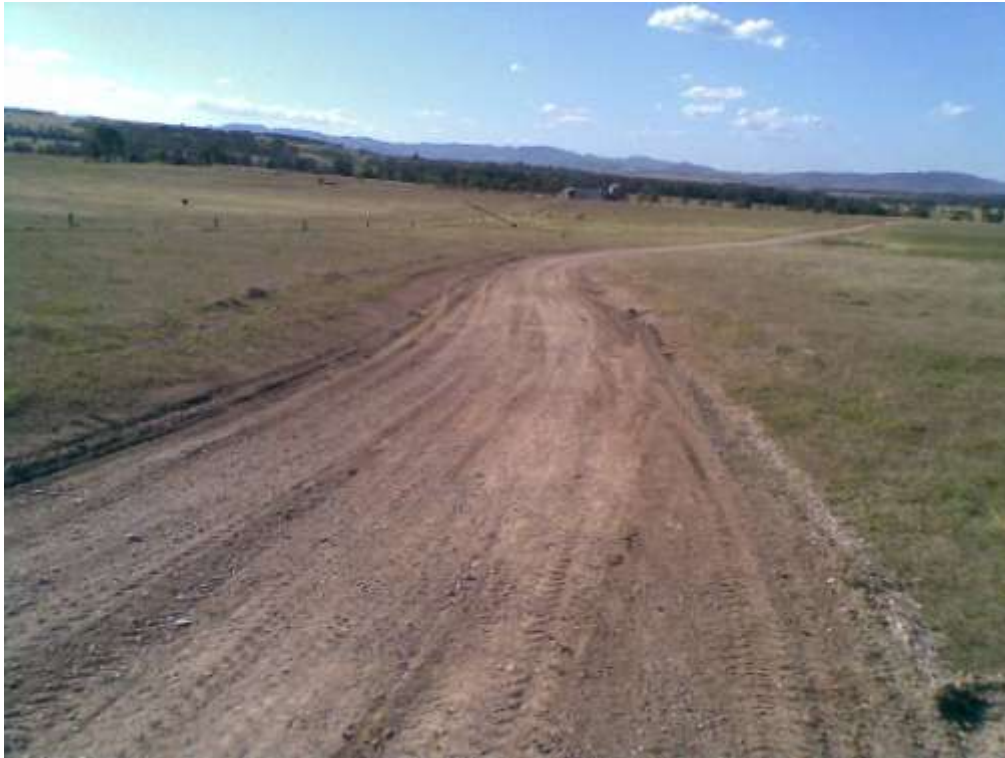
Figure 9: Access road looking north post remediation using a grader with ripping tines on 11/06/10.

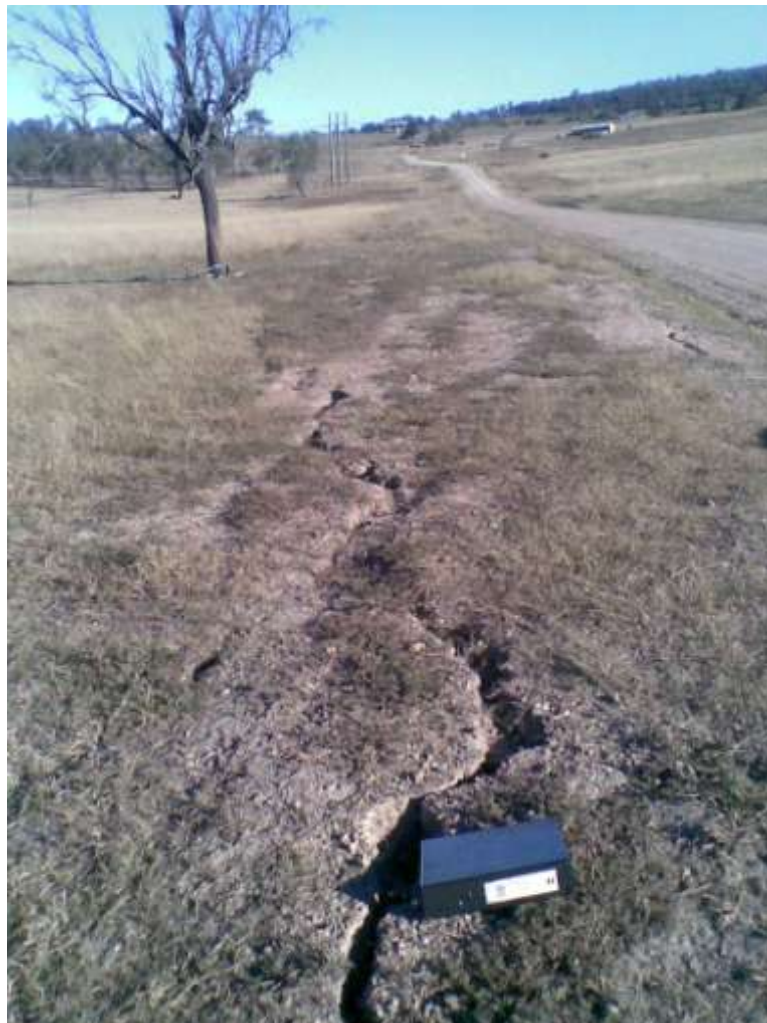
Figure 10: Gateroad crack on surface. In the background the 3 pole power line structure can be seen. This image was taken post stays being fitted to the power line on 12/05/10.

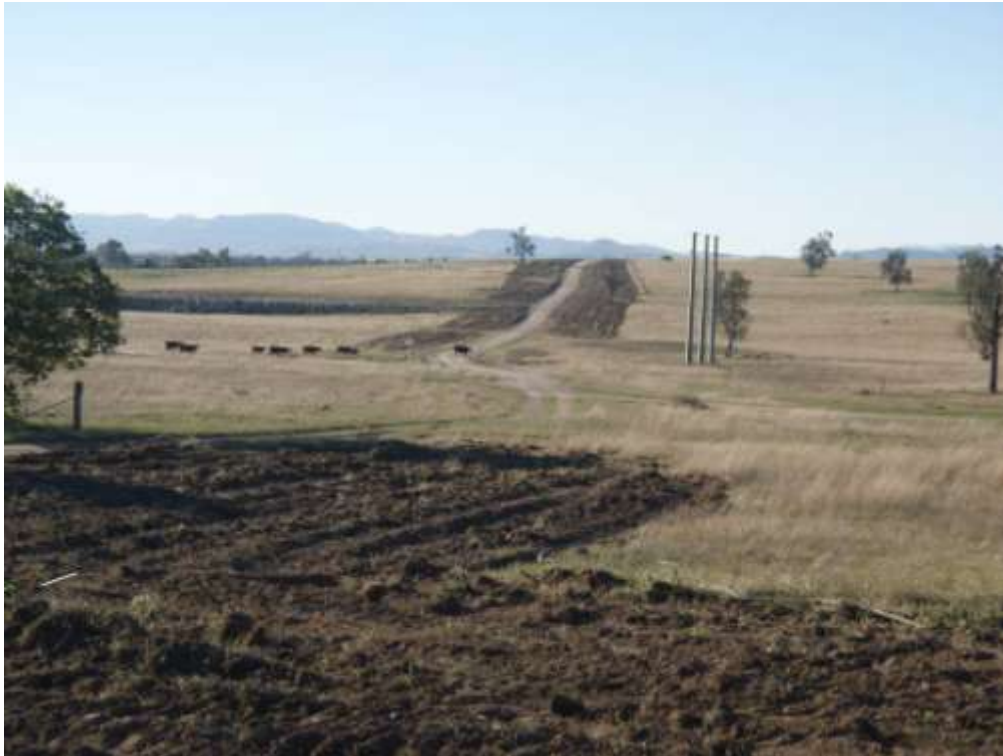
Figure 11: Gateroad cracks post remediation. The ripped section runs the length of visible surface cracks. Image taken looking north. Remediation completed on 25/06/10.

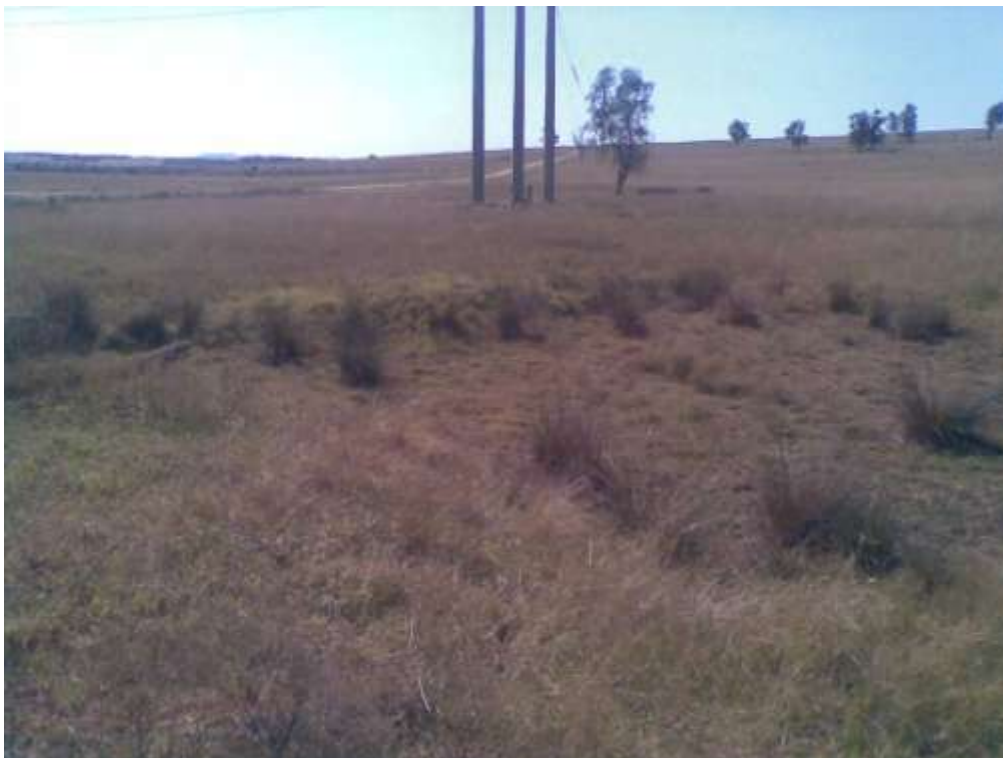
Visual and survey monitoring of the existing 3 pole 132kV power structure over Longwall 5 is undertaken regularly. **Appendix 1, Figure 12** shows the 3 pole structure post stays being fitted. The survey data was recorded and again supplied to the Principal Subsidence Engineer as per the *Ashton Mine Subsidence Monitoring Programme Longwall 5-6*. The effects of subsidence on this structure can be seen in **Appendix 2**. A maximum of 1.051m of subsidence has been recorded on the power poles to date. Monitoring of this power pole set will continue during the first section of Longwall 6 extraction.

Figure 12: 3 pole power line structure (background) and subsided area (foreground) before significant rain events. Image looking north-west on 30/04/10.

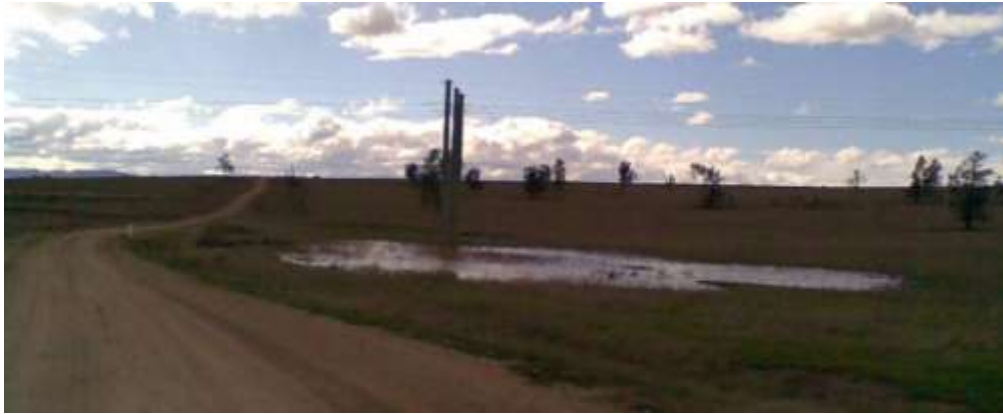
Figure 13: Ponding under Longwall 5 3 pole power line structure on 11/08/10 looking north.

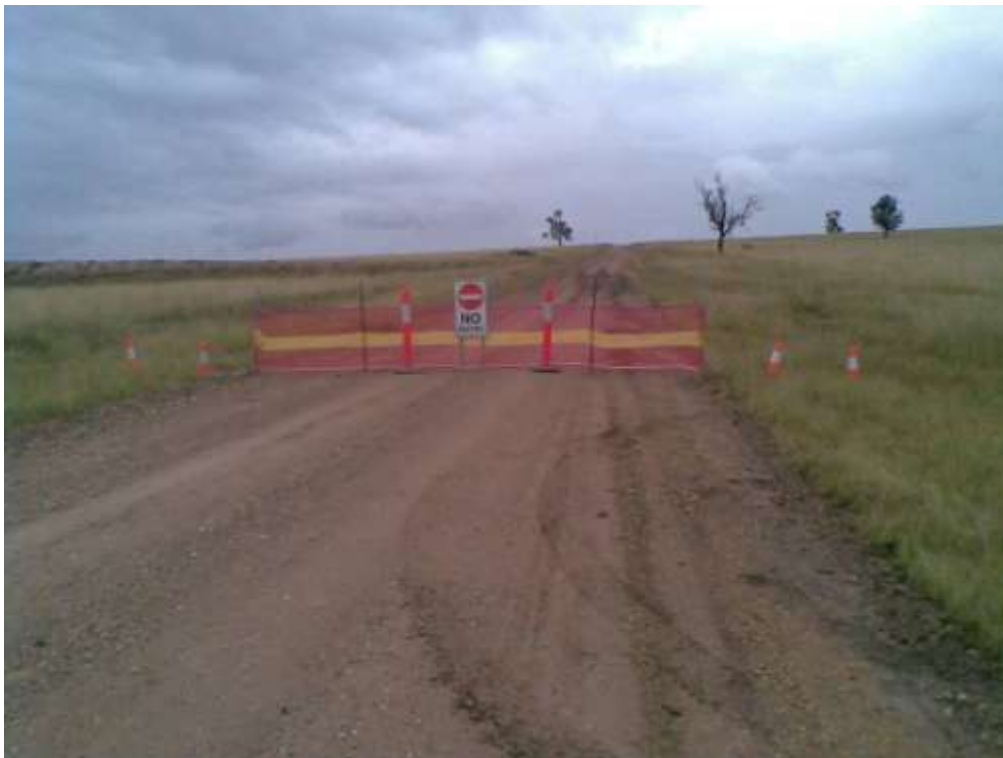
The Diversion Road was cracked during mining. A diversion was put in place during the impact period until the road was repaired. Detours consisted of a detour sign at appropriate forks in the road and another barrier closer to the undermined area. This diversion directed traffic along the normal access road. Remediation of the dirt road occurred on the 11 June 2010 using a grader. Diversions such as that shown in **Figure 14** were also put into place while any road was being undermined. This was the case for all roads bar the single access road during the mining of Longwall 4. The single access road required a grader to be permanently on site during mining so that any cracks could be repaired thus allowing the road to remain open and serviceable. This occurred from chainage 590m to 20m. All stakeholders were informed of any road closures before undermining occurred. **Figures 8 and 9** in show an example of access road surface cracking and the access road once repaired. The repaired access road is highlighted in brown in **Figure 3**. All of the access road was graded as part of Longwall 6 remediation (although only an isolated portion was subsidence effected) to keep it serviceable and safe. For the residence residing in the property located over Longwall 6, the only access road to the property was undermined. During undermining the road was visually inspected daily. No subsidence cracking created a safety issue or resulted in a road closure. All necessary repairs were made to the road to keep it serviceable after undermining.

Figure 14: Road barrier which blocked road access whilst road was being undermined.
