# Duralie Coal Mine Annual Review

# 2020

Reporting Period: 1<sup>st</sup> July 2019 to 30<sup>th</sup> June 2020

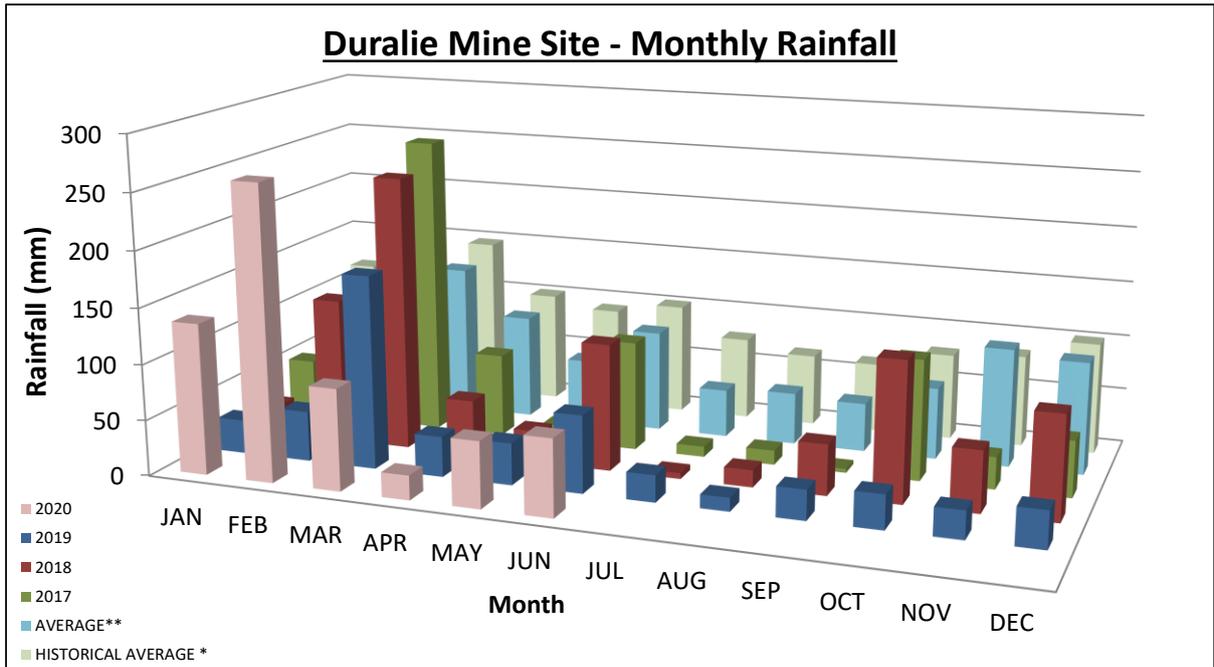
**Figure 2-1: Monthly Rainfall for 2017 to 2020 and Historical Averages**

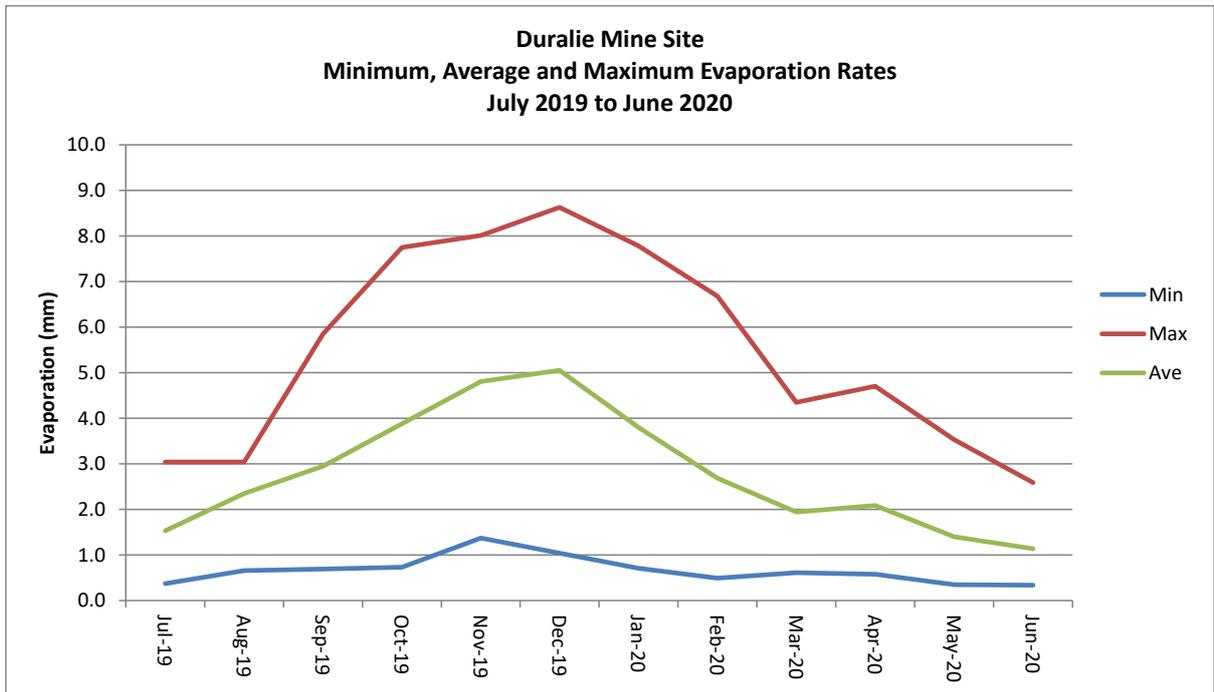
**Figure 2-2: Minimum, Maximum and Average Evaporation Rates During the Reporting Period**

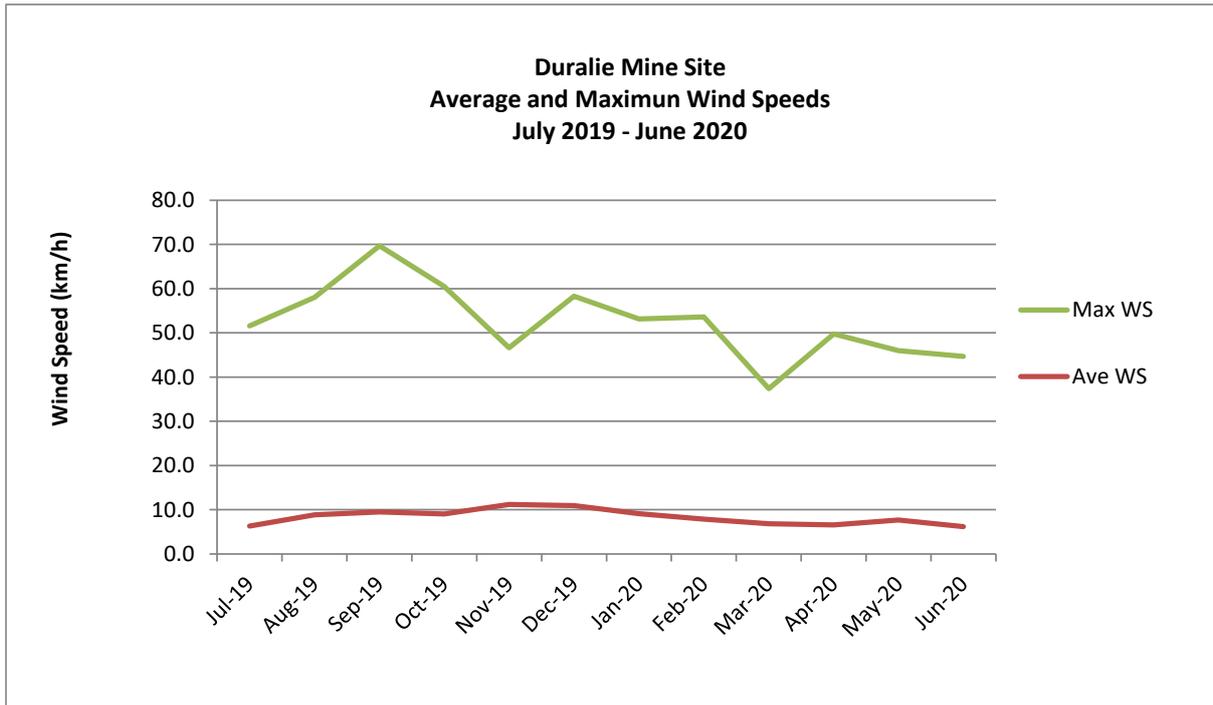
**Figure 2-3: Maximum and Average Wind Speeds During the Reporting Period**

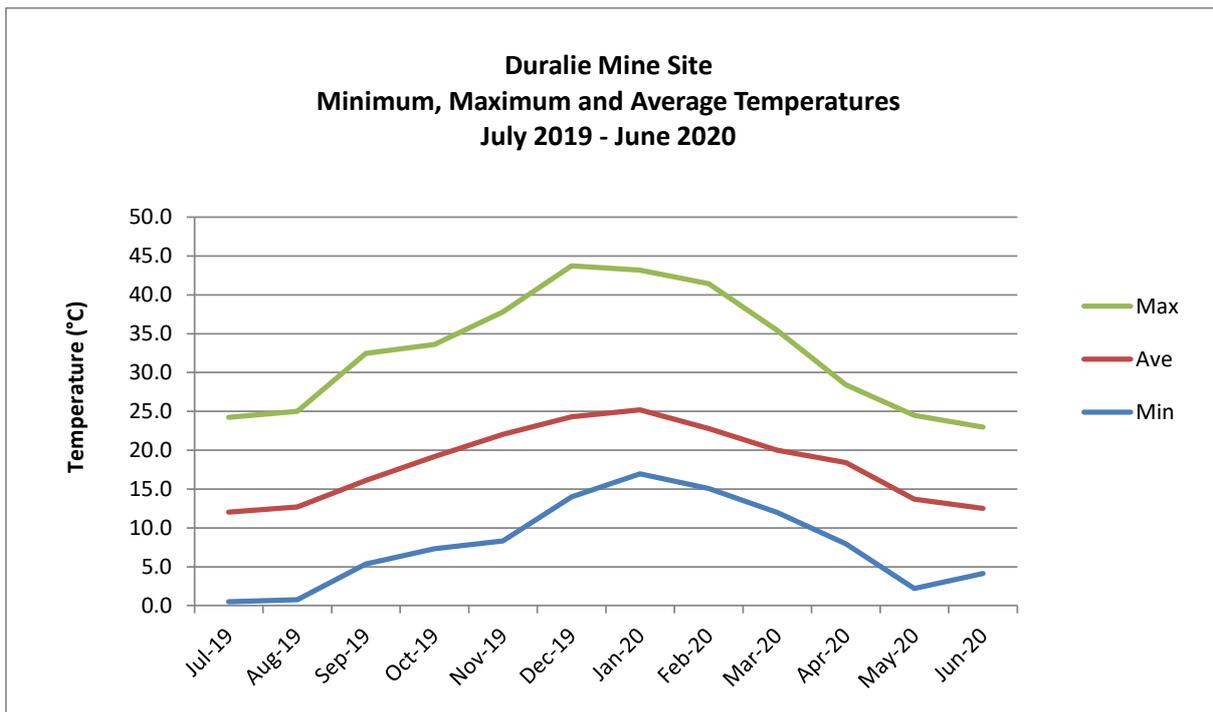
**Figure 2-4: Minimum, Maximum and Average Temperatures During the Reporting Period**

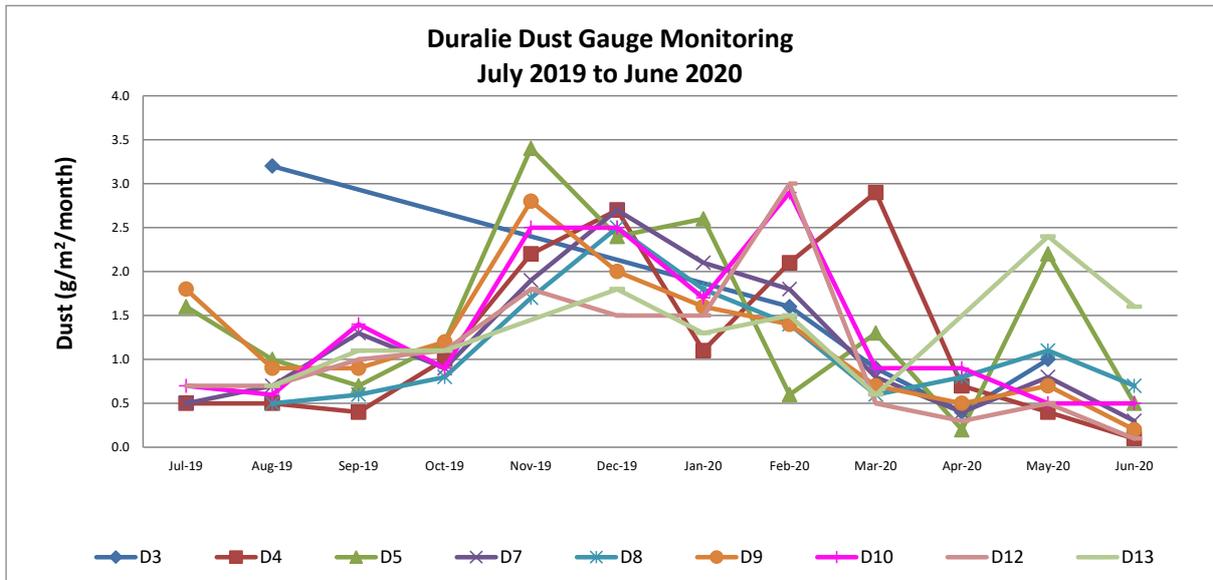
Figure 3-1: Monthly Depositional Dust Monitoring Results (minus contaminated results) during the Reporting Period

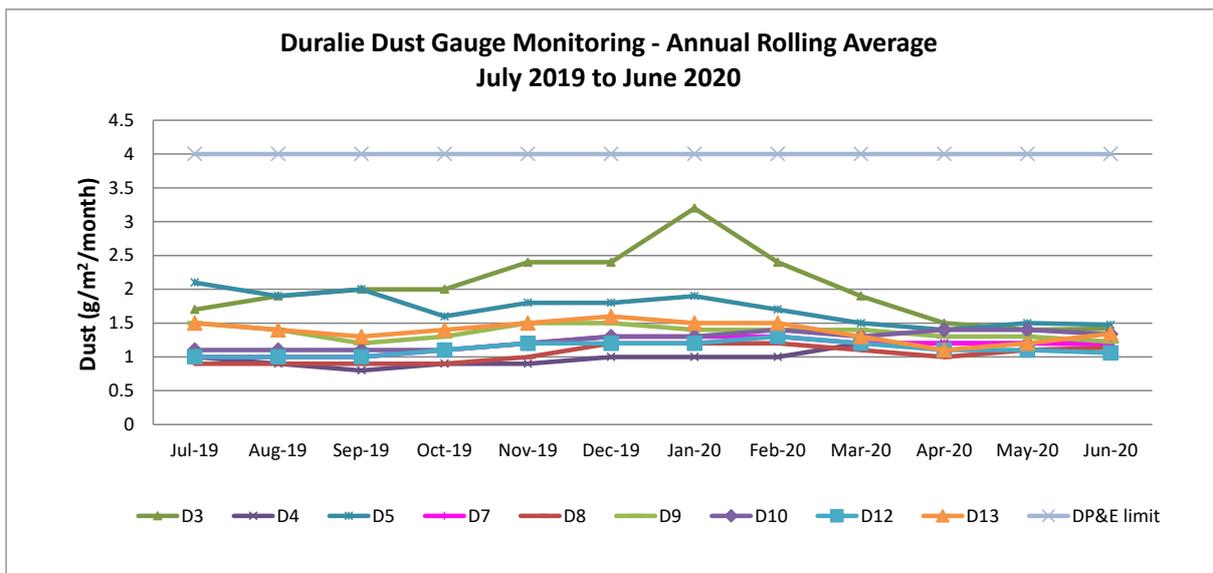
Figure 3-2: Rolling Annual Average Depositional Dust Monitoring Results (minus contaminated results) during the Reporting Period

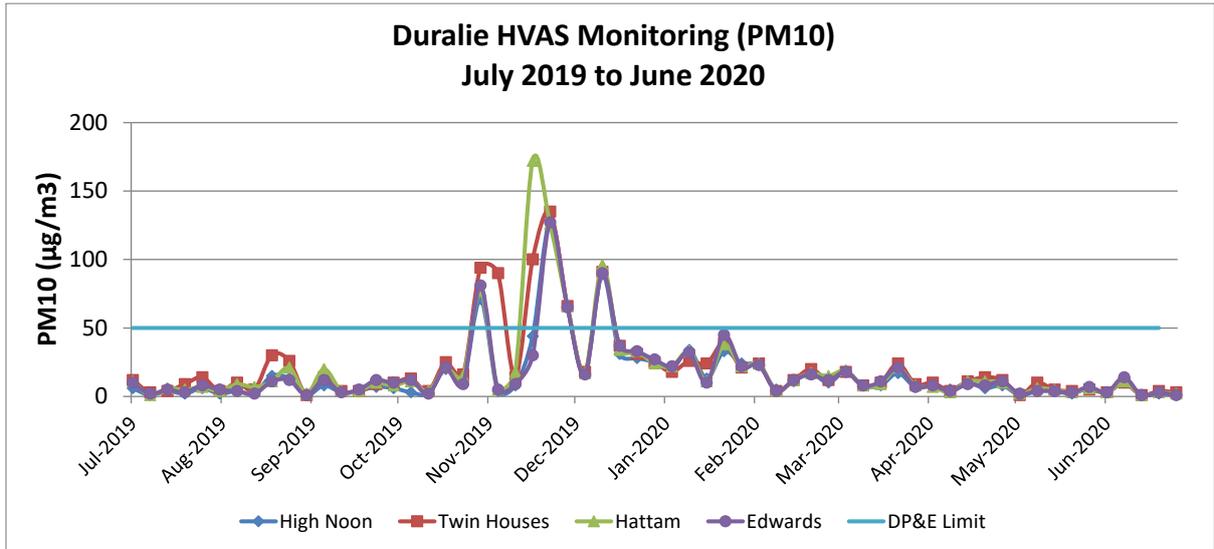
**Figure 3-3: High Volume Air Sampling (PM<sub>10</sub>) Results during the Reporting Period**

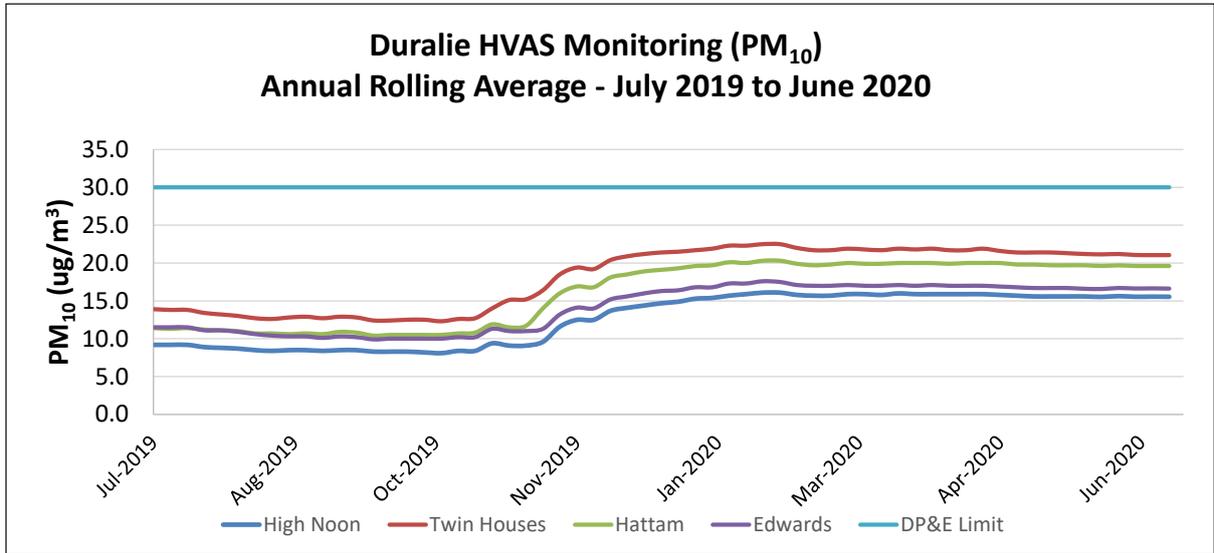
**Figure 3-4: Rolling Annual Average HVAS (PM<sub>10</sub>) Results during the Reporting Period**

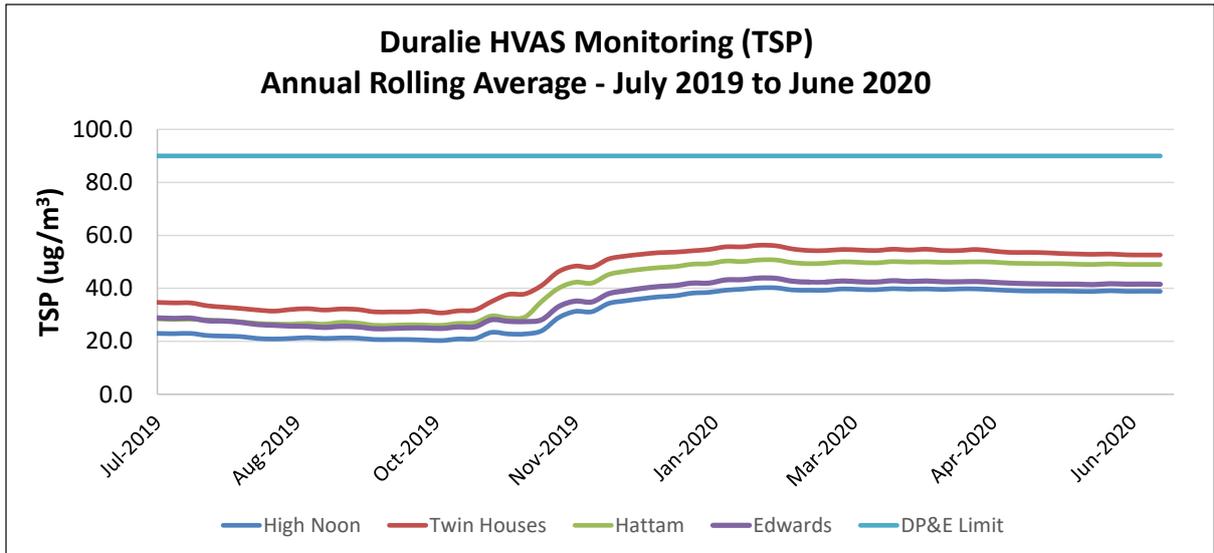
Figure 3-5: Rolling Annual Average HVAS (TSP) Results during the Reporting Period

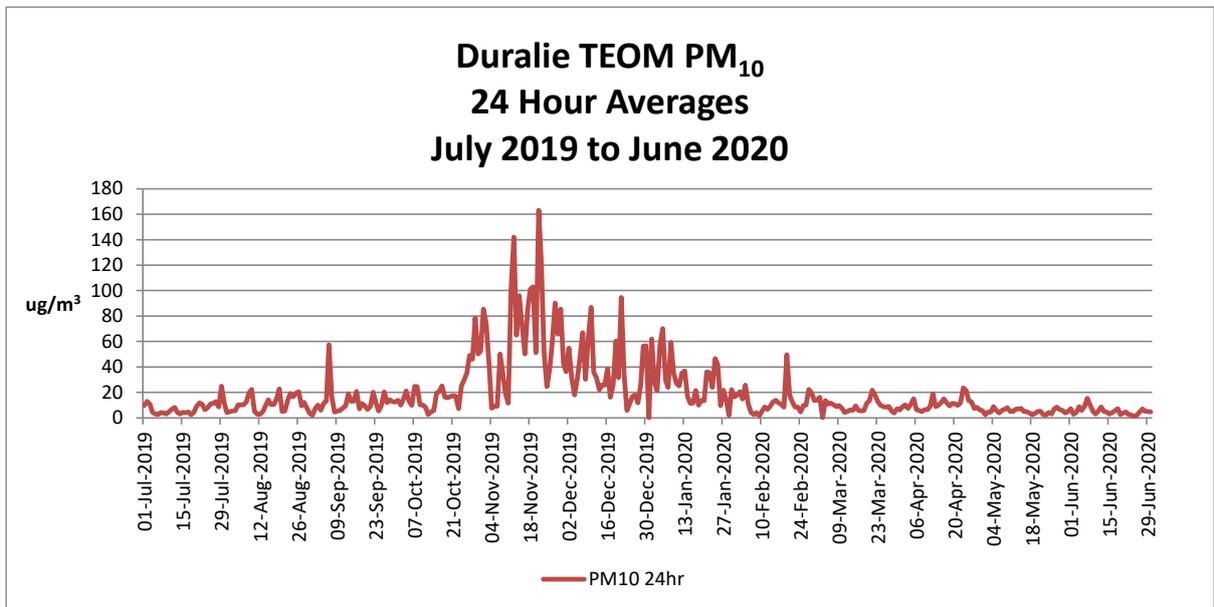
Figure 3-6: Real Time Dust Monitoring (PM<sub>10</sub>) Results during the Reporting Period

Results show that all monitoring locations (in terms of monitored days) did not exceed the National Environmental Protection Measure (NEPM) of 50ug/m<sup>3</sup>/day, listed under Condition 19, Schedule 3 of the Project Approval, with the exception during late October to early December 2020 when the region was experiencing catastrophic bushfires. The HVAS 24 hour criteria is to be assessed on an incremental impact (i.e. increase in concentrations due to the development alone, excluding background concentrations from other sources).

On all exceedance events the TEOM monitor also recorded multiple alarms. It is noted that over this period, widespread bushfires were occurring throughout the Northern & Mid Coasts of NSW which were causing very poor regional air quality.

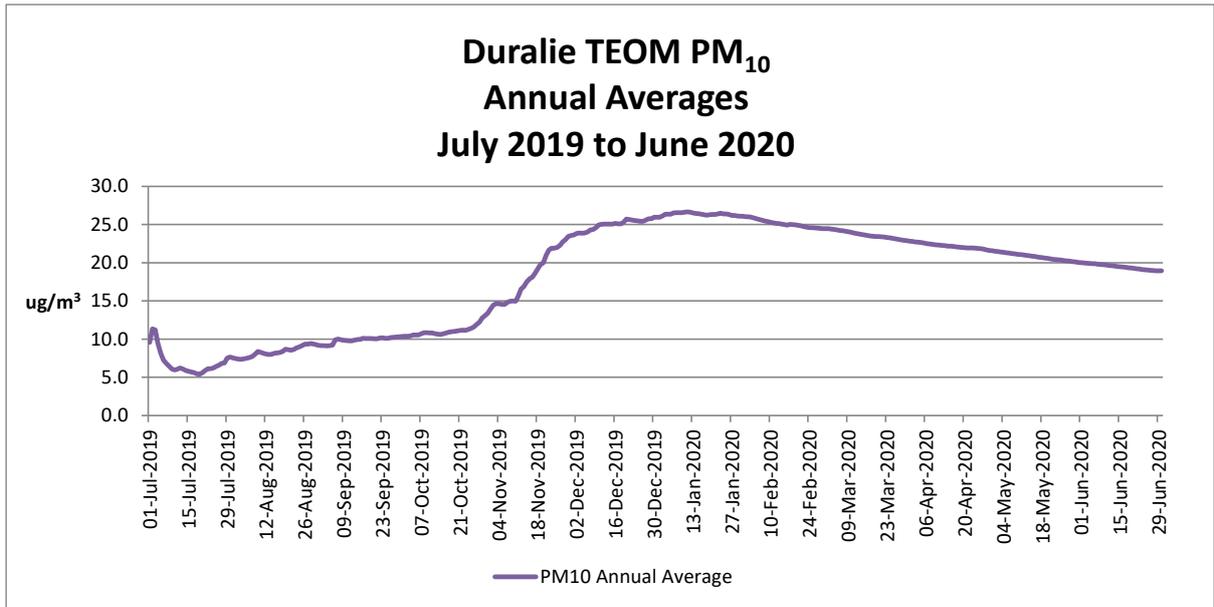
**Figure 3-7: Rolling Annual Average TEOM (PM<sub>10</sub>) Results during the Reporting Period**

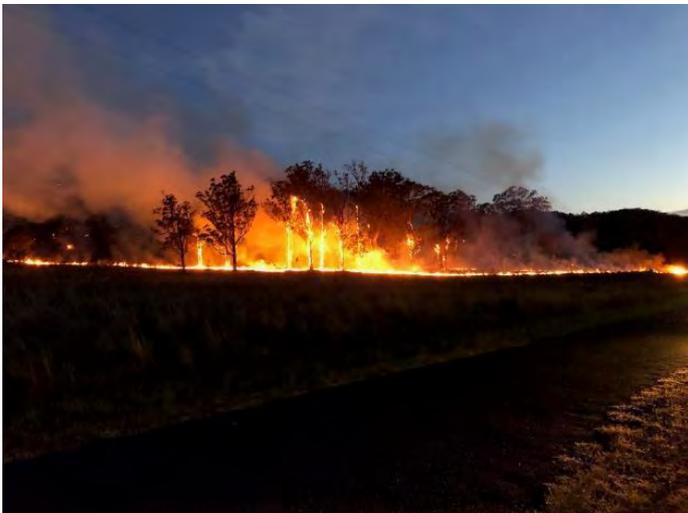
Plate 6 –Photograph showing the intensity of the fire at the southern offset (15th November)

*Recommendations include future fire suppression in the offset area, fence removal and repair, clearing tracks, follow-up weeds control and ongoing monitoring.*

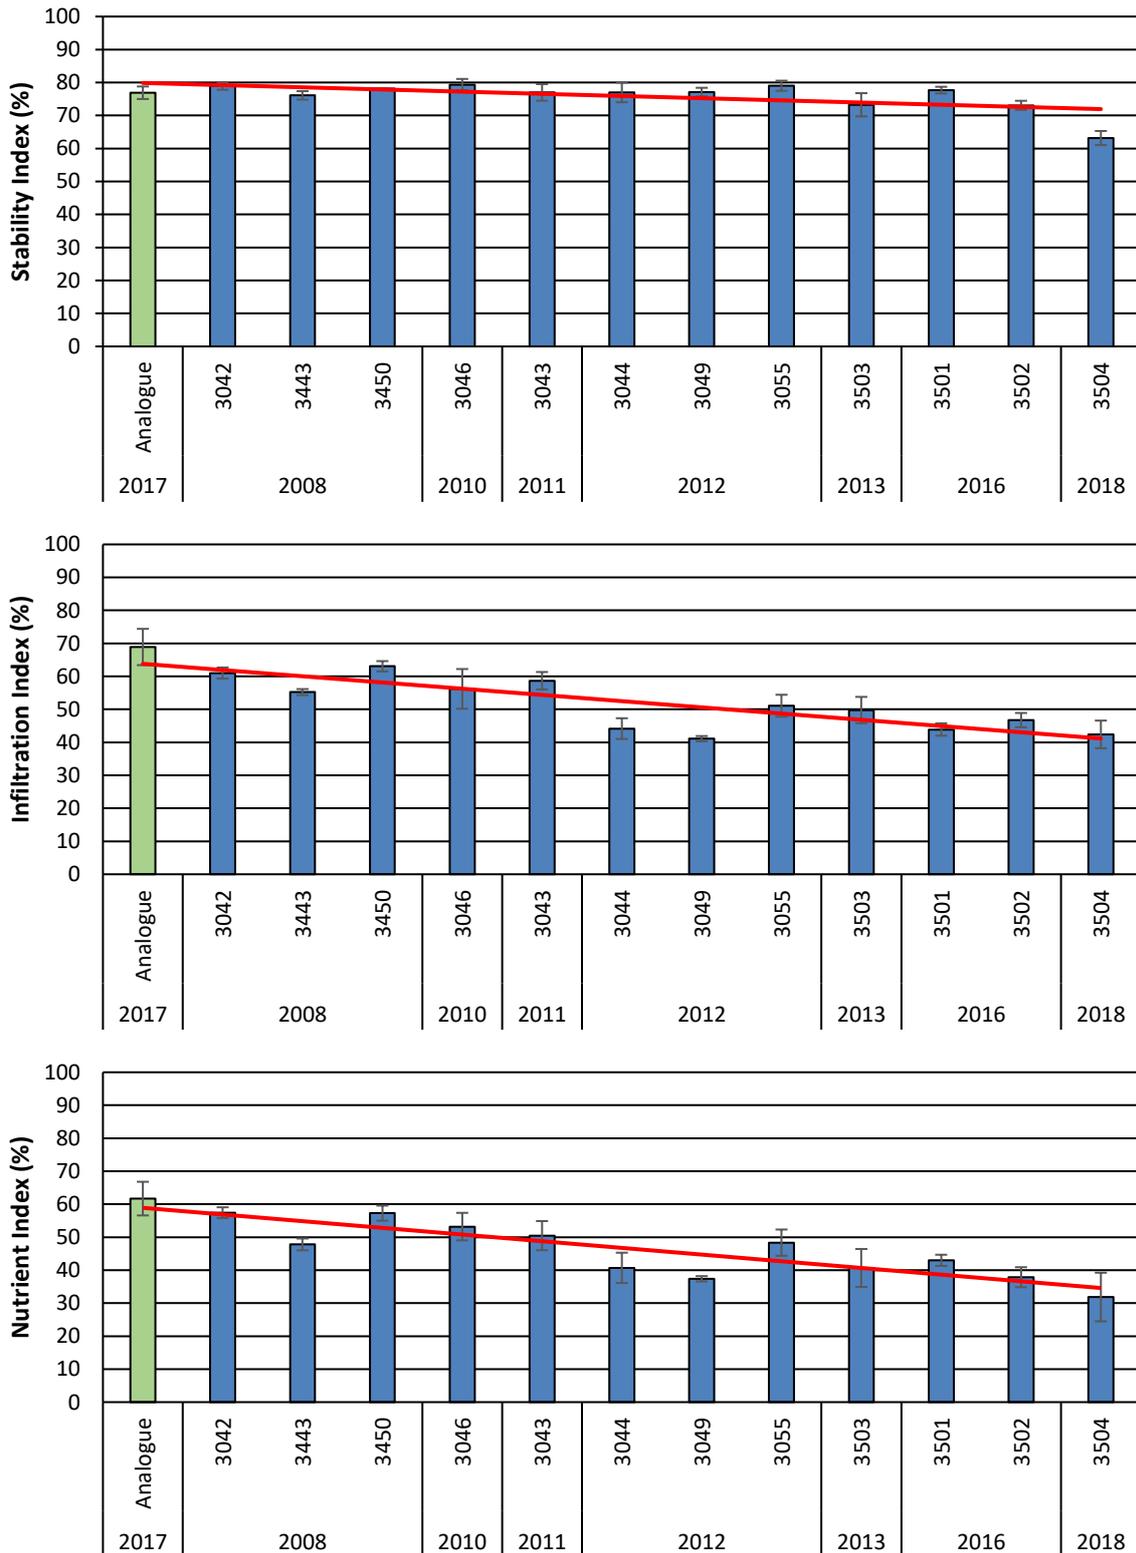
**Figure 3: Landscape Functional Analysis results by Index for the 2020 survey of the Duralie Rehabilitation. Transects are grouped by year of rehabilitation. Error bars are Standard Errors of Mean. Red line is linear trendline.**

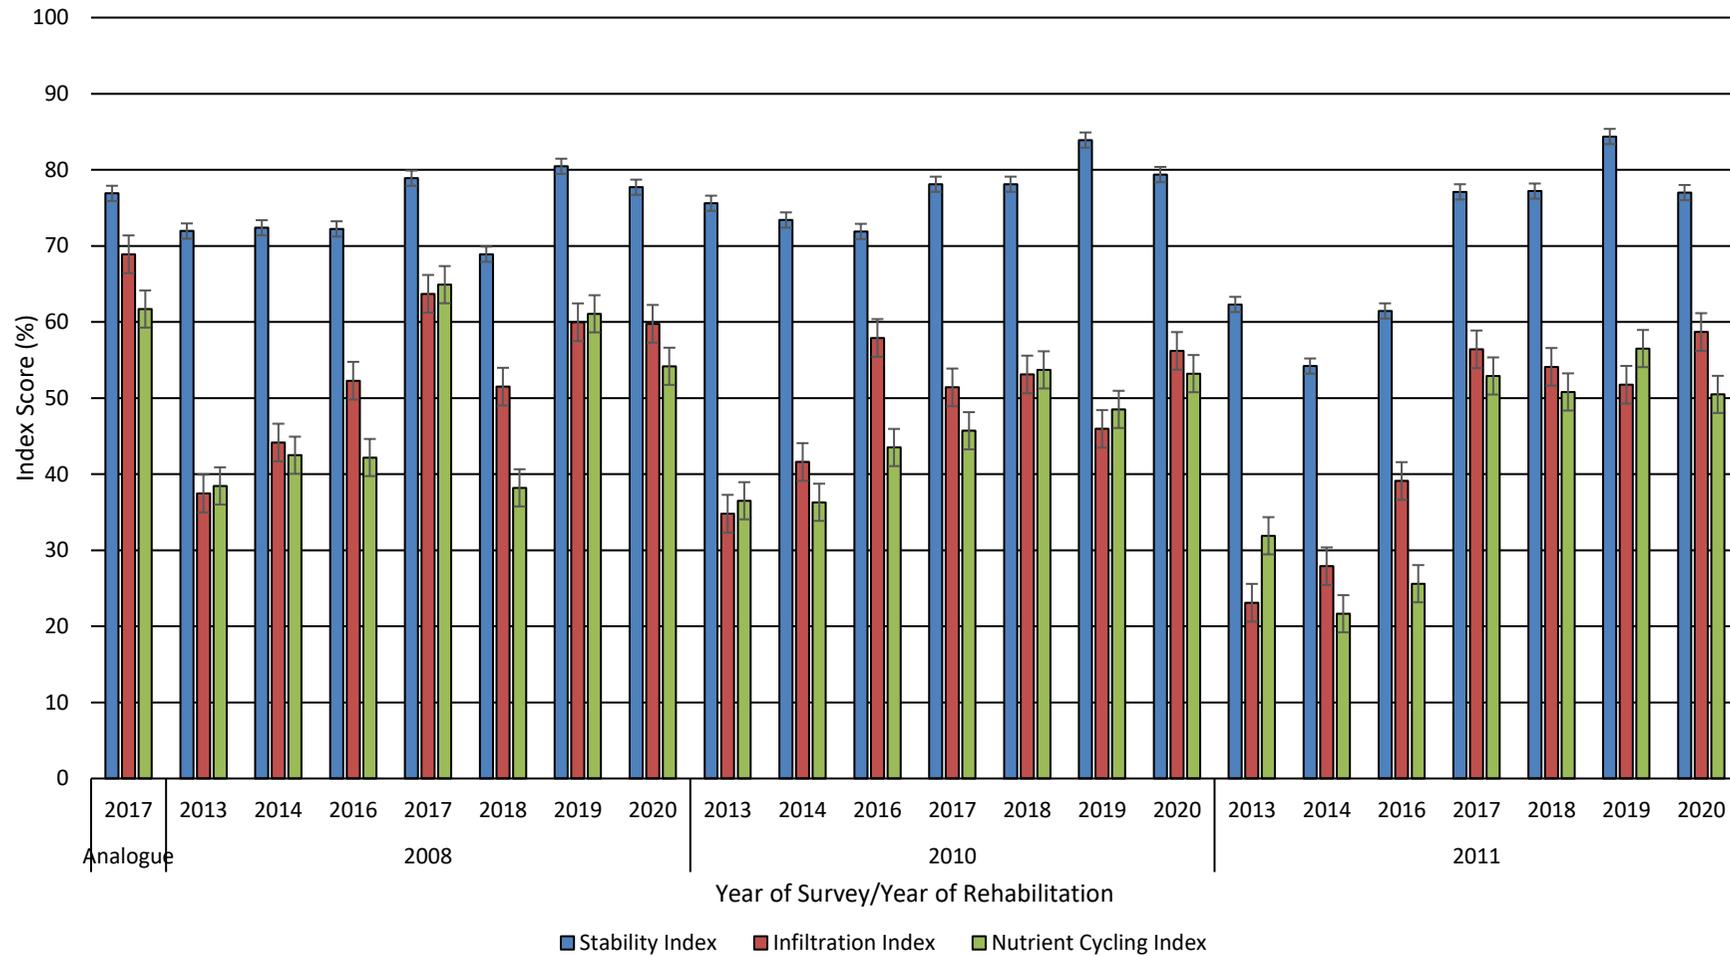
**Figure 4: Landscape Functional Analysis results for the surveys of the 2008 to 2011 rehabilitation areas on the Duralie Coal Mine spoil emplacement and comparison to the 2017 average analogue sites derived from the Biodiversity Offsets Areas. Standard Error bars are shown where statistically valid, i.e. three or more transects in that age cohort for the 2020 survey**

only twice in the 2008 rehabilitation (2017 and 2019) have analogue values been achieved (**Figure 4**). This may in part be attributed to the areas surveyed – Transect 3444 located at the far southern end of the spoil emplacement with a dense multi-generational canopy cover of Eucalypts and sparser mid-storey and shrub species. The 2013 rehabilitation has recorded lower values this year which may in part be due to the die-off of the *Acacias* and the opening up of the transect area with more grass production.

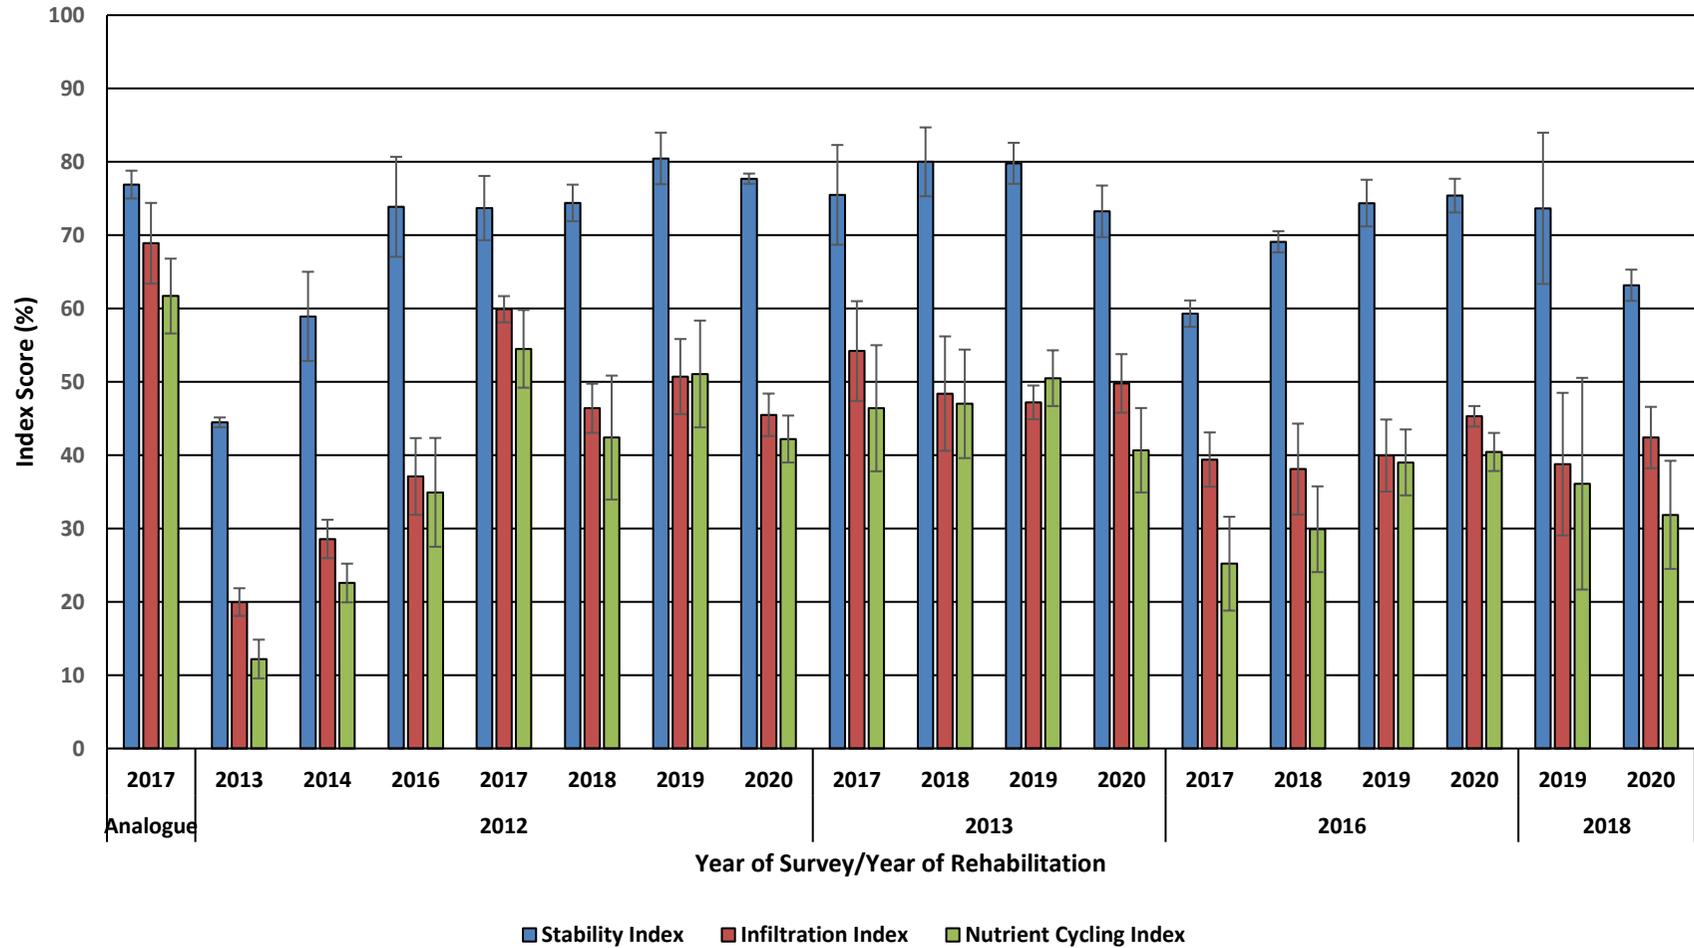
**Figure 5:** Landscape Functional Analysis results for the surveys of the 2012 to 2018 rehabilitation areas on the Duralie Coal Mine spoil emplacement and comparison to the 2017 average analogue sites derived from the Biodiversity Offsets Areas. Standard Error bars are shown where statistically valid, i.e. three or more transects in that age cohort for the 2020 survey

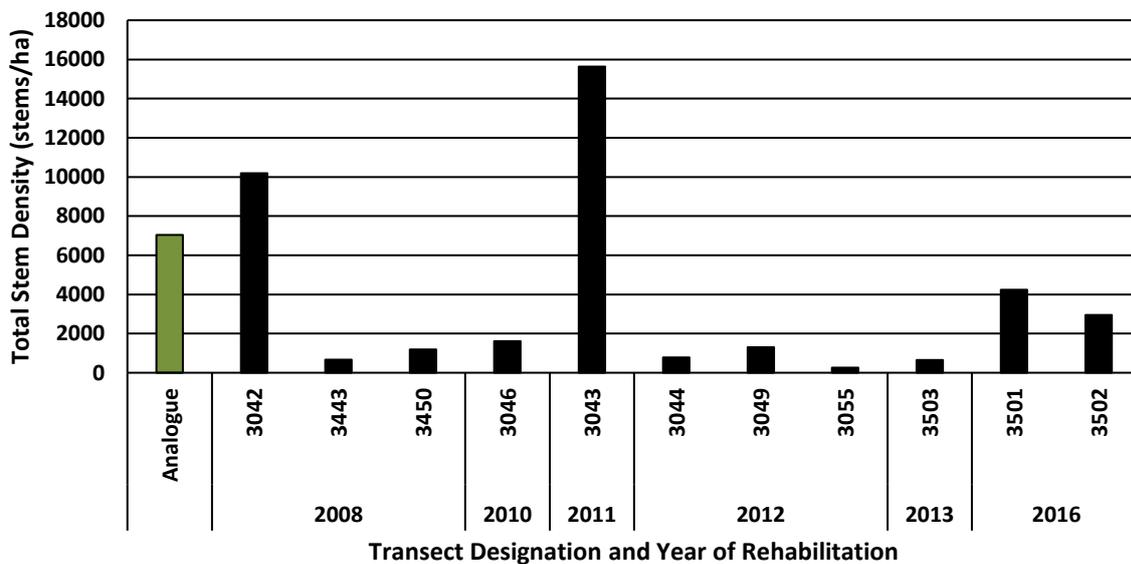
**Figure 6:** 2020 survey data Total Stem Densities for the individual Duralie Spoil Emplacement LFA Transects compared to average Analogue data surveyed in 2017

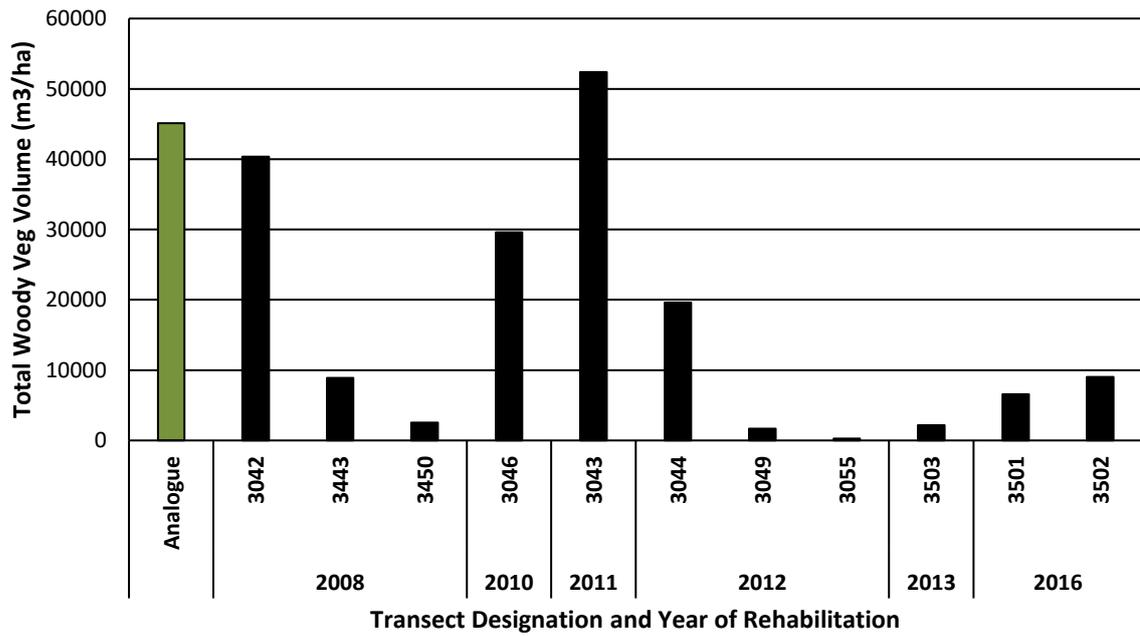
**Figure 7:** 2020 survey data Total Woody Vegetation Volume for the individual Duralie Spoil Emplacement LFA Transects compared to average Analogue data surveyed in 2017

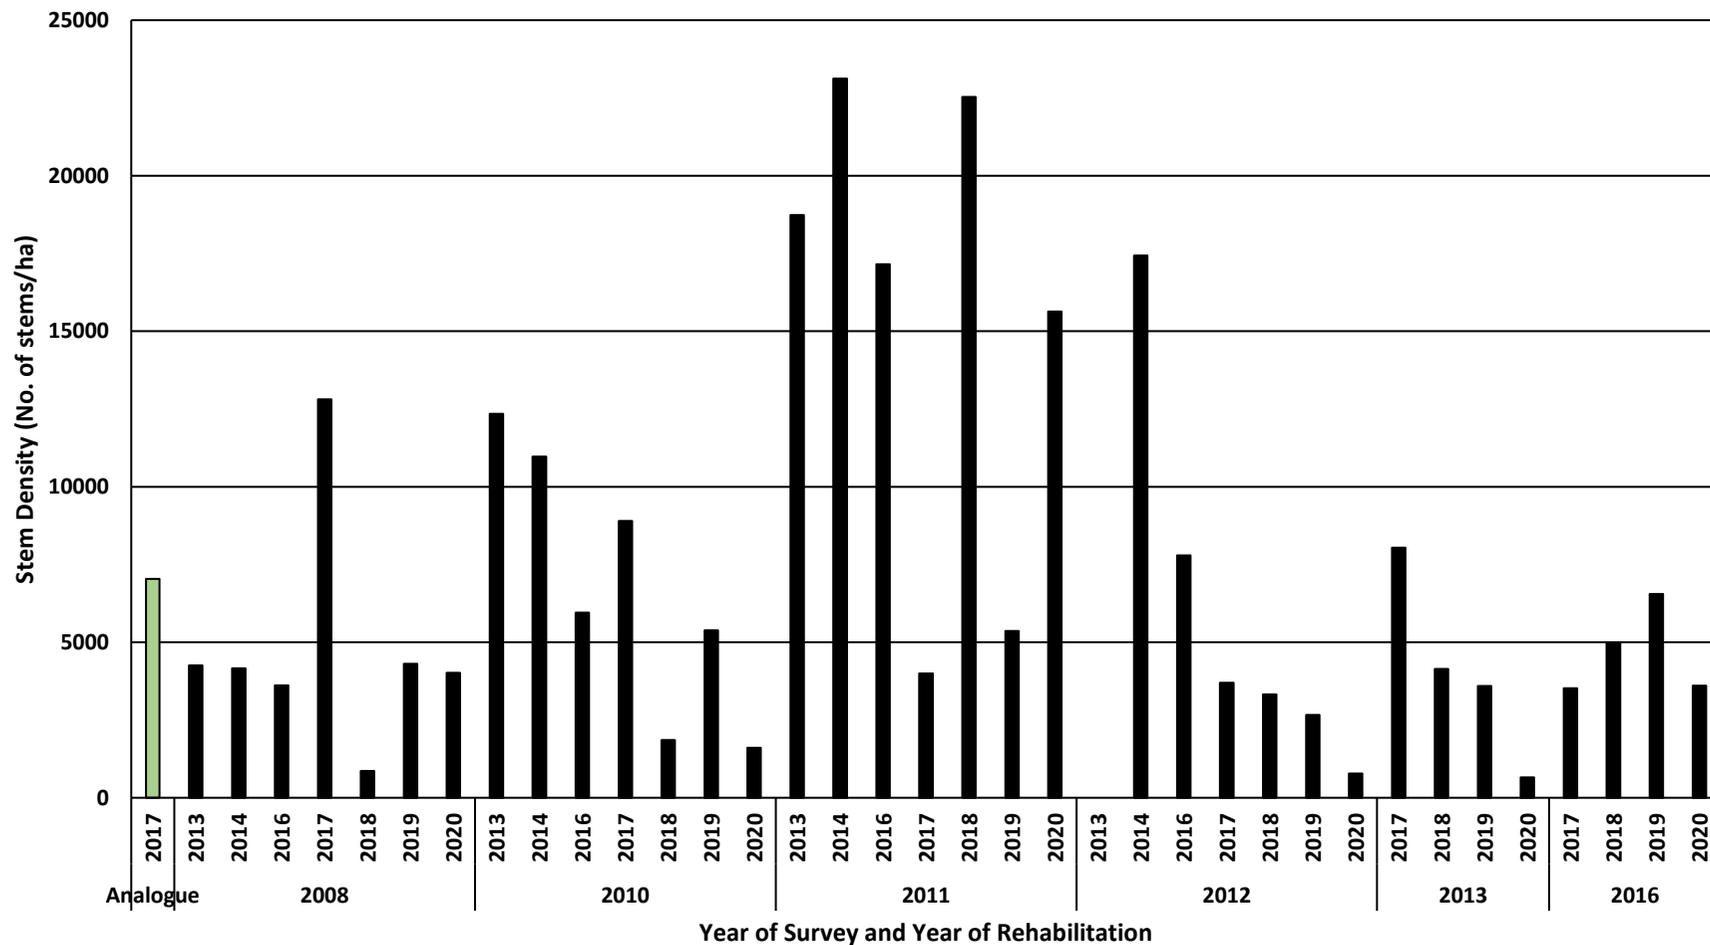
**Figure 8: Average Total Stem Density (stems/ha) values recorded from the 2020 survey, comparison to previous surveys and the 2017 Average Analogue values derived from the Biodiversity Offsets Areas**

The 2016 rehabilitation has recorded a decrease in the average stem density in 2020 (3600 stems/ha) compared to the 2019 survey (6548 stems/ha) and the 2018 survey (4988 stems/ha) (**Figure 8**). Canopy volume has also recorded a decrease this survey (7808 m<sup>3</sup>/ha) compared to the 2019 survey (11,486 m<sup>3</sup>/ha), after increasing substantially when compared to the 2018 survey (2168 m<sup>3</sup>/ha) (**Figure 9**).

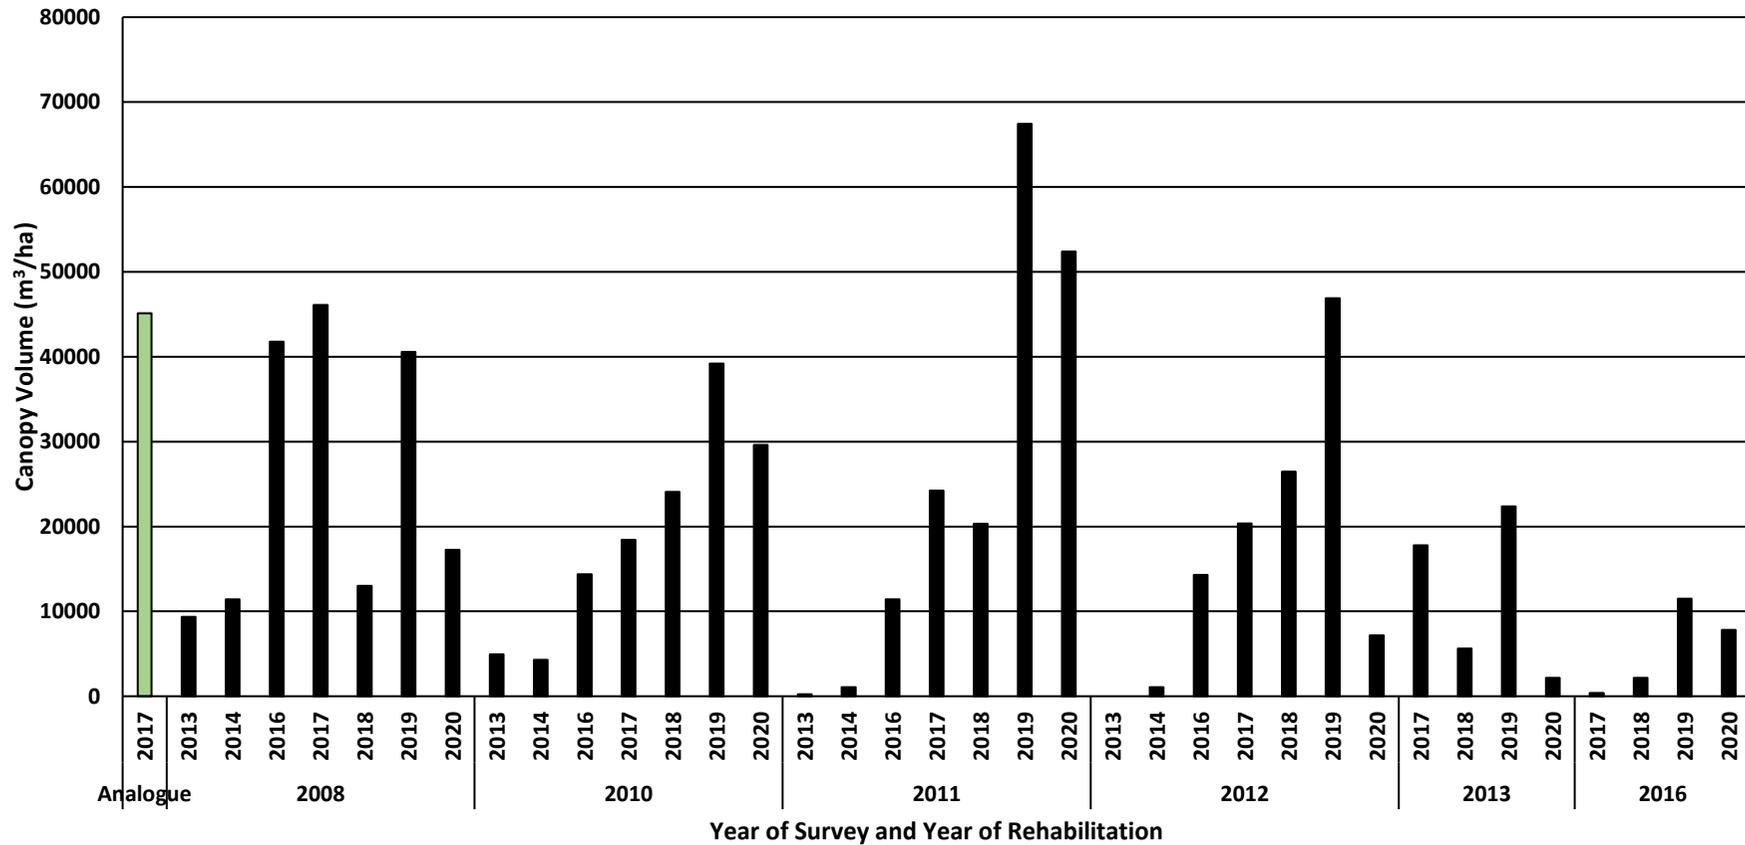
**Figure 9: Average Total Woody Vegetation Volume (m³) values recorded from the 2020 survey, comparison to previous surveys and the 2014 and 2017 Average Analogue values derived from the Biodiversity Offsets Areas**

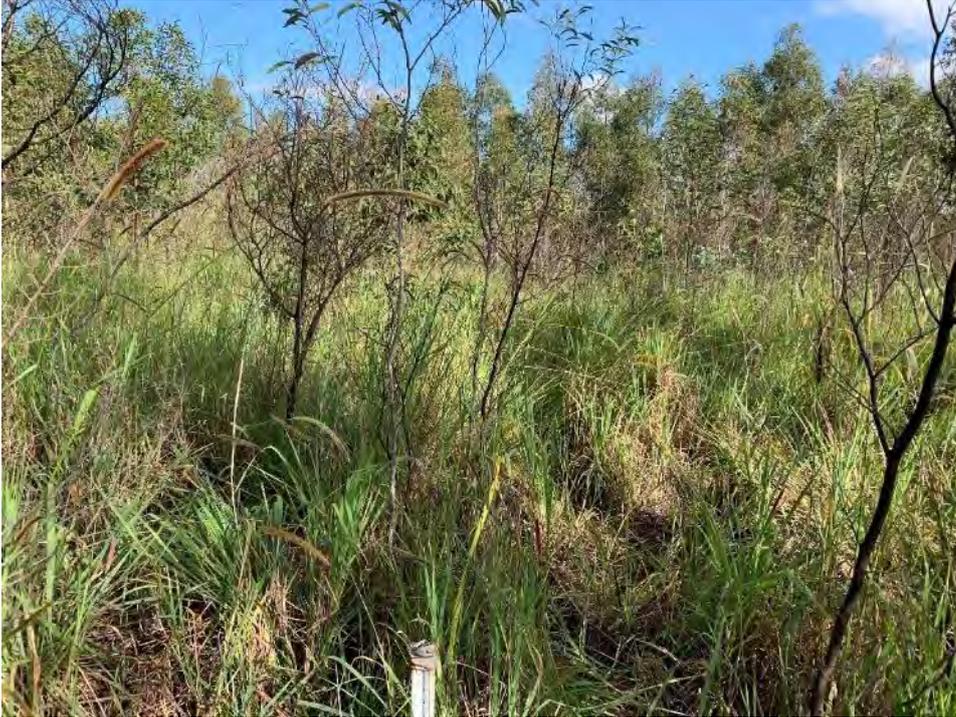
**Plate 1:** Transect 3049 (2012 rehab) – looking down LFA transect. Note the open nature of the woody vegetation due to sparse canopy species and some *Acacia* species die-off and the dense exotic groundcover

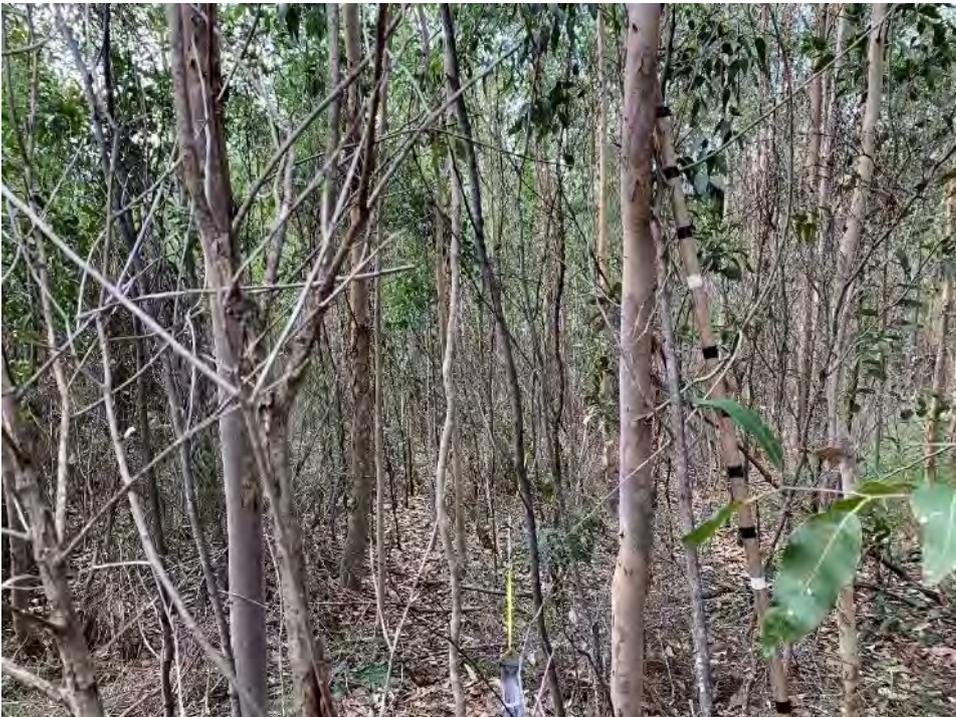
**Plate 2:** Photograph of Transect 3043 LFA in the 2010 rehabilitation area. Note the dense Eucalypts, litter layer and sparser groundcover

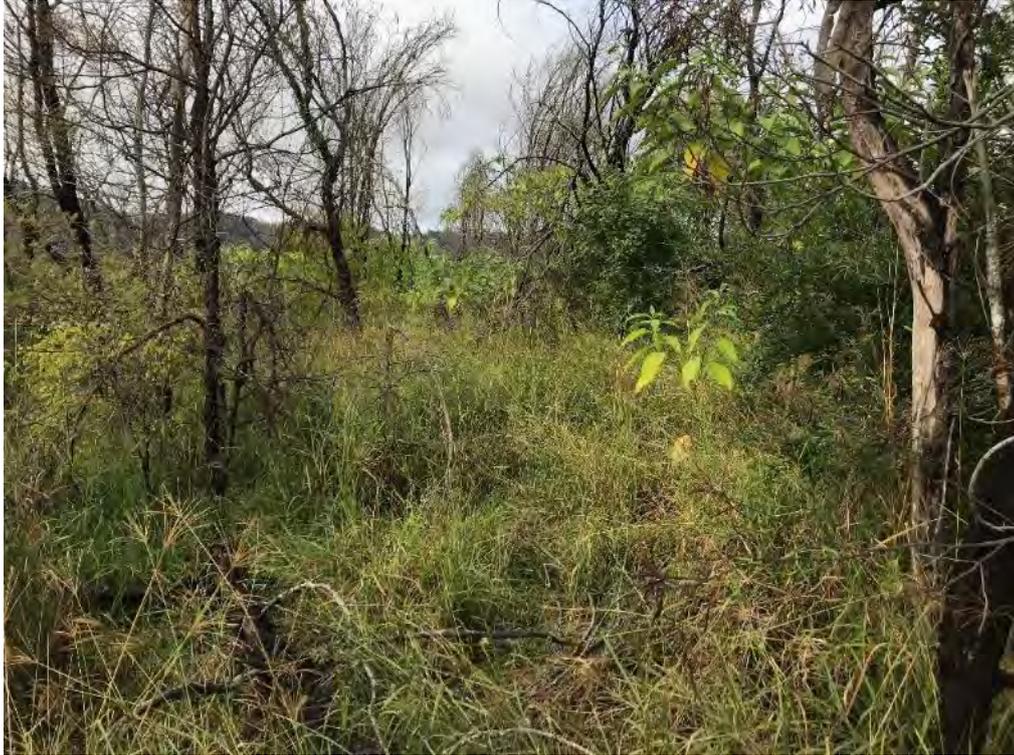
**Plate 11:** Transect 3450 looking south from the transect start (perpendicular to LFA transect) showing dense exotic grasses and the death of the *Acacias* that were the main canopy in this section of the rehabilitation. Note the proliferation of woody weeds – visible here are Lantana, Wild Tobacco and Privet.

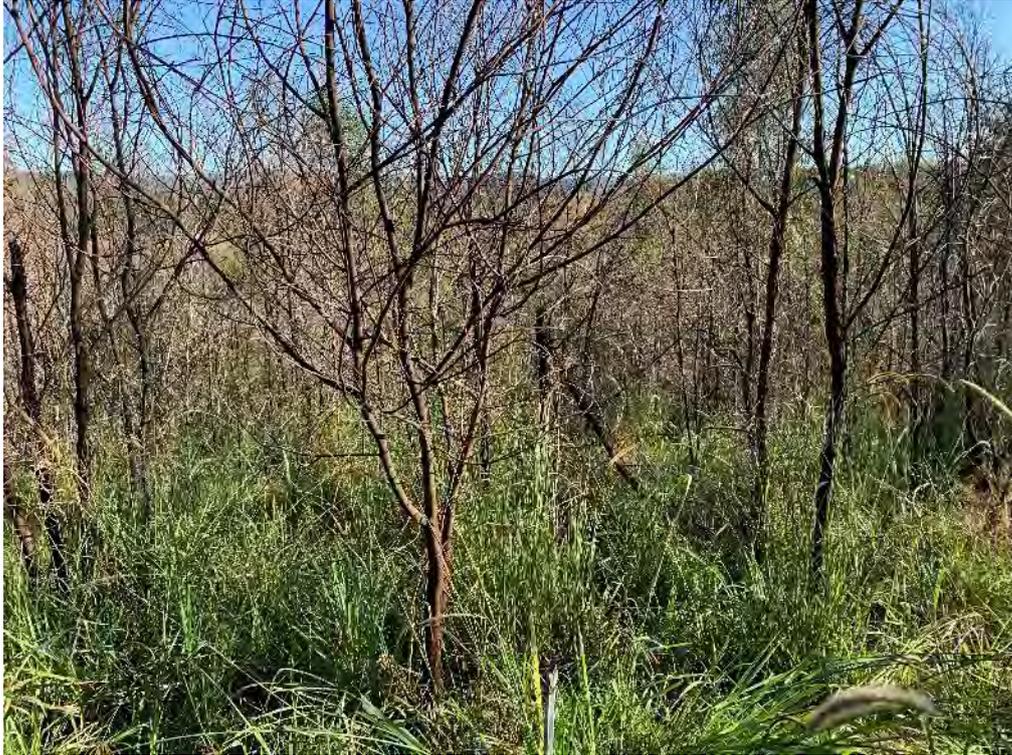
**Plate 20:** Start of Transect 3055 (2012 rehabilitation area) looking down the LFA transect. Note the massive die-off of *Acacia* species
