# Duralie Coal Mine Annual Review

# 2020

Reporting Period: 1<sup>st</sup> July 2019 to 30<sup>th</sup> June 2020

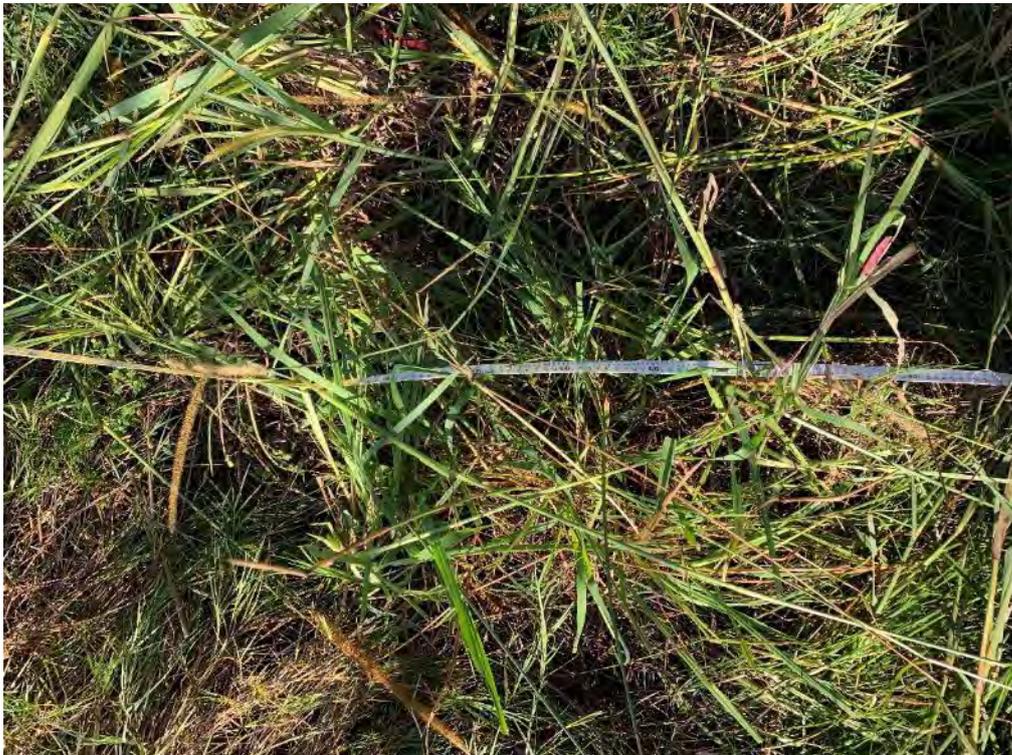
**Plate 21:** Transect 3055 at the 10 - 11m point showing the grassy groundcover and grassy litter that have colonised the soil surface since the die-off of the canopy

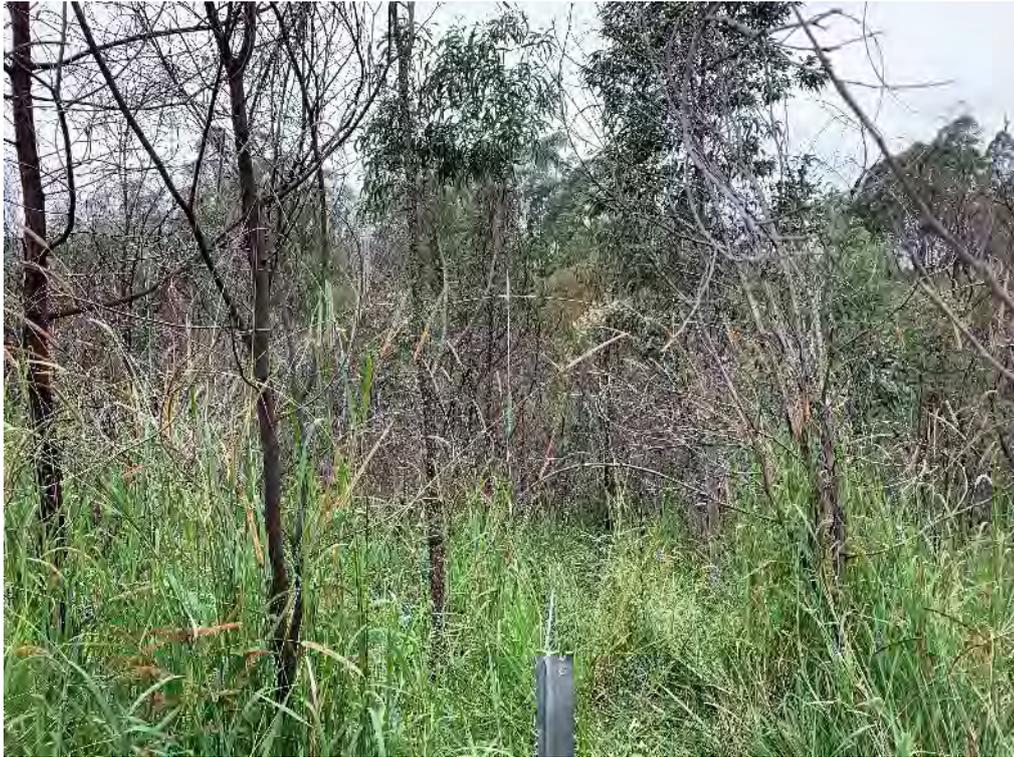
**Plate 22:** Transect 3503 (2013 rehab) looking down the transect. Note the open nature of the cover at the top of the transect due to *Acacia die-off*. Canopy cover increases down the transect

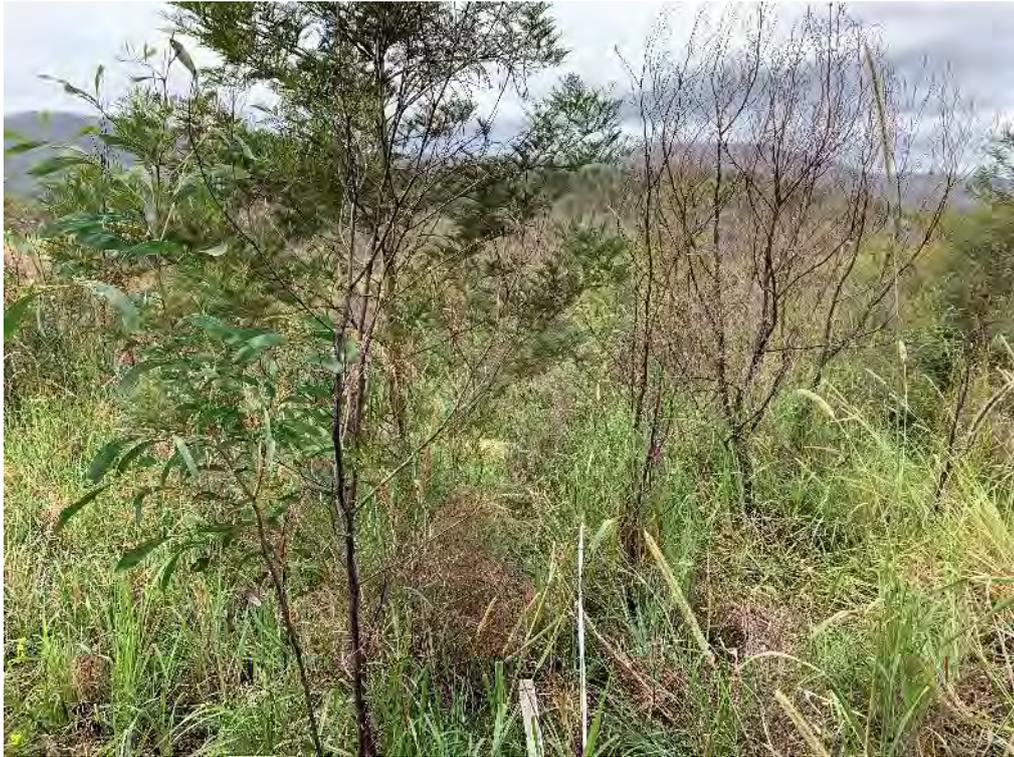
**Plate 26:** Start of Transect 3502 (2016 rehabilitation area) looking down the LFA transect. Note the die-off of *Acacias*

The vegetation structure of Transect 3502 (**Plate 26**) was measured in two strata producing a total stem density of 2955 stems/ha and a total woody vegetation volume of 9,037 m<sup>3</sup>/ha. The upper stratum consisted only of *Acacia* species >2m in height up to 5m. These species were *A. decurrens*, *A. falcata*, *A. irrorata* and *A. ulicifolia*. This stratum recorded a stem density of 967 stems/ha at mean spacing of 3.21m. The lower stratum consisted of the above *Acacia* species plus *D. ulicifolia* and *P. villosa*. This stratum had a density of 1986 stems/ha at a mean spacing of 2.24m. other native species observed in the vicinity of the transect included *A. implexa*, *C. maculata*, and the vine *Kennedia rubicunda*. The appearance of canopy species is especially important in this area as previous surveys have failed to locate any such species. There was evidence of *Acacia* die-off observed, but *Acacia* seedlings were also observed to be germinating, indicating a second generation of these species. The groundcover is again dominated by exotic grasses.
