# **DURALIE COAL MINE ANNUAL REVIEW 2022**

Reporting Period: 1<sup>st</sup> July 2021 to 30<sup>th</sup> June 2022

# Duralie Coal Mine 2022 Rehabilitation EFA Monitoring

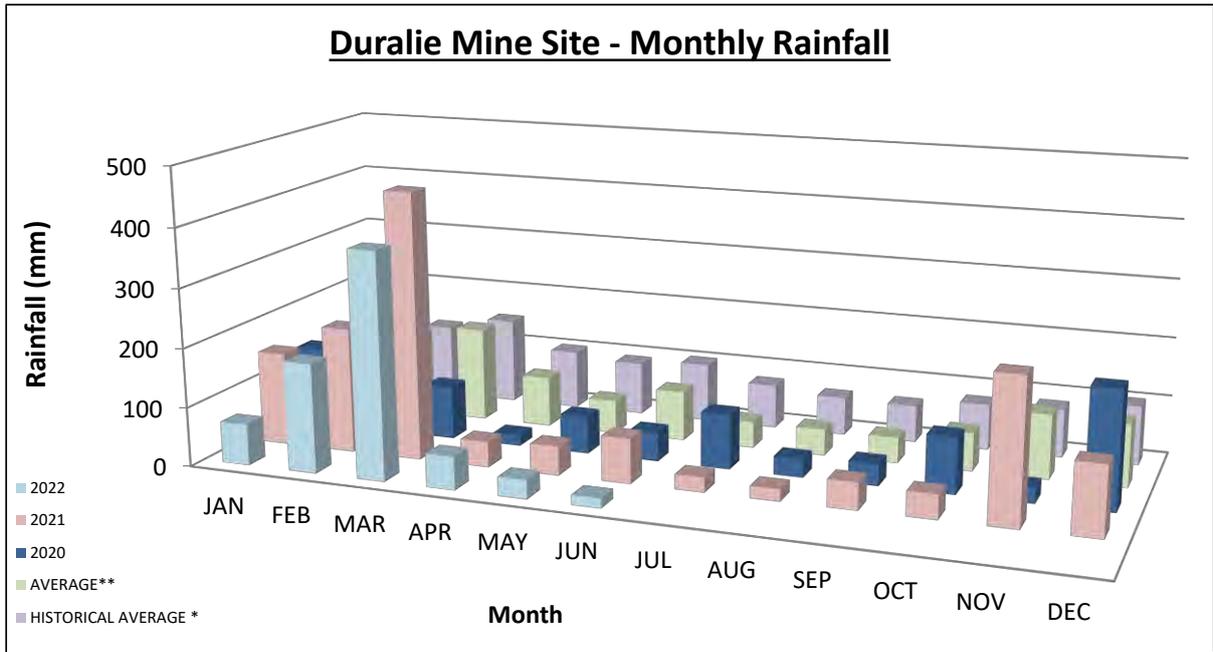
**Figure 2-1: Monthly Rainfall for 2020 to 2022 and Historical Averages**

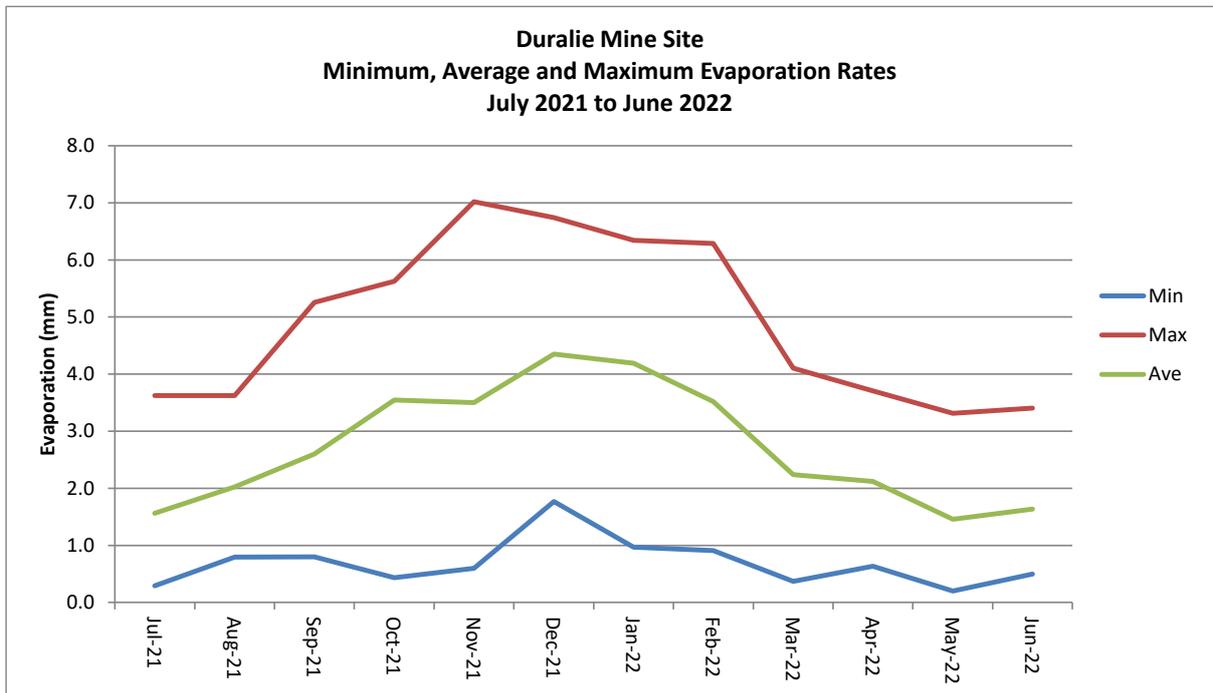
**Figure 2-2: Minimum, Maximum and Average Evaporation Rates During the Reporting Period**

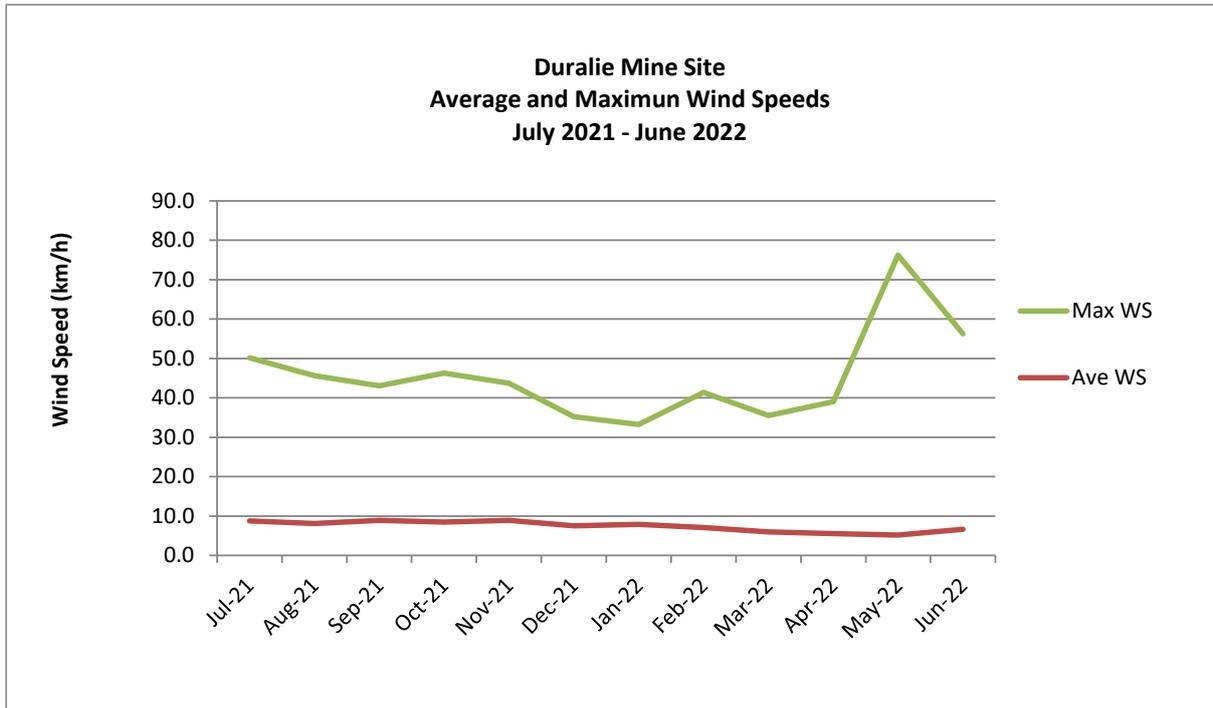
**Figure 2-3: Maximum and Average Wind Speeds During the Reporting Period**

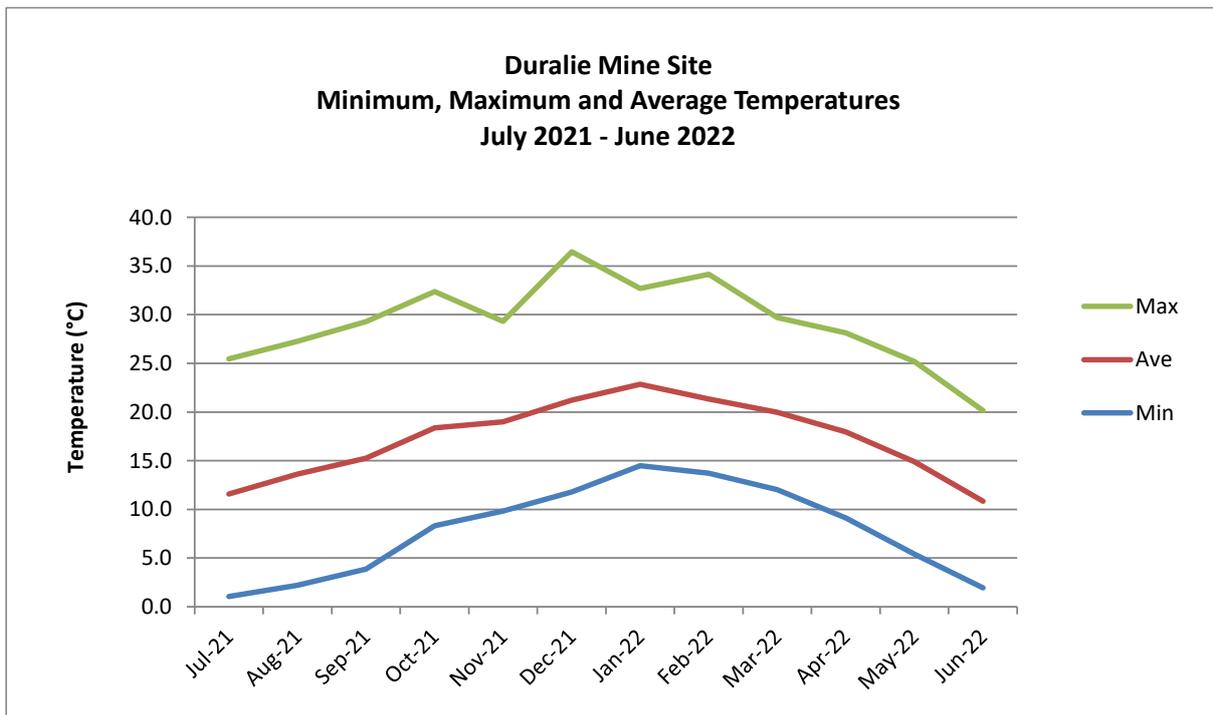
**Figure 2-4: Minimum, Maximum and Average Temperatures During the Reporting Period**

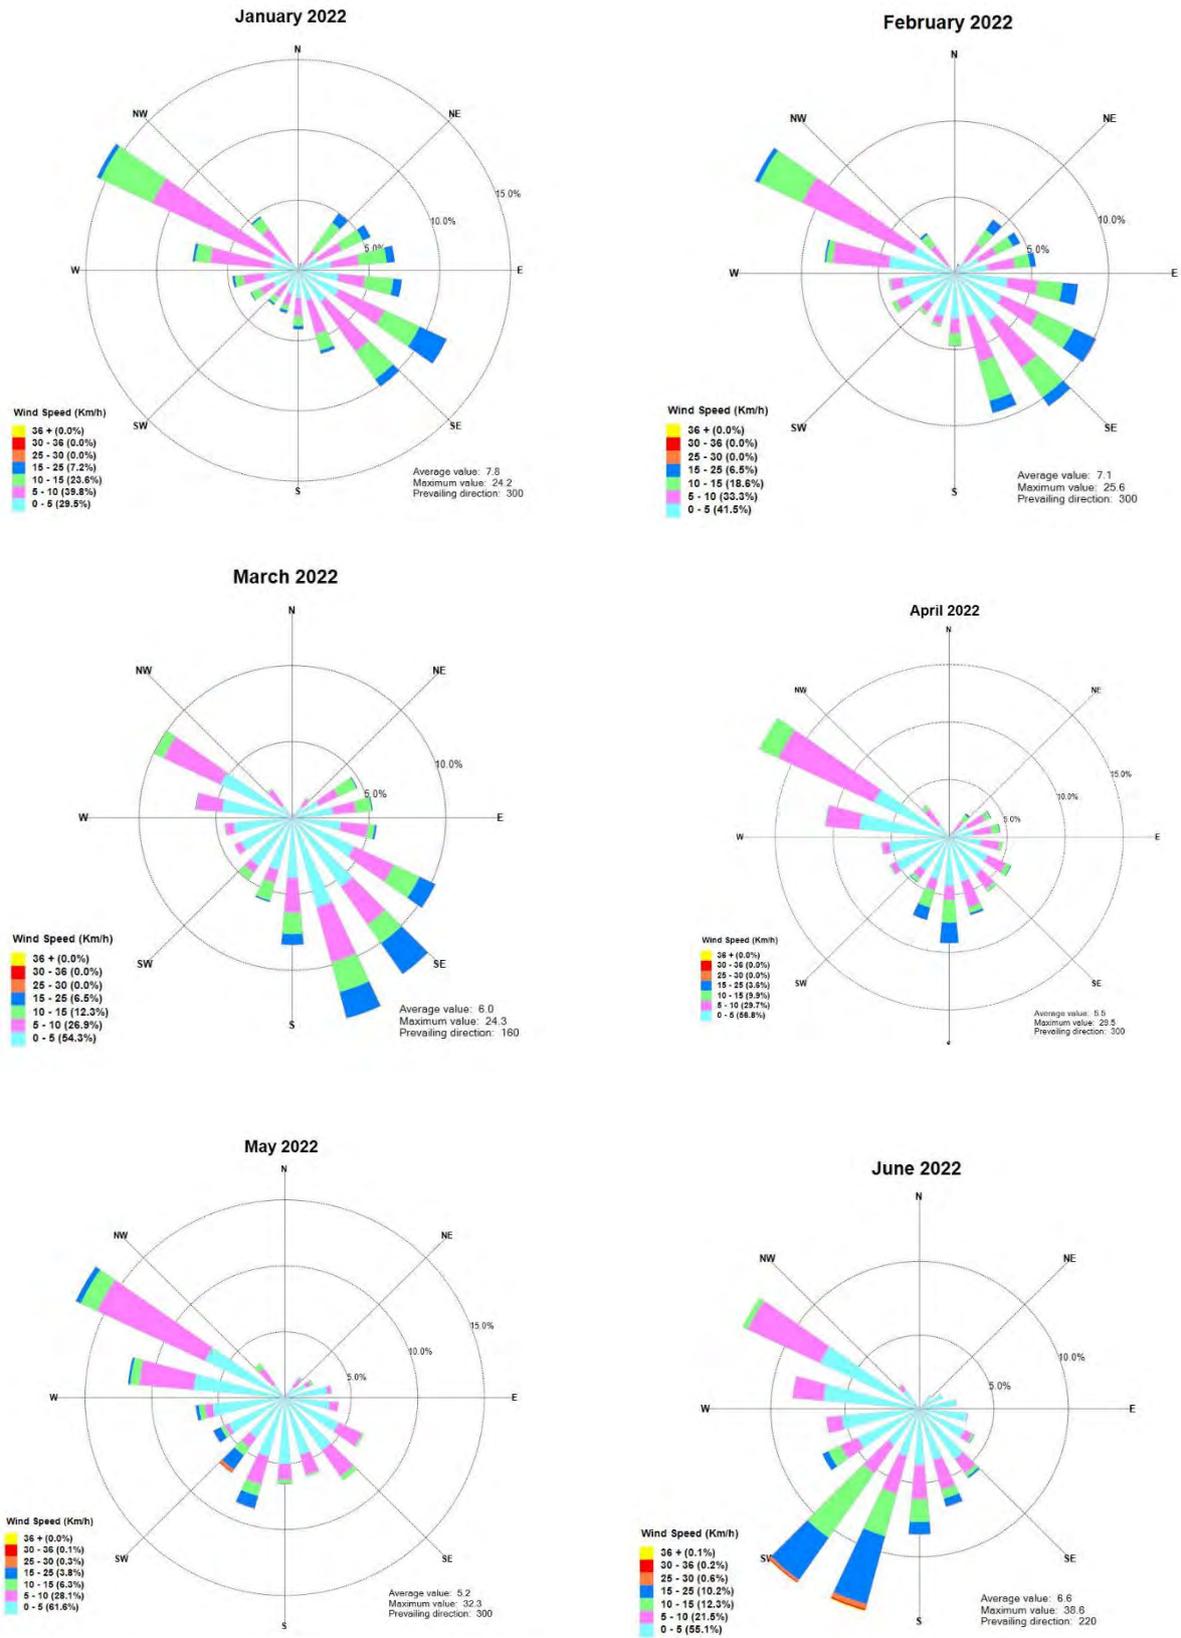
Figure 2-5 (continued): Monthly Windroses showing wind direction, speed and frequencies

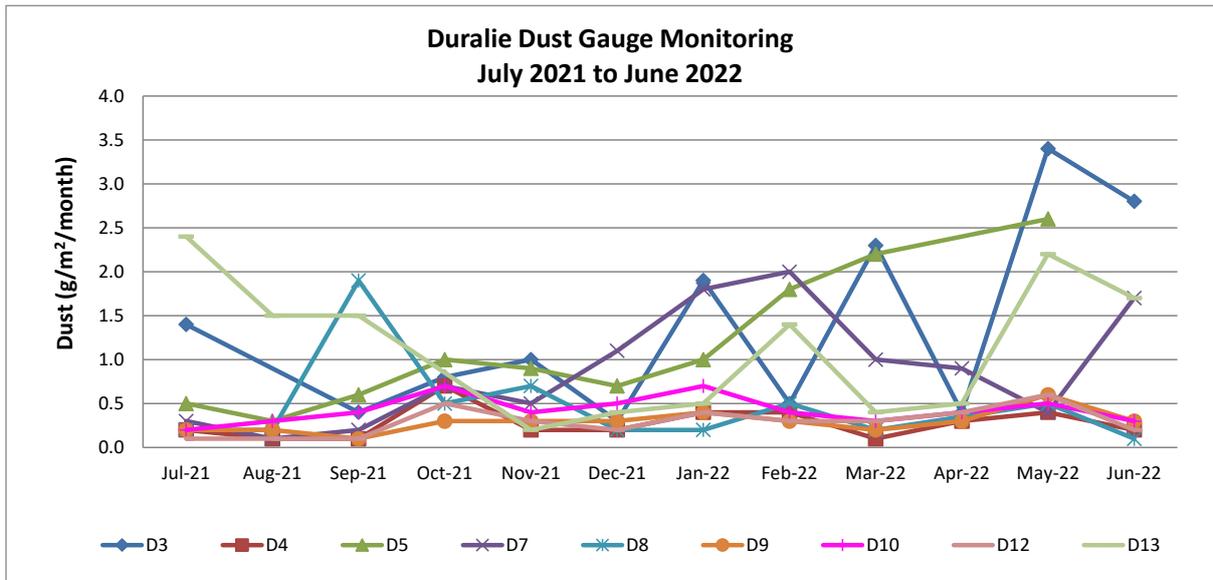
**Figure 3-1: Monthly Depositional Dust Monitoring Results (minus contaminated results) during the Reporting Period**

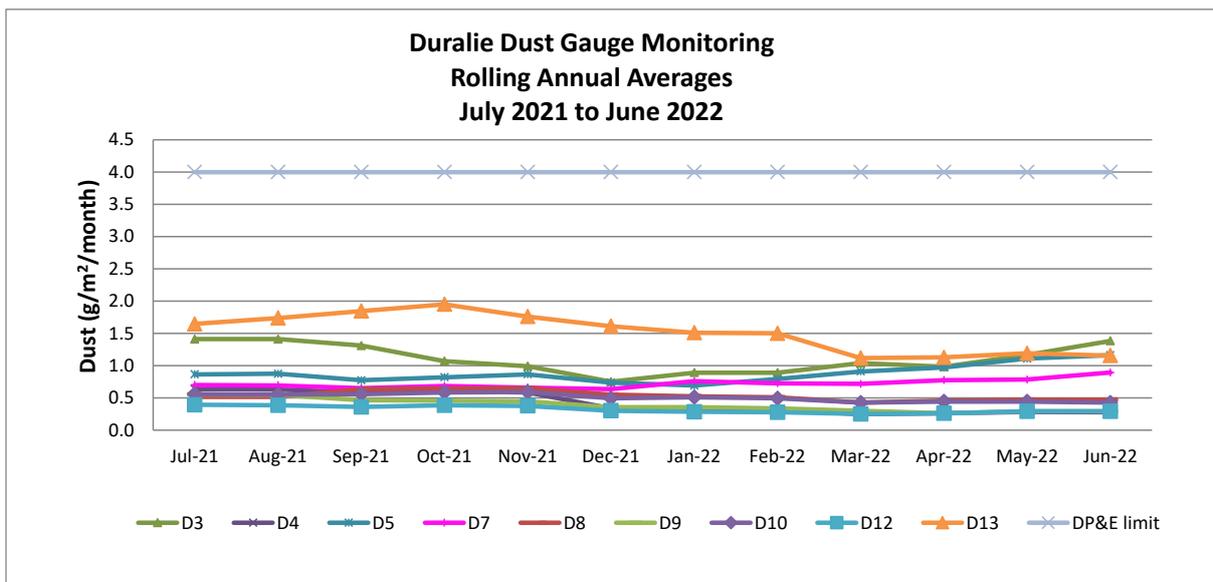
**Figure 3-2: Rolling Annual Average Depositional Dust Monitoring Results (minus contaminated results) during the Reporting Period**

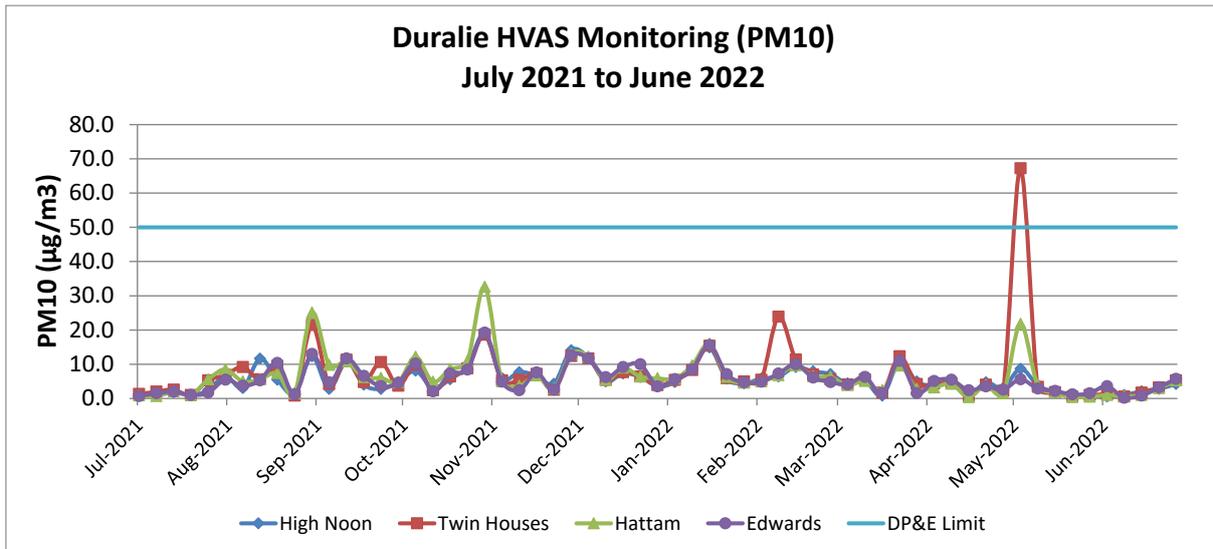
**Figure 3-3: High Volume Air Sampling (PM<sub>10</sub>) Results during the Reporting Period**

HVAS PM<sub>10</sub> monitoring results show that all monitoring locations (in terms of monitored days) did not exceed the National Environmental Protection Measure (NEPM) of 50ug/m<sup>3</sup>/day, listed under Condition 19, Schedule 3 of the Project Approval, except for one result at Twin Houses HVAS on 4 May 2022. It was found that the one high result was not mine related but due to a road diversion from Bucketts Way to Johnsons Creek Road. **Figure 3-3 (Appendix 3)** shows the recorded PM10 24hr results across the four HVAS monitoring sites during the reporting period.

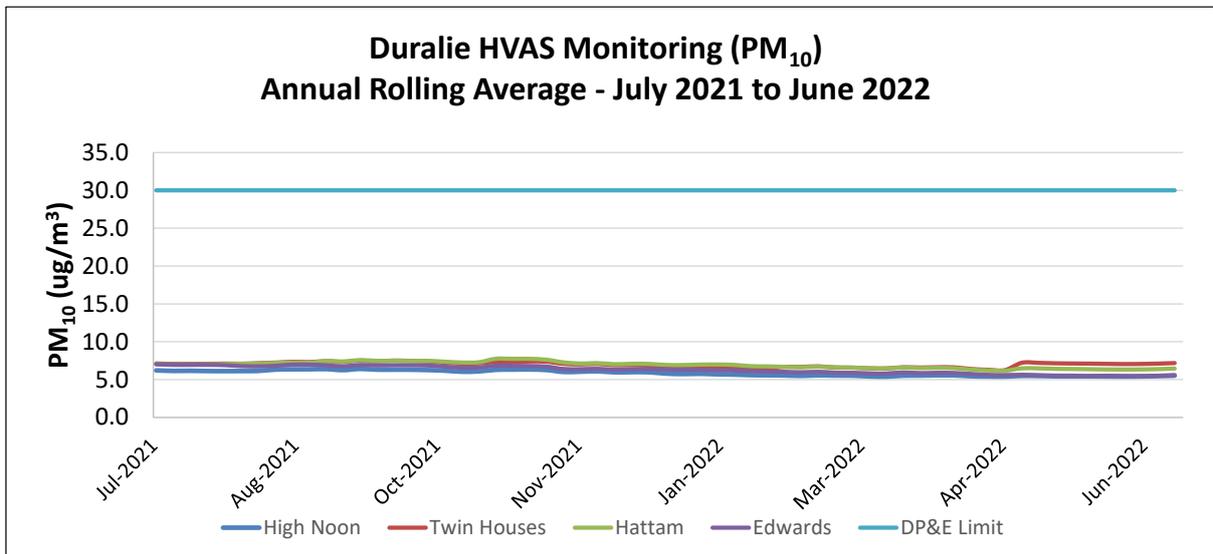
**Figure 3-4: Rolling Annual Average HVAS (PM<sub>10</sub>) Results during the Reporting Period**

The HVAS annual rolling averages remained low and fluctuations generally reflect changes in meteorological conditions throughout the year, i.e. rainfall and wind. Annual rolling averages are presented in **Table 6.7**.

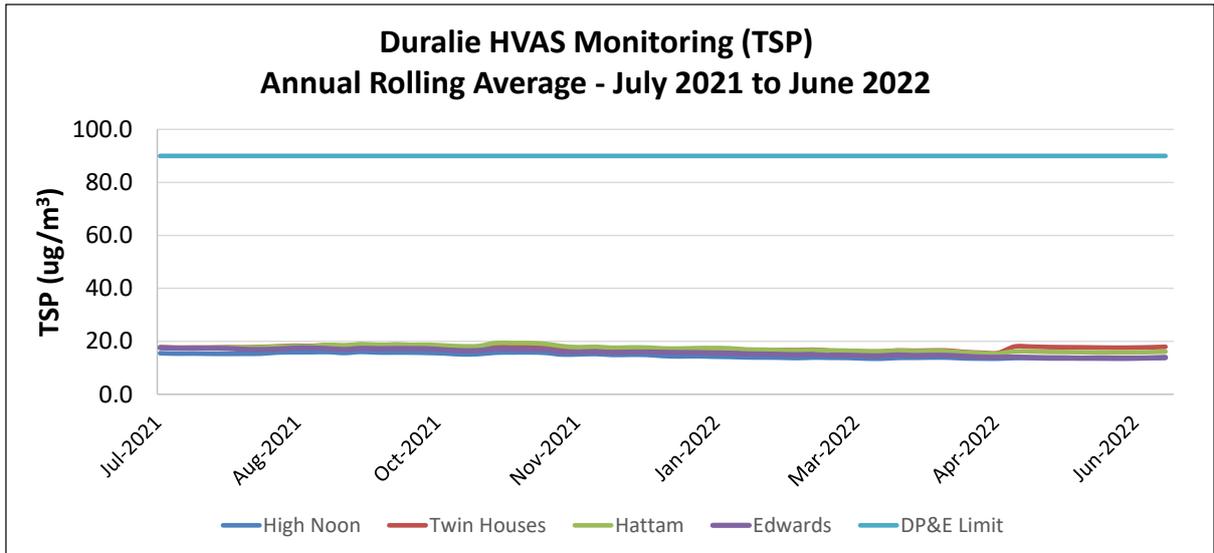
**Figure 3-5: Rolling Annual Average HVAS (TSP) Results during the Reporting Period**

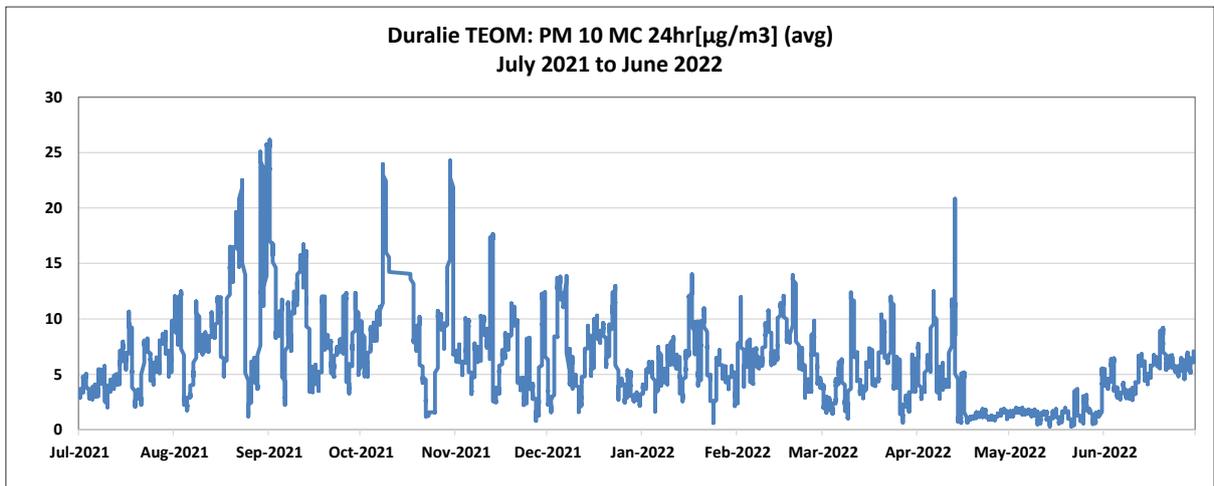
**Figure 3-6: Real Time Dust Monitoring (TEOM PM<sub>10</sub>) Results during the Reporting Period**

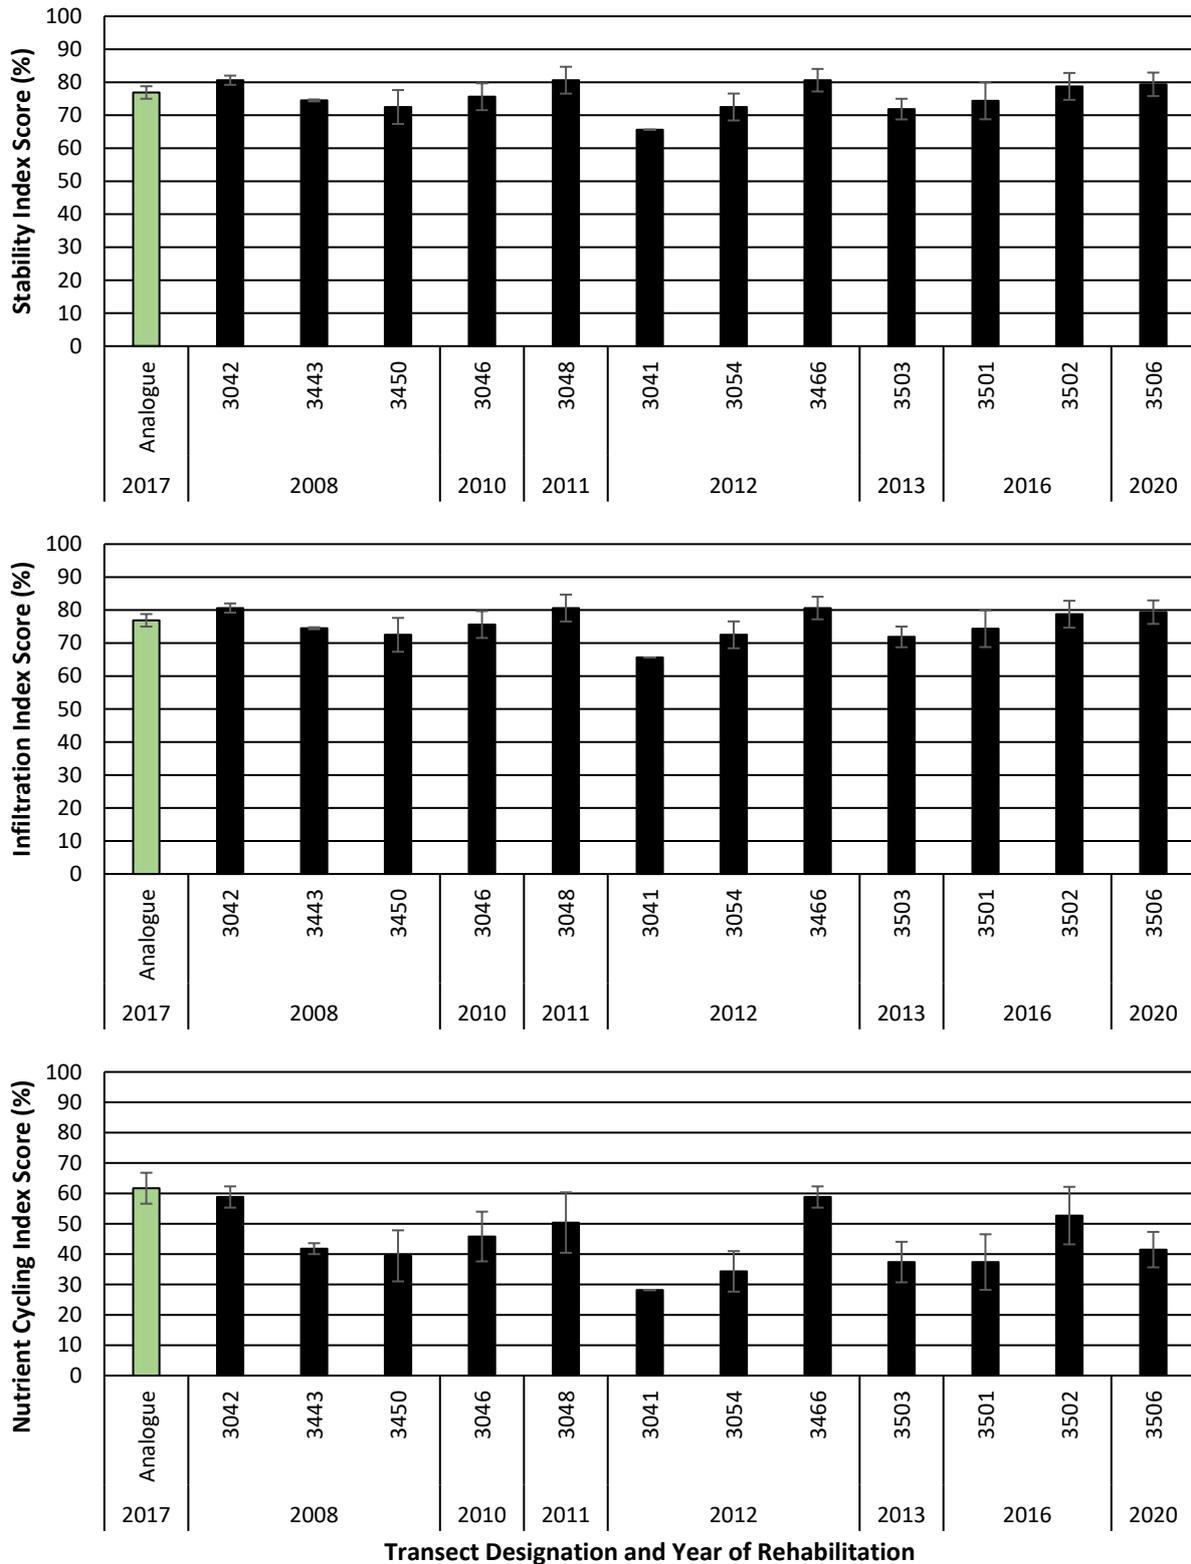
**Chart 1: Landscape Functional Analysis results by Index for the 2022 survey of the Duralie Spoil Emplacement Woodland Rehabilitation. Transects are grouped by year of rehabilitation. Error bars are Standard Errors of the Mean.**

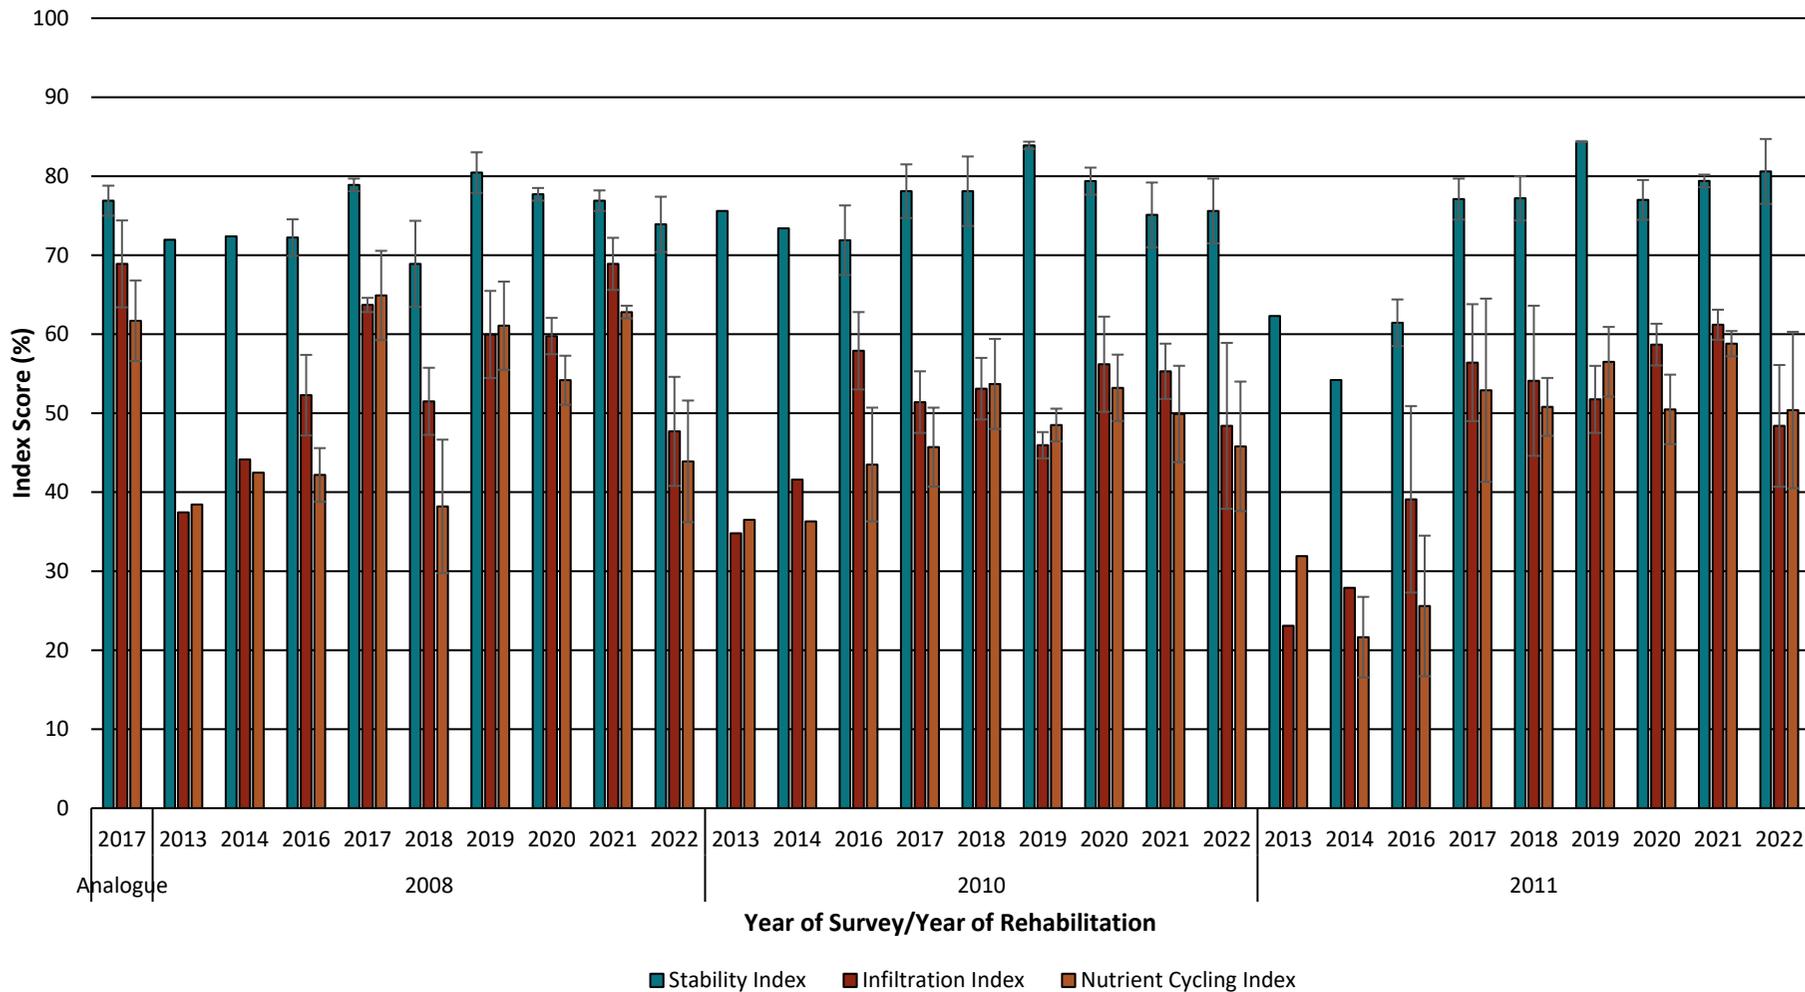
**Chart 2: Landscape Functional Analysis results for the surveys of the 2008 to 2011 rehabilitation areas on the Duralie Coal Mine spoil emplacement and comparison to the 2017 average analogue sites derived from the Biodiversity Offsets Areas.**

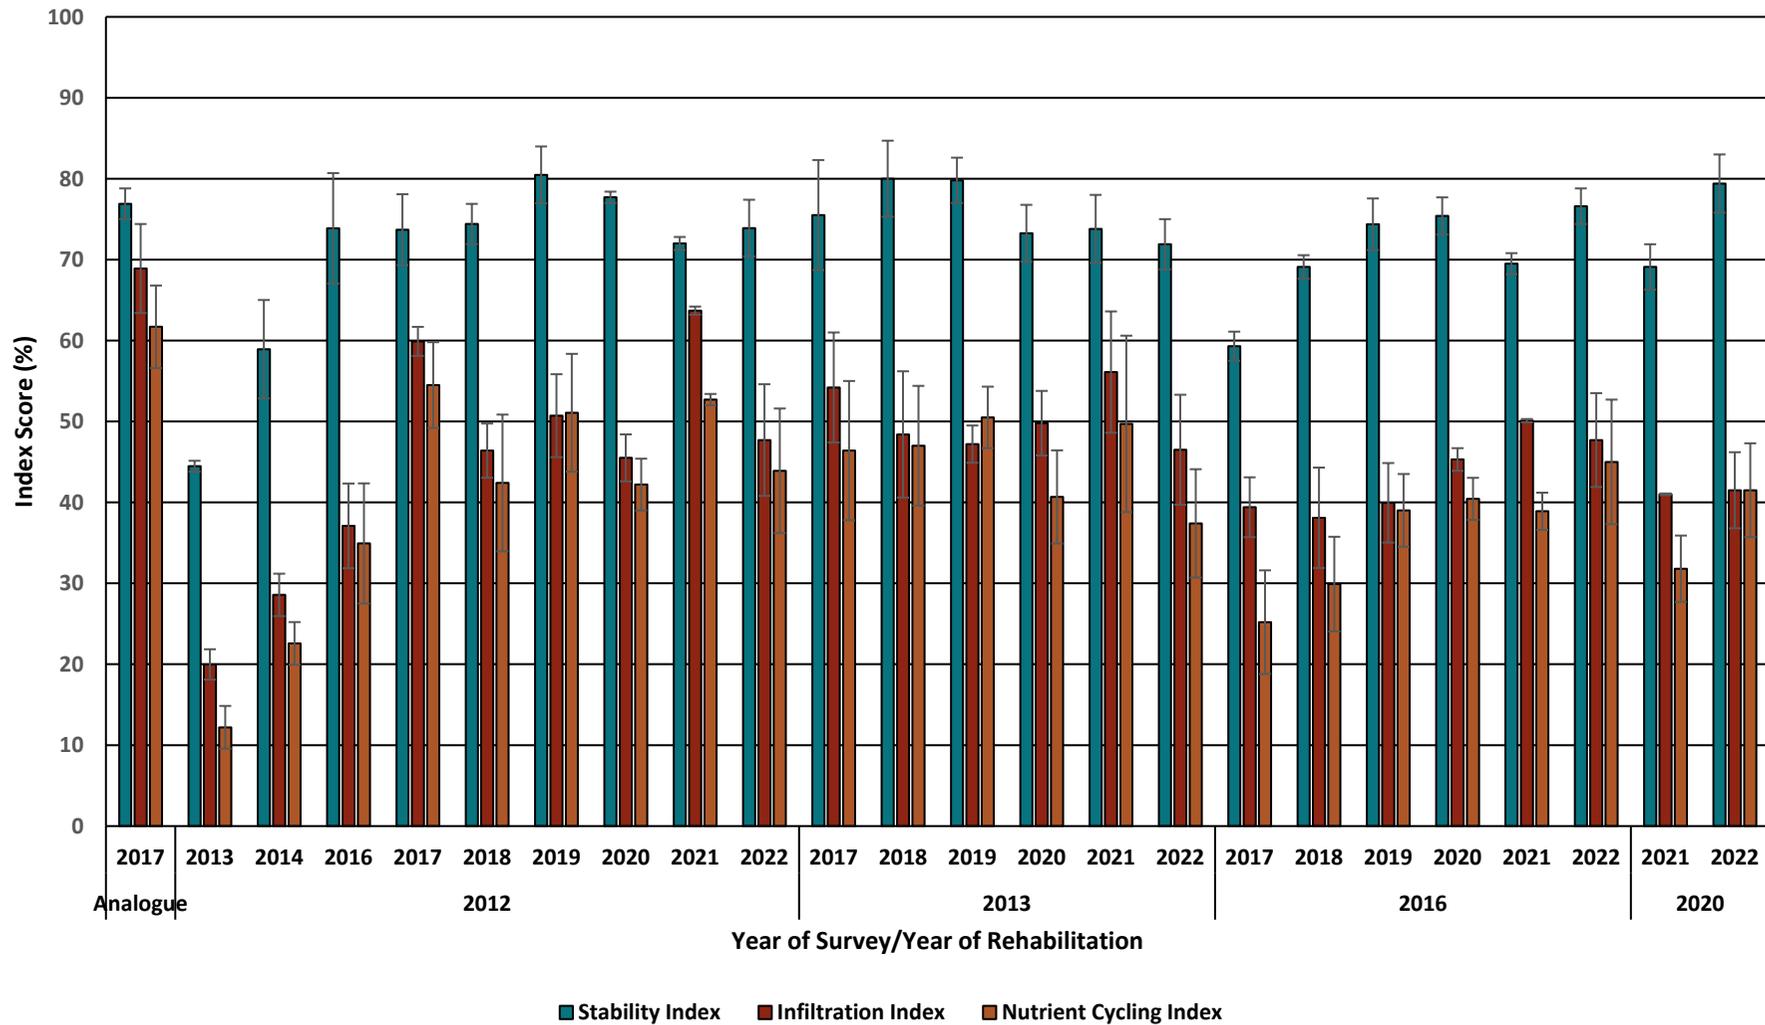
**Chart 3: Landscape Functional Analysis results for the surveys of the 2012 to 2020 rehabilitation areas on the Duralie Coal Mine spoil emplacement and comparison to the 2017 average analogue sites derived from the Biodiversity Offsets Areas.**

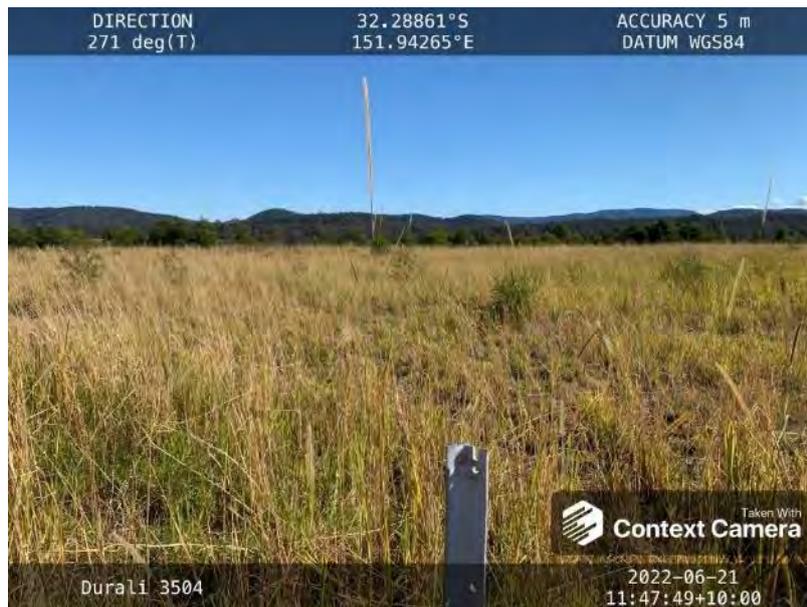
Transects 3504 2018 rehabilitation and Transect 3505 2020 rehabilitation have been rehabilitated to pasture. These areas have not been seeded or planted with woody vegetation and no woody vegetation was recorded during the survey. Nonetheless, it was noted that Transect 3504 has some minor *Acacia* colonisation (**Plate 1**). Transect 3505 does not yet have *Acacias* encroaching – but will given the proximity of native rehabilitation - but *Tagetes minuta* (Stinking Roger) was becoming established.

**Plate 1: Transect 3504 2018 Pasture rehabilitation showing *Acacia* colonisation**

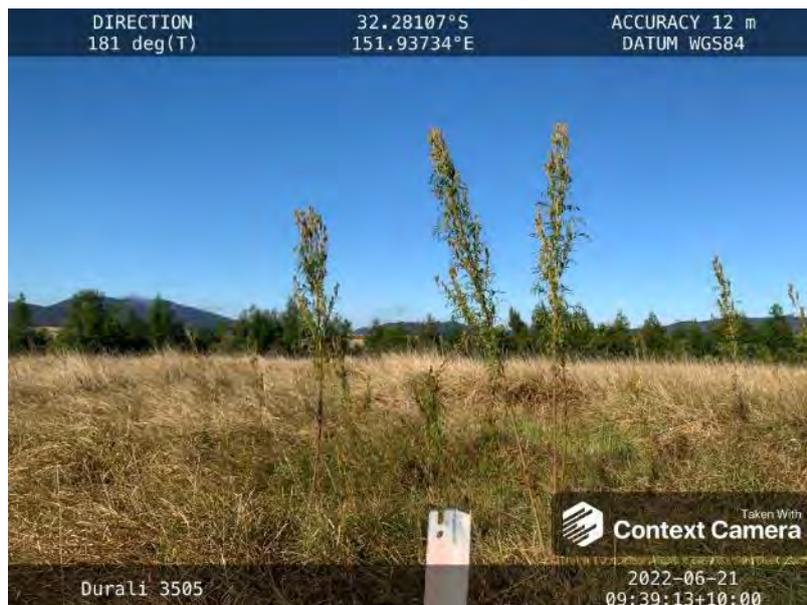
**Plate 2: Transect 3505 2020 Pasture rehabilitation showing *Tagetes minuta* (Stinking Roger) colonising**

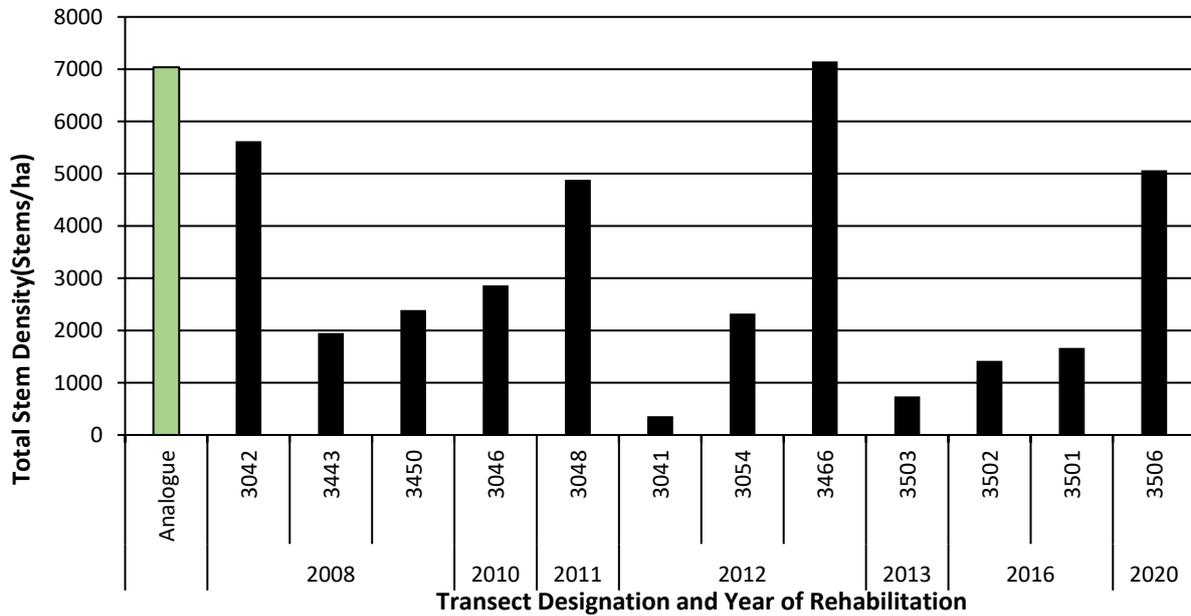
**Chart 4: Total stem density by transect and year of rehabilitation for the 2022 DCM Spoil Emplacement**

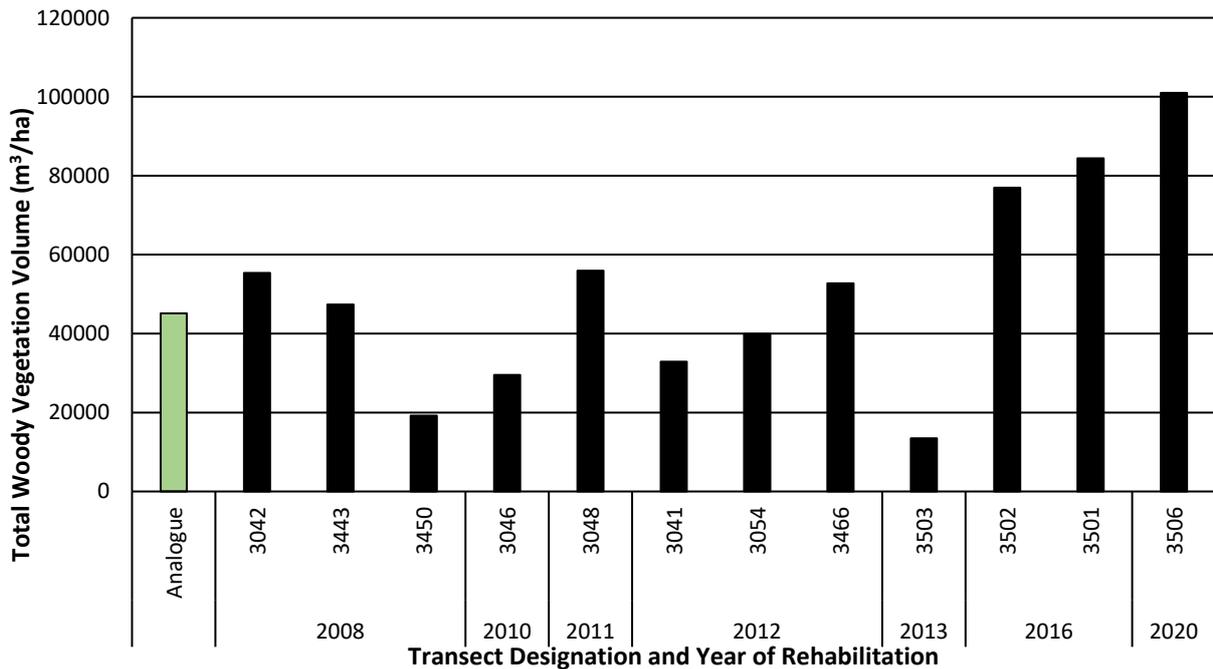
**Chart 5: Total woody vegetation volume by transect of year of rehabilitation for the 2022 survey of the DCM spoil emplacement**

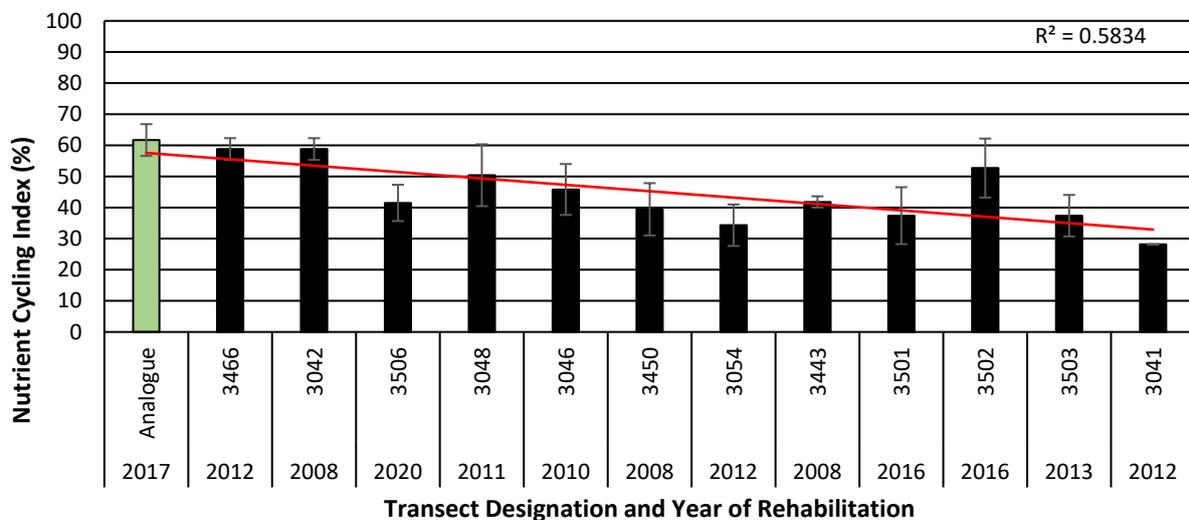
The difference between the grassy and litter dominated groundcover has been remarked upon above. The relationship between the density of the woody vegetation, the resulting groundcover and its affect on the Nutrient Cycling Index is shown in **Chart 6**. While the age of the rehabilitation also has an impact on litter accumulation, it can be seen that there is a correlation between stem density and nutrient cycling with high density areas producing more litter.

**Chart 6: Nutrient Cycling Index arranged by total stem density from highest (left) to lowest (right). Trend line in red, with the trend line correlation ( $R^2$  number) in top right**

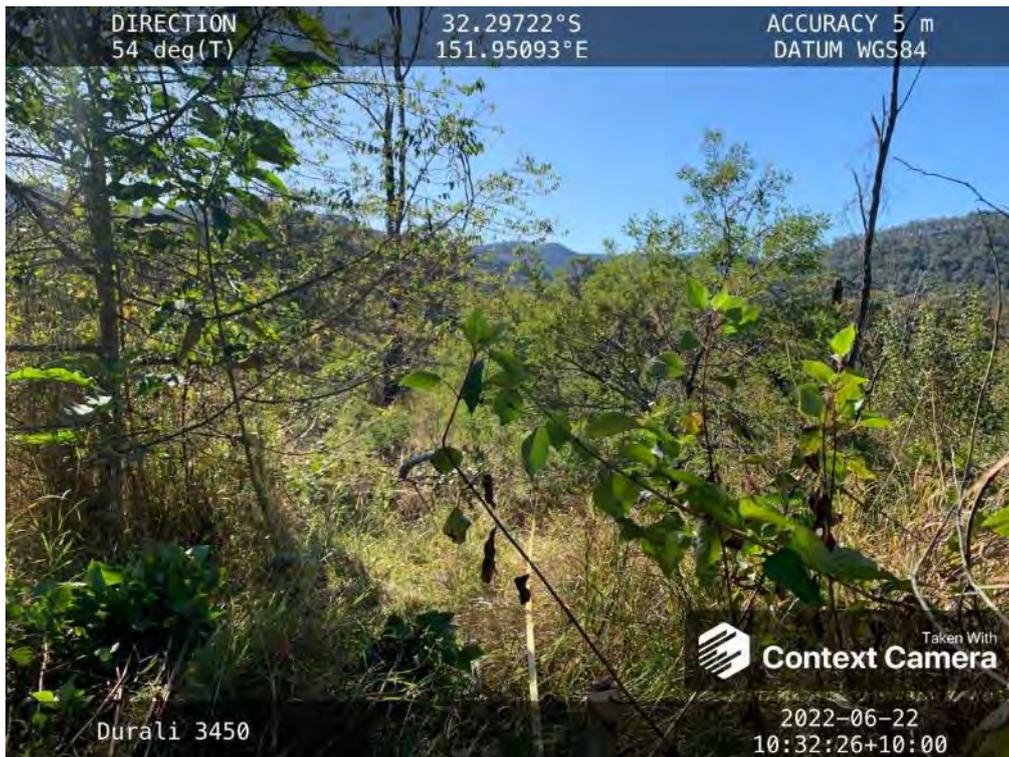
**Plate 5: Transect 3450 2008 Rehabilitation. Note the open nature of the rehab, no Eucalypts were seeded into this area.**

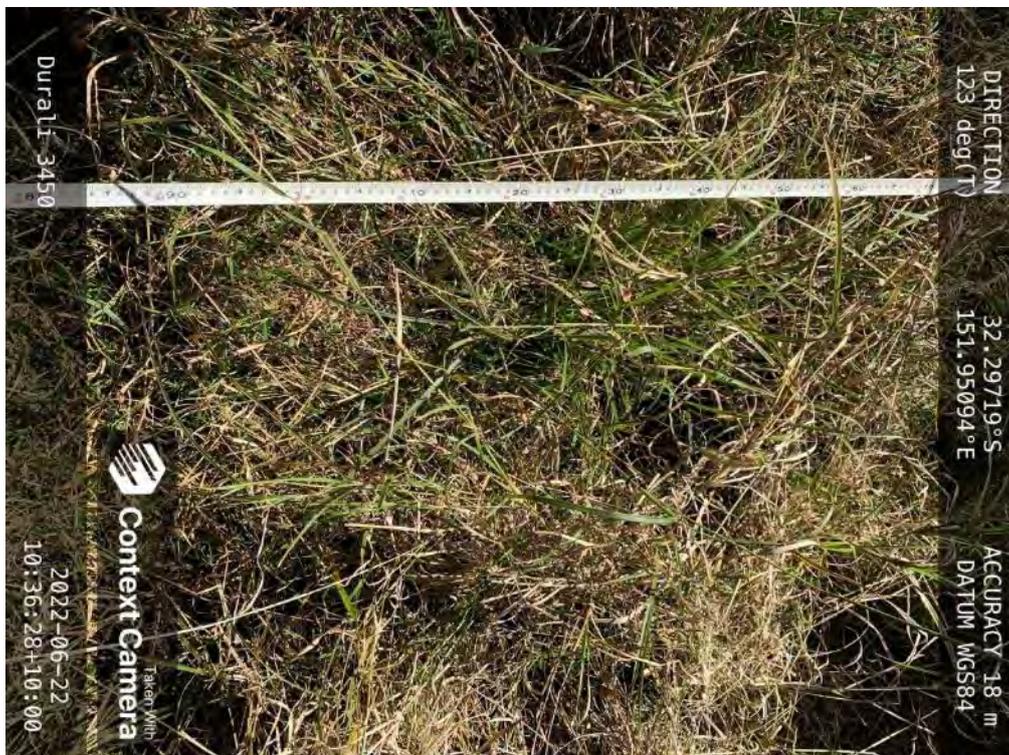
**Plate 6: Transect 3450 2008 Rehabilitation at the 3m point of the LFA transect showing typical dense exotic grassy understorey**

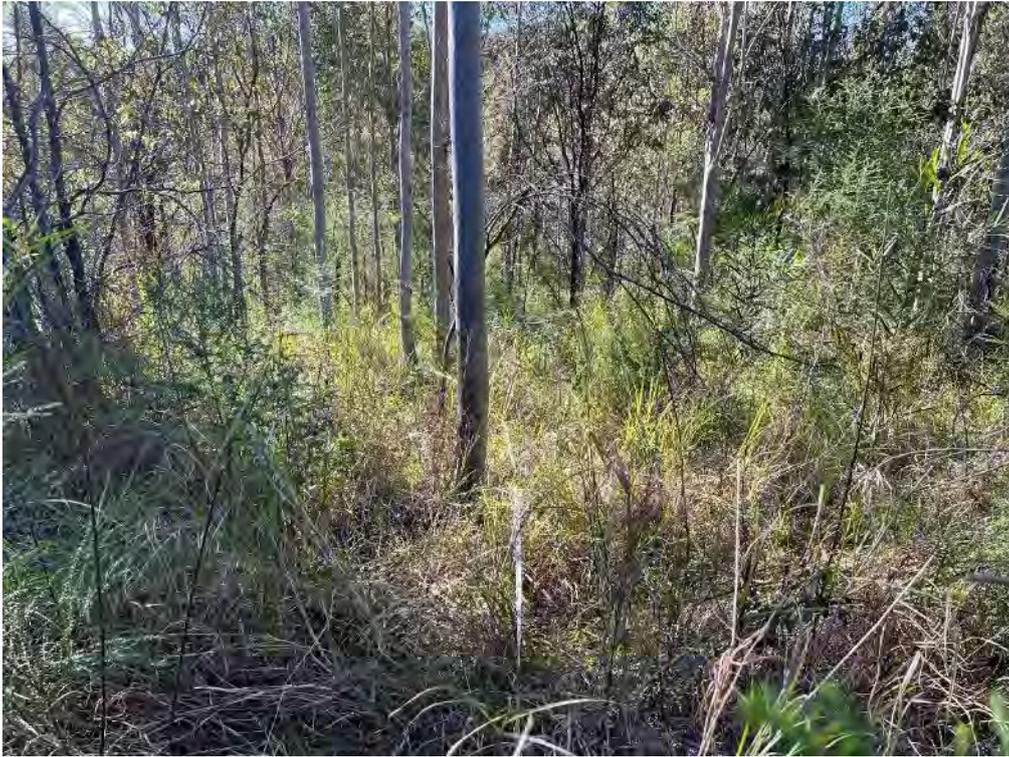
**Plate 7: Transect 3046 2010 Rehabilitation looking down LFA transect. Note the density of Eucalyptus stems and the exotic groundcover**

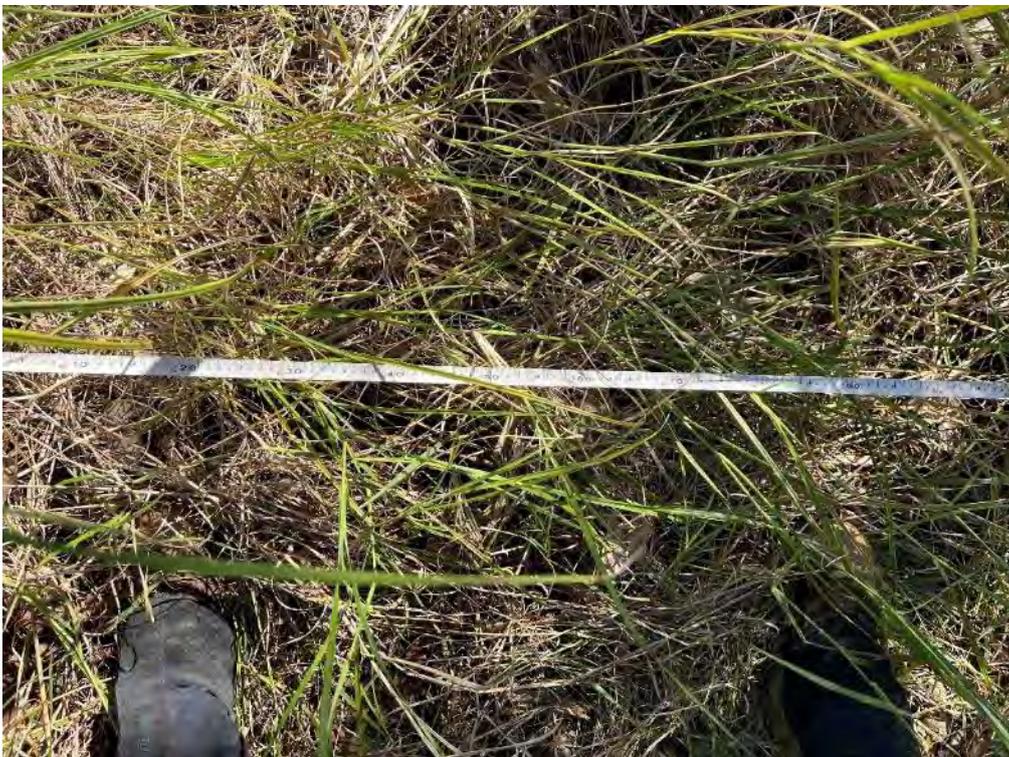
**Plate 8: Transect 3046 2010 Rehabilitation - exotic ground cover at the 5m point on the LFA transect**

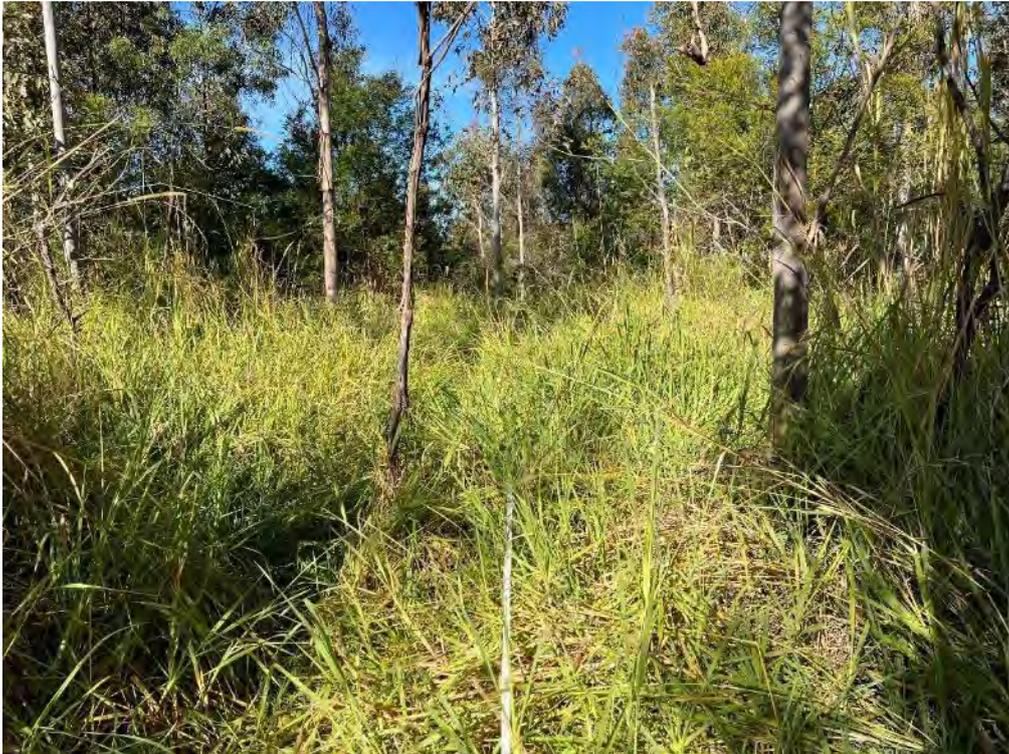
**Plate 11: Transect 3041 2012 Rehabilitation looking down the LFA transect showing sparser woody vegetation, but very dense exotic ground cover – *Setaria sphacelata*.**
