# **DURALIE COAL MINE ANNUAL REVIEW 2022**

Reporting Period: 1<sup>st</sup> July 2021 to 30<sup>th</sup> June 2022

# Duralie Coal Mine 2022 Rehabilitation EFA Monitoring

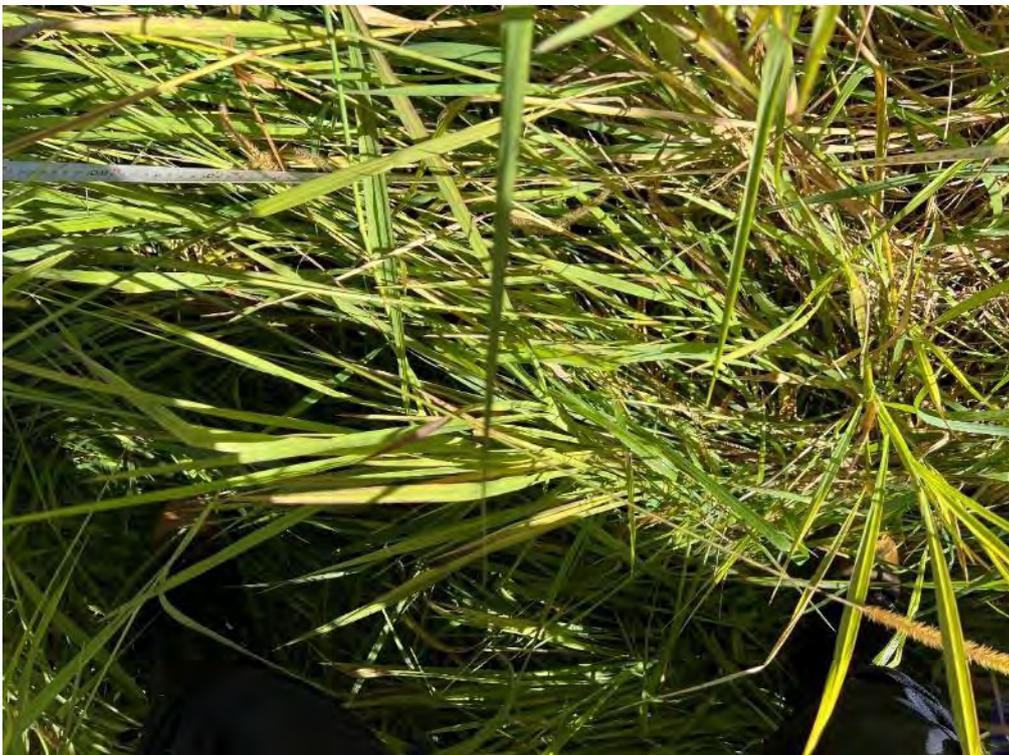
**Plate 12: Transect 3041 2012 Rehabilitation. Dense ground cover at the 5m point in the LFA transect is approximately 1.5 m in height**

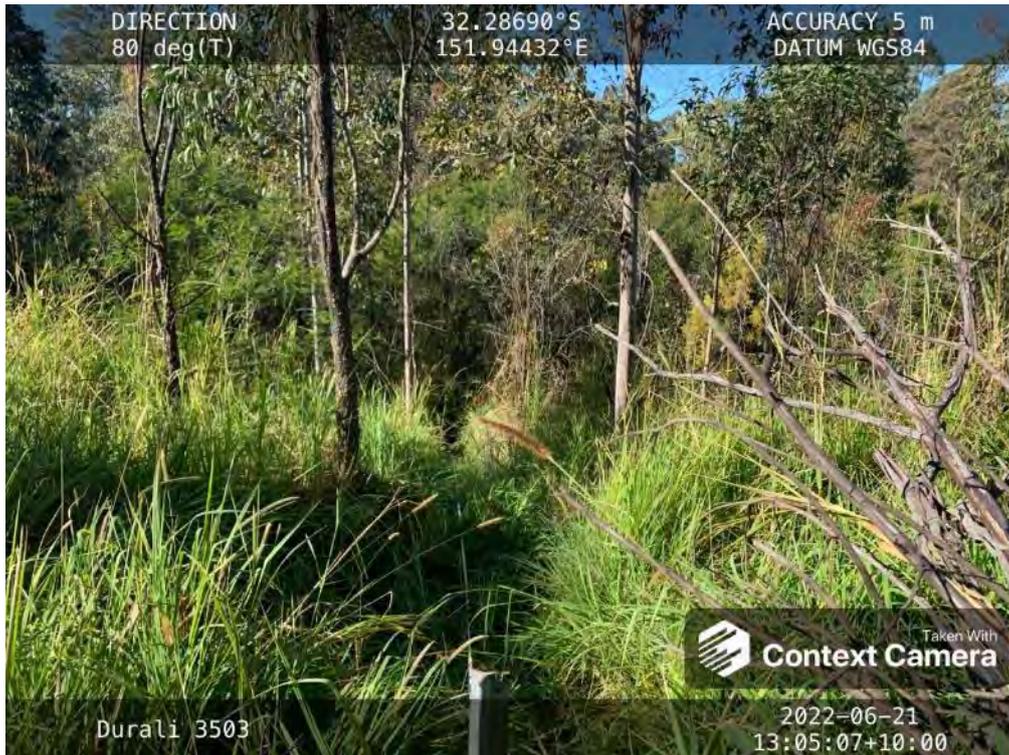
**Plate 17: Transect 3503 2013 Rehabilitation looking down the LFA transect. Note the dense exotic groundcover – *Setaria sphacelata***

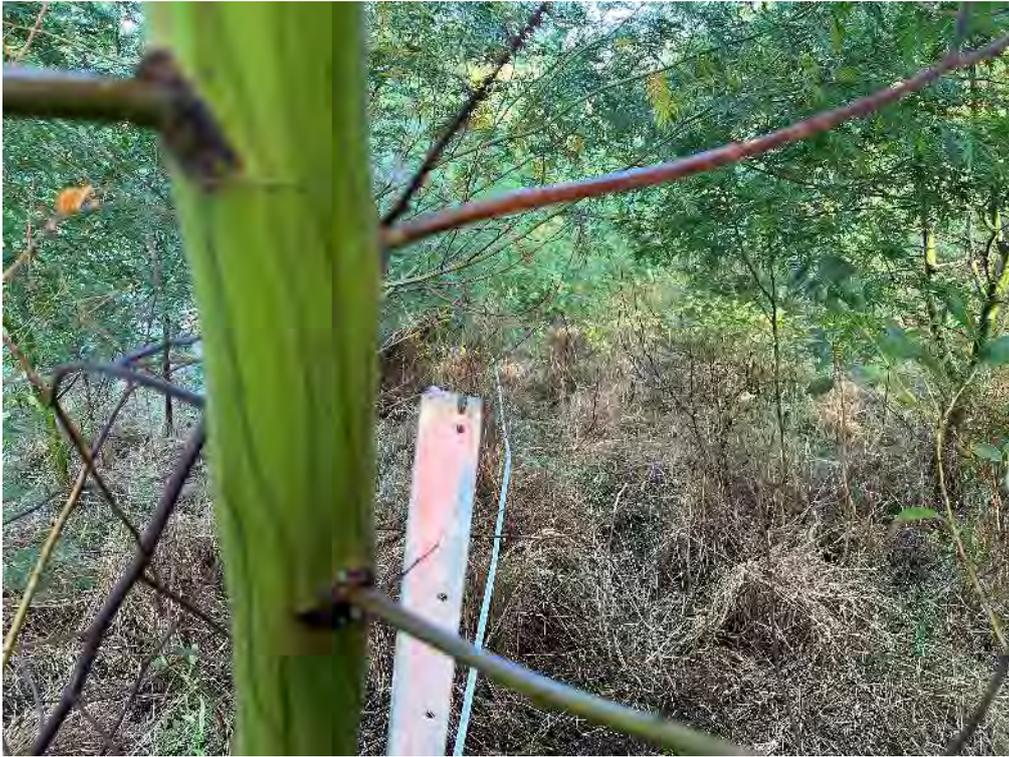
Transect 3506 (**Plate 23**) recorded a total stem density of 5064 stems/ha with a TWV of 100, 963.00 m<sup>3</sup>/ha. The vegetation structure was measured in two strata – nearest Eucalypt, nearest stem. The Eucalypt stratum recorded 1, 332 stems/ha with TWV of 613 m<sup>3</sup>/ha. All Eucalypts were very young – maximum estimated height was 3.5m, with the majority between 1.0m and 2.0m tall. All were recorded as generic Eucalypts (*Eucalyptus spp.*) at this stage. The second stratum recorded a stem density of 3, 732 stems/ha with a TWV of 100, 350 m<sup>3</sup>/ha. This stratum was dominated by *A. irrorata*, which have achieved a large size in a reasonably short period of time. The largest had an estimated height of 8m, with many in the 4.0 to 6.0m range, which has contributed to the very large canopy volume. Other species included *A. falcata*, *A. longifolia*, *Acacia longissima* (Long-leaf Wattle), *A. ulicifolia*. Vines included *G. clandestina*, *G. varians* and *K. rubicunda*. Despite the very dense groundcover of exotic grasses including *S. sphacelata* and *Cenchrus clandestinus* (Kikuyu), some off the seeded native grass species were still present with *Themeda triandra* (Kangaroo Grass), *Entolasia stricta* (Wiry Panic) and *Chloris truncata* (Windmill Grass) all recorded. Wild Tobacco was the only woody weed observed, but evidence of feral pigs (trotter prints) was observed.

**Plate 23: Transect 3506 2020 Rehabilitation looking down the LFA transect showing dense Acacias and shrubs and exotic and native grass groundcover**
