Duralie Coal CCC Meeting

Presentation –
Company Report &
Overview of Activities

February 2019

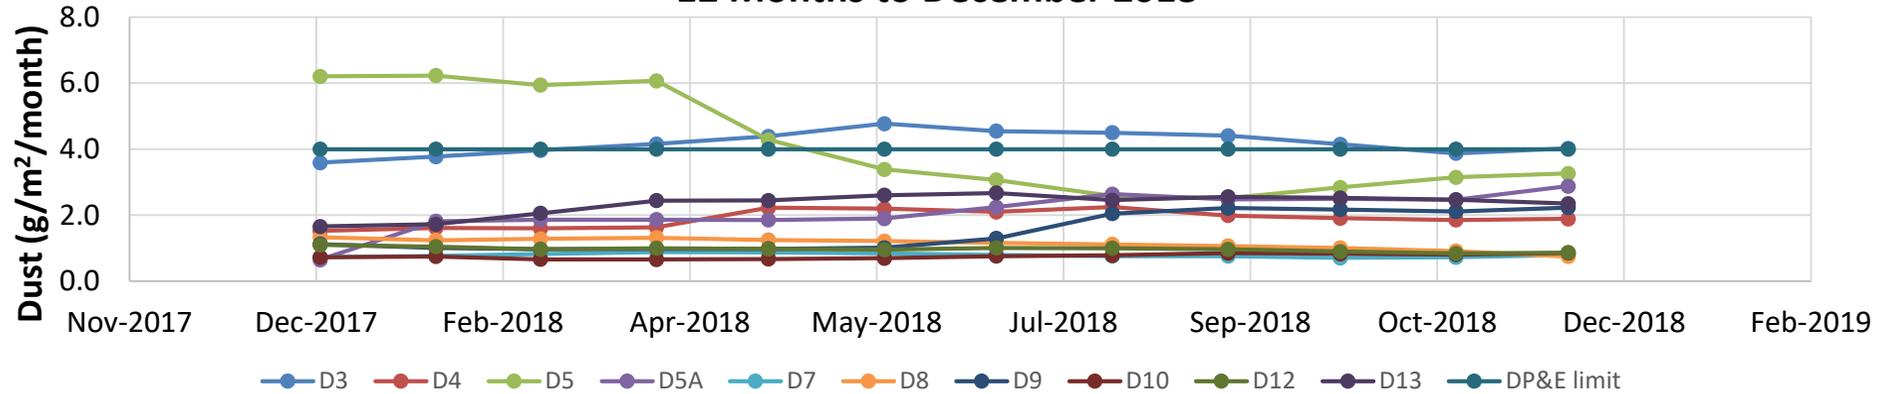
**Duralie Dust Deposition - Annual Rolling Average
12 Months to December 2018**

- Mar-18** D3 – 6.4 Very Heavy - 30% Dirt, 0% Coal, 0% Vegetation, 10% Insects, 60% Polysaccharide Slime. D13 – 5.2 Very Heavy - 30% Dirt, 0% Coal, 0% Vegetation, 0% Insects, 70% Polysaccharide Slime

- Apr-18** D13 – 4.9 Very Heavy - 50% Dirt, 0% Coal, 0% Vegetation, 0% Insects, 50% Polysaccharide Slime
- May-18** D3- 4.3 Heavy - 40% Dirt, 0% Coal, 0% Vegetation, 0% Insects, 60% Polysaccharide Slime. D4- 10.6 Very Heavy - 10% Dirt, 0% Coal, 0% Vegetation, 0% Insects, 90% Polysaccharide Slime

- Jun-18** D3 – 9.5 Very Heavy - 10% Dirt, 90% Polysaccharide Slime. D13 – 4.4 Very Heavy - 40% Dirt, 60% Polysaccharide Slime
- Jul-18** D5- Very Heavy - 60% Dirt, 40% Polysaccharide Slime. D5A- Very Heavy - 60% Dirt, 40% Polysaccharide Slime

- Aug-18** D9 - Insects, bird droppings and vegetation. Medium - 30% Dirt, 10% Vegetation, 10% Insects, 50% Polysaccharide Slime
- Oct-18** D3 - Medium - 20% Dirt, 10% Vegetation, 10% Insects and 60% Polysaccharide Slime

- High levels in D3 and D5 due to contamination of multiple samples. Additional site D5A installed for comparison.
- Due to frequent contamination of dust gauges the HVAS results should also be used when interpreting results

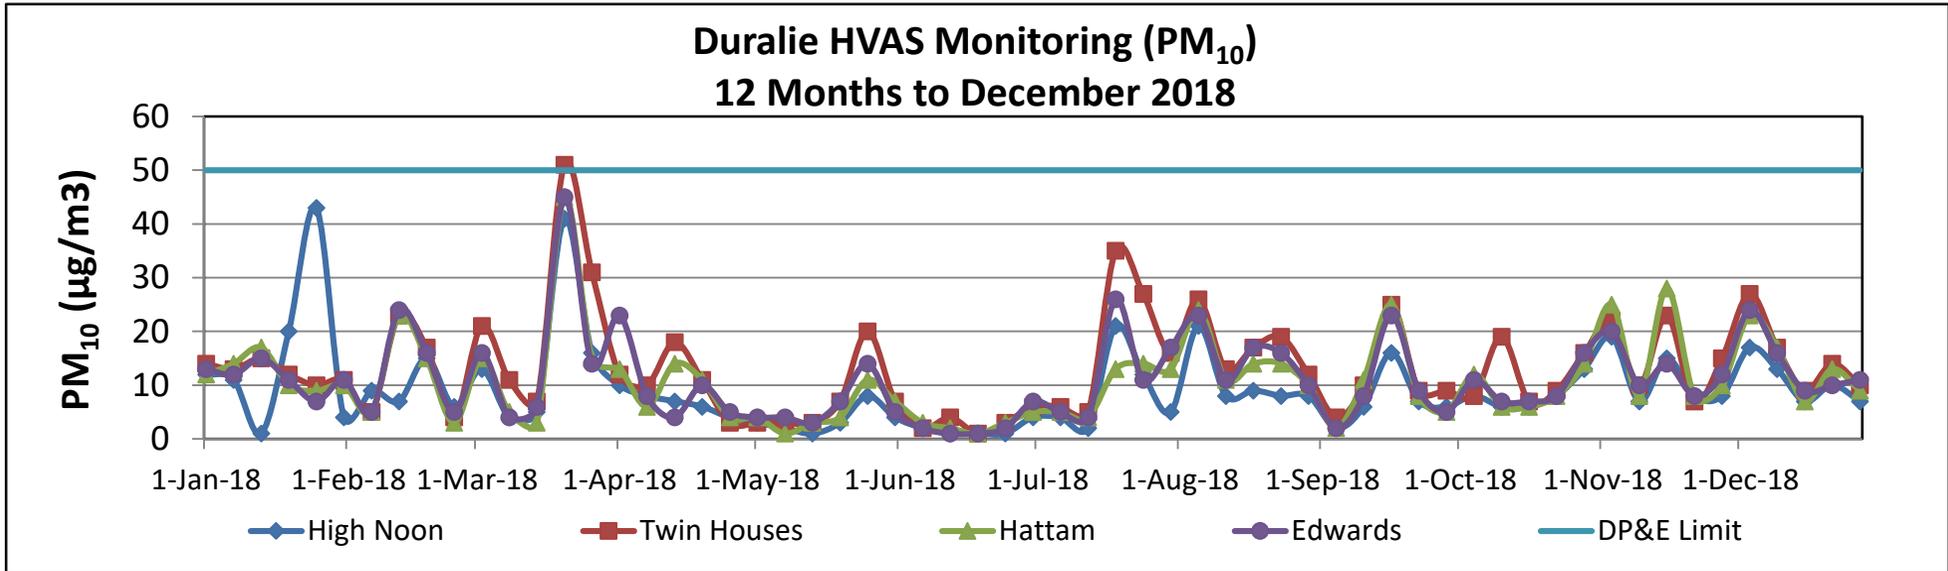
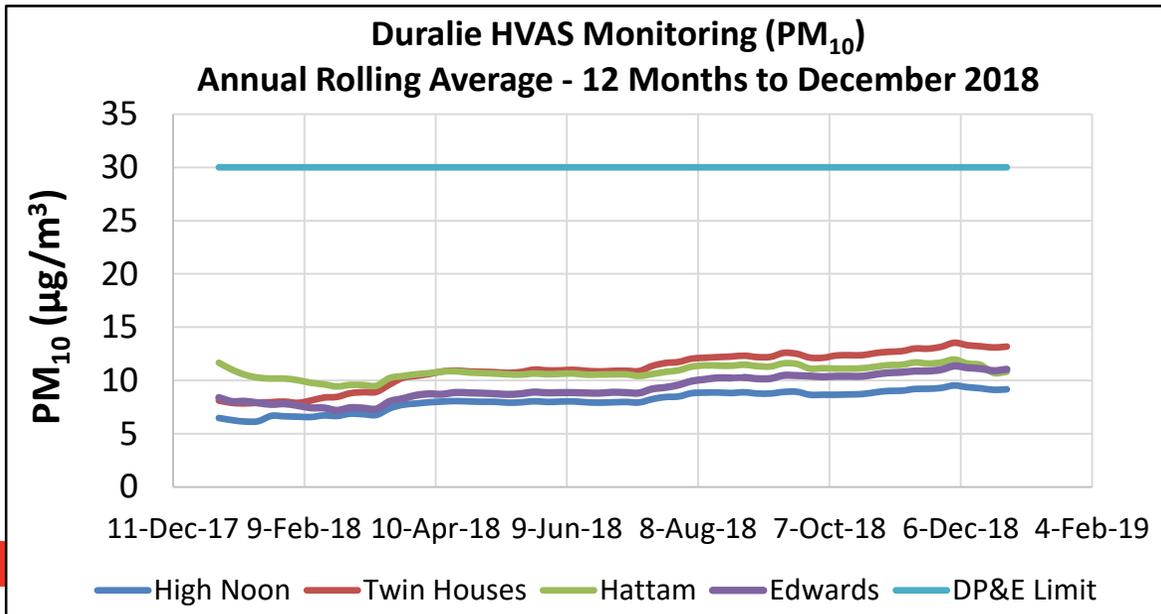
- All sites below DP&E limit. Typically low results during winter and higher during spring/ summer.
- High results across all monitors on 20-Mar-18 due to hazy conditions across valley following a southerly change and prolonged dry weather.
- Minor increasing trend over previous 12 months.
- HVAS results provide more reliable data compared to dust deposition results and should be referred to when interpreting dust emissions.

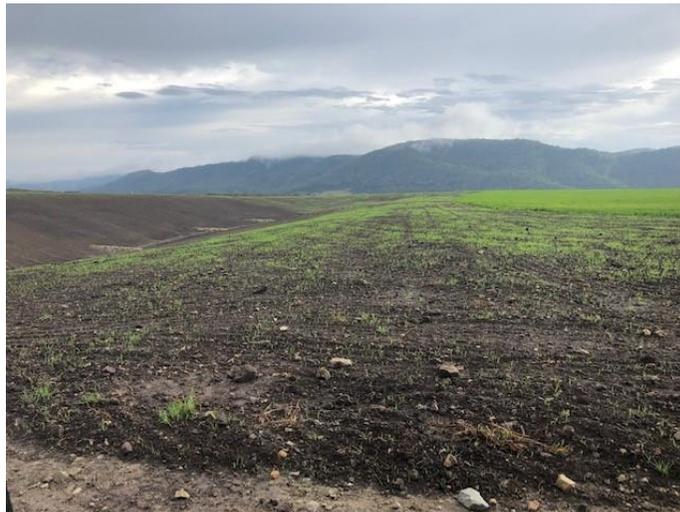
Photo: Completed native rehabilitation on the Weismantel waste emplacement Dec 2018.

Management Area	Project	Status
Rehabilitated Waste emplacements	<ul style="list-style-type: none"> • Final landforms designs • Bulk Shaping • Rehabilitation Works • Rehabilitation maintenance 	<ul style="list-style-type: none"> • Final landform designs have been progressed for the waste emplacement areas in Clareval and Weismantel. • A D11 Dozer has continued bulk shaping works on the Weismantel waste emplacement during Q4 2018. Approximately 60ha completed in 2018. • Rehabilitation of 35ha was completed during Q4 2018, including topsoil spreading, ground preparation and seeding. Approximately 15 hectares of native vegetation and 20 hectares of pasture rehabilitation was planted. • During December 2018 20 ha of pasture rehabilitation was slashed and turkey litter applied.

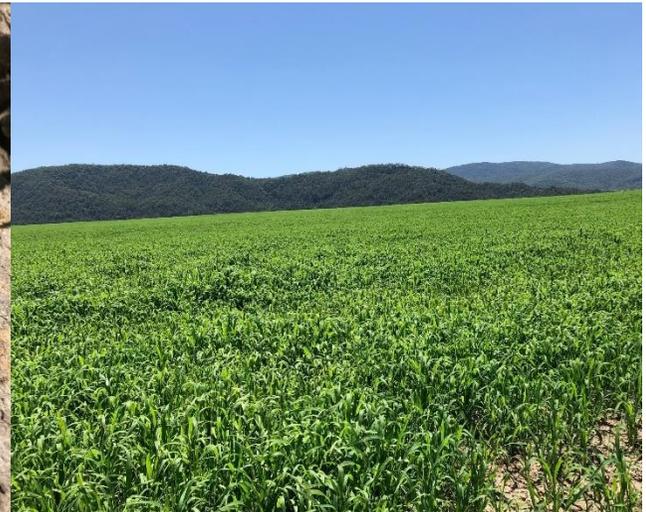
Photo: Completed pasture rehabilitation on the Weismantel waste emplacement Dec 2018.
