Duralie Coal CCC Meeting

Presentation –
Company Report &
Overview of Activities

February 2020

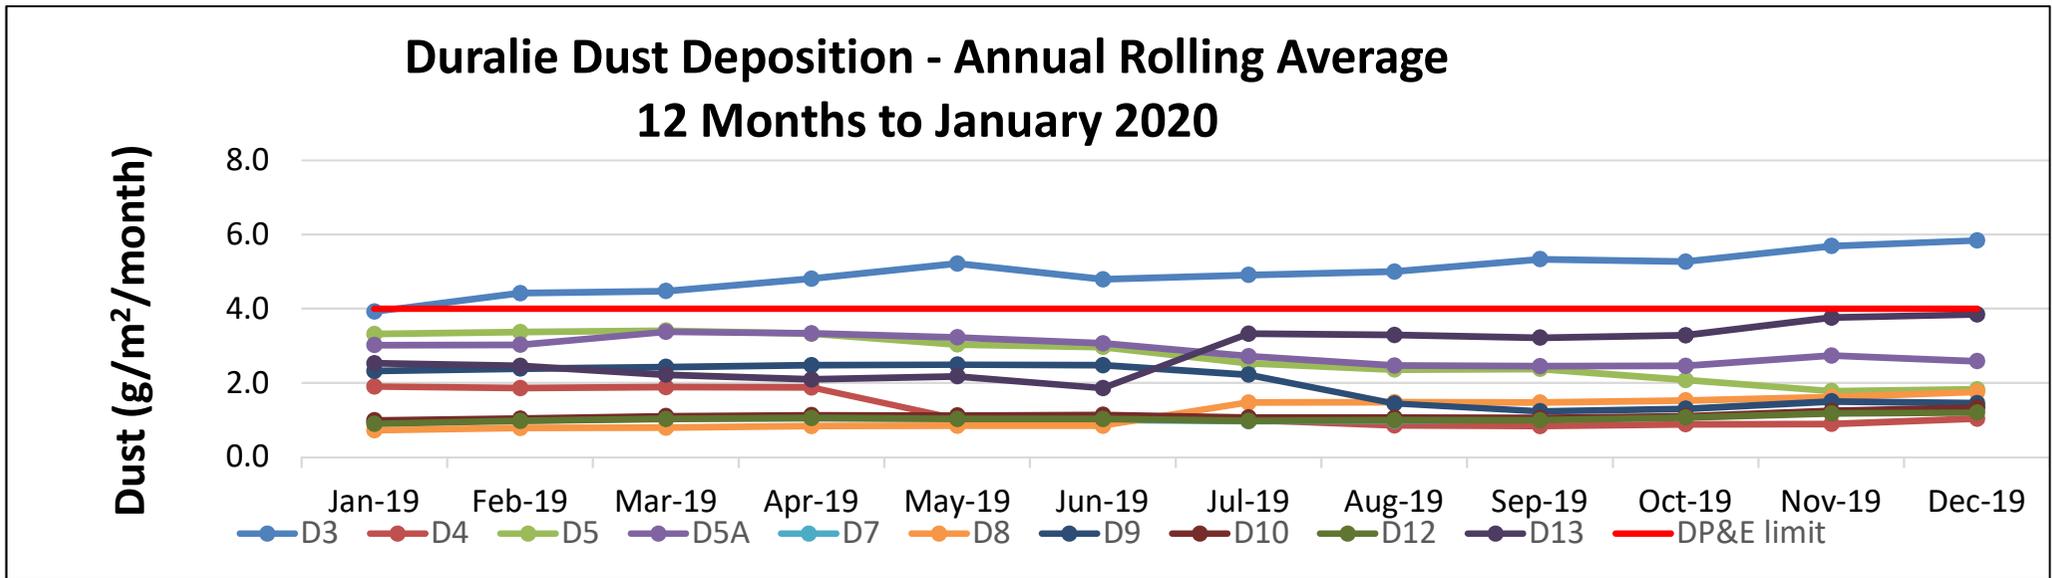
- Mar-19 Very Heavy - 20% Dirt, 0% Coal, 10% Vegetation, 10% Insects and 60% Polysaccharide Slime
- Apr-19 Very Heavy - 40% Dirt, 0% Coal, 10% Vegetation, 10% Insects and 40% Polysaccharide Slime
- May-19 Very Heavy - 20% Dirt, 80% Polysaccharide Slime
- Jun-19 Heavy - 20% Dirt and 80% Polysaccharide Slime
- Jul-19 Heavy - 30% Dirt, 0% Coal, 0% Vegetation, 0% Insects and 70% Polysaccharide Slime
- Sep-19 Heavy - 20% Dirt and 80% Polysaccharide Slime
- Oct-19 Heavy - 30% Dirt and 70% Polysaccharide Slime
- Nov-19 Heavy - 60% Dirt, 40% Polysaccharide Slime
- Dec-19 Heavy - 60% Dirt, 40% Polysaccharide Slime

- High levels in D3 and D5 due to contamination of multiple samples. Additional site D5A installed for comparison
- Due to frequent contamination of dust gauges the HVAS results should also be used when interpreting results

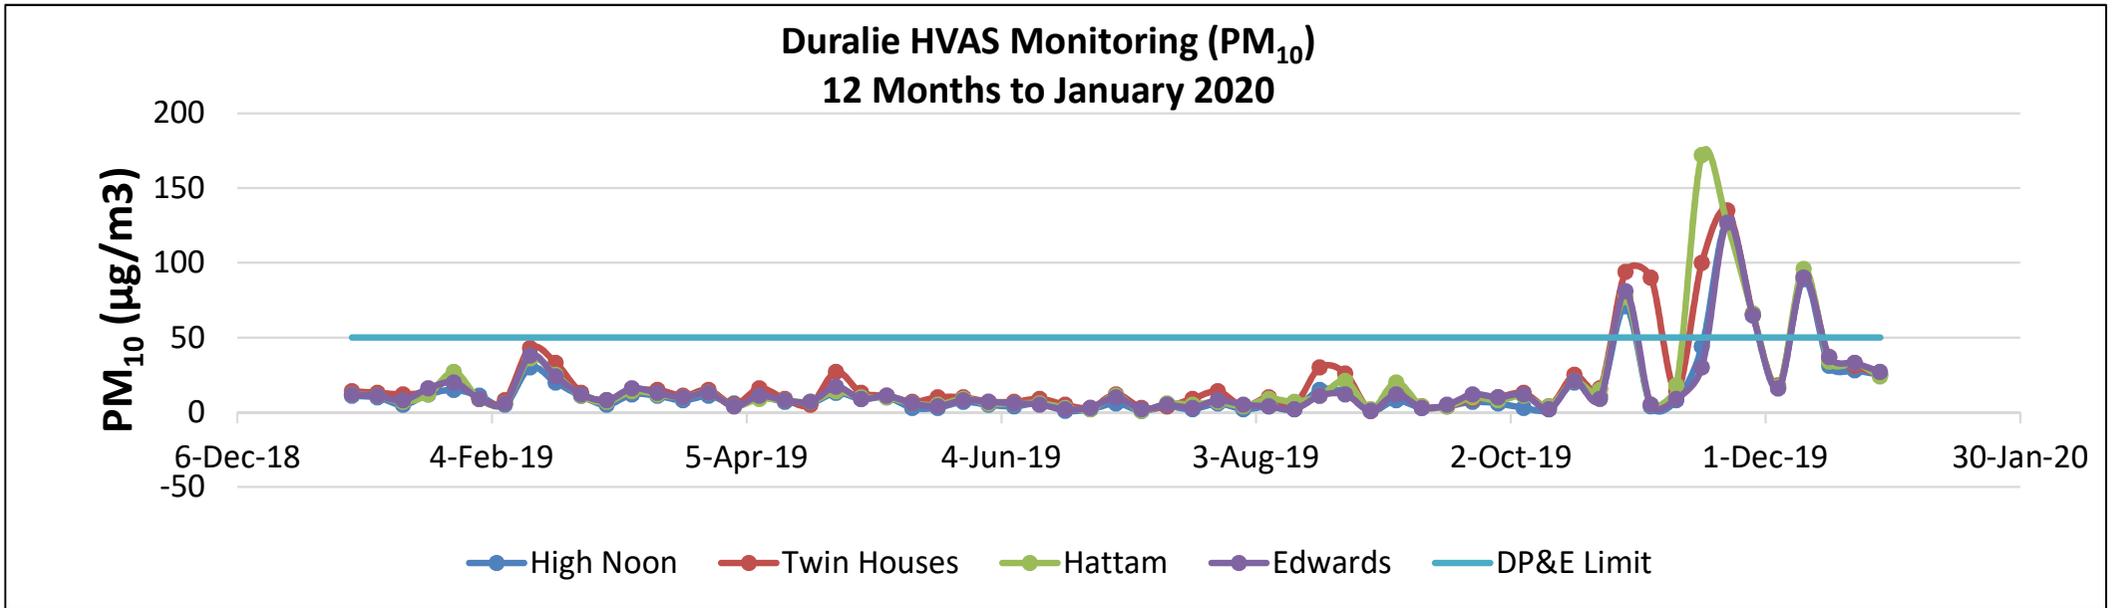
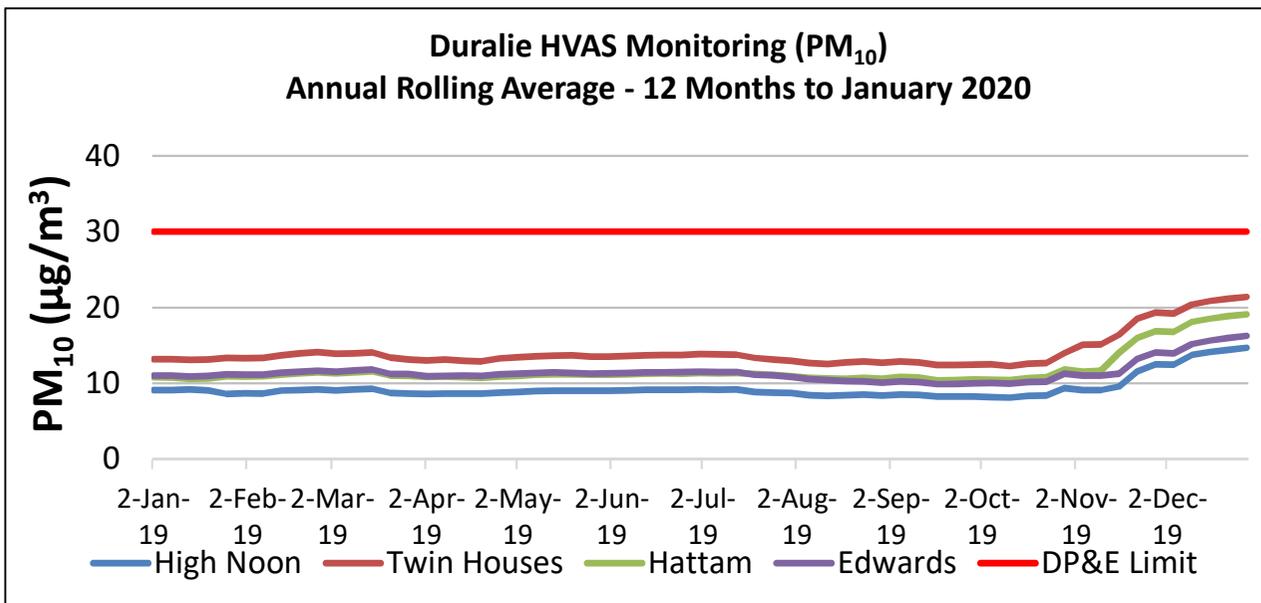
- All sites below DP&E limit. Typically low results during winter and higher during spring/ summer.
- Minor increasing trend over previous 12 months.
- HVAS results provide more reliable data compared to dust deposition results and should be referred to when interpreting dust emissions.

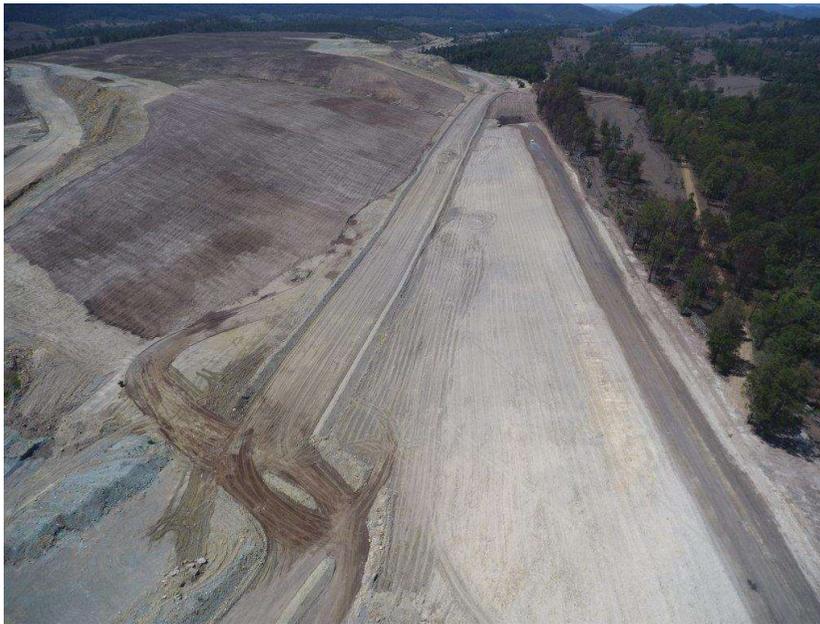
Photo: Bulk shaping and topsoiling at Weismantel waste emplacement and Duralie Haul Rd, taken Jan 2020.

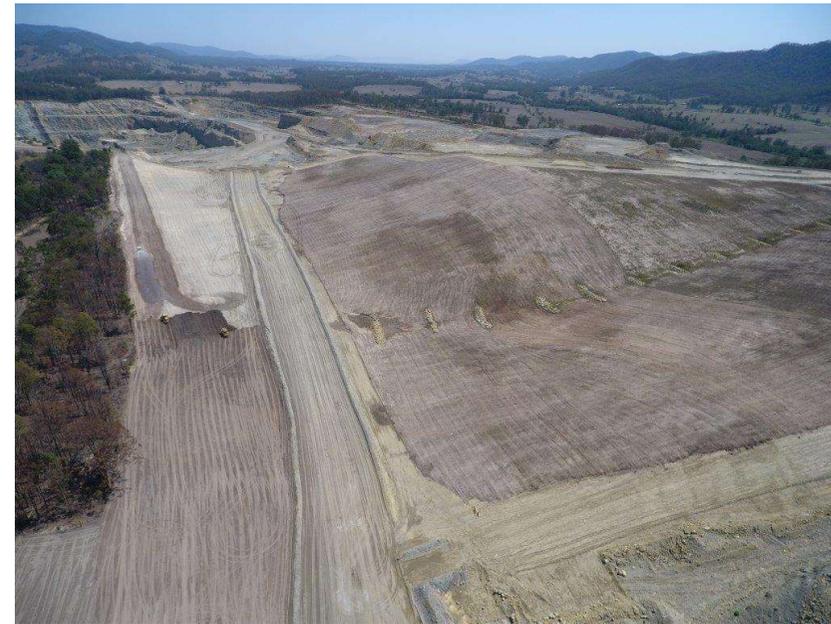
Photo: Bulk shaping and topsoiling at Weismantel waste emplacement and Duralie Haul Rd, taken Jan 2020.

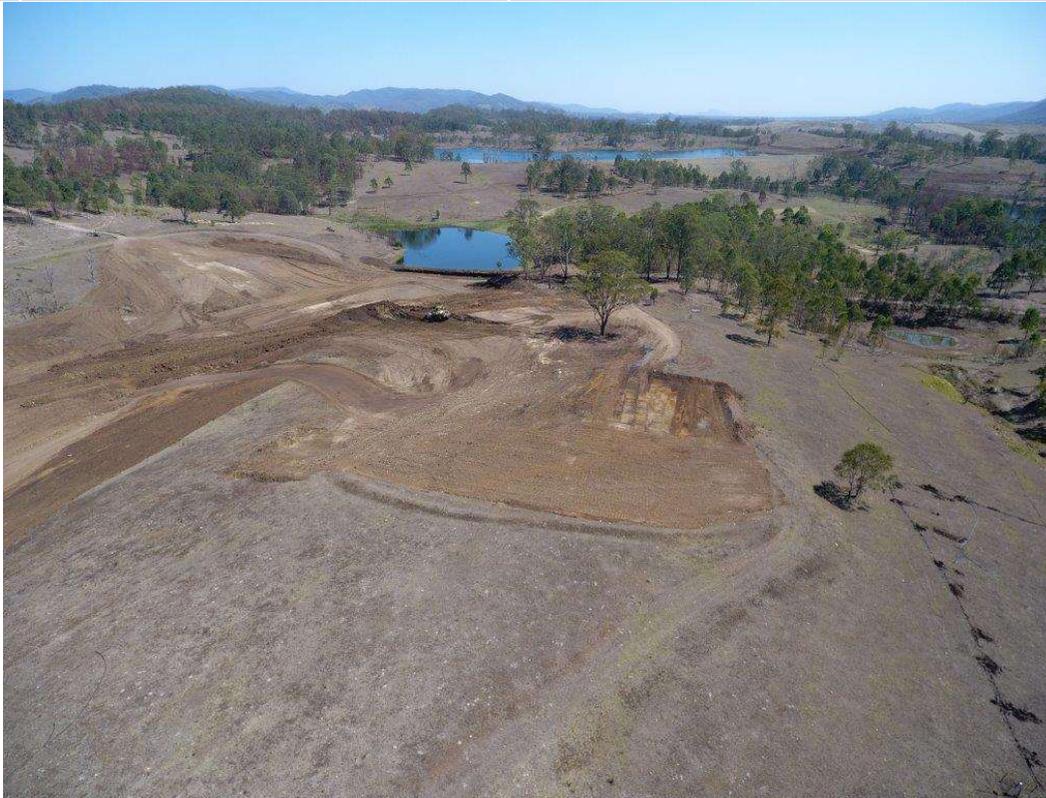
Management Area	Project	Status
Dam Decommissioning	<ul style="list-style-type: none">Auxiliary Dam 1	<ul style="list-style-type: none">Decommissioning and rehabilitation of AD1 is proposed to commenced in October 2019Clay has been recovered and is being stockpiled for use for the clay lining in the Coal Shaft Creek Reconstruction.

Photo: shaping and topsoiling partially completed at Auxiliary Dam 1, Jan 2020.
