# Monthly Environmental Monitoring Report

Yancoal Mount Thorley Warkworth

April 2019

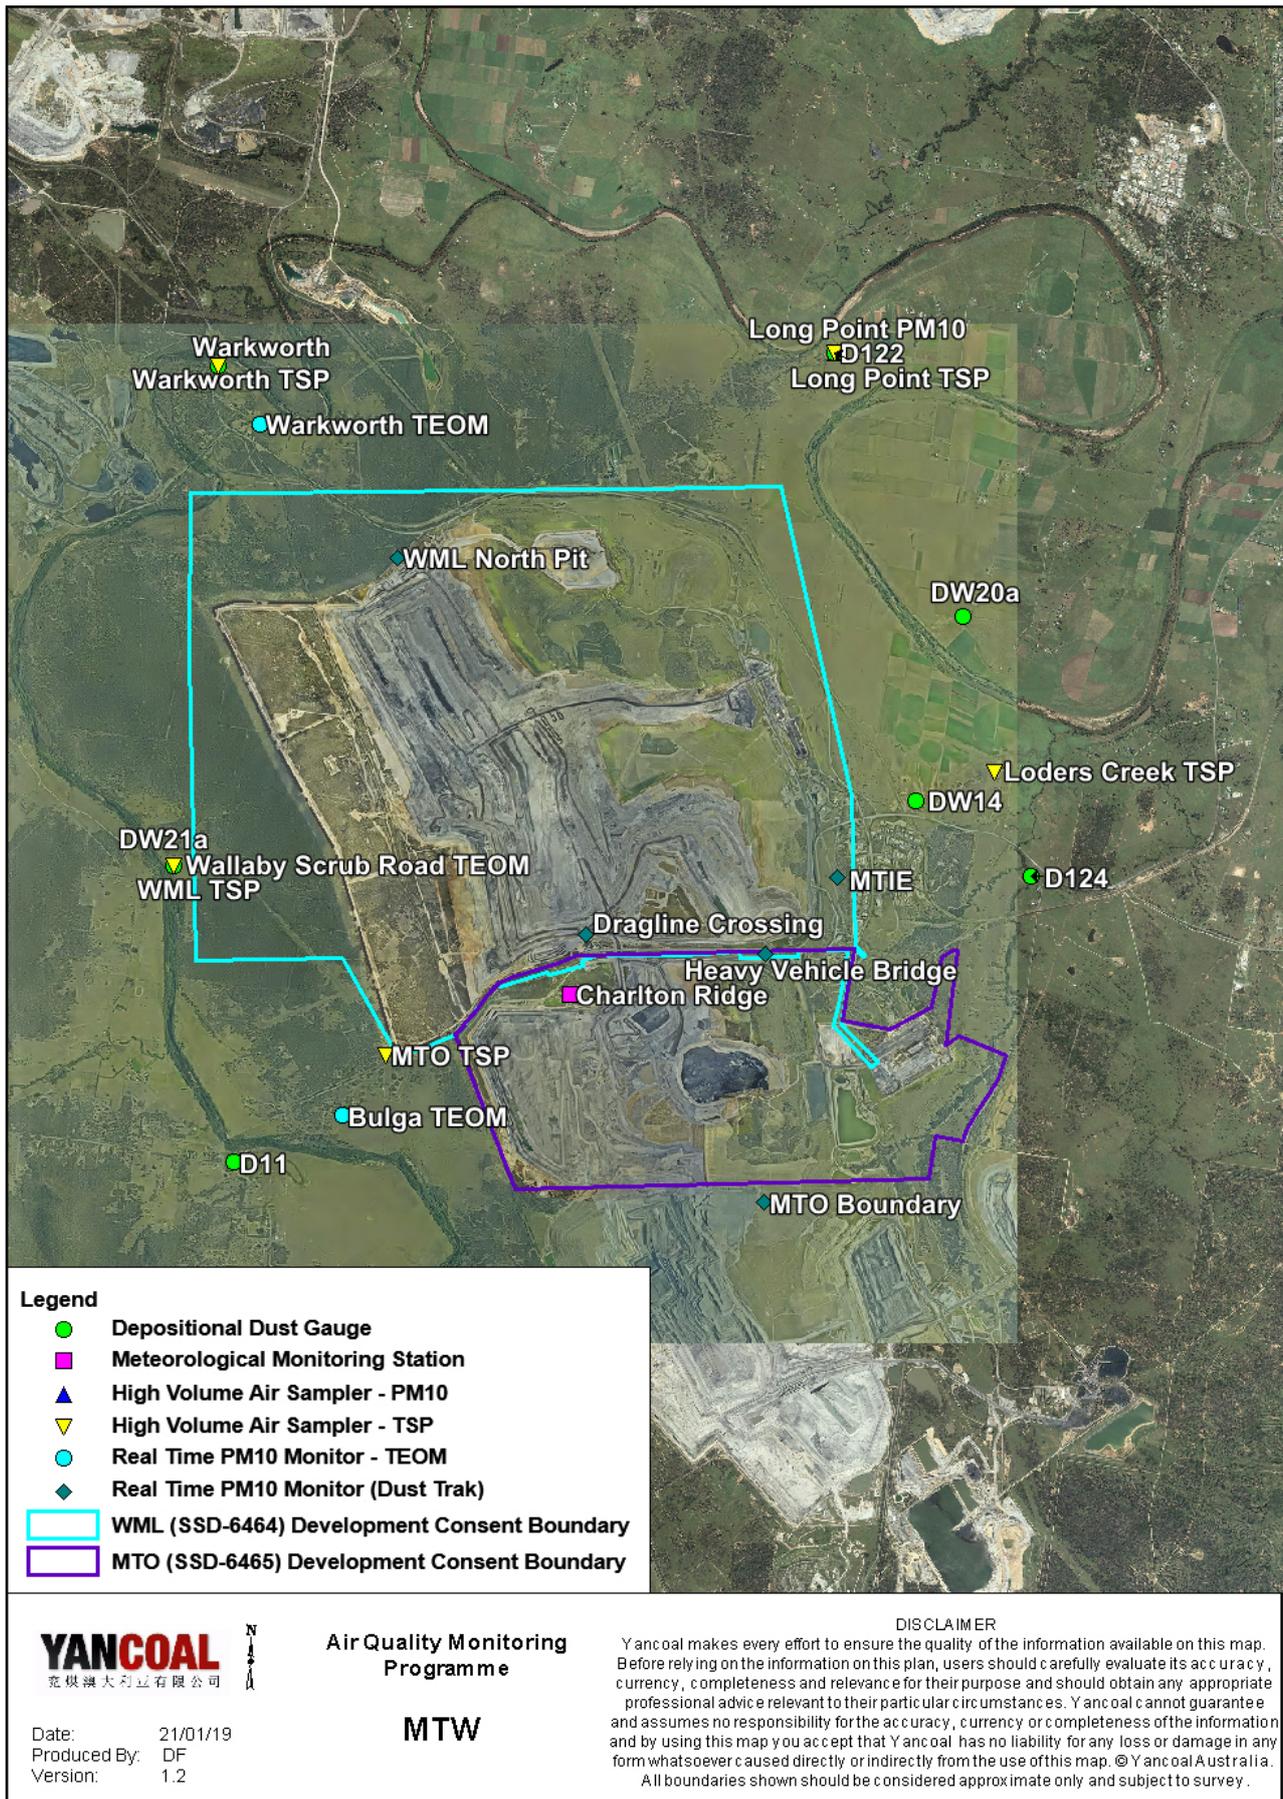
Figure 3: Air Quality Monitoring Locations

Meteorological data is collected at MTW's 'Charlton Ridge' meteorological station (refer to **Figure 3: Air Quality Monitoring Locations**).

location of these monitors can be found in Figure 3. Each HVAS was run for 24 hours on a six-day cycle in accordance with EPA requirements.
