Managed by Rio Tinto Coal Australia

Mount Thorley Warkworth
Monthly Environmental Report
February 2017

Coal & Allied Operations Pty Ltd

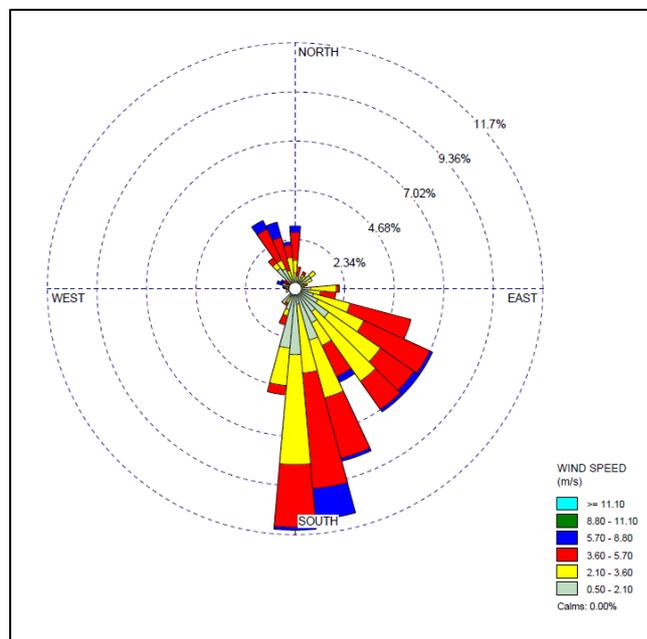
Figure 2: Charlton Ridge Wind Rose – February 2017

Winds from the South were dominant throughout the reporting period as shown in Figure 2.

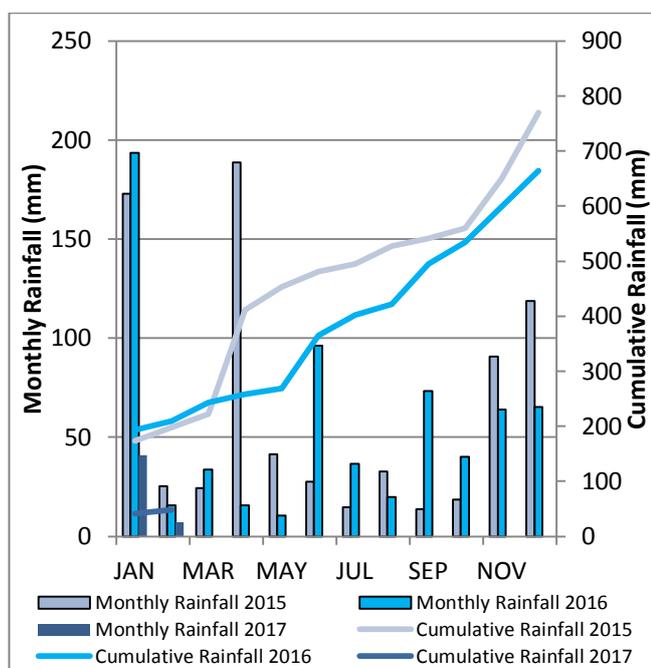
Figure 1: Rainfall Trend YTD

Rainfall for the period is summarised in Table 1, the year-to-date trend and historical trend are shown in Figure 1.

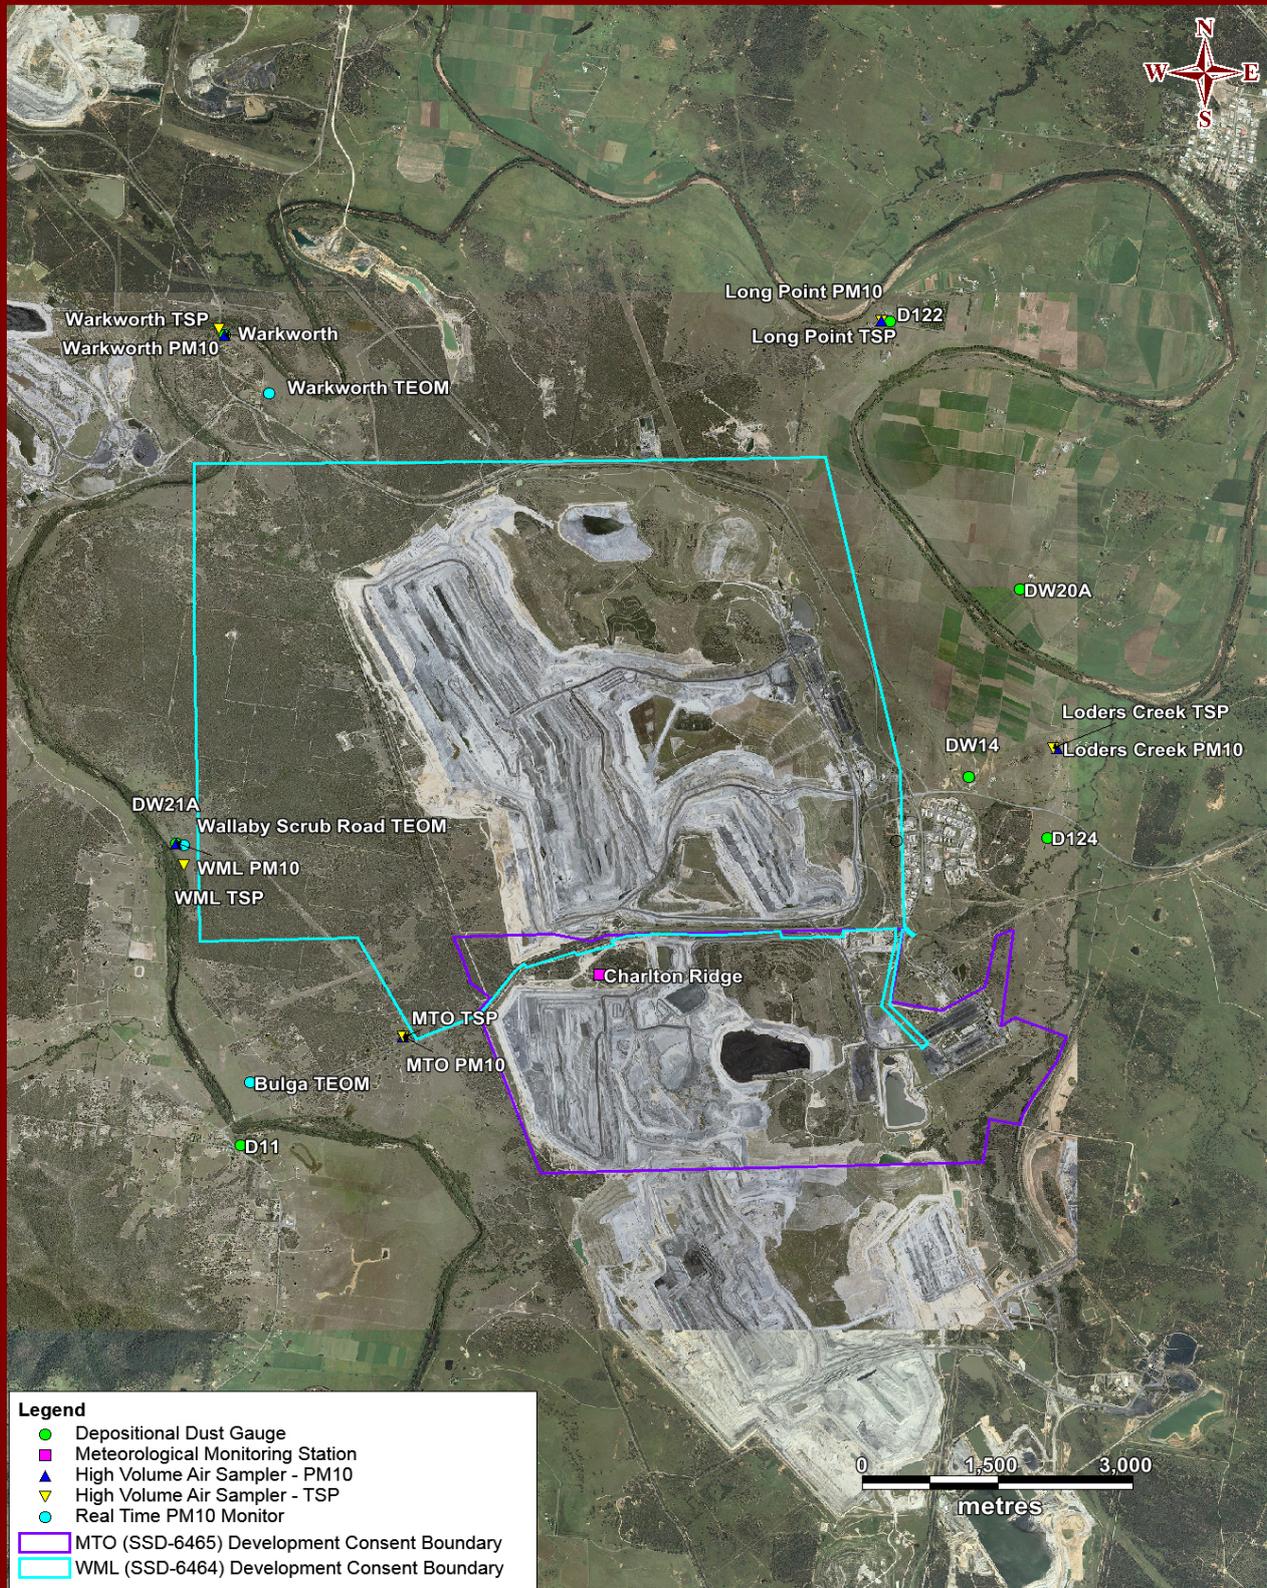
Figure 3: Air Quality Monitoring Locations

Meteorological data is collected at MTW's 'Charlton Ridge' meteorological station (refer to Figure 3: Air Quality Monitoring Locations).

Suspended particulates are measured by a network of High Volume Air Samplers (HVAS) measuring Total Suspended Particulates (TSP) and Particulate Matter <10µm (PM₁₀). The location of these monitors can be found in Figure 3. Each HVAS was run for

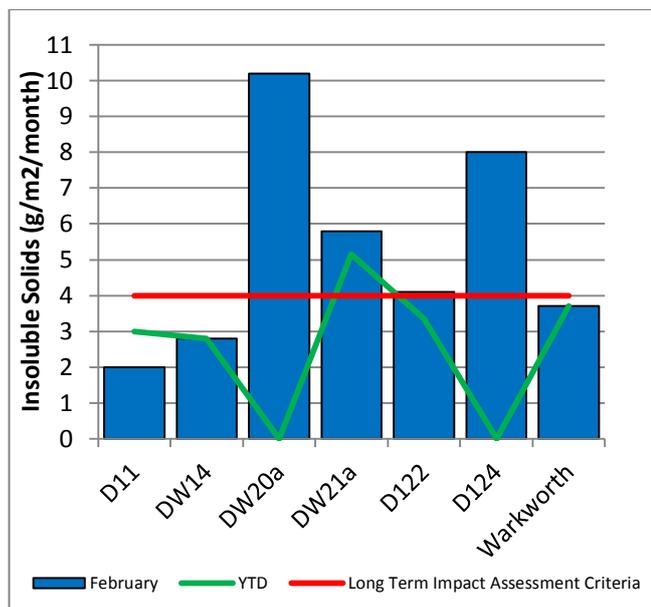
Figure 4: Depositional Dust – February 2017

Figure 4 displays insoluble solids results from depositional dust gauges during the reporting period compared against the year-to-date average and the annual impact assessment criteria.

During the reporting period the DW20a, DW21a, D122 and D124 monitors recorded monthly results above the long term impact assessment criteria of 4.0 g/m² per month. Field notes associated with DW20a and D124 confirm the presence of insects and vegetation. As such the results are considered contaminated and will be excluded from calculation of the annual average. There is no evidence to suggest that the Dw21a and D122 results are contaminated. Accordingly, these results will be included in the annual average calculation.

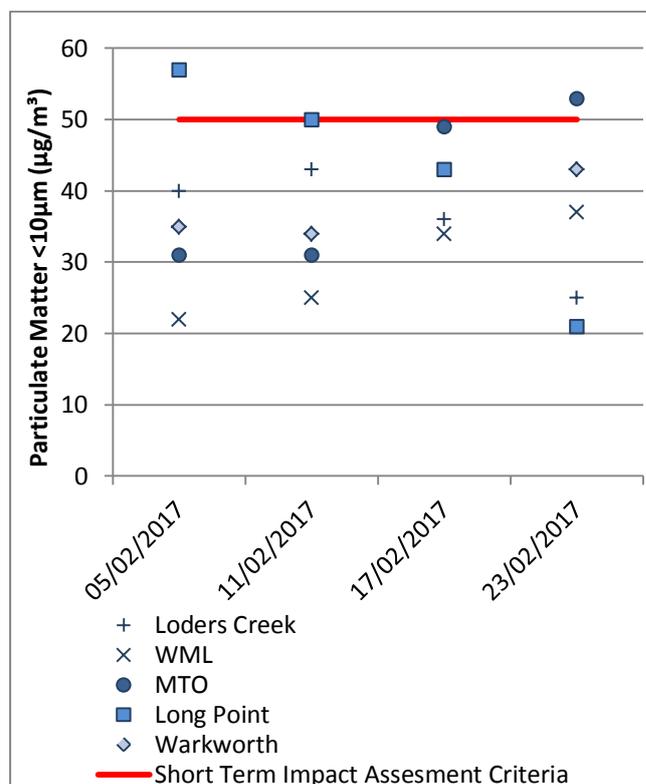
Figure 5: Individual PM₁₀ Results – February 2017

Figure 5 shows the individual PM₁₀ results at each monitoring station against the short term impact assessment criteria of 50µg/m³.

On 5/02/2017 and on one HVAS PM₁₀ unit recorded a result greater than the short term (24hr) PM₁₀ impact assessment criteria at Long Point (57µg/m³).

On 23/02/2017 one HVAS PM₁₀ unit recorded a result greater than the short term (24hr) PM₁₀ impact assessment criteria; MTO (53µg/m³).

Investigation indicates that that the likely MTW contribution to the results at Long Point on the 5th February is less than 75%. Accordingly, no further action is required (as per approved Air Quality Monitoring Programme).

Investigation indicates that that the likely MTW contribution to the result at MTO on the 23rd February is less than 75%. Accordingly, no further action is required (as per approved Air Quality Monitoring Programme).

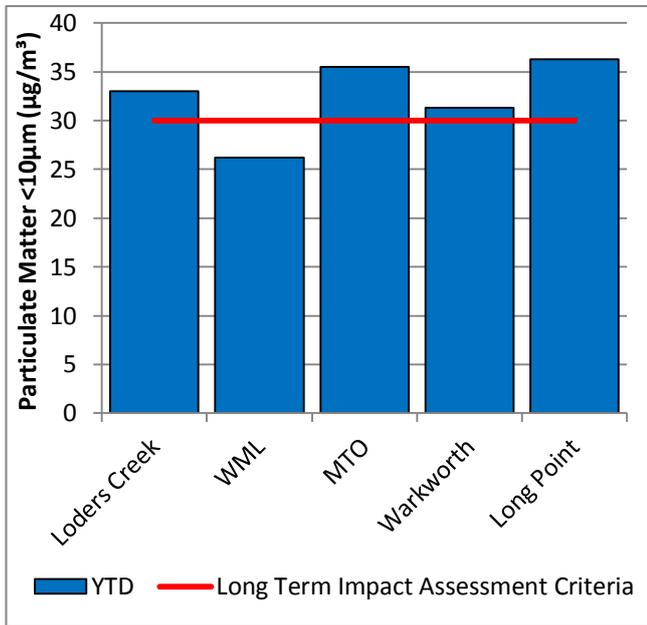
Figure 6: Annual Average PM₁₀ – February 2017

Figure 6 shows the annual average PM₁₀ results against the long term impact assessment criteria.

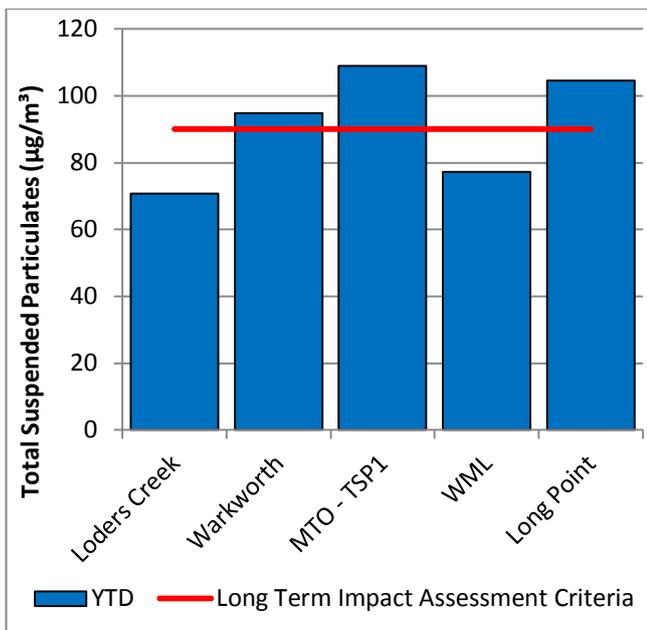
Figure 7: Annual Average Total Suspended Particulates – February 2017

Figure 7 shows the annual average TSP results compared against the long term impact assessment criteria of 90µg/m³.

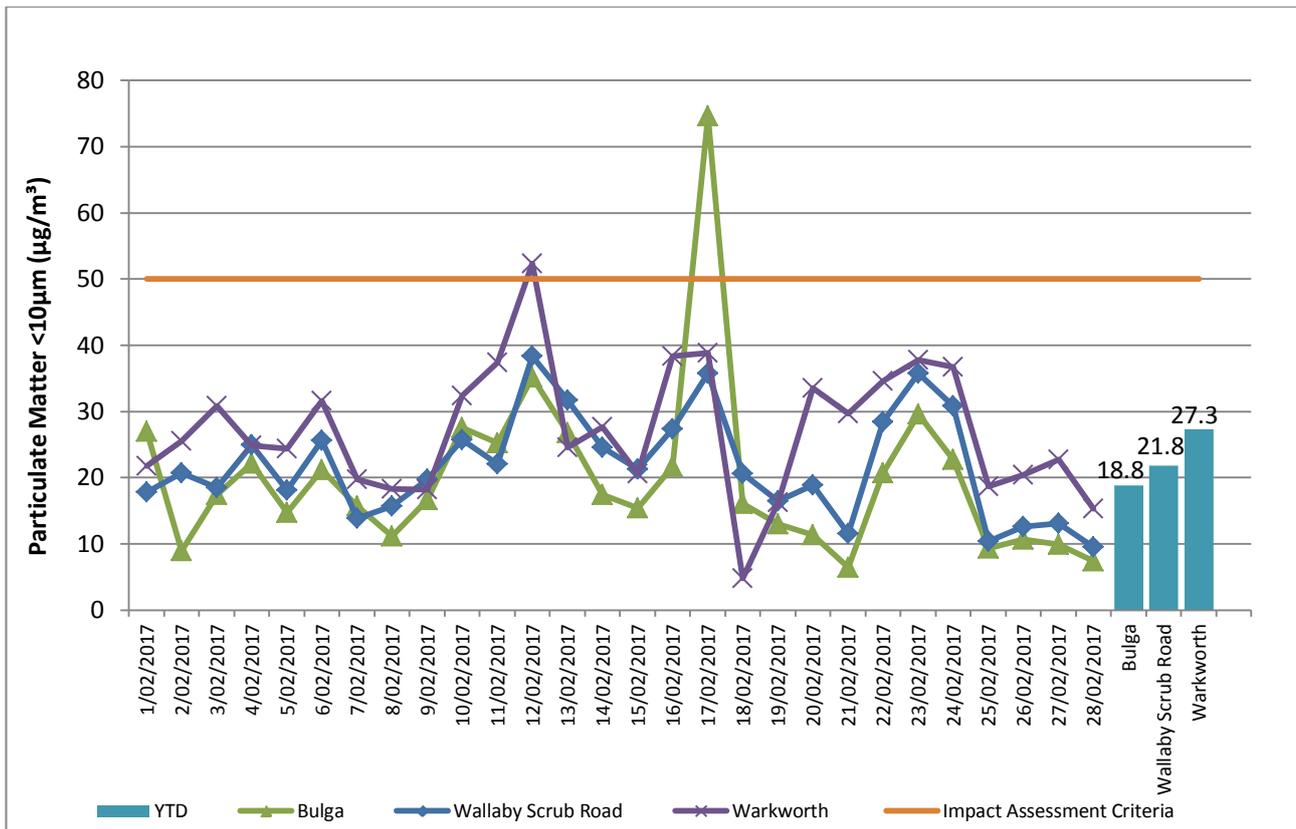
Figure 8: Real Time PM₁₀ daily 24hr average and annual average – February 2017

Results for real time dust sampling are shown in Figure 8, including the daily 24 hour average PM₁₀ result and the annual PM₁₀ average.

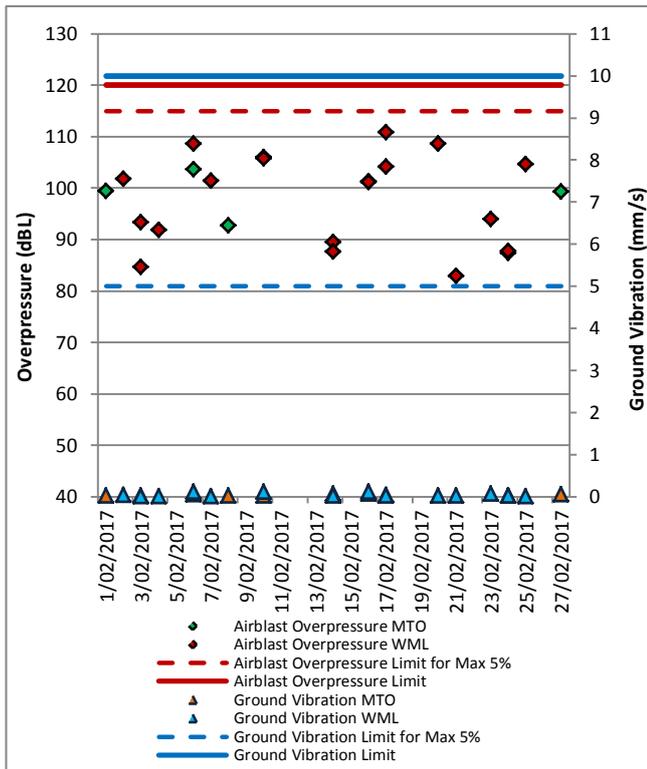
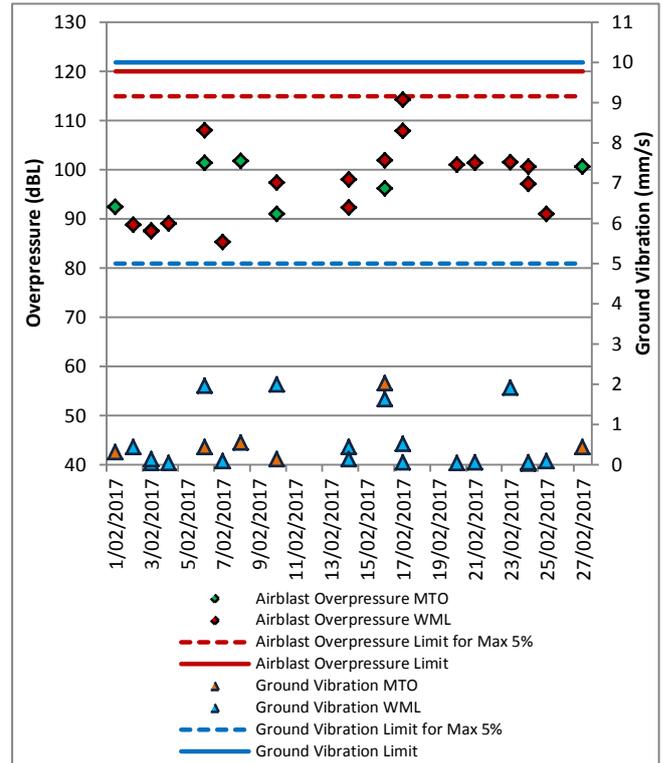
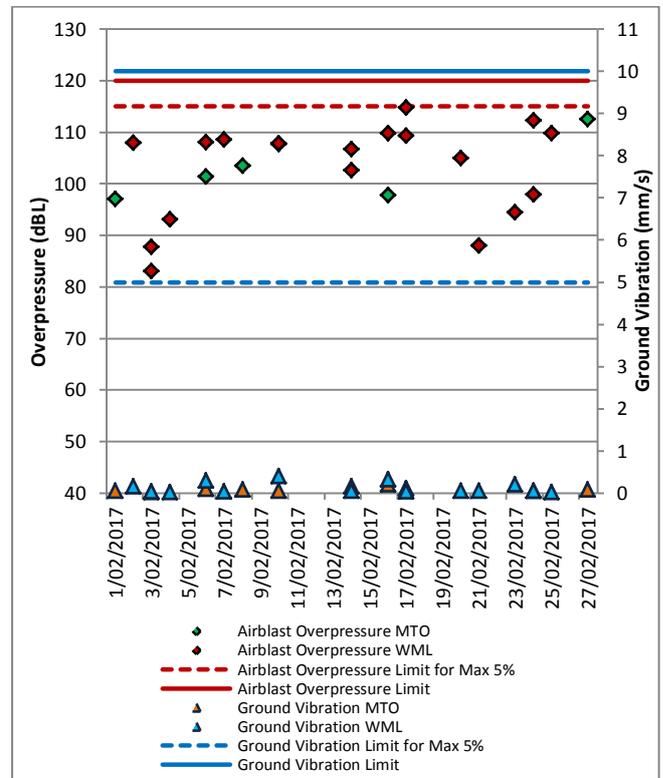
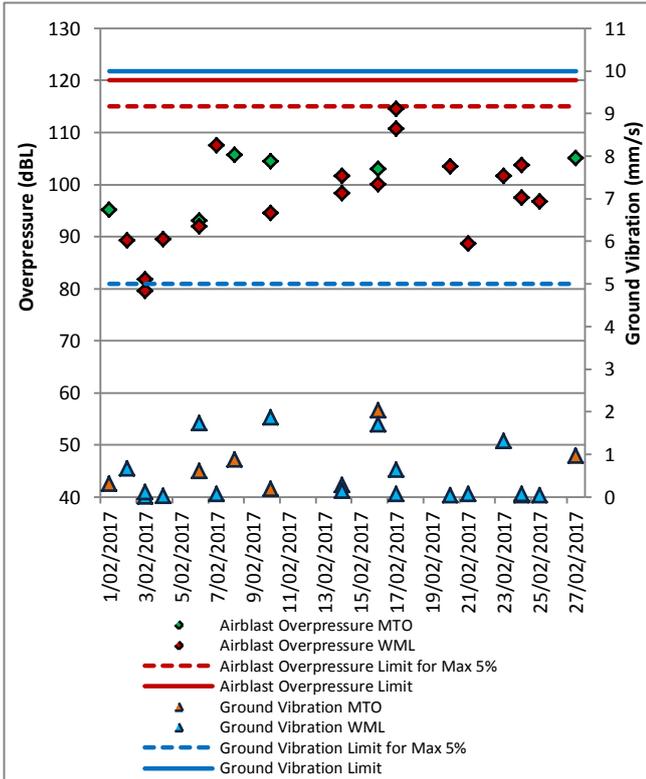
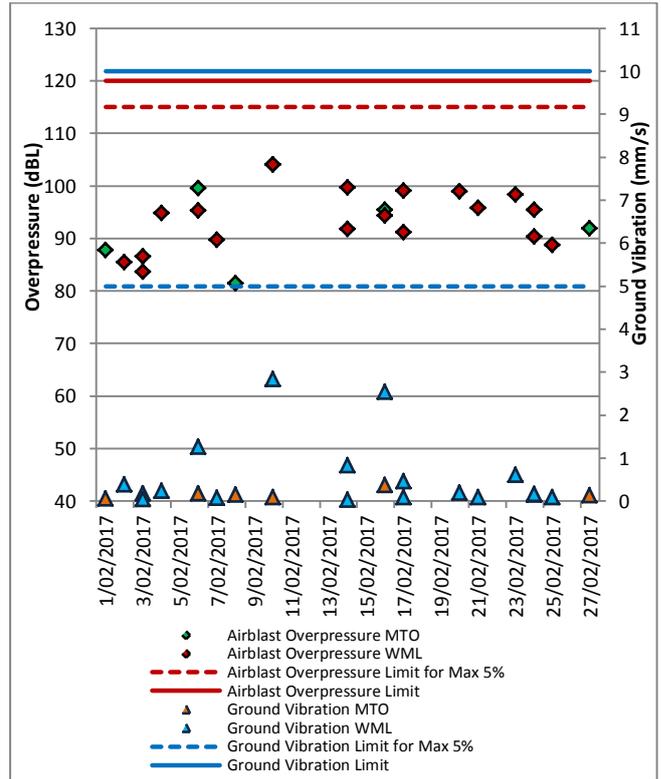
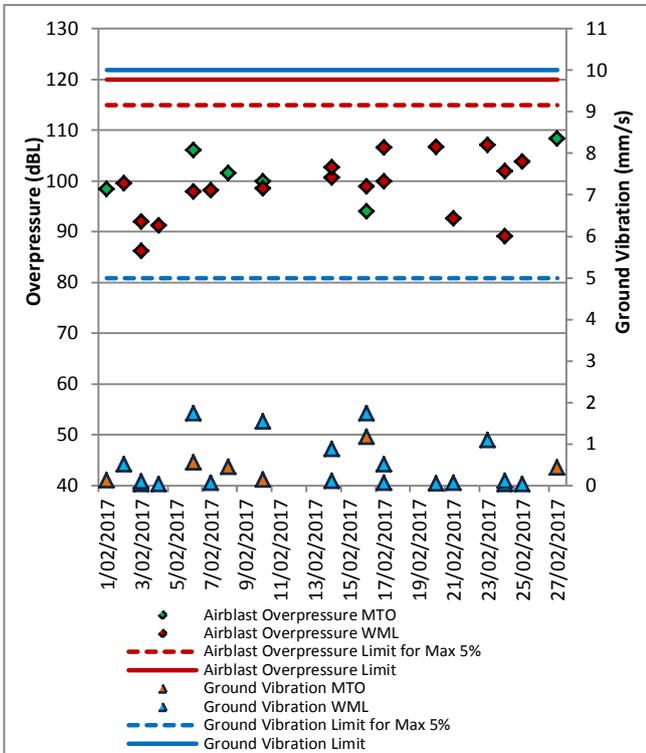
During February 2017, 24 blasts were initiated at MTW. Figure 9 to Figure 14 show the blast monitoring results for the reporting period against the impact assessment criteria. The criteria are summarised in Table 2.

During the reporting period no blasts exceeded the 115 dB(L) 5% threshold for airblast overpressure or 5mm/s 5% threshold for ground vibration

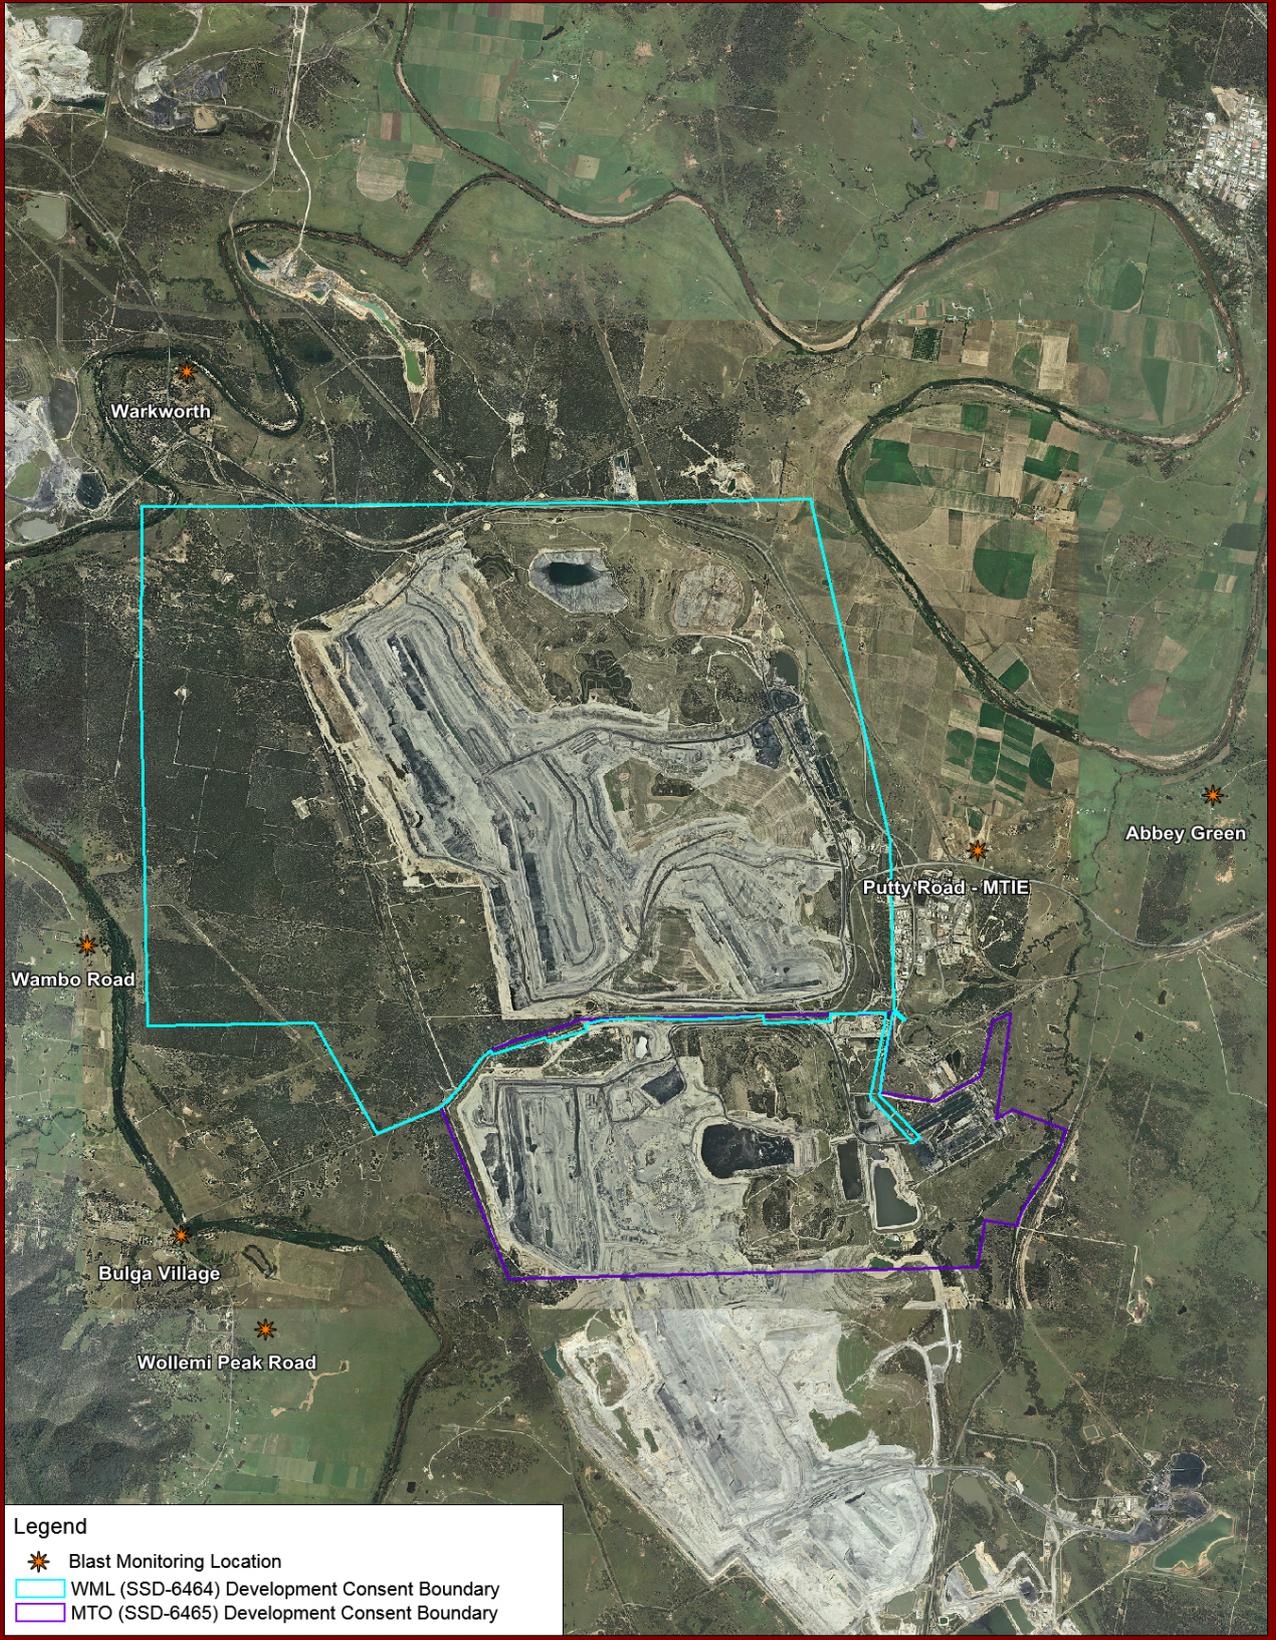
Figure 15: MTW Blast Monitoring Location Plan

MTW have a network of six blast monitoring units. These are located at nearby privately owned residences and function as regulatory compliance monitors.

The location of these monitors can be found in Figure 15.

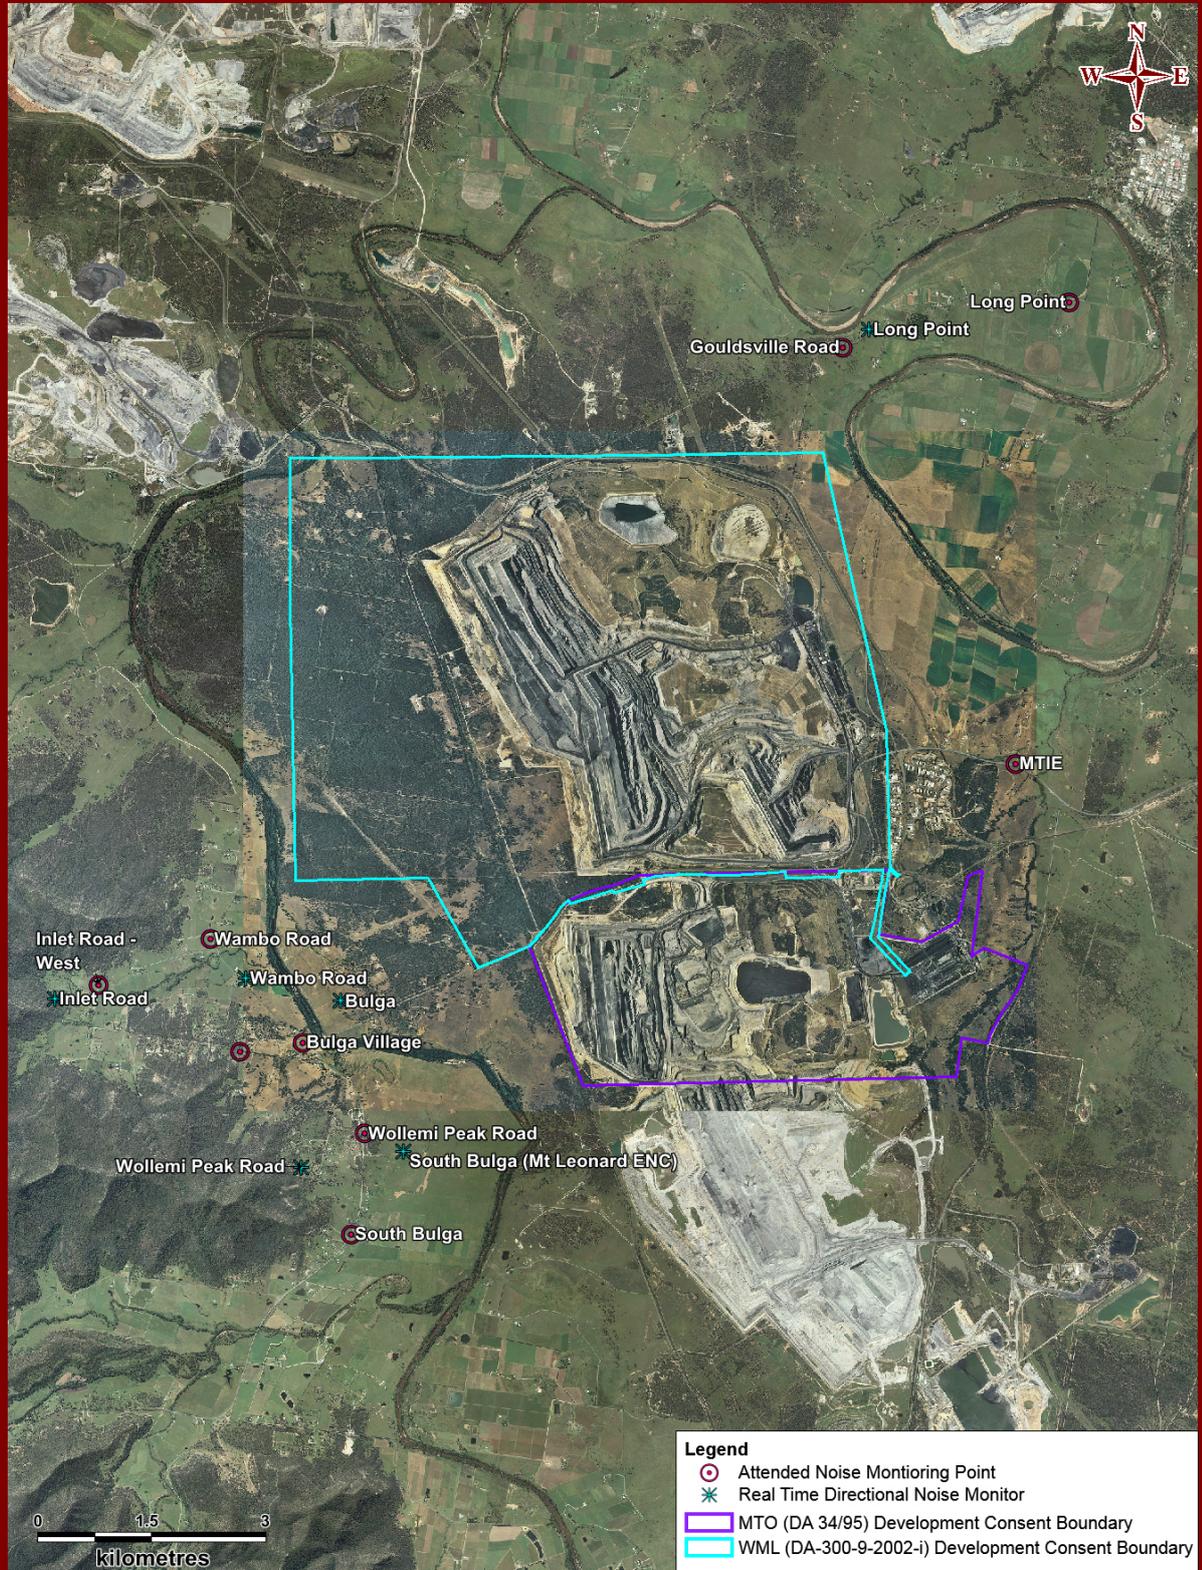
Figure 16: Noise Monitoring Location Plan

Routine attended noise monitoring is carried out in accordance with the MTW Noise Management Plan. A review against EIS predictions will be reported in the Annual Review. The purpose of the noise surveys is to quantify and describe the acoustic environment around the site and compare results with specified limits. Real time noise monitoring also occurs at nine sites surrounding MTW. Noise monitoring locations are displayed in Figure 16.

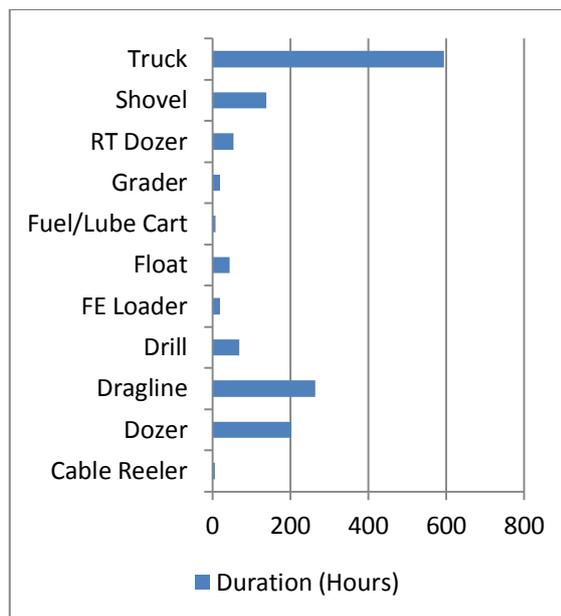
Figure 17: Operational Downtime by Equipment Type – February 2017

During February, a total of 1416.4 hours of equipment downtime was logged in response to environmental events such as dust, noise and adverse meteorological conditions. Operational downtime by equipment type is shown in Figure 17.

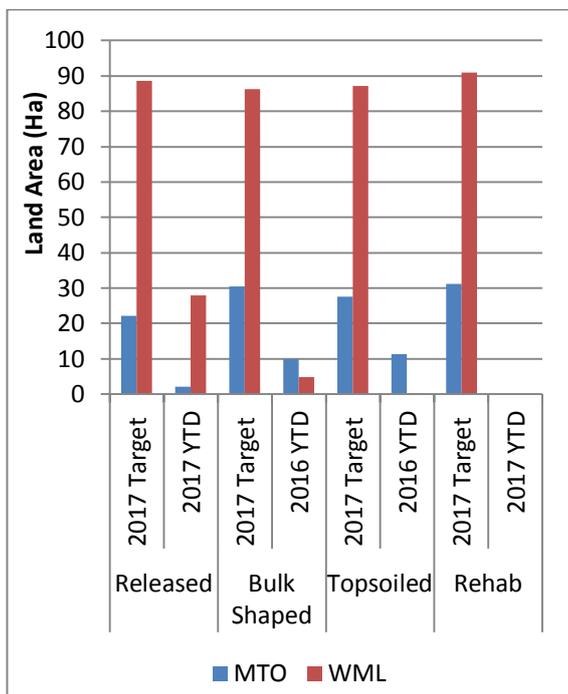
Figure 18: Rehabilitation YTD - February 2017

During February, 4.4 Ha of land was released, 5.9 Ha of land was bulk shaped and 9.0 Ha of land was topsoiled.
