Monthly Environmental Monitoring Report

Yancoal Mount Thorley Warkworth

July 2019

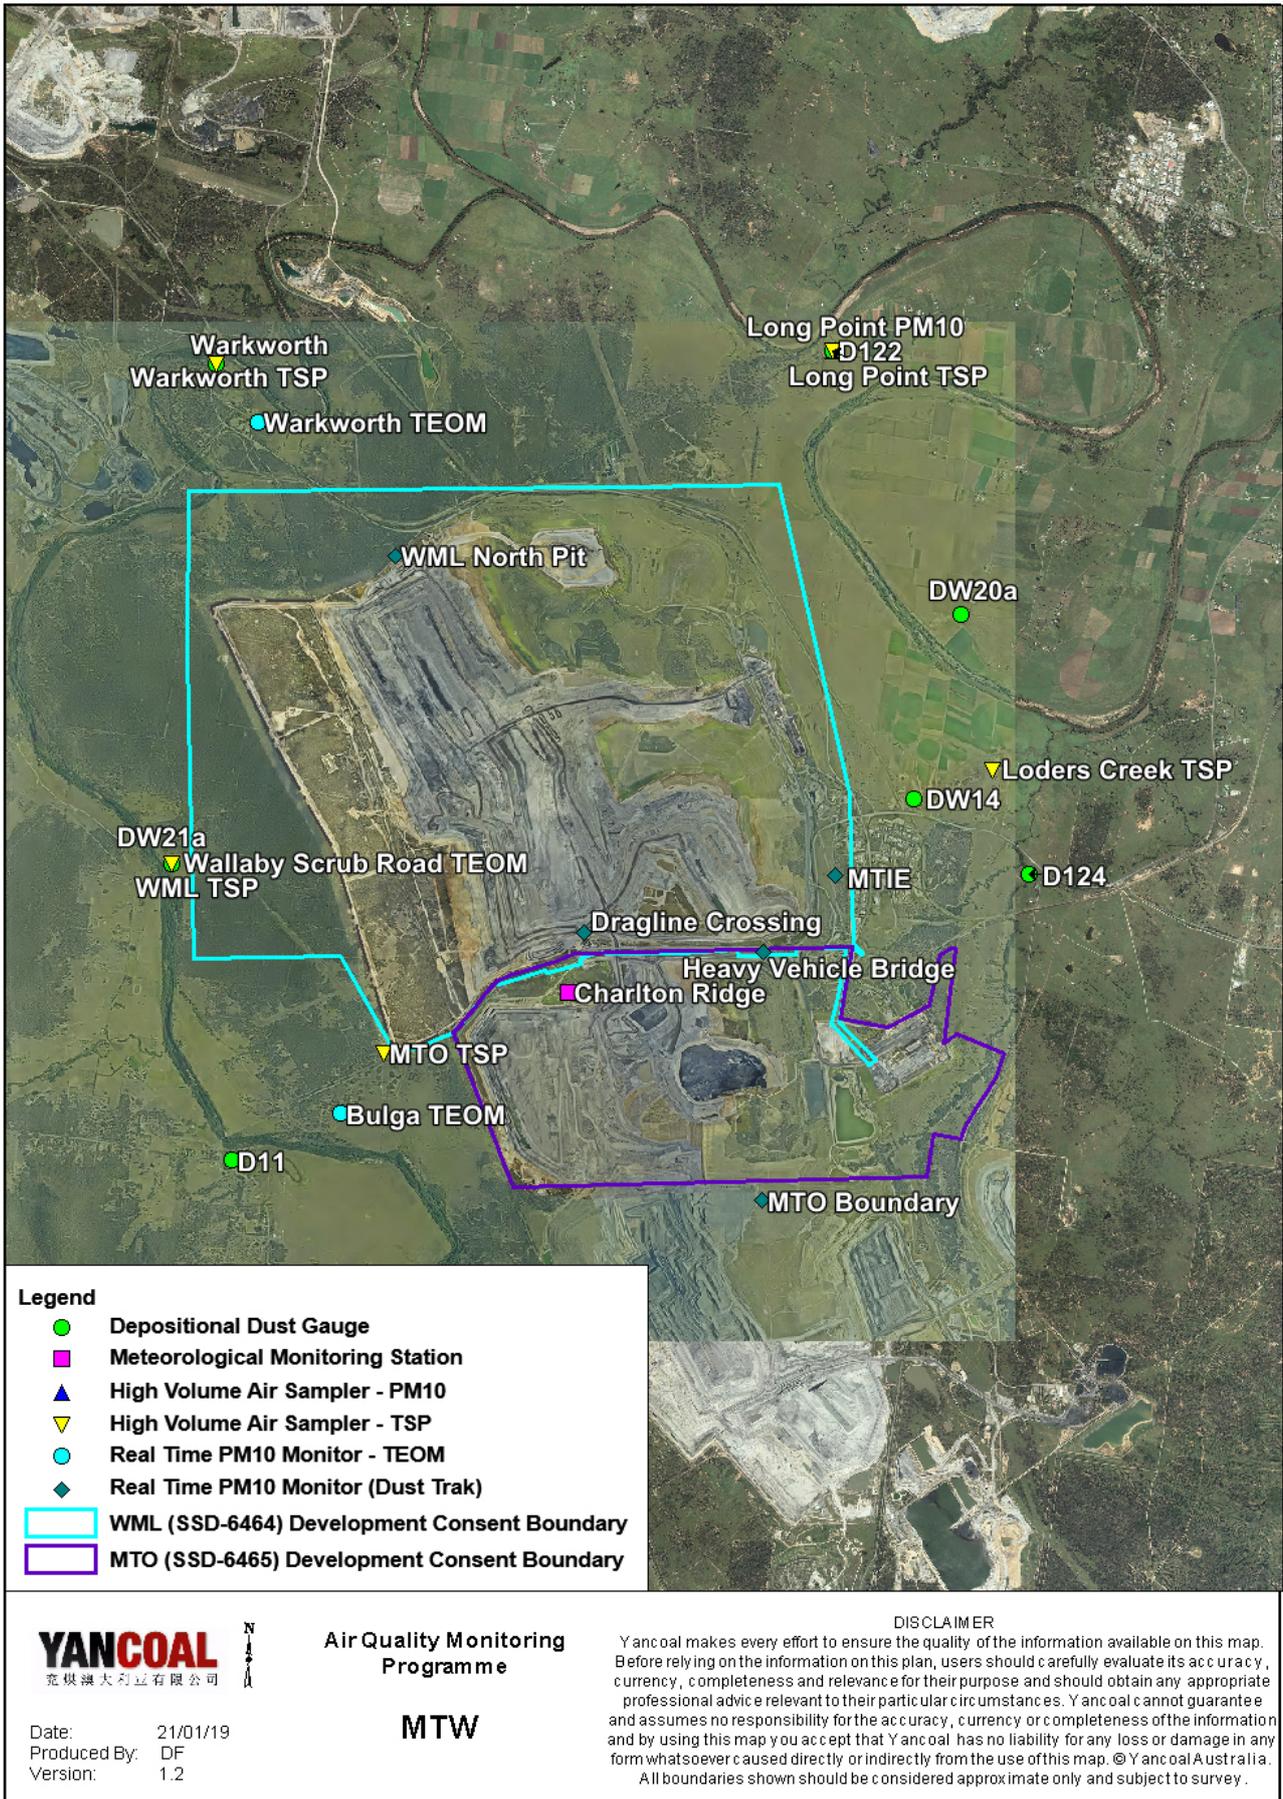
Figure 3: Air Quality Monitoring Locations

Meteorological data is collected at MTW's 'Charlton Ridge' meteorological station (refer to **Figure 3: Air Quality Monitoring Locations**).

location of these monitors can be found in Figure 3. Each HVAS was run for 24 hours on a six-day cycle in accordance with EPA requirements.
