Managed by Rio Tinto Coal Australia

Mount Thorley Warkworth
Monthly Environmental Report
June 2017

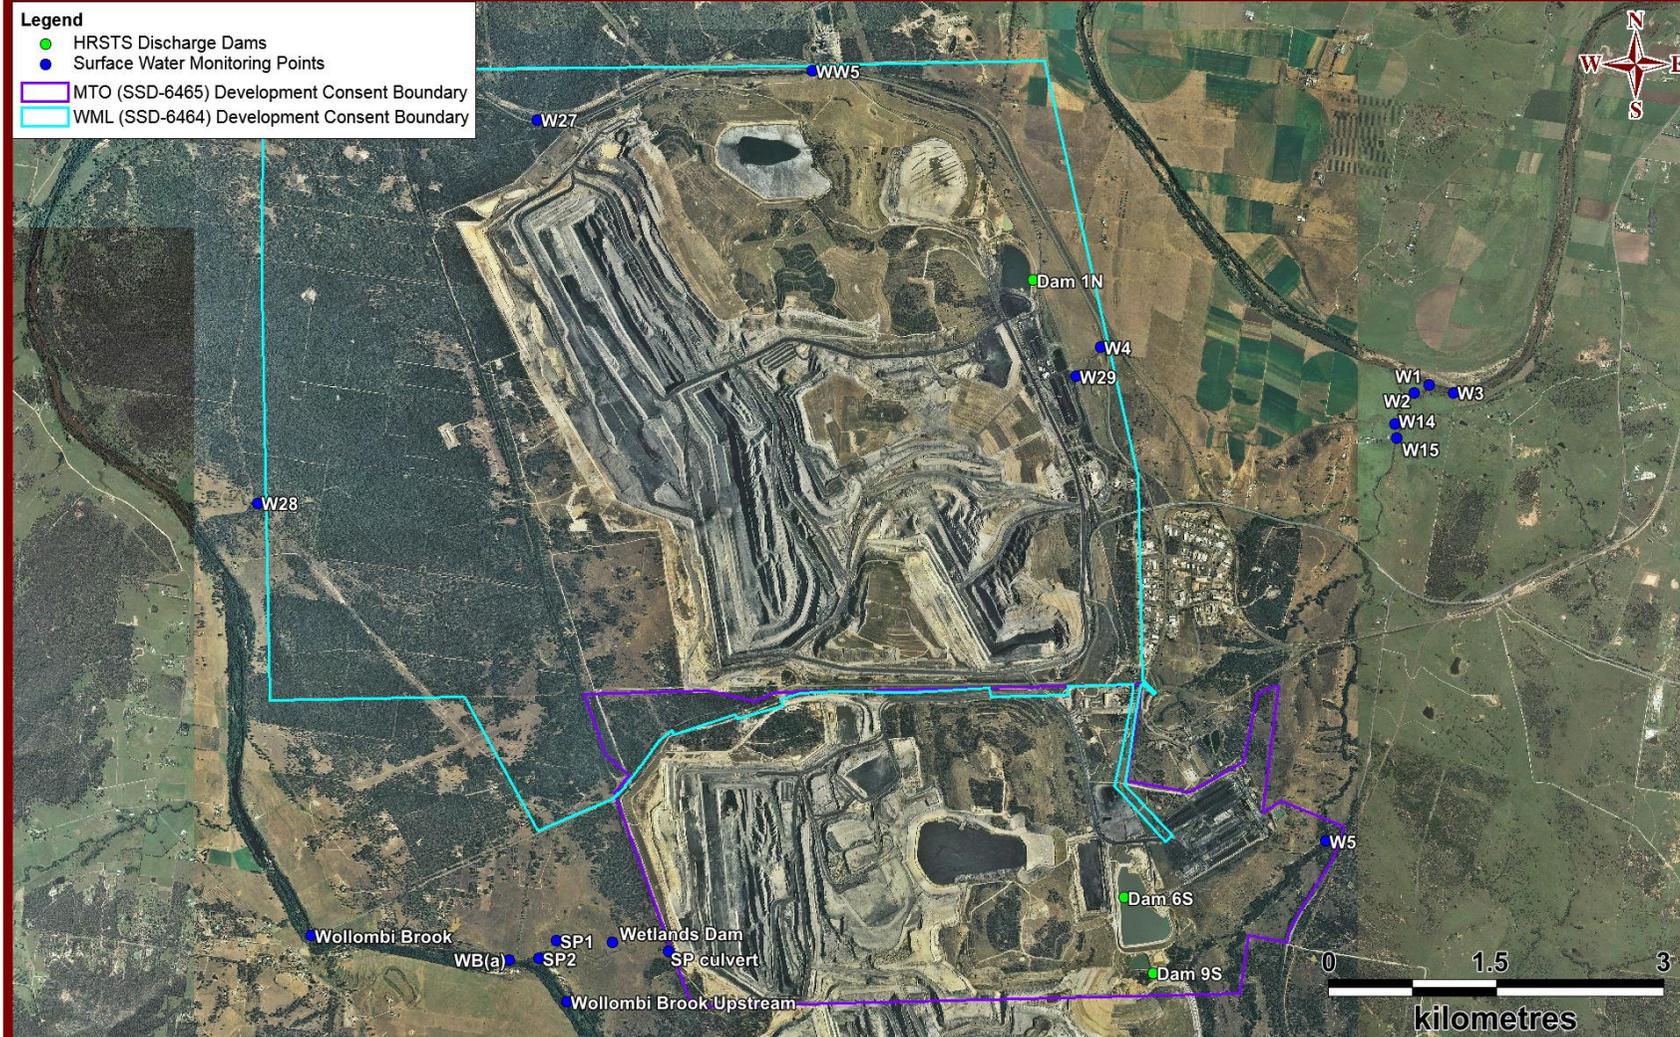
Figure 15: Surface Water Monitoring Location Plan

Surface Water Monitoring Programme

Monitoring is conducted at mine site dams and surrounding natural watercourses. The surface water monitoring locations are outlined in Figure 15.

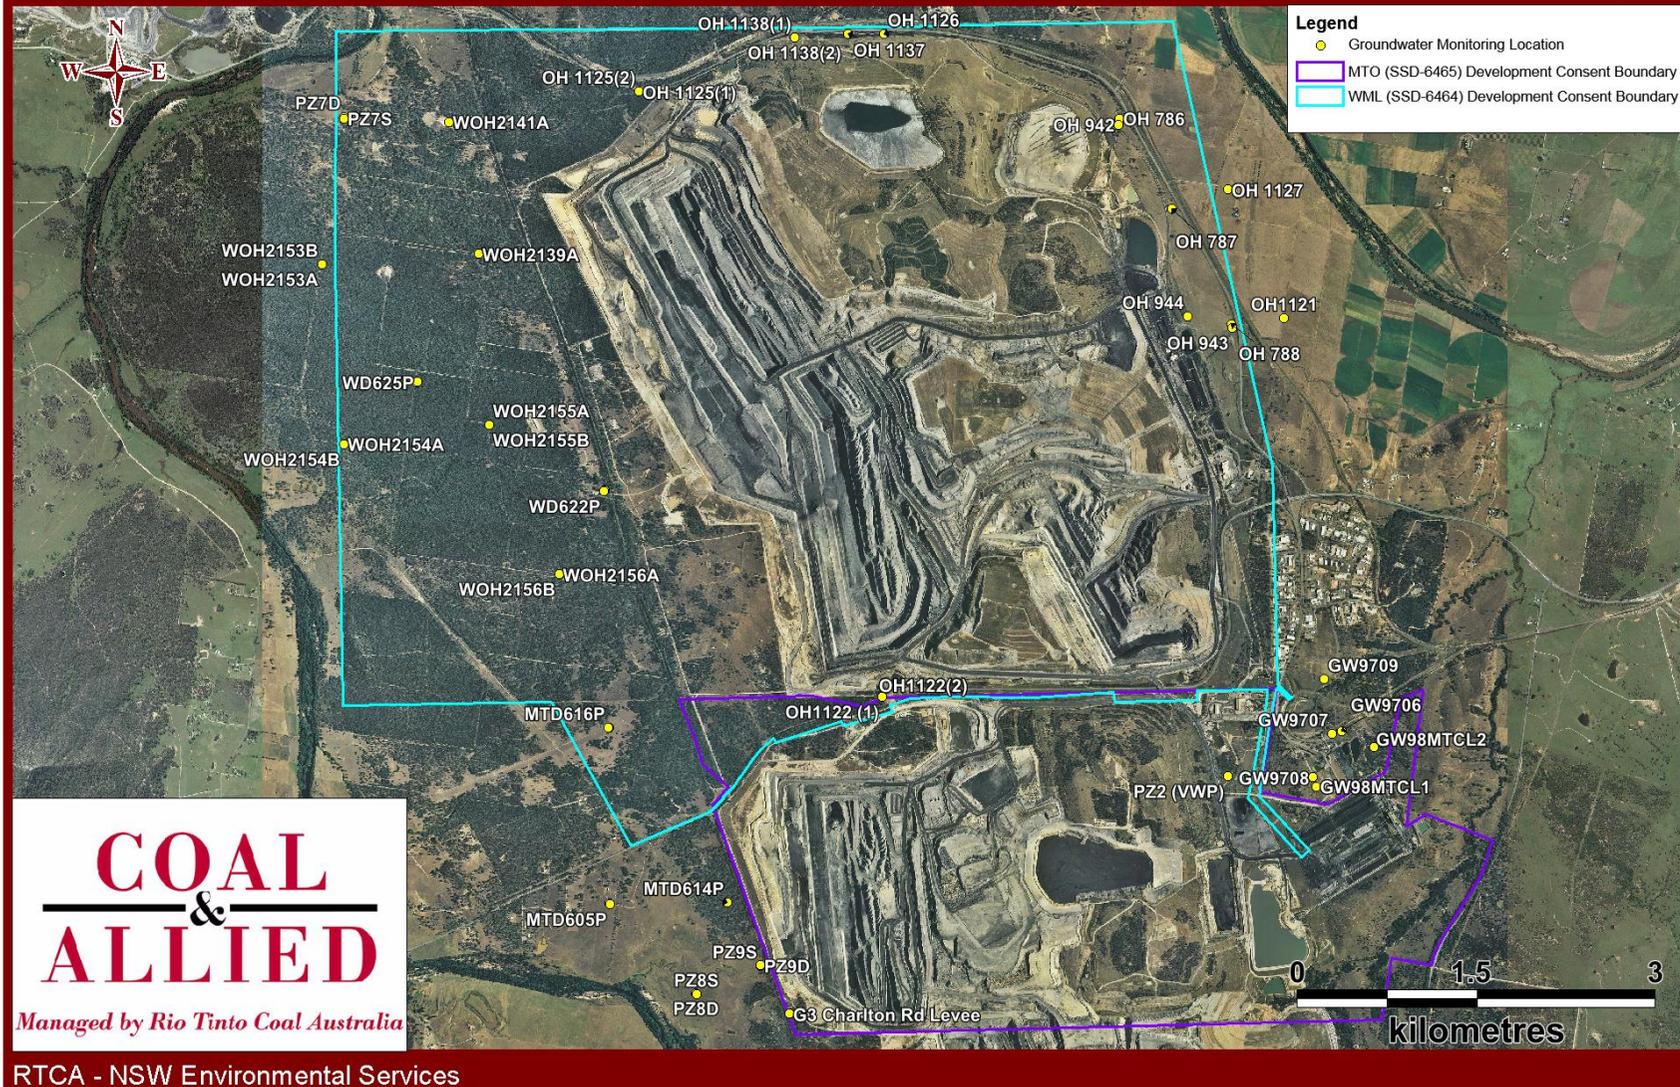
Figure 59: Groundwater Monitoring Location Plan

Groundwater Monitoring Locations

Internal trigger limits have been developed to assess monitoring data on an on-going basis, and to highlight potentially adverse groundwater impacts. The process for evaluating monitoring results against the internal triggers and subsequent responses are outlined in the MTW Water Management Plan. Locations of groundwater bores are shown in Figure 59.

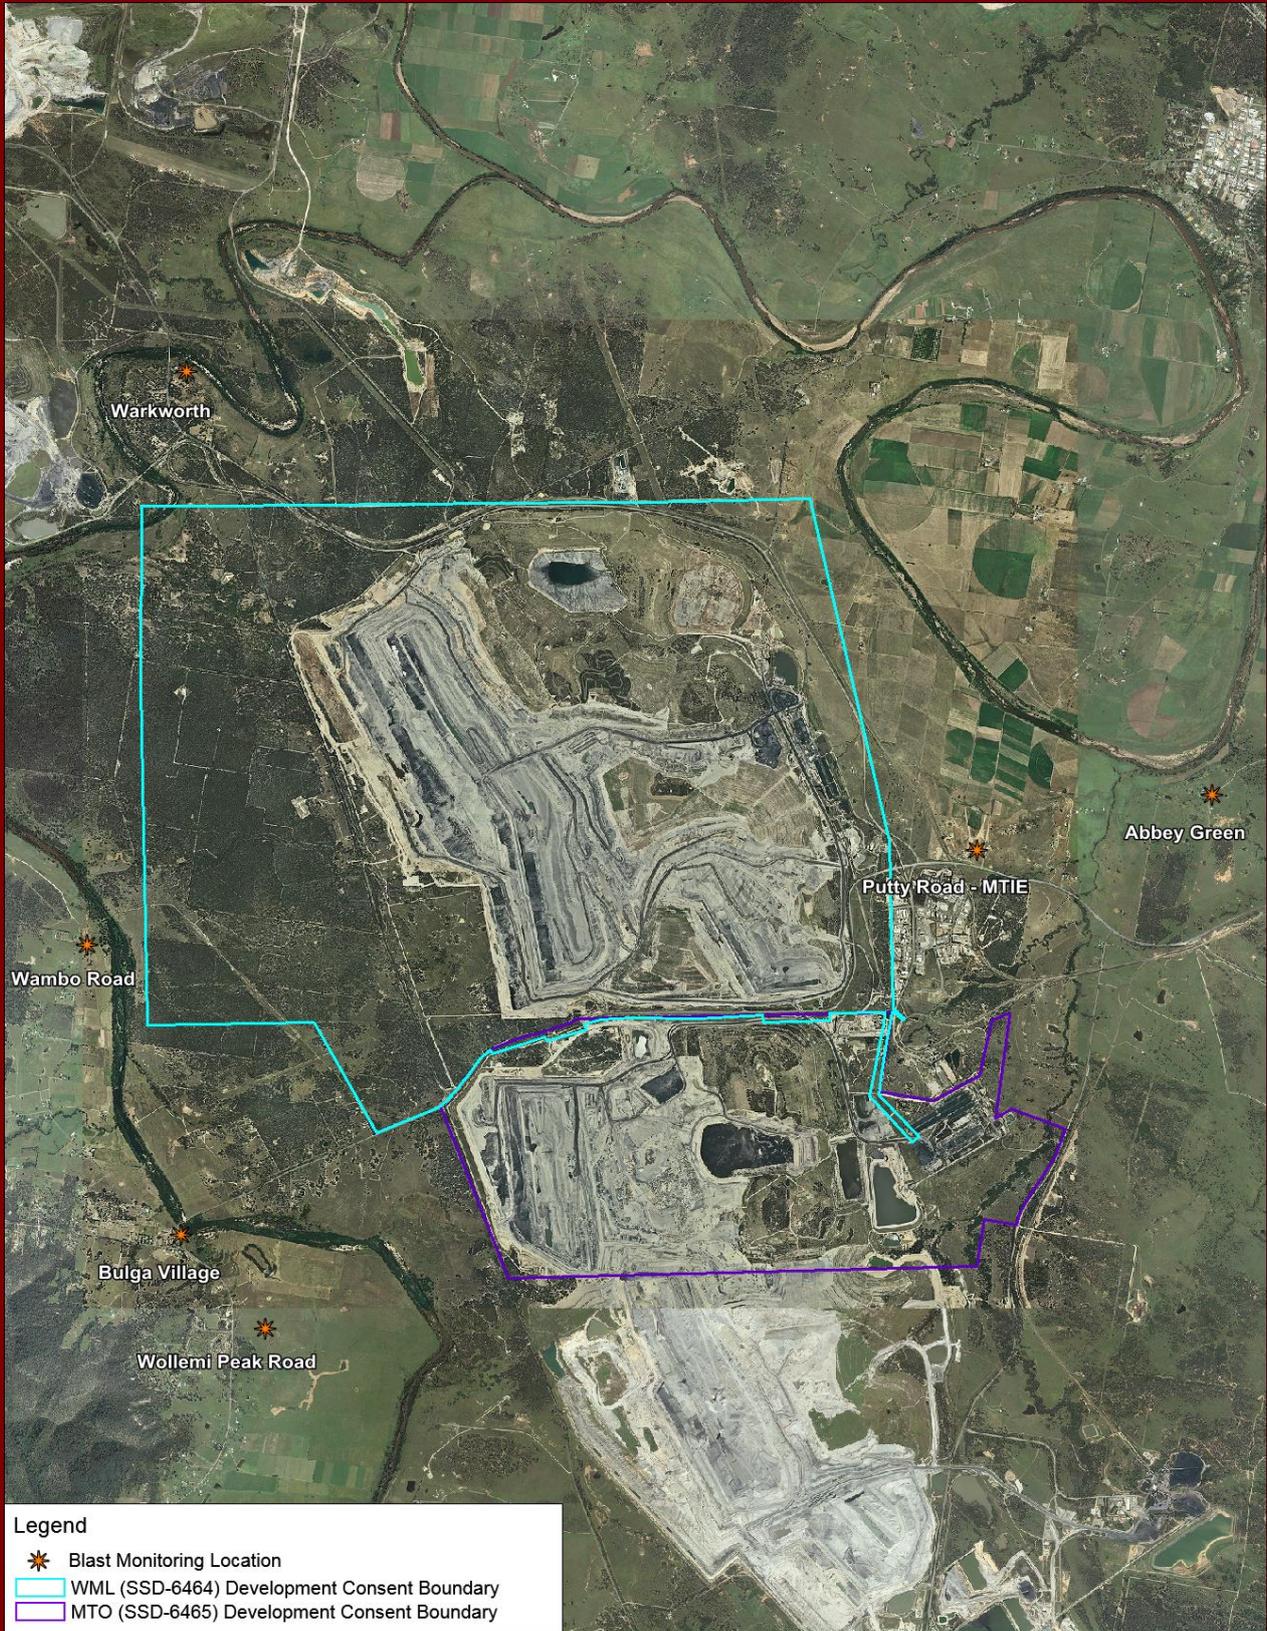
Figure 66: Blast and Vibration Monitoring Location Plan

**Mount Thorley Warkworth
Blast Monitoring Locations**

MTW have a network of six blast monitoring units. These are located at nearby privately owned residences and function as regulatory compliance monitors.

The location of these monitors can be found in Figure 66.

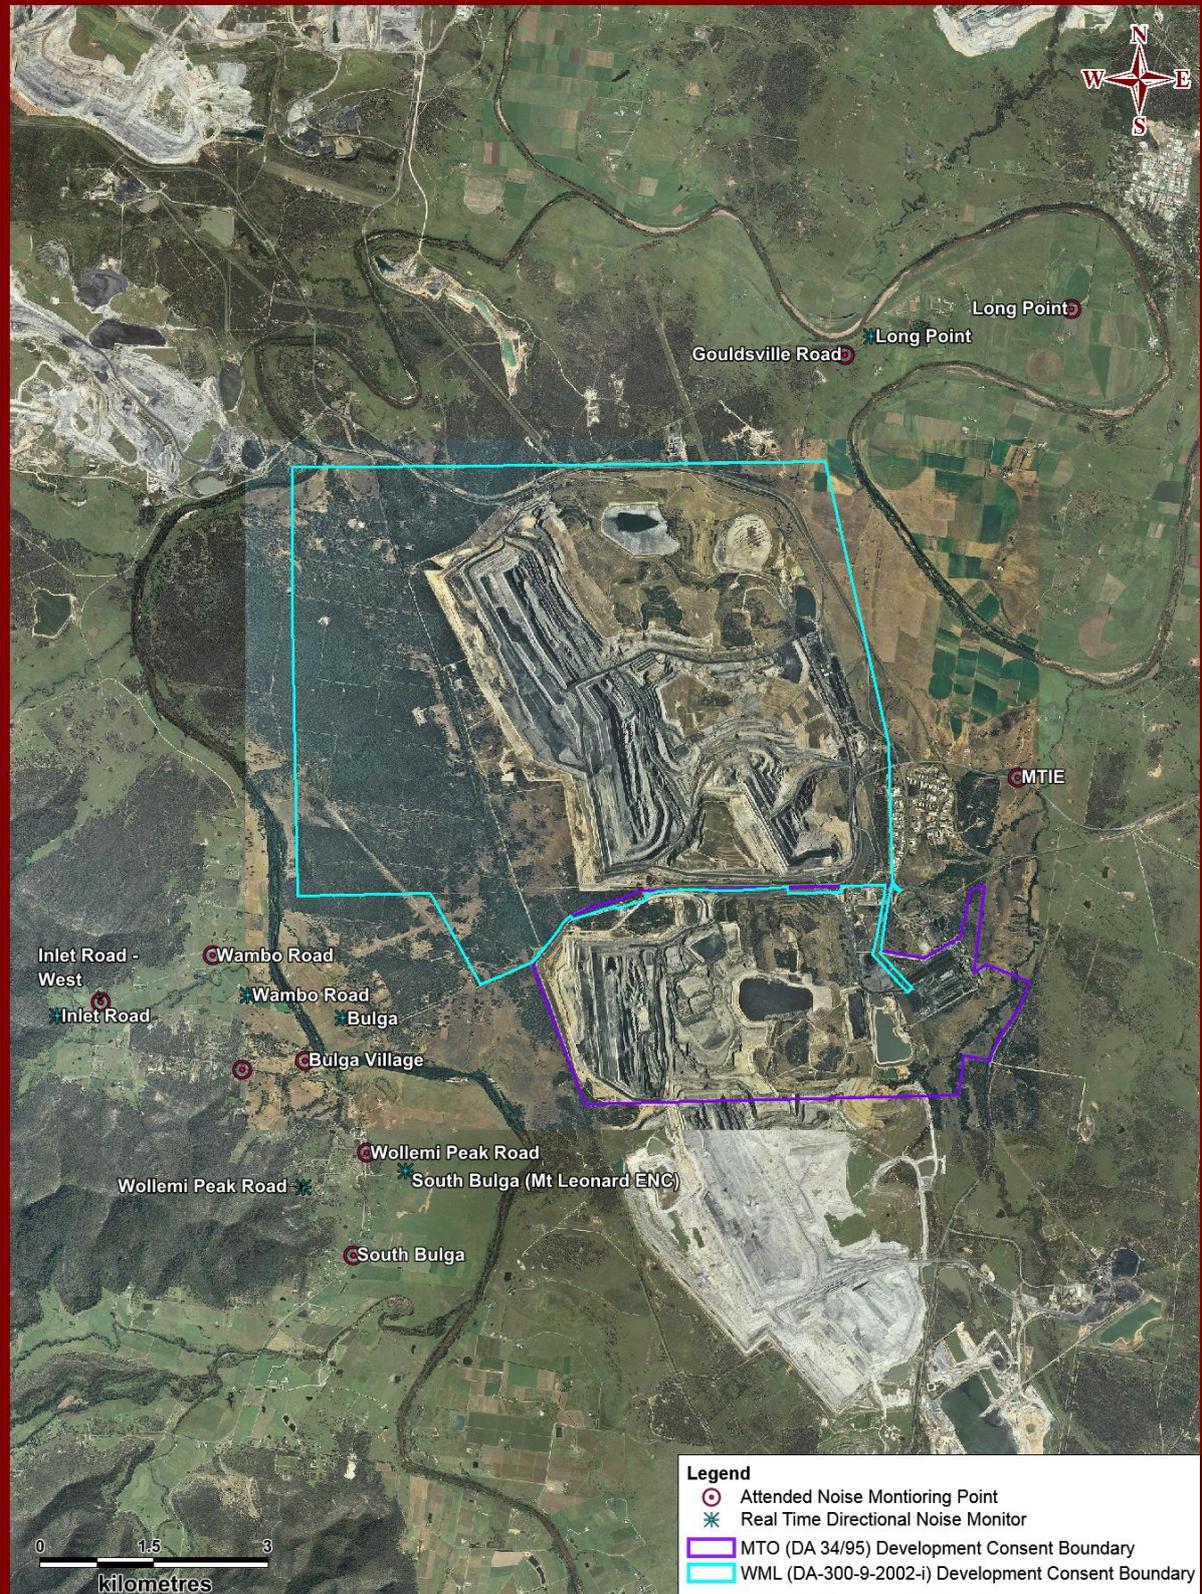
Figure 67: Noise Monitoring Location Plan

Routine attended noise monitoring is carried out in accordance with the MTW Noise Management Plan. A review against EIS predictions will be reported in the Annual Review. The purpose of the noise surveys is to quantify and describe the acoustic environment around the site and compare results with specified limits. Unattended monitoring (real time noise monitoring) also occurs at five sites surrounding MTW. The attended noise monitoring locations are displayed in Figure 67.
