Monthly Environmental Monitoring Report

Yancoal Mount Thorley Warkworth

January 2020

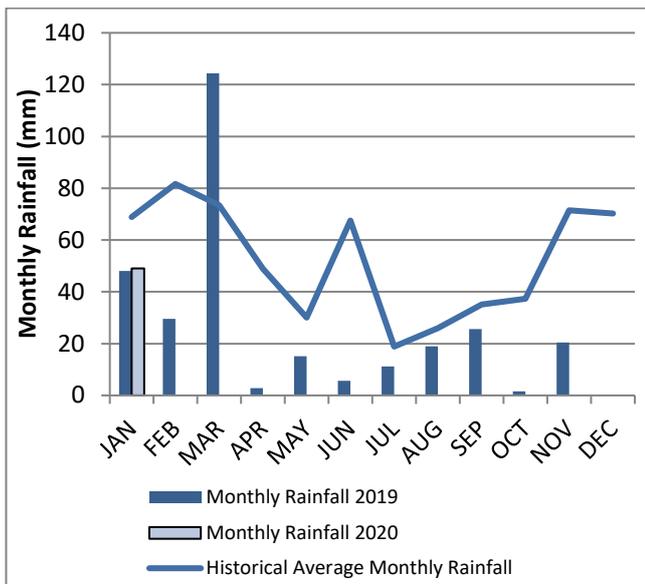
Figure 1: Rainfall Trend YTD

Rainfall for the reporting period is summarised in **Table 1**. The year-to-date monthly rainfall totals, 2020 monthly rainfall totals and historical average monthly rainfall trend are shown in **Figure 1**.

Note: The historical average monthly rainfall is calculated from 2007 to 2019 monthly totals

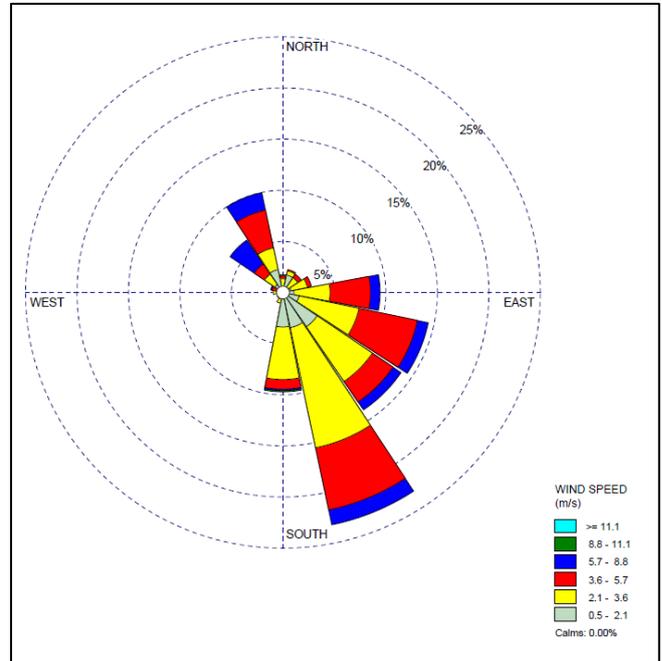
Figure 2: Charlton Ridge Wind Rose – January 2020

Winds from the southeast were dominant during the reporting period as shown in **Figure 2**.

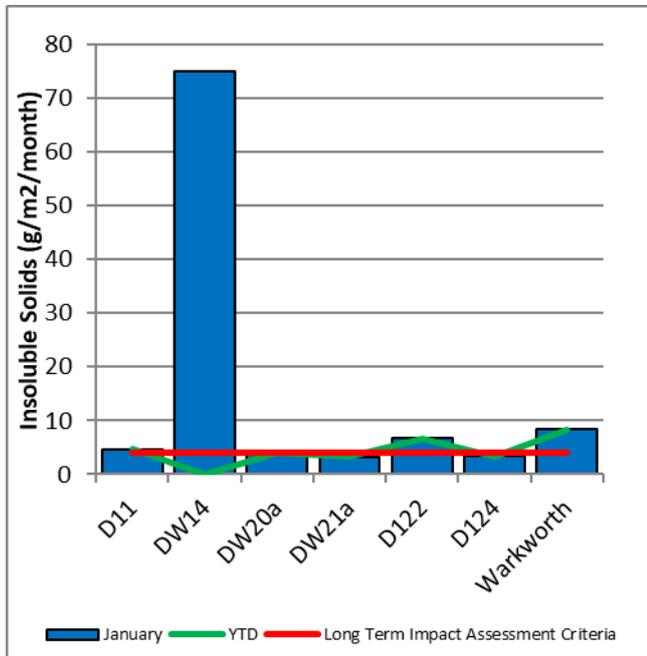
Figure 4: Depositional Dust – January 2020

Figure 4 displays insoluble solids results from depositional dust gauges during the reporting period compared against the year-to-date average and the annual impact assessment criteria.

During the reporting period the D11, DW14, D122 and Warkworth monitors recorded monthly results above the long-term impact assessment criteria of 4.0 g/m² per month. Field notes associated with DW14 confirm the presence of insects. As such the result is considered contaminated and will be excluded from calculation of the annual average. Regional bushfire smoke and related ash deposition are likely to have contributed to elevated dust deposition results, although there is insufficient evidence to confirm that the D11, D122 and Warkworth results are contaminated. Accordingly, the results will be included in the annual average calculation.

An annual assessment of MTW’s compliance with the Long-Term Impact Assessment Criteria will be provided in the 2020 Annual Review Report.

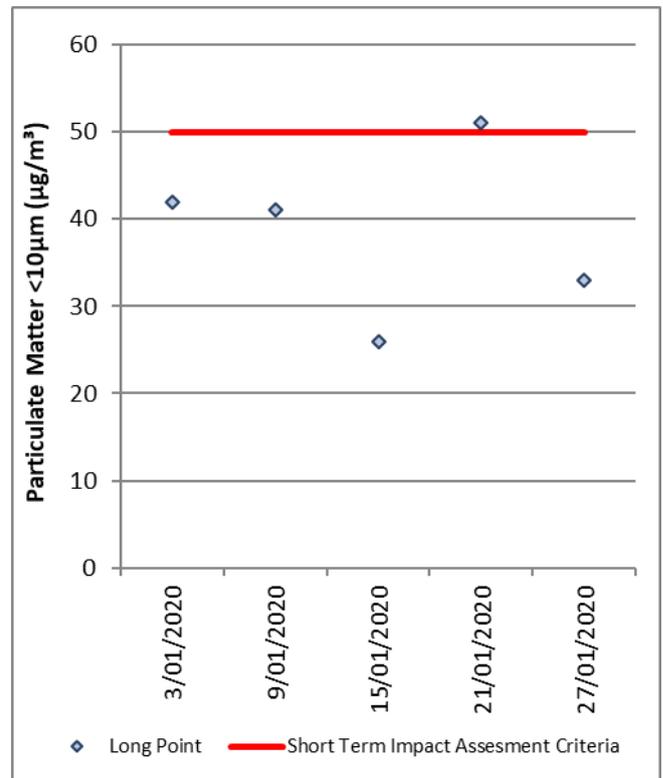
Figure 5: Individual PM10 Results – January 2020

Figure 5 shows the individual PM₁₀ results at each monitoring station against the short-term impact assessment criteria of 50µg/m³.

On 21 January 2020 the Long Point HVAS PM₁₀ unit recorded a result of 51 µg/m³, which is greater than the short term (24hr) PM₁₀ impact assessment criteria.

Investigation determined that the wind direction was generally not from MTW’s angle of influence and that the likely MTW contribution to the results is less than 75%. Accordingly, no further action is required (as per approved Air Quality Monitoring Programme).

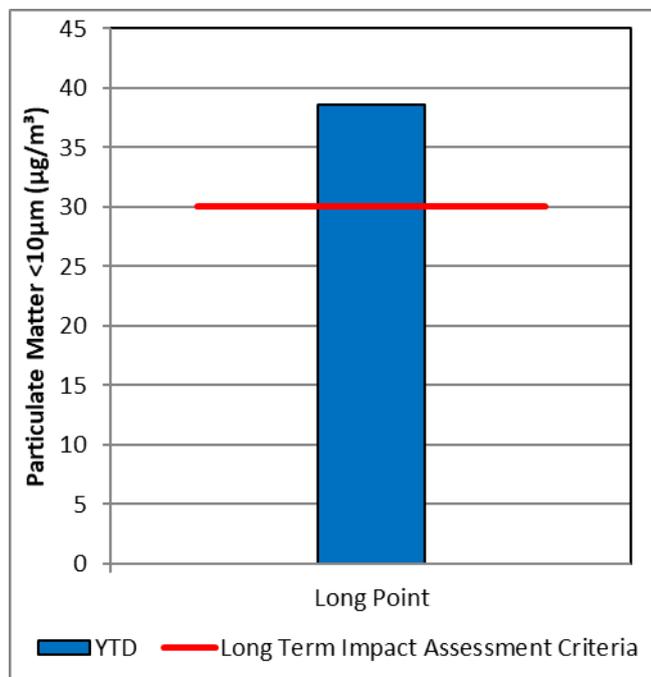
Figure 6: Annual Average PM₁₀ – January 2020

Figure 6 shows the annual average PM10 result against the long term impact assessment criteria.

An assessment of MTW’s contribution to the long term assessment criteria will be reported in the 2020 Annual Review Report.

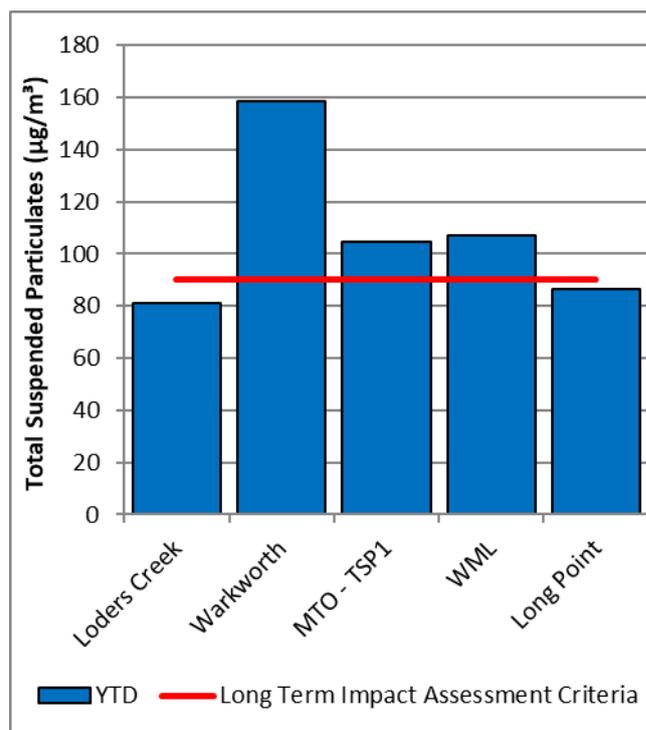
Figure 7: Annual Average Total Suspended Particulates – January 2020

Figure 7 shows the annual average TSP results compared against the long-term impact assessment criteria of 90µg/m³.

An assessment of MTW’s contribution to the long-term assessment criteria will be reported in the 2020 Annual Review Report.

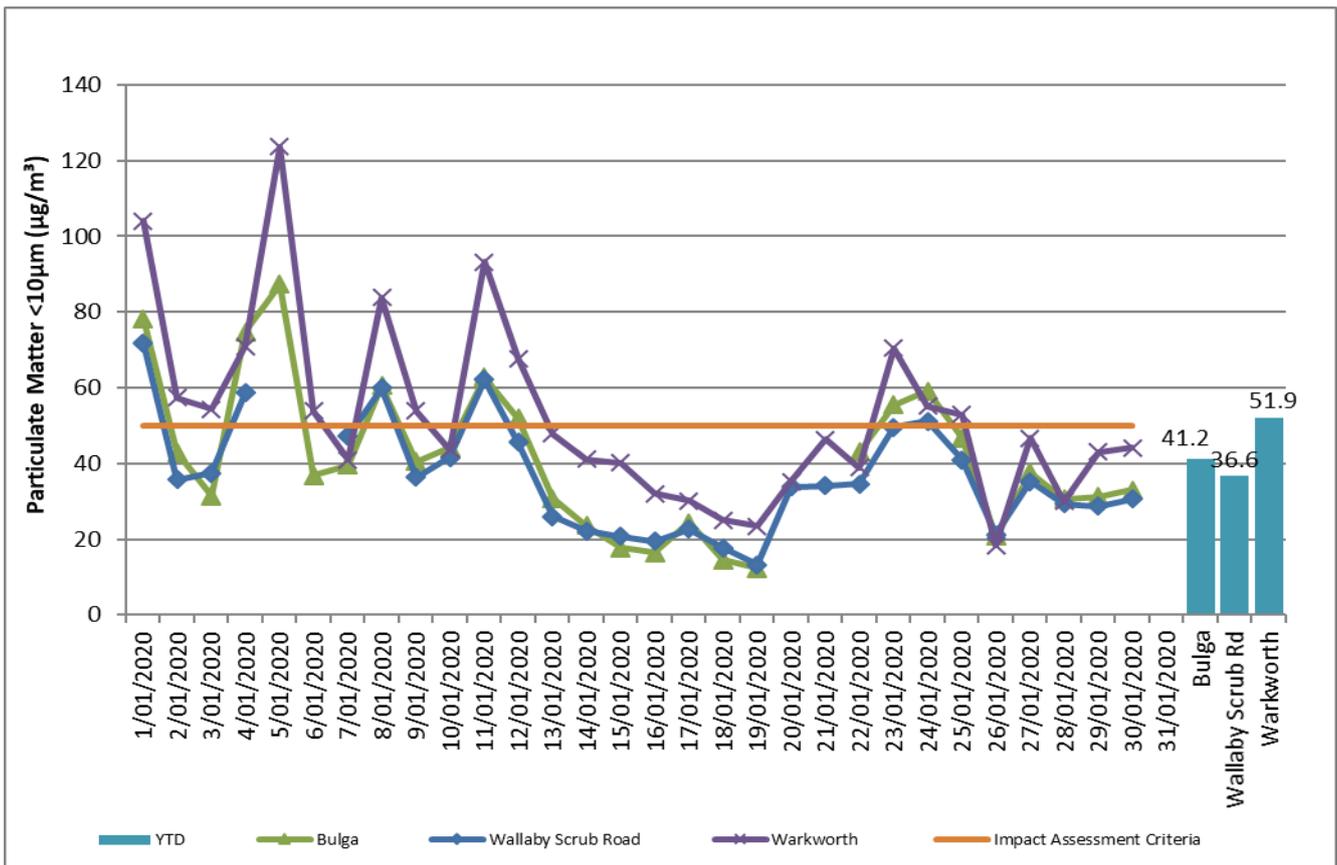
Figure 8: Real Time PM₁₀ daily 24hr average (line graphs) and YTD annual average (column graphs) – January 2020

Results for real time dust sampling are shown in Figure 8, including the daily 24-hour average PM₁₀ result and the annual PM₁₀ average.

On 1, 2, 3, 4, 5, 6, 8, 9, 11, 12, 23, 24 and 25 January 2020, the Bulga OEH, Wallaby Scrub Road and/or Warkworth OEH TEOM’s exceeded the short term (24hr) criteria.

Investigation into these exceedances determined that the wind direction was generally not from MTW’s angle of influence and/or background PM₁₀ levels were elevated. The maximum potential contributions to the results were less than 75% and

less than 50 µg/m³. Accordingly, MTW operations are not considered to be a significant contributor to the results as described in the MTW Air Quality Management Plan and no further action is required. Elevated PM₁₀ levels during January 2020 are considered partially attributable to bushfires in the region.

Data was not available on 5 and 6 January 2020 from the Wallaby Scrub Road monitor or on 20 and 21 January 2020 from the Bulga OEH TEOM due to equipment issues.

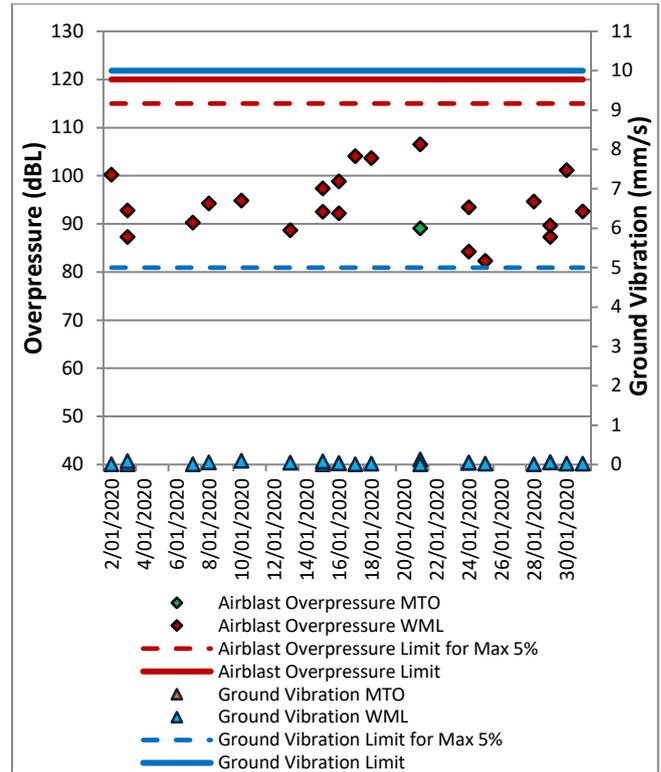
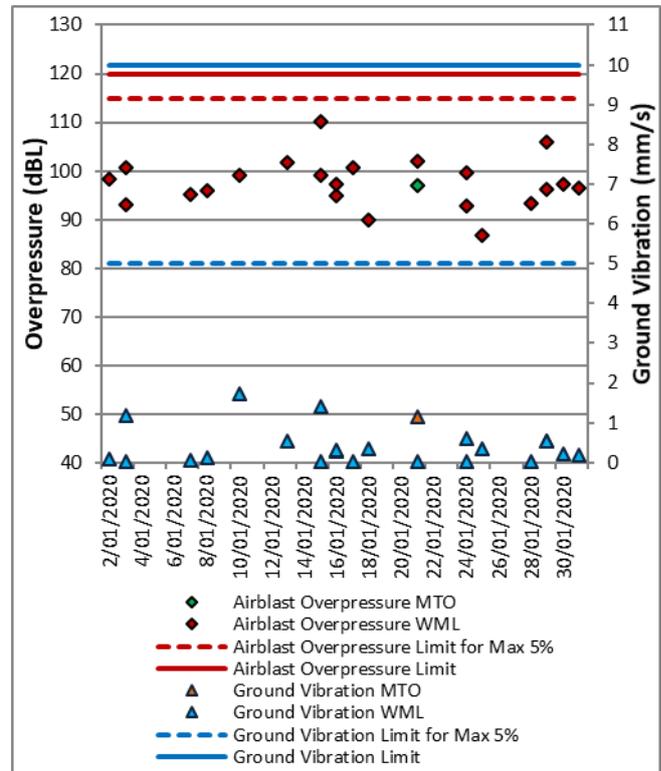
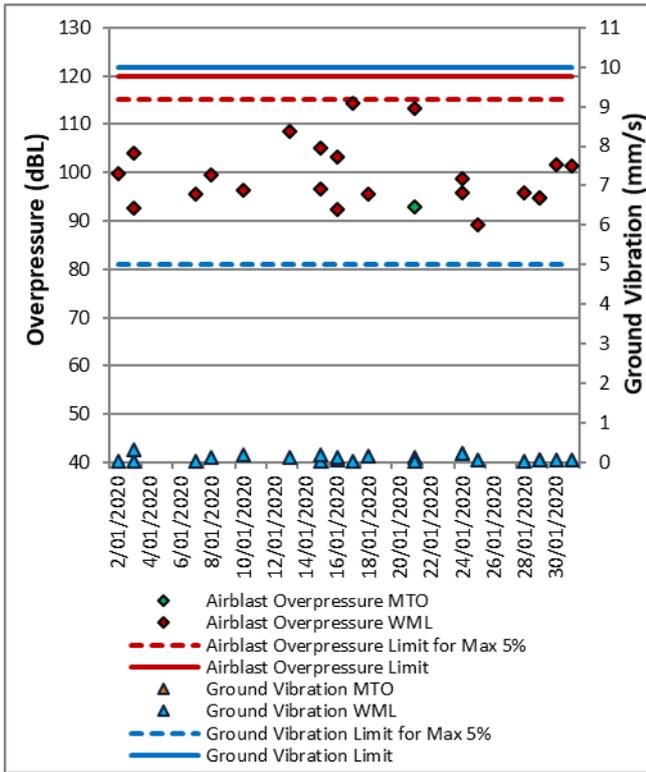
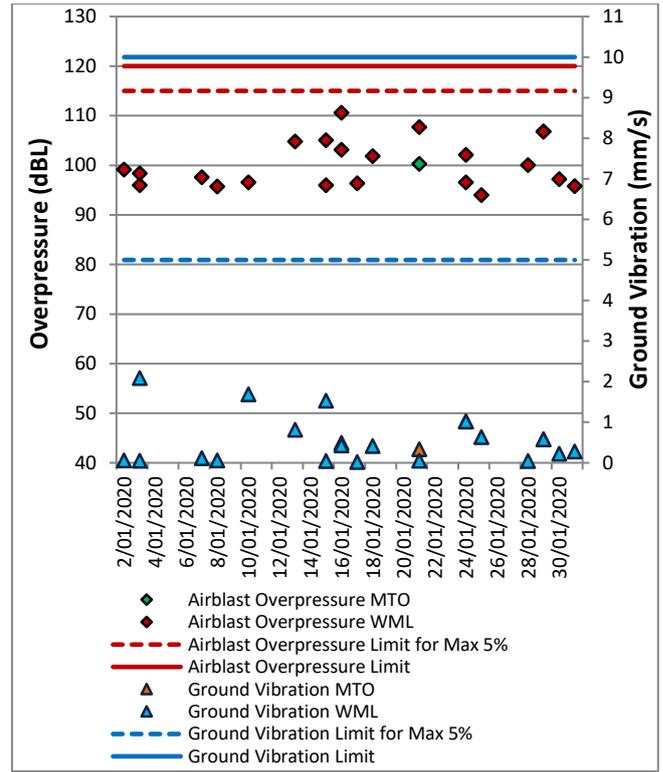
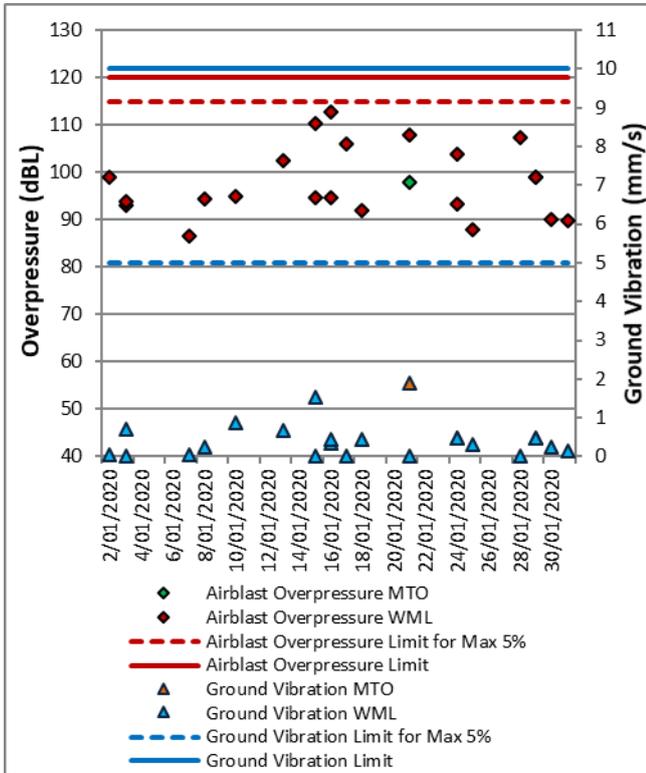
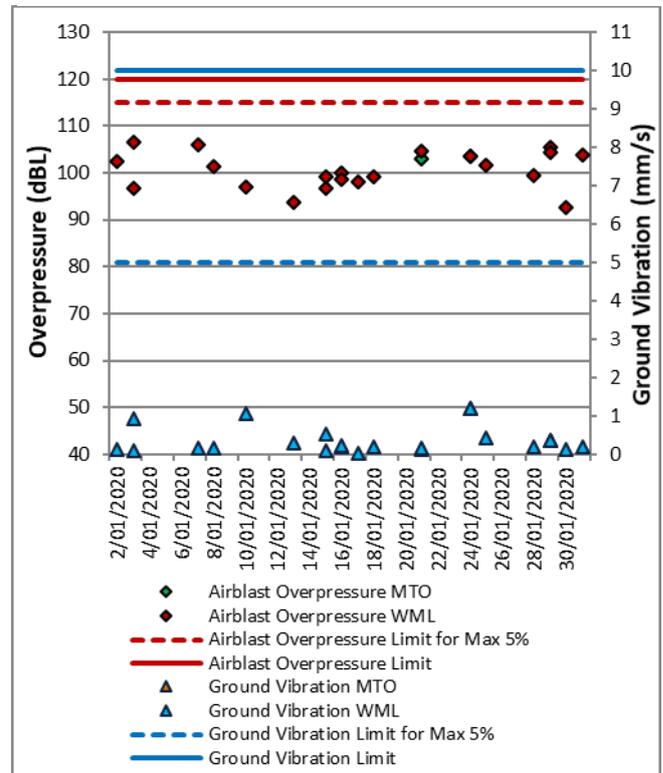
During January 2020, 23 blasts were initiated at MTW. **Figure 9** to **Figure 14** show the blast monitoring results for the reporting period against the impact assessment criteria. The criteria are summarised in **Table 2**.

During the reporting period no blasts exceeded the 115 dB(L) 5% threshold for airblast overpressure or 5mm/s 5% threshold for ground vibration.

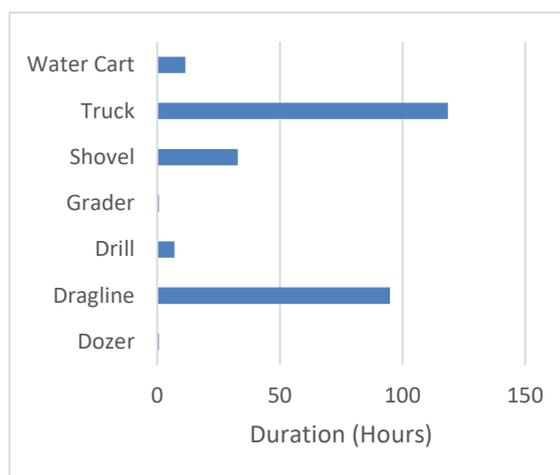
Figure 17: Operational Downtime by Equipment Type – January 2020

During January, a total of 266 hours of equipment downtime was logged in response to environmental events such as dust, noise and adverse meteorological conditions. Operational downtime by equipment type is shown in **Figure 17**.
