Stratford Coal CCC Meeting

Presentation –
Company Report &
Overview of Activities

May 2021

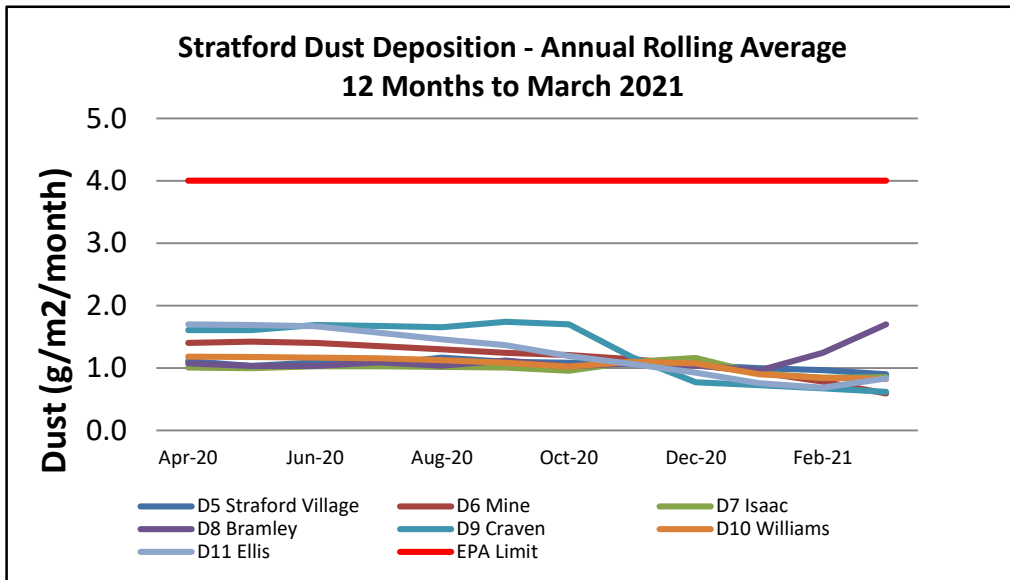
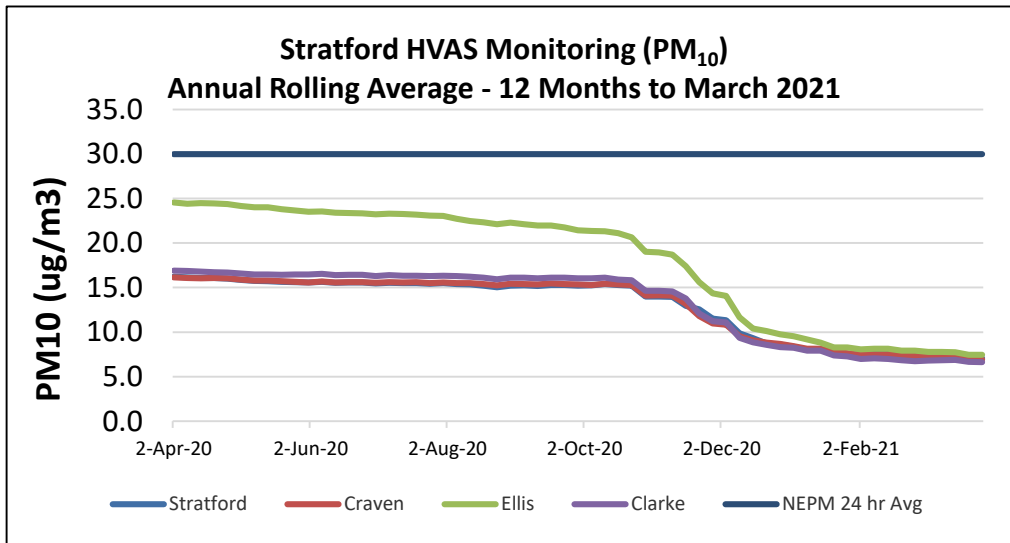
3a. Air Quality Management

- Generally good overall air quality.
- All sites below DPIE limit. Air quality results lower during months with higher rainfall.
- Steep decreasing trend during December 2020 due to elimination of bushfire affected results in 2019.
- HVAS results provide more reliable data compared to dust deposition results and should be referred to when interpreting dust emissions.
