MOOLARBEN COAL PROJECT

MOOLARBEN COAL PROJECT
ABORIGINAL CULTURAL HERITAGE
ASSESSMENT REPORT
STAGE 2

**A report to
Moolarben Coal Mines Pty Limited**

**By
Giles Hamm
Cultural Heritage Consultant
Archaeological Risk Assessment Services Pty Ltd
December 2008**

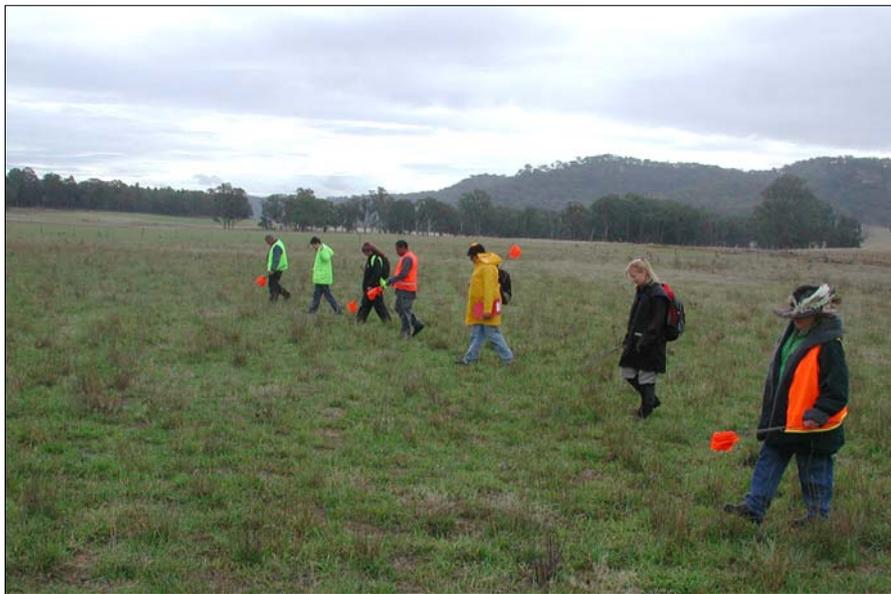
Plate 1: Seen here surveying OC3 at Stage 1 Moolarben Creek applying BST in wet conditions, the search team formed comparatively straight lines in open pastures to locate and flag cultural materials on the ground. With ground visibility here estimated to average $50\pm 10\%$, the team effectively identified all medium to large sized stone artefacts in the transect.

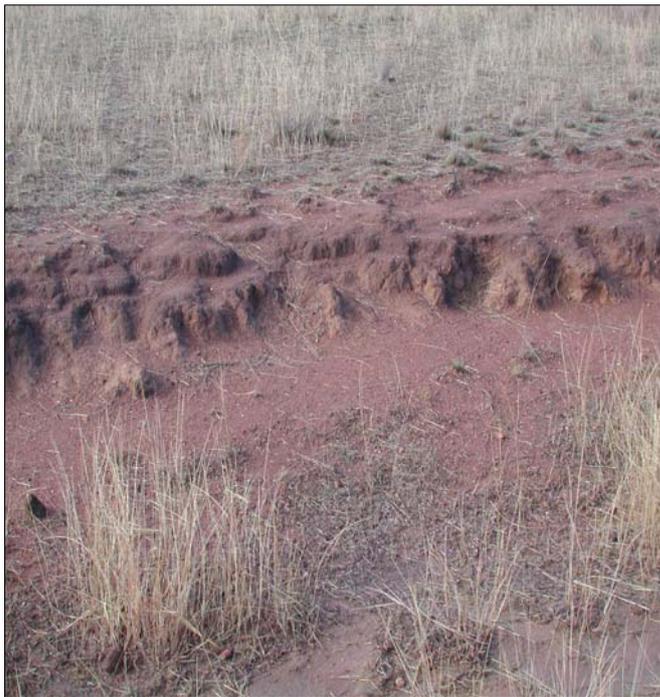
Plate 2: Shown here in Survey Transect (encompassing an erosion gully caused by diversion of surface runoff through a railroad culvert) is a typical example of marked differences in visibility patterns seen at a micro-scale between the red soil and the stubble in the surrounding pasture. Visibility of the red soil is estimated at greater than 90%, whereas that of the pasture varies between 30-70% per square metre due to different quantities of loose plant material, live weeds, and matting formed by a combination of both plant material and fine sediment. Search team members were asked to slow the search to concentrate in areas of high visibility such as this. As expected, no artefacts were discovered here.

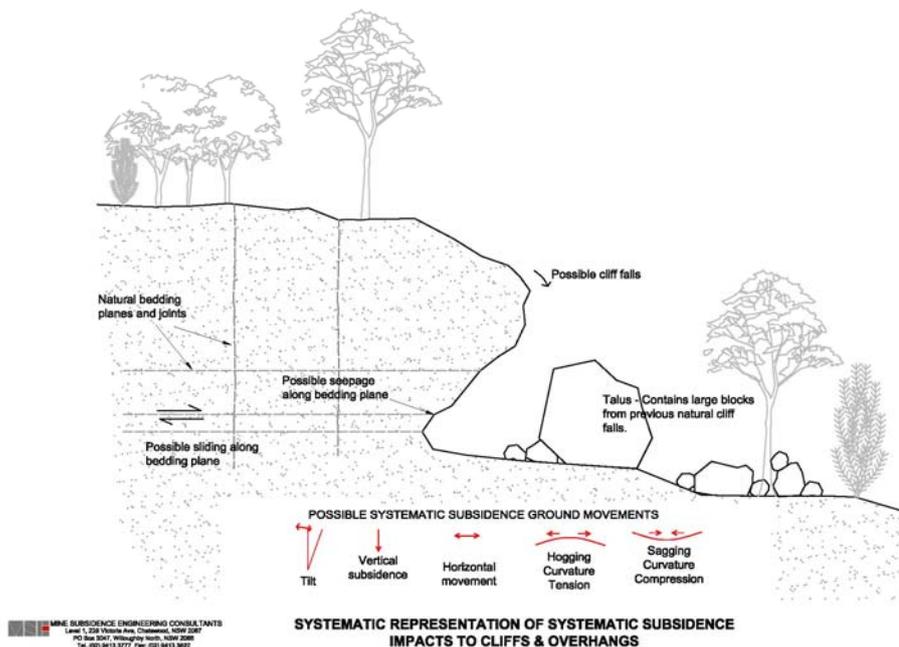
Figure 22: Systematic representation of systematic subsidence impacts to cliffs and overhangs.

Tilt is calculated as the change in subsidence between two points divided by the distance between those points. Tilt is, therefore, the first derivative of the subsidence profile. The sign of tilt is not important, but the convention usually adopted is for a positive tilt to indicate the ground increasing in subsidence in the direction of measurement. The maximum tilt, or the steepest portion of the subsidence profile, occurs at the point of inflection in the subsidence trough, where the subsidence is roughly equal to one half of the maximum subsidence. Tilt is usually expressed in millimetres per metre (Mine Subsidence Engineering 2008). For archaeological sites the above stress may cause fracturing or cracking such as shown in Figure 22 below (Mine Subsidence Engineering 2008).

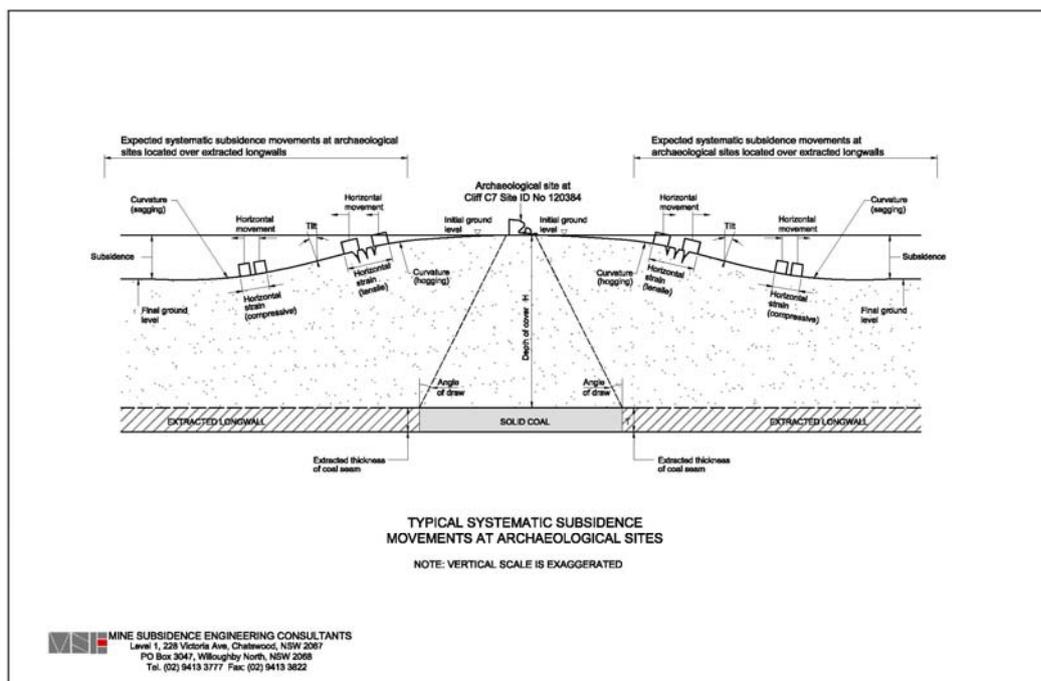
Figure 23: Typical systematic subsidence movements at archaeological sites.

For open sites and archaeological deposits the effect of subsidence impacts can be shown as movement of sandstone surfaces or benches causing cracking and bringing about the creation of troughs or depressions (see Figure 23 below from Mine Subsidence Engineering 2008.)

These movements may also cause the increase in surface water run-off and bring about erosion and displacement of artefacts and potential archaeological deposits. Sites especially vulnerable would be located at the heads of gullies or on sandstone benches (i.e. grinding grooves or stone arrangements on ridge-crests).

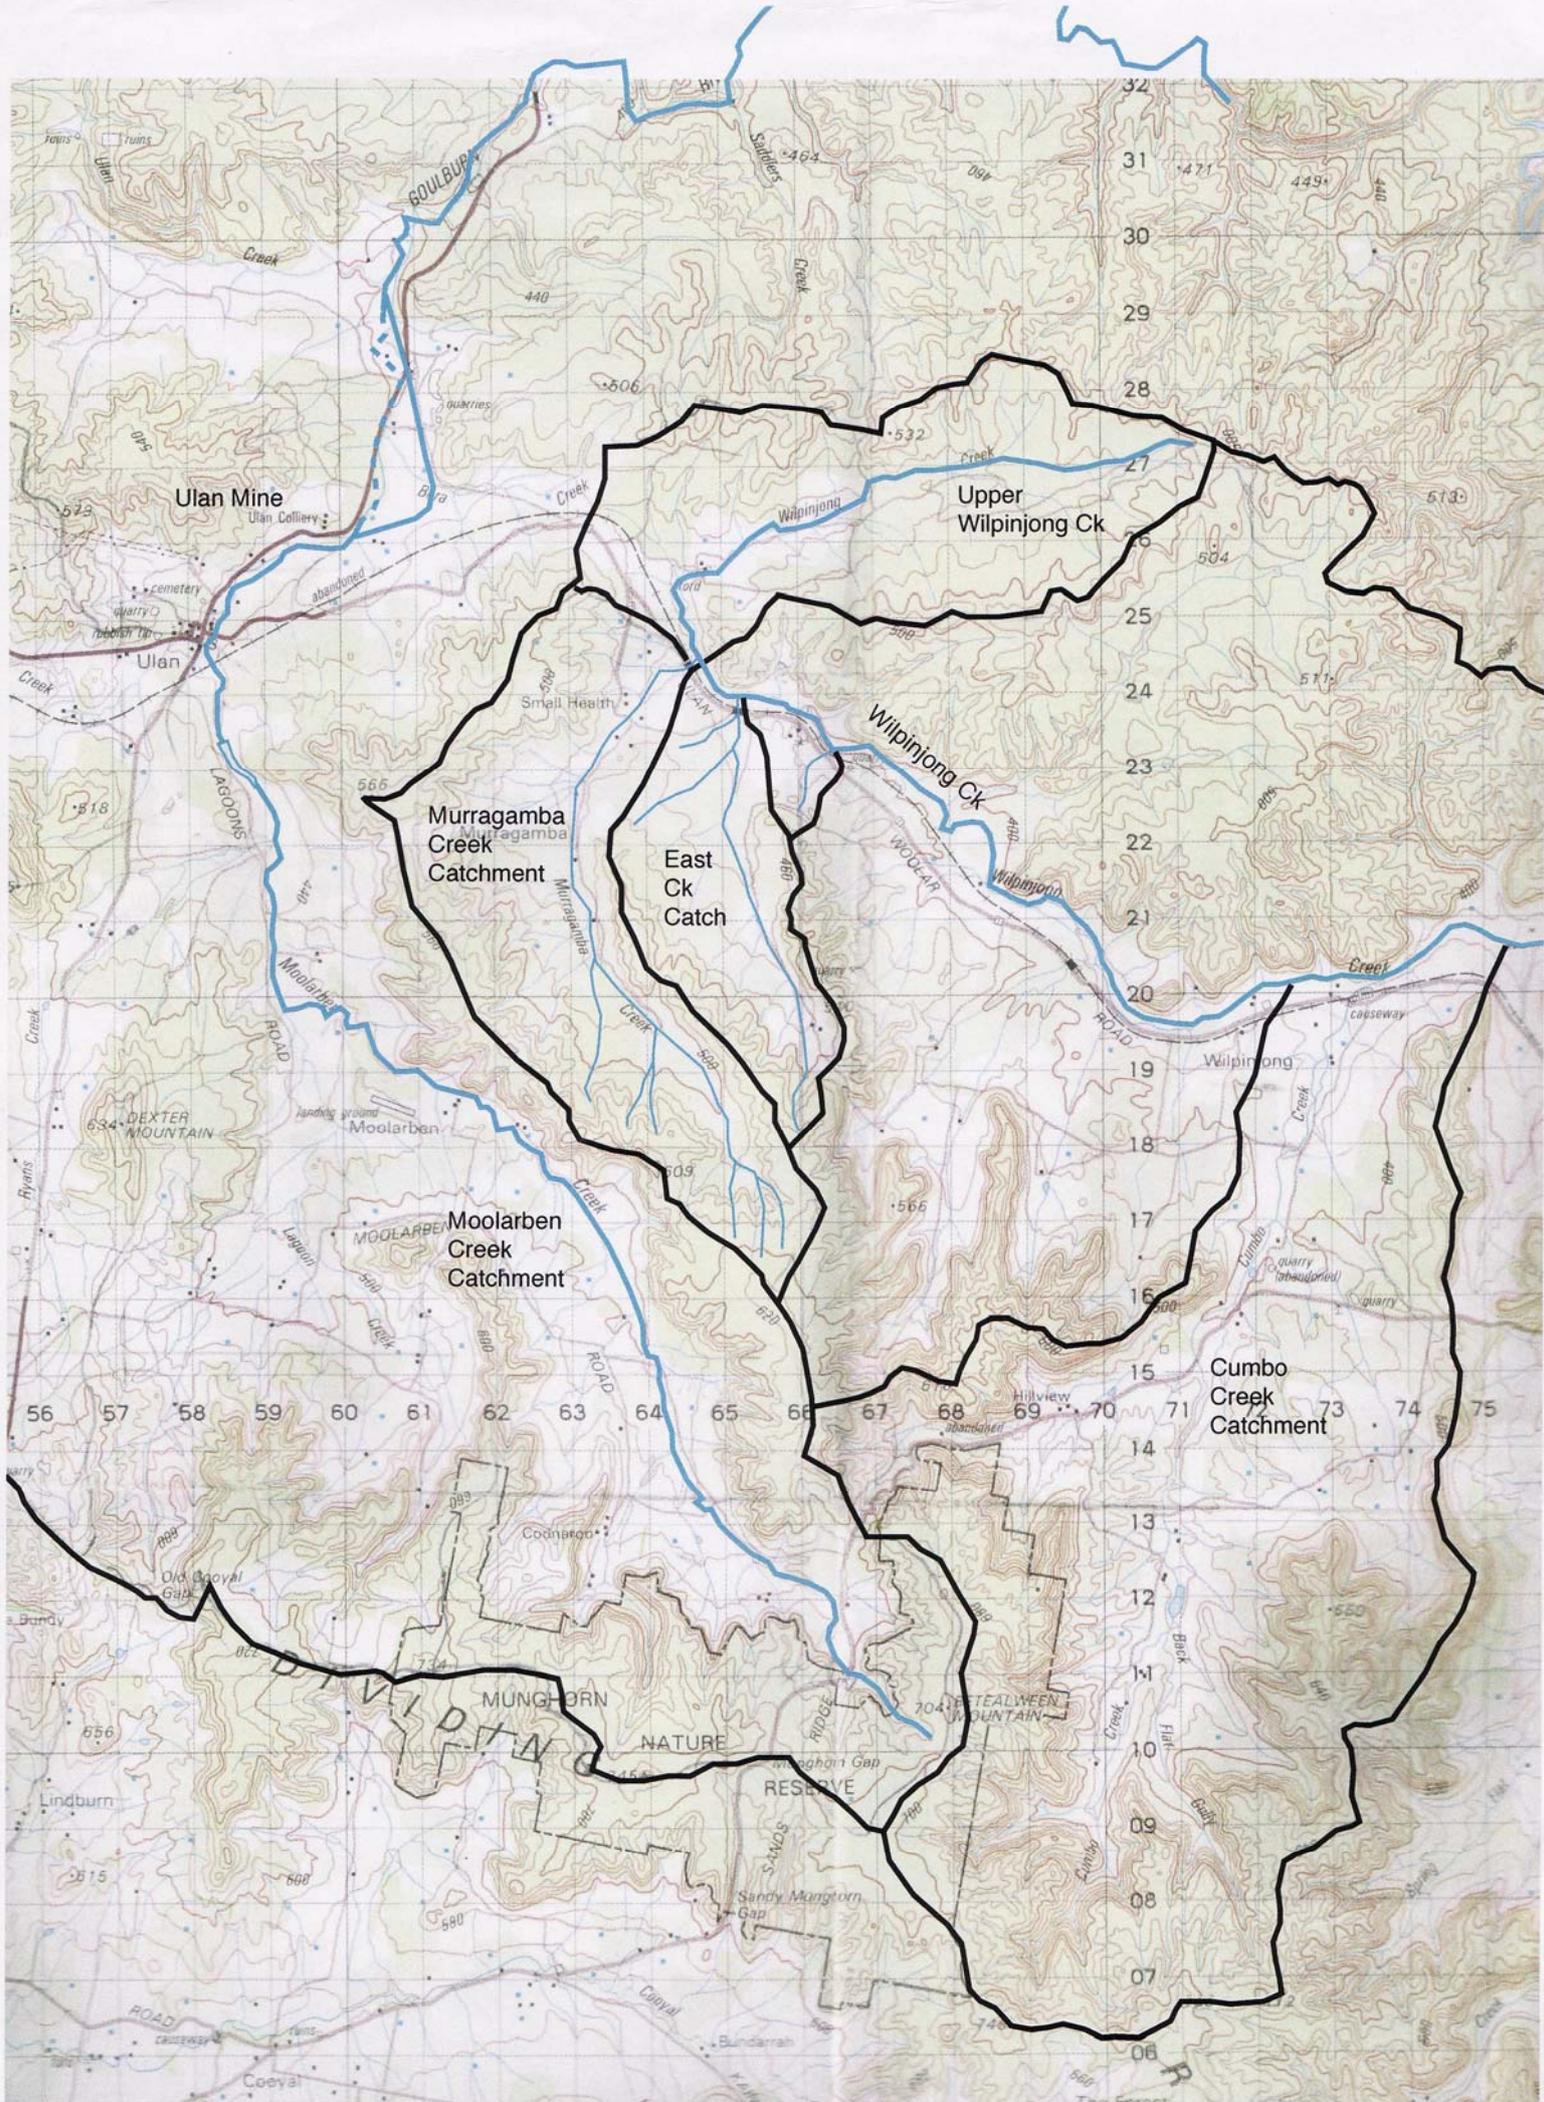
FIGURE 14: Drainage and catchment features of the MCP Stage 2 study area. Scale = 1:25,000 Wollar sheet.

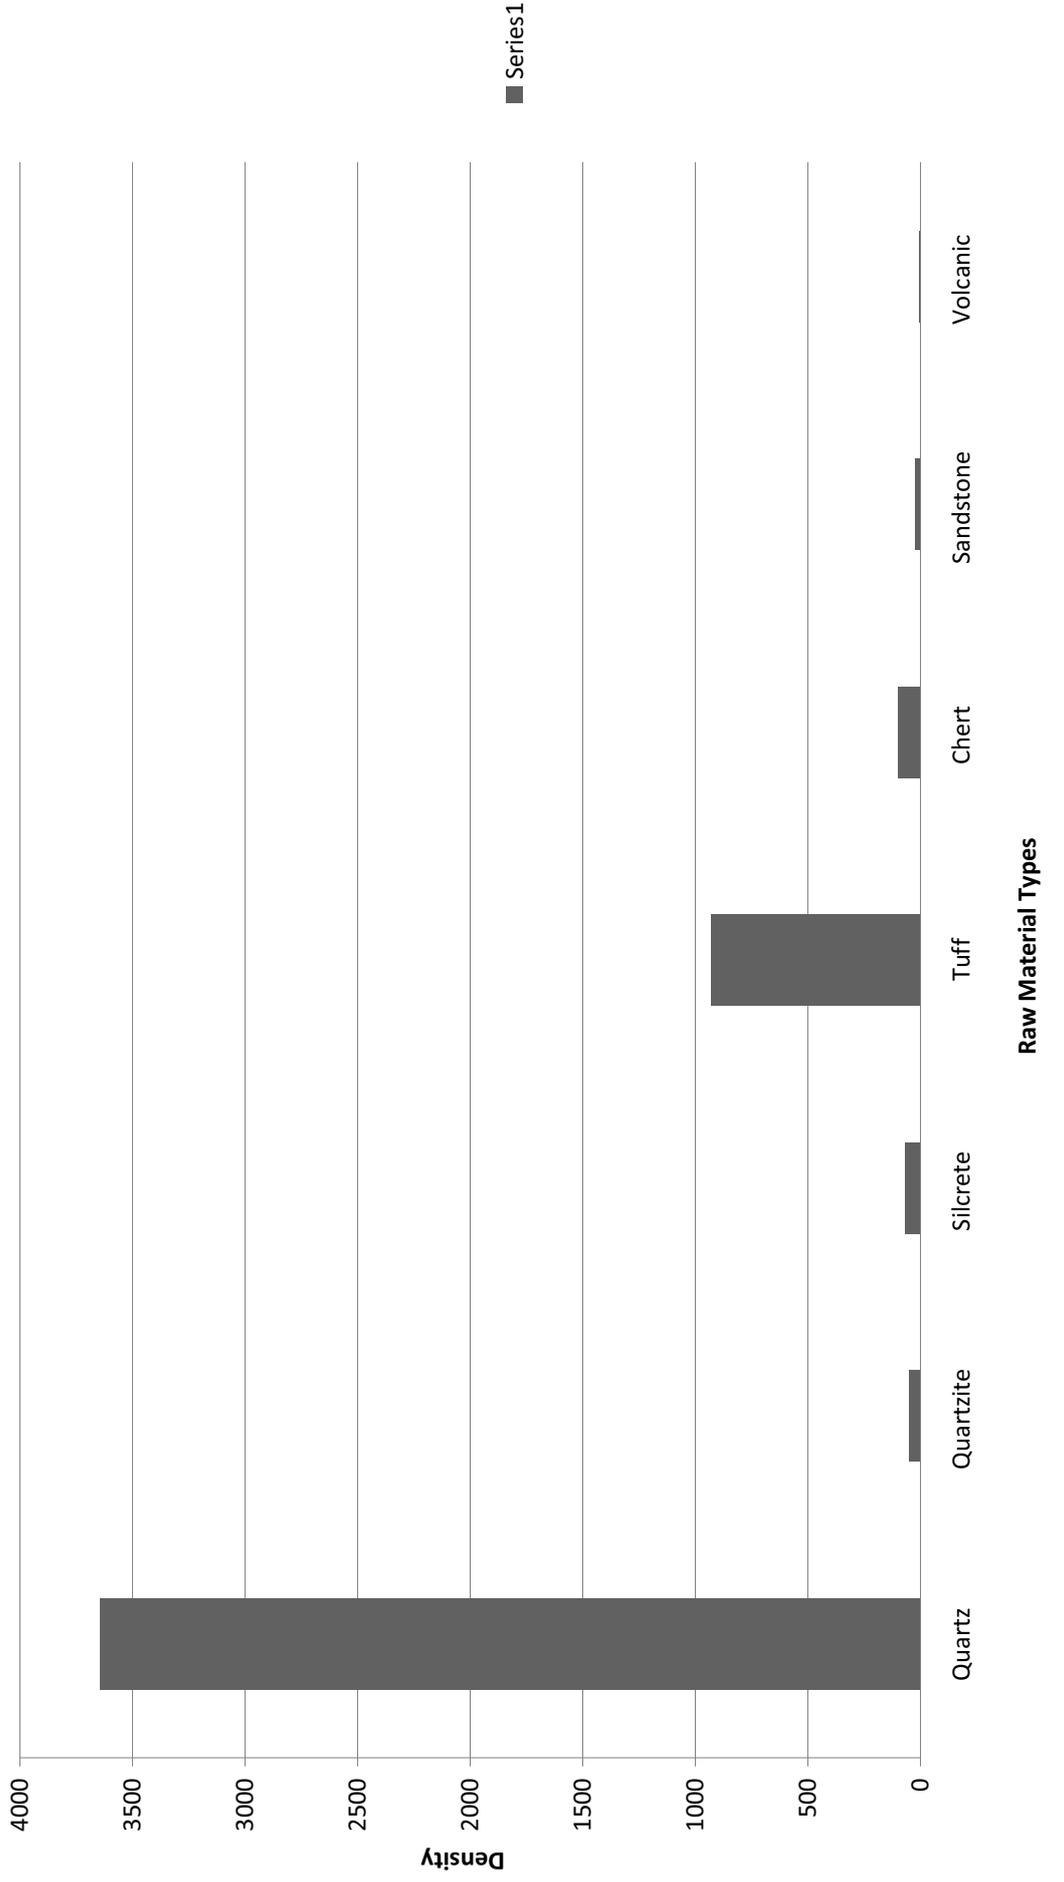
Figure 15: Raw Material Types MCP Stage 2 N=4825

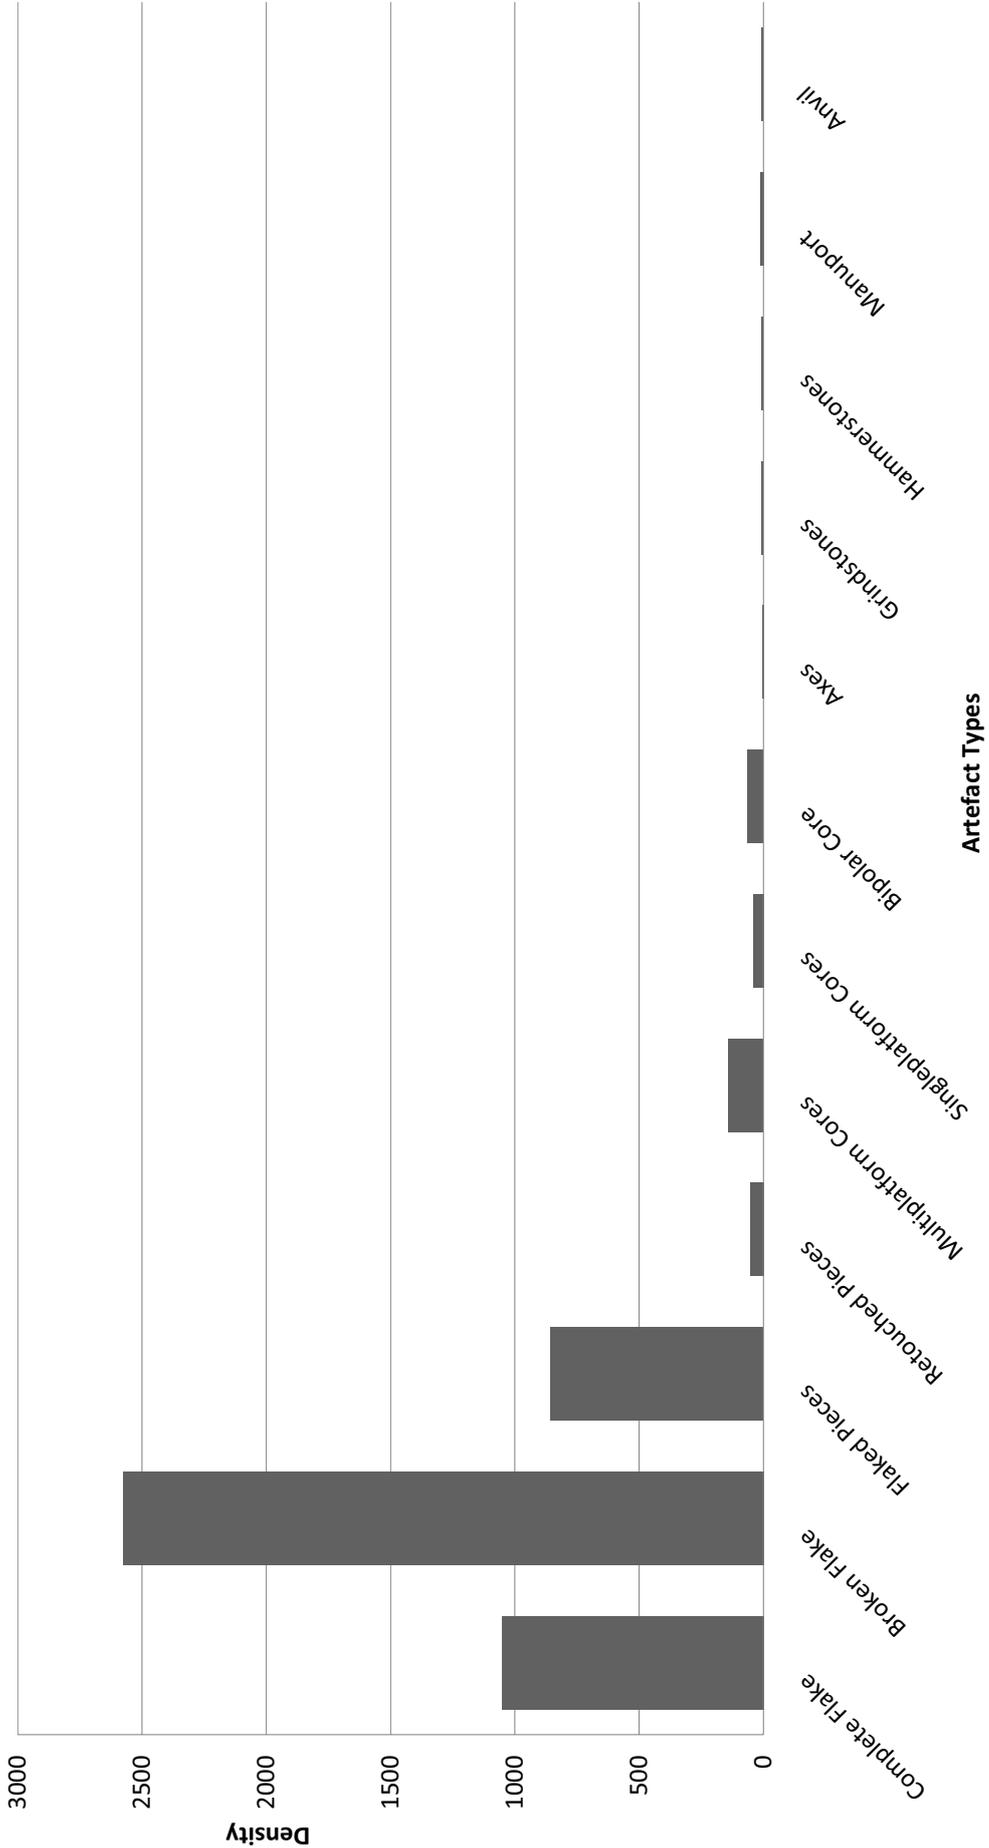
Figure 16: Artefact Types recorded in MCP Stage 2 N=4825

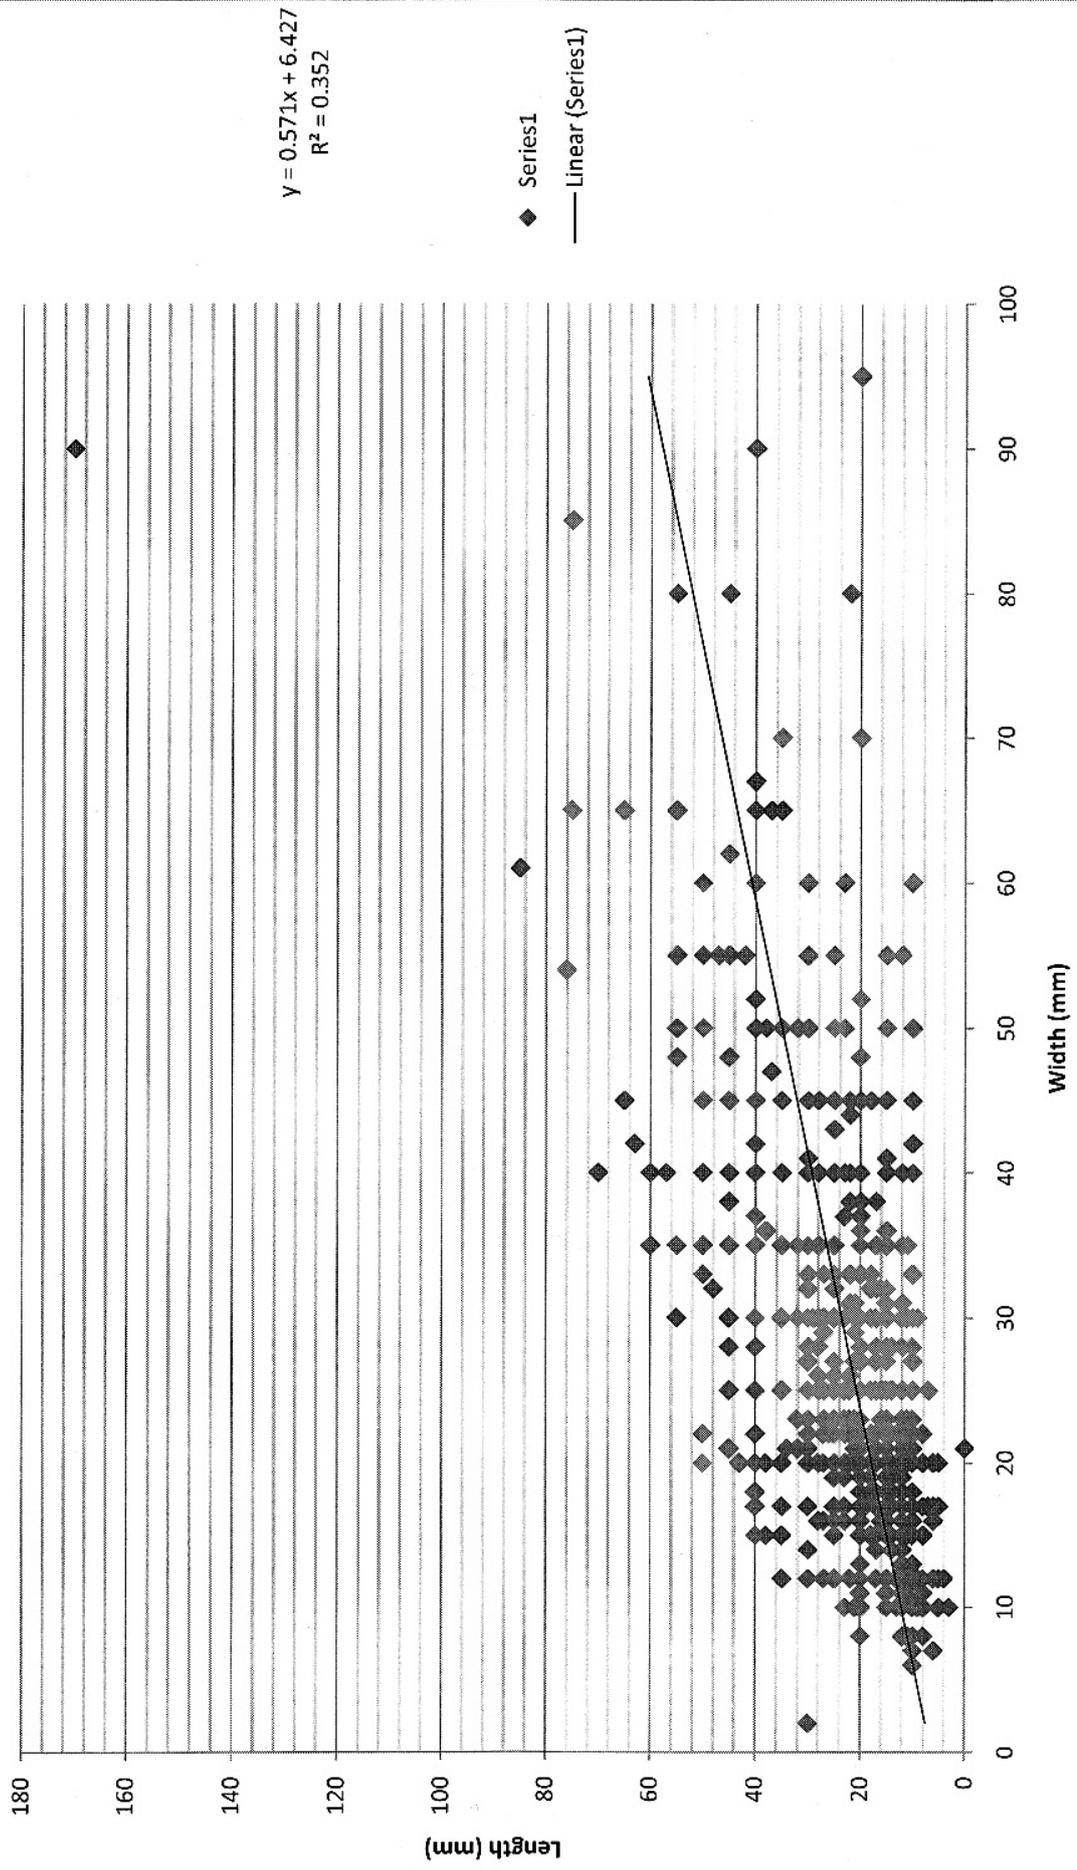
Figure 17: Size Distribution of Complete Flakes recorded for MCP Stage 2
N=1095

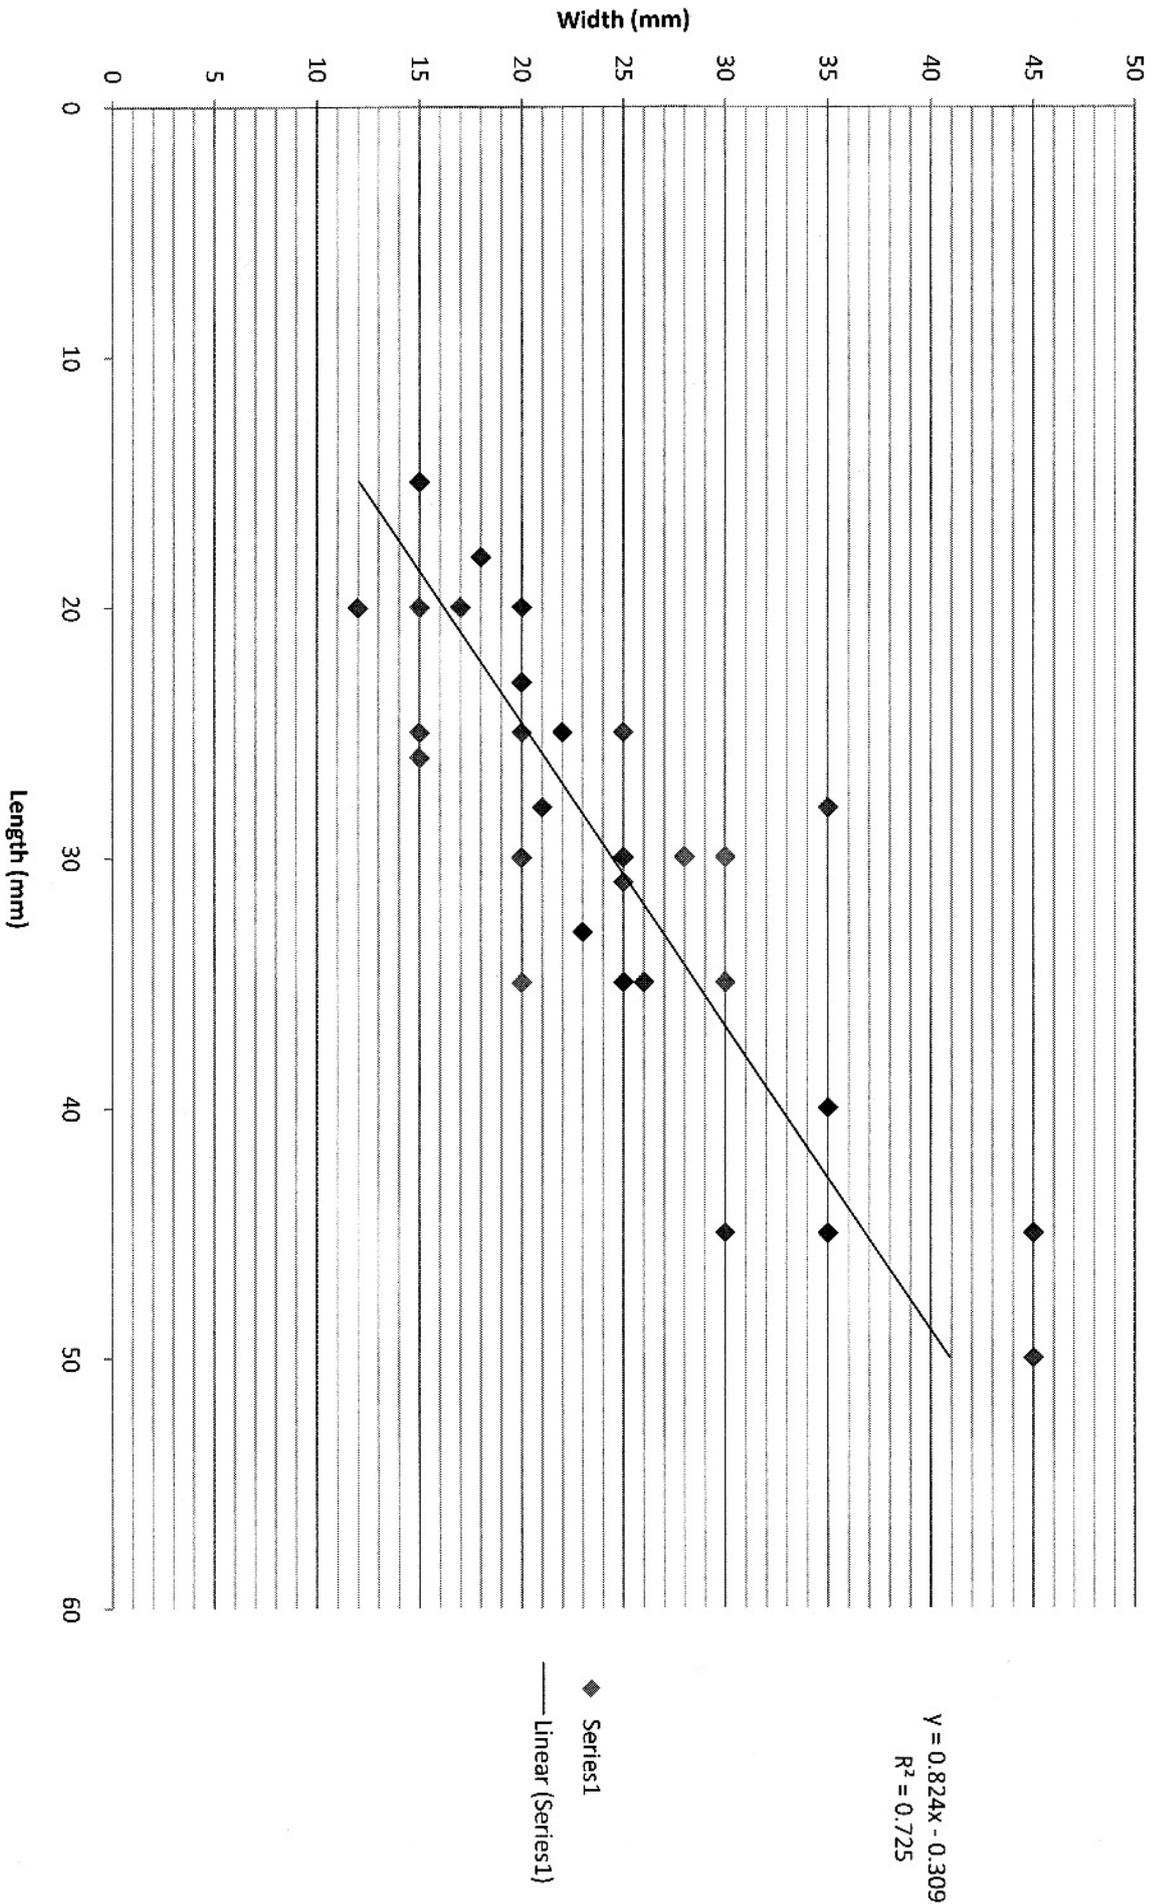
Figure 18: Bipolar Cores Size Distribution N=62 (all quartz)

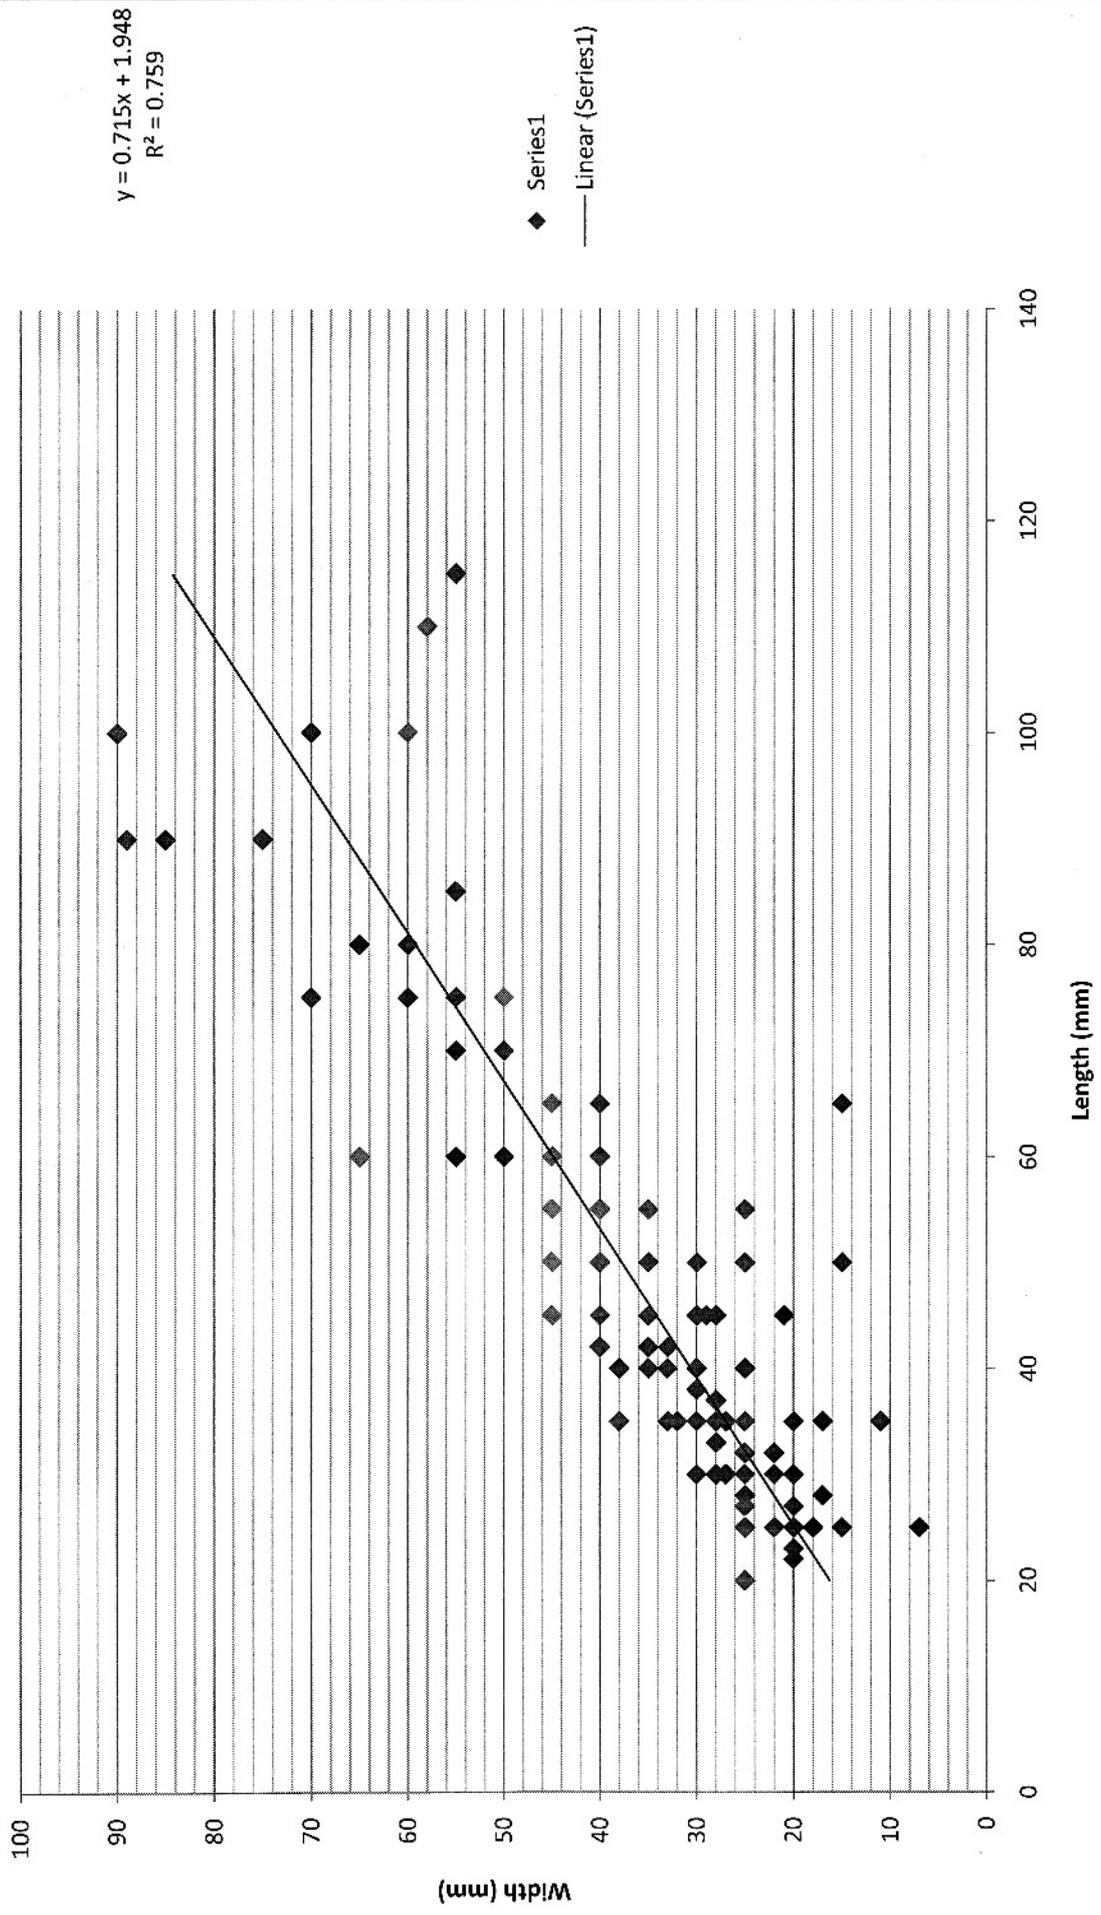
Figure 19: SP & MP Cores Size Distribution MCP Stage 2 N=179 (all raw materials)

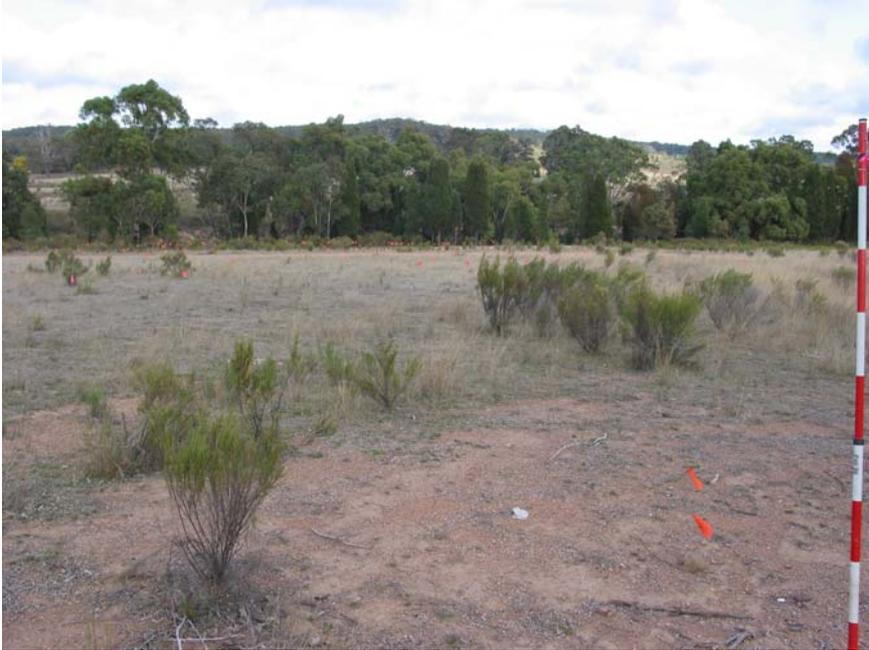
Plate 1: Artefact Scatter Site: S2 MC 43 located in ploughed paddocks. Open Cut 4. Red flags represent artefacts.

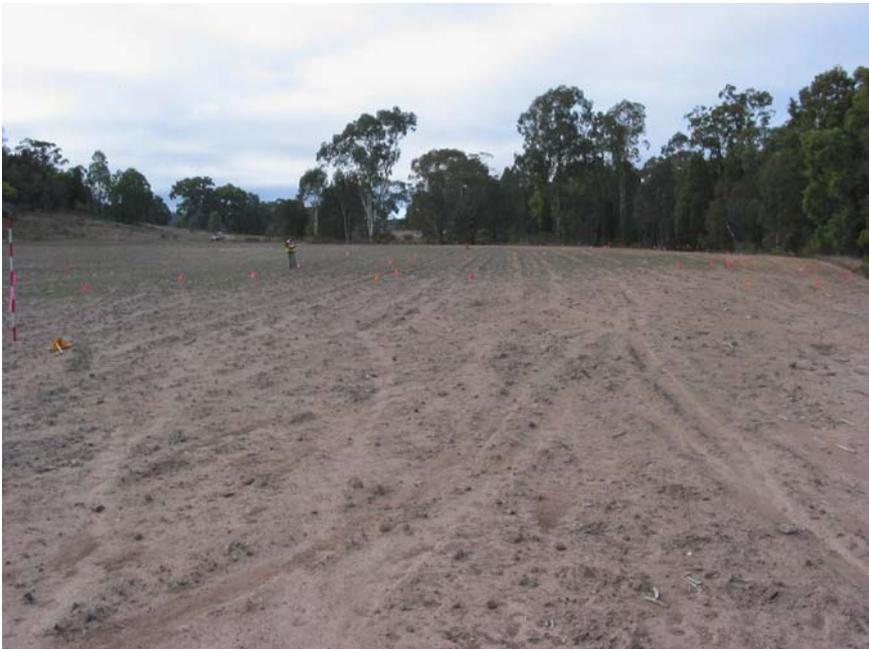
Plate 2: Artefact Scatter Site: S2MC 54 Open Cut 4 area. Red flags represent artefacts.

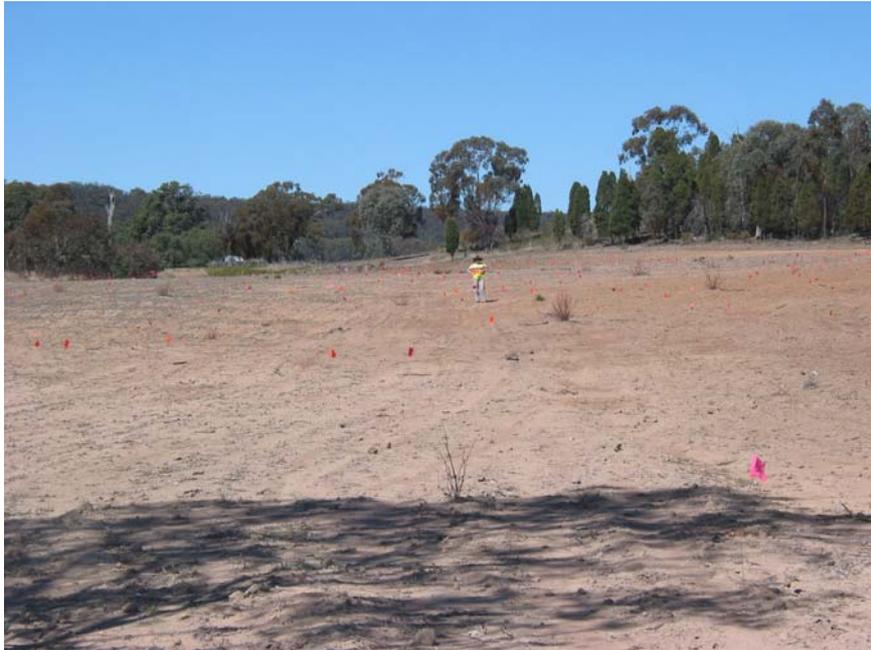
Plate 3: Artefact Scatter Site and PAD: S2 MC64: Murragamba Creek. Red flags represent artefacts.

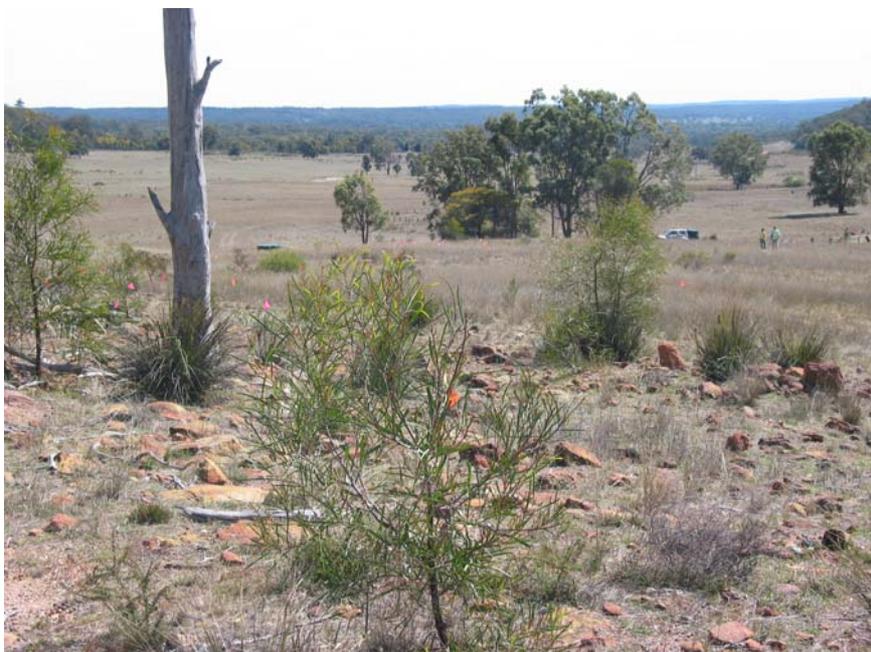
Plate 4: Grinding Groove and Artefacts Scatter Site: S2MC 151 within Ridge Crest Creek drainage. Powers Conservation Area. Red flags represent artefacts.

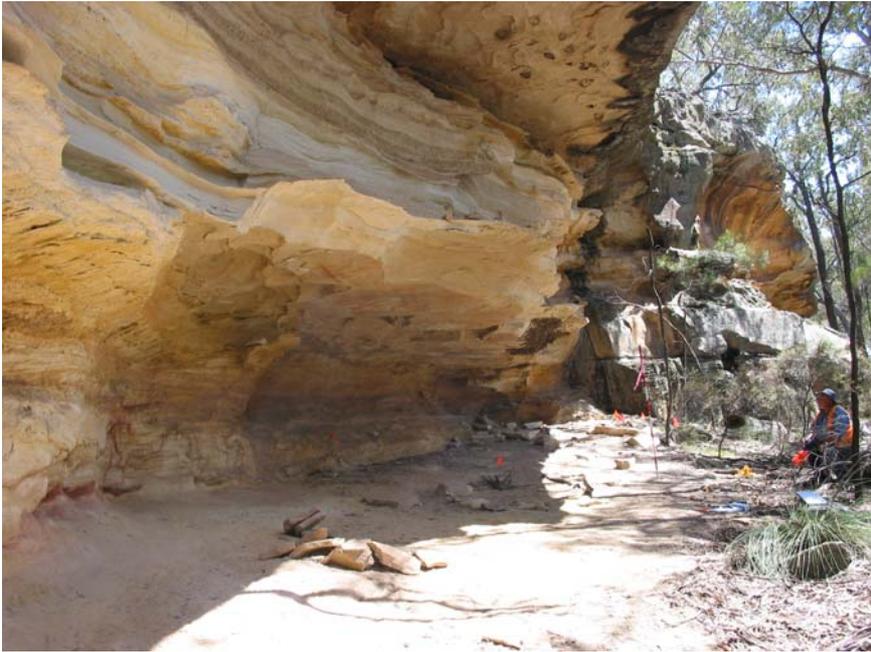
Plate 5: Rock-shelter Site S2MC 236 (36-3-0134) Underground No 2. Red flags represent surface artefacts.

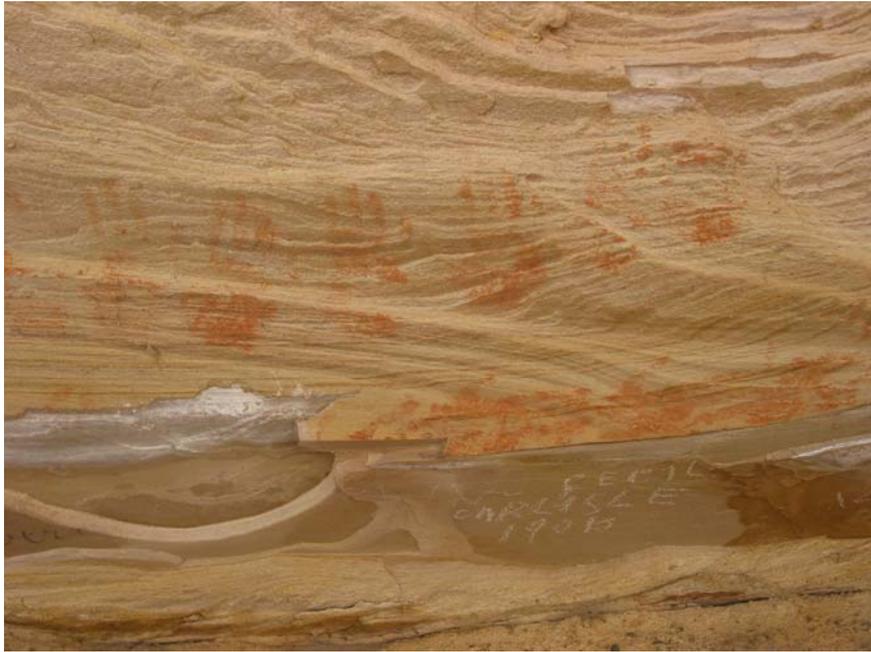
Plate 7: Rock-shelter Site S2 MC 236(36-3-0134): Area. Red hand stencils with European graffiti overlain.

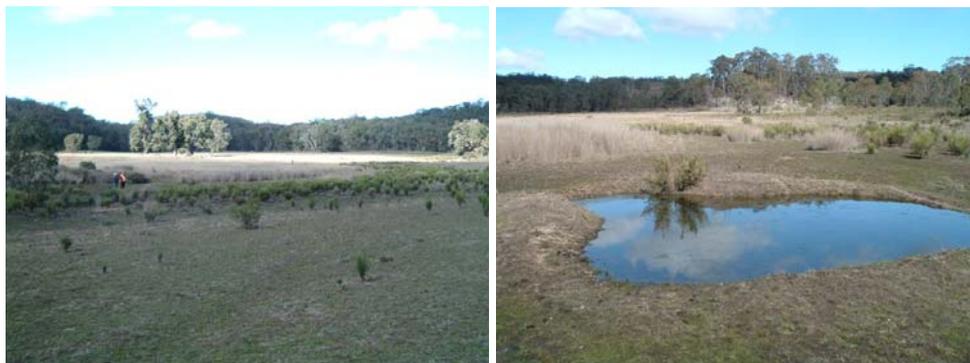
Figures 1 and 2. Left: valley floor near the head of Murragamba Creek. No defined channel is present and a pool located near the figure has been excavated on a spring. Right: the pool and spring.

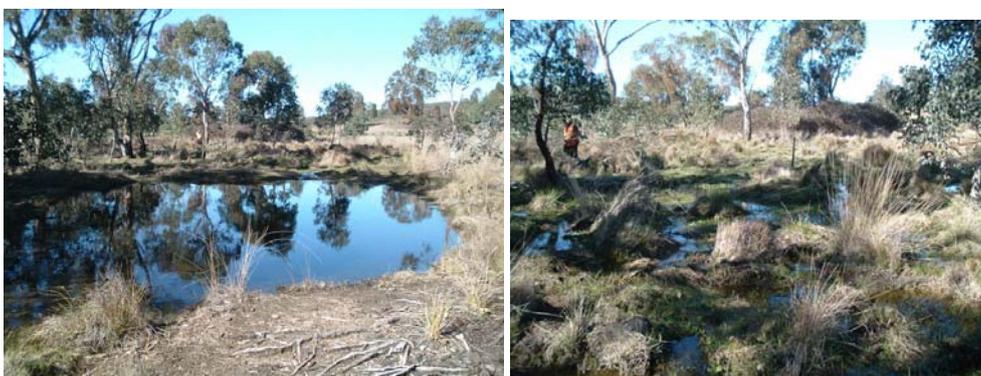
Figures 3 and 4. 'Chain of ponds' feature located in the mid-section of Murragamba Creek.
