**Yancoal**  
**Mount Thorley Warkworth Operations**  
**Community Consultative Committee Meeting**  
**Monday 14 May 2018**

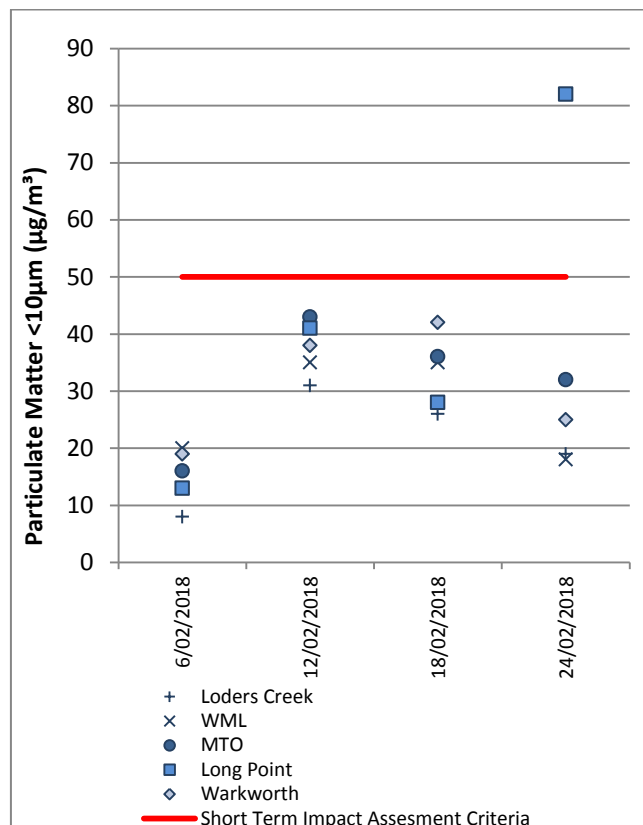
Figure 5 shows the individual PM<sub>10</sub> results at each monitoring station against the short term impact assessment criteria of 50µg/m<sup>3</sup>.

On 24/02/2018 the Long Point HVAS PM<sub>10</sub> unit recorded a result of 82µg/m<sup>3</sup>, which is greater than the short term (24hr) PM<sub>10</sub> impact assessment criteria.

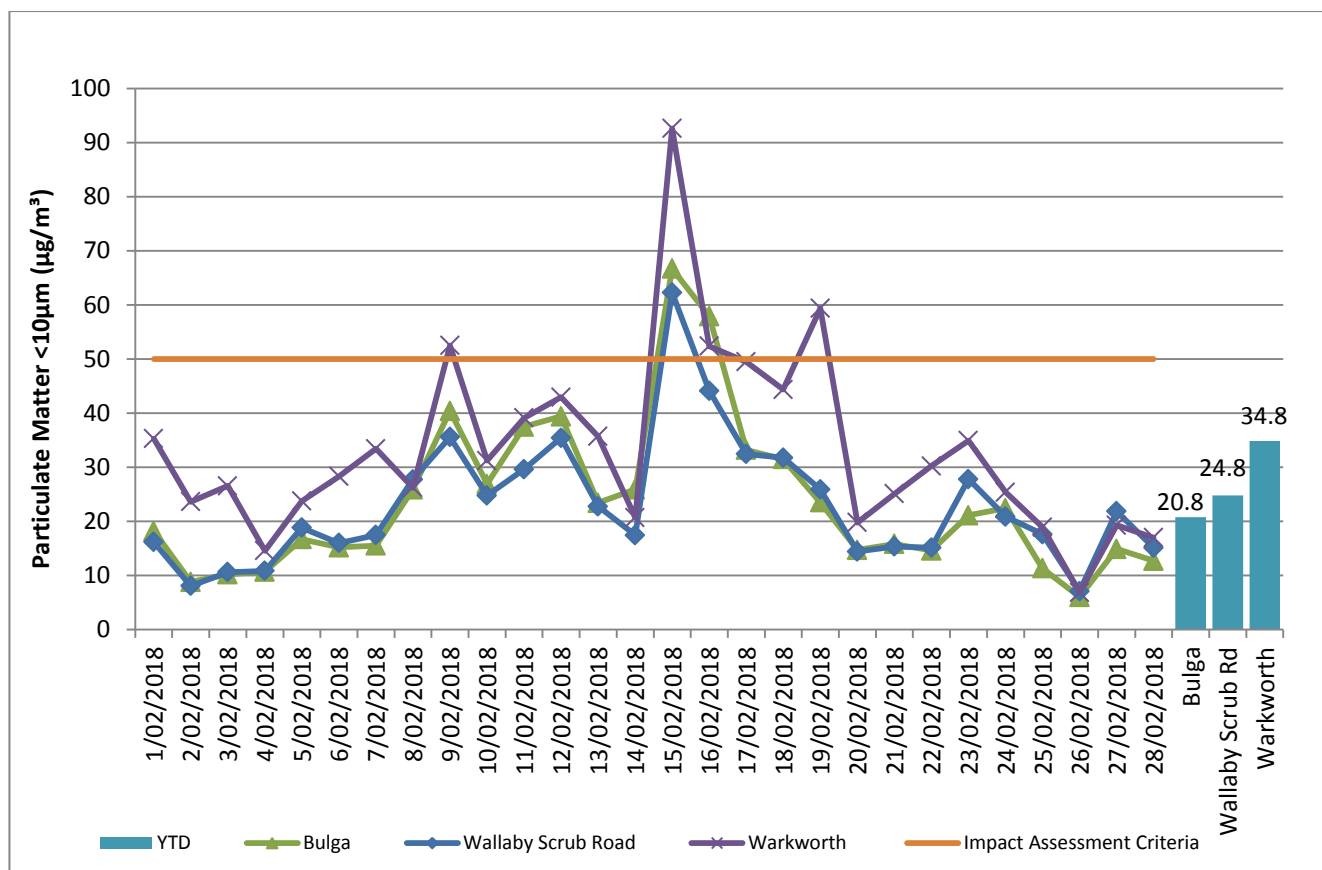
Figure 8: Real Time PM<sub>10</sub> daily 24hr average and annual average – February 2018

During February, the real time monitoring system generated 196 automated air quality related alerts, including 6 alerts for adverse meteorological conditions and 190 alerts for elevated PM<sub>10</sub> levels.

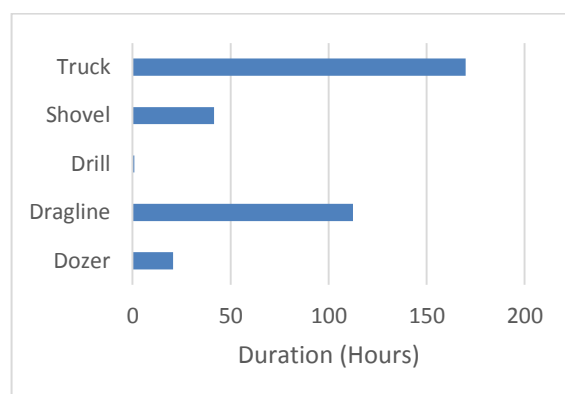
**Figure 17: Operational Downtime by Equipment Type – February 2018**

During February, a total of 346 hours of equipment downtime was logged in response to environmental events such as dust, noise and adverse meteorological conditions. Operational downtime by equipment type is shown in Figure 17.

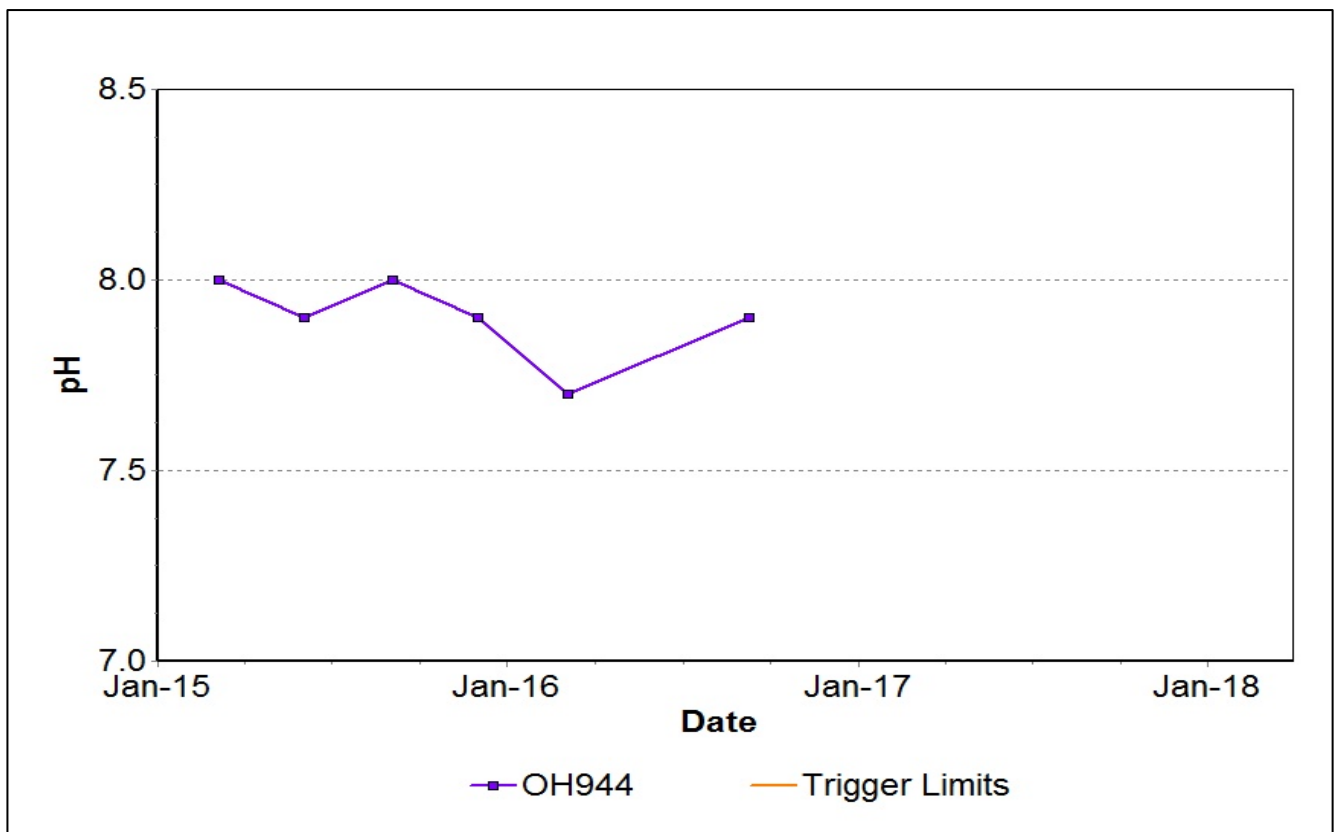
Figure 57: Hunter River Alluvium 5 Seam pH Trend – March 2018

*Note: There has been insufficient water to sample since September 2016.*
