Monthly Environmental Monitoring Report

Yancoal Mount Thorley Warkworth

December 2024

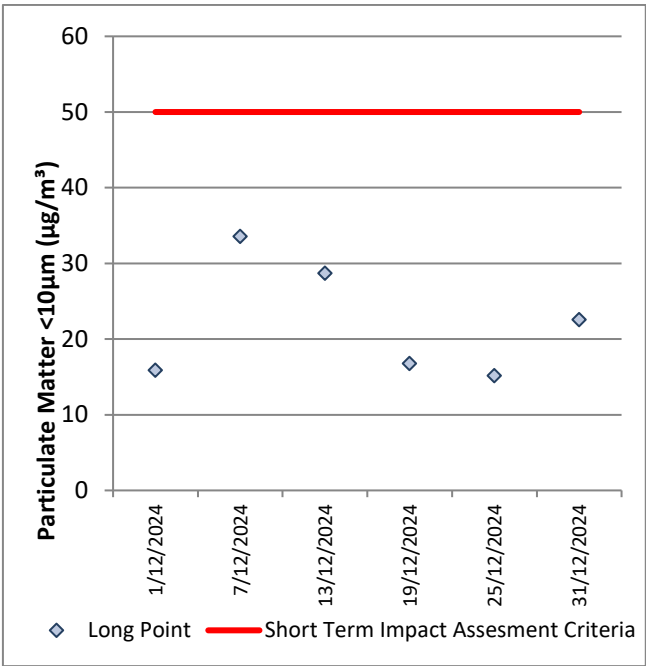
Figure 5: Individual PM10 Results – December 2024

Figure 5 shows the individual PM₁₀ results at each monitoring station against the short-term impact assessment criteria of 50µg/m³.

There were no exceedances of the short term (24hr) PM10 impact assessment criteria during December 2024.
