# Monthly Environmental Monitoring Report

Yancoal Mount Thorley Warkworth

December 2025

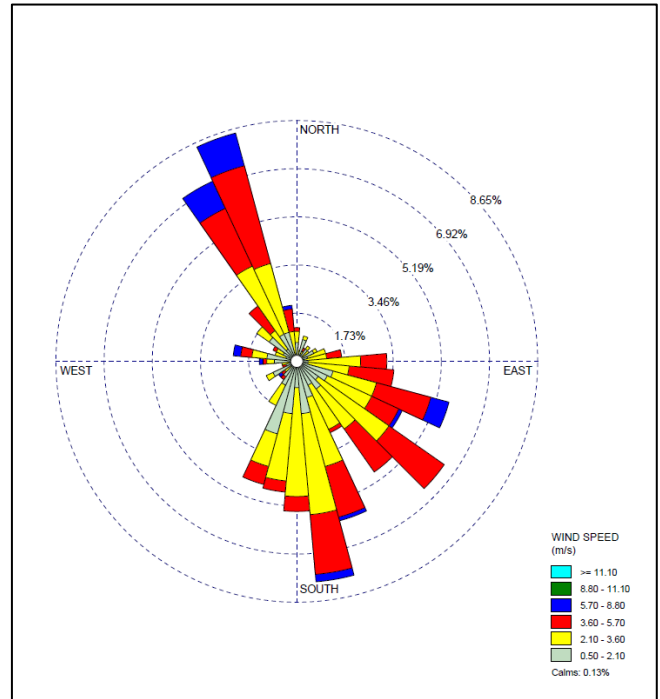
**Figure 2: Charlton Ridge Wind Rose – December 2025**

Winds from the Southeast and Northwest were dominant during the reporting period as shown in **Figure 2**.

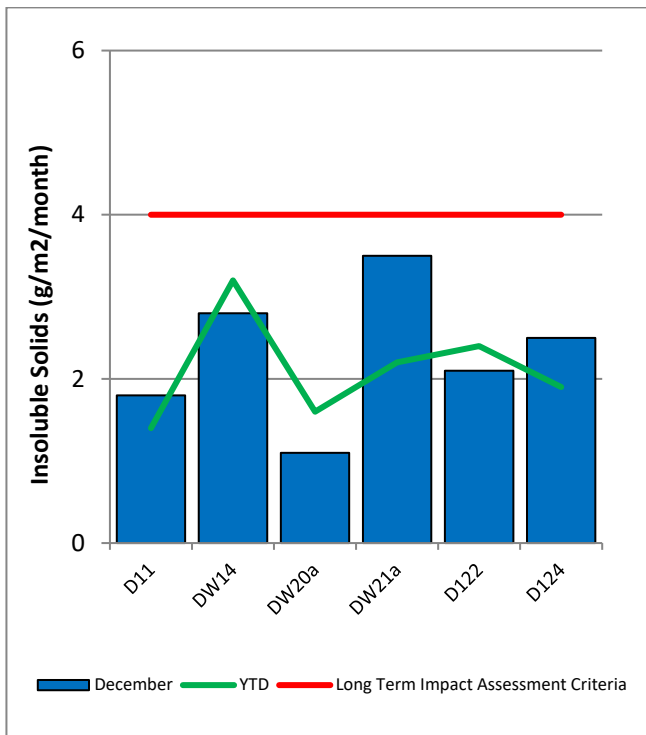
**Figure 4: Depositional Dust – December 2025**

**Figure 4** displays insoluble solids results from depositional dust gauges during the reporting period compared against the year-to-date average and the annual impact assessment criteria.

An annual assessment of MTW’s compliance with the Long-Term Impact Assessment Criteria will be provided in the 2025 Annual Review Report.

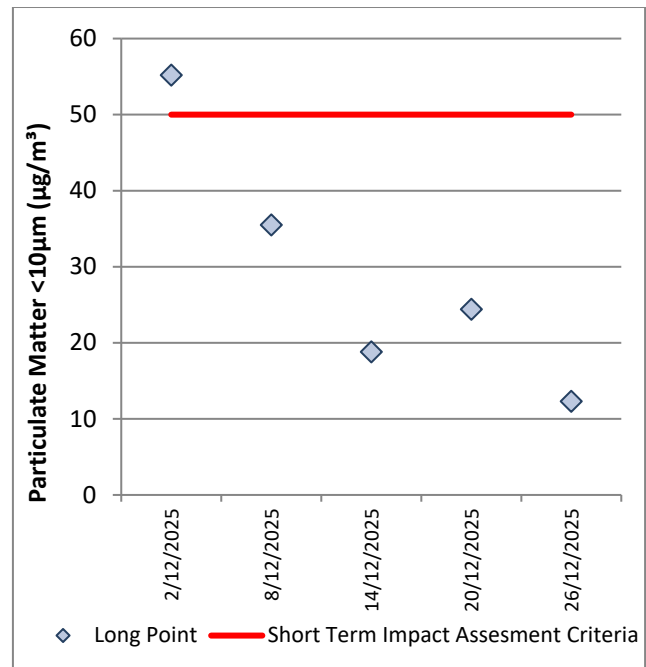
**Figure 5: Individual PM<sub>10</sub> Results – December 2025**

**Figure 5** shows the individual PM<sub>10</sub> results at each monitoring station against the short-term impact assessment criteria of 50µg/m<sup>3</sup>.

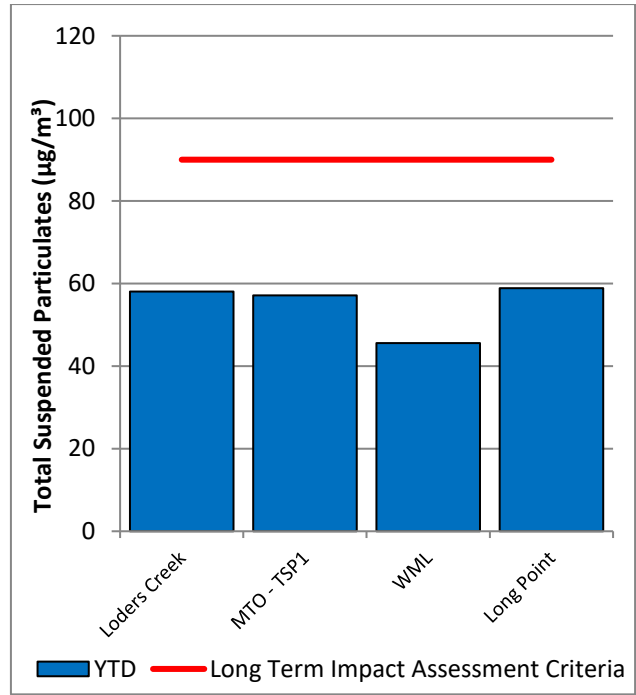
Figure 7: Annual Average Total Suspended Particulates – December 2025

Figure 7 shows the annual average TSP results compared against the long-term impact assessment criteria of 90µg/m<sup>3</sup>.

An assessment of MTW’s compliance with the Long-Term Impact Assessment Criteria will be provided in the 2025 Annual Review Report.

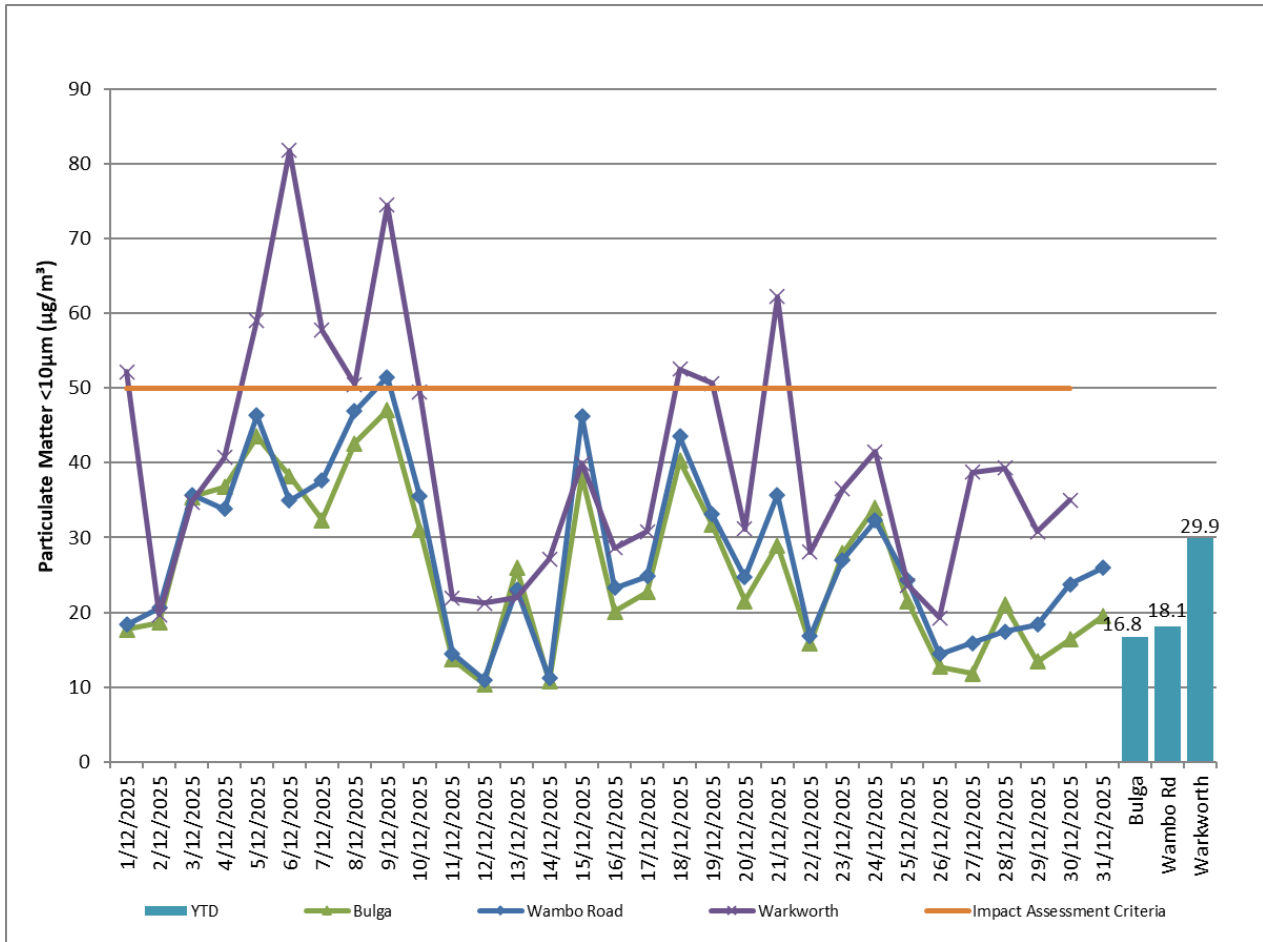
Figure 8: Real Time PM<sub>10</sub> daily 24hr average (line graphs) and YTD annual average (column graphs) – December 2025

Results for real time dust sampling are shown in Figure 8, including the daily 24-hour average PM<sub>10</sub> result and the annual PM<sub>10</sub> average.

On 1 December 2025, the Warkworth TEOM (59.4 ug/m3) exceeded its short-term (24hr) criteria. The measurement was assessed for MTW’s potential contribution based on meteorological conditions and background PM<sub>10</sub> levels on the day resulting in a maximum estimated contribution of 0.1 ug/m3. Accordingly, no further action is required (as per the approved Air Quality Monitoring Programme).

On 5 December 2025, the Warkworth TEOM (59.1 ug/m3) exceeded its short-term (24hr) criteria. The measurement was assessed for MTW’s potential contribution based on meteorological conditions and background PM<sub>10</sub> levels on the day resulting in a maximum estimated contribution of 4.8 ug/m3. Accordingly, no further action is required (as per the approved Air Quality Monitoring Programme).

On 6 December 2025, the Warkworth TEOM (91.3 ug/m<sup>3</sup>) exceeded its short-term (24hr) criteria. The measurement was assessed for MTW's potential contribution based on meteorological conditions and background PM<sub>10</sub> levels on the day resulting in a maximum estimated contribution of 9.7 ug/m<sup>3</sup>. Accordingly, no further action is required (as per the approved Air Quality Monitoring Programme).

On 7 December 2025, the Warkworth TEOM (57.7 ug/m<sup>3</sup>) exceeded its short-term (24hr) criteria. The measurement was assessed for MTW's potential contribution based on meteorological conditions and background PM<sub>10</sub> levels on the day resulting in a maximum estimated contribution of 16.0 ug/m<sup>3</sup>. Accordingly, no further action is required (as per the approved Air Quality Monitoring Programme).

On 9 December 2025, the Wambo TEOM (51.5 ug/m<sup>3</sup>) exceeded its short-term (24hr) criteria. The measurement was assessed for MTW's potential contribution based on meteorological conditions and background PM<sub>10</sub> levels on the day resulting in a maximum estimated contribution of 17.7 ug/m<sup>3</sup>. Accordingly, no further action is required (as per the approved Air Quality Monitoring Programme).

On 9 December 2025, the Warkworth TEOM (74.5 ug/m<sup>3</sup>) exceeded its short-term (24hr) criteria. The measurement was assessed for MTW's potential contribution based on

meteorological conditions and background PM<sub>10</sub> levels on the day resulting in a maximum estimated contribution of 25.9 ug/m<sup>3</sup>. Accordingly, no further action is required (as per the approved Air Quality Monitoring Programme).

On 19 December 2025, the Warkworth TEOM (50.7 ug/m<sup>3</sup>) exceeded its short-term (24hr) criteria. The measurement was assessed for MTW's potential contribution based on meteorological conditions and background PM<sub>10</sub> levels on the day resulting in a maximum estimated contribution of 2.4 ug/m<sup>3</sup>. Accordingly, no further action is required (as per the approved Air Quality Monitoring Programme).

On 21 December 2025, the Warkworth TEOM (62.2 ug/m<sup>3</sup>) exceeded its short-term (24hr) criteria. The measurement was assessed for MTW's potential contribution based on meteorological conditions and background PM<sub>10</sub> levels on the day resulting in a maximum estimated contribution of 10.2 ug/m<sup>3</sup>. Accordingly, no further action is required (as per the approved Air Quality Monitoring Programme).

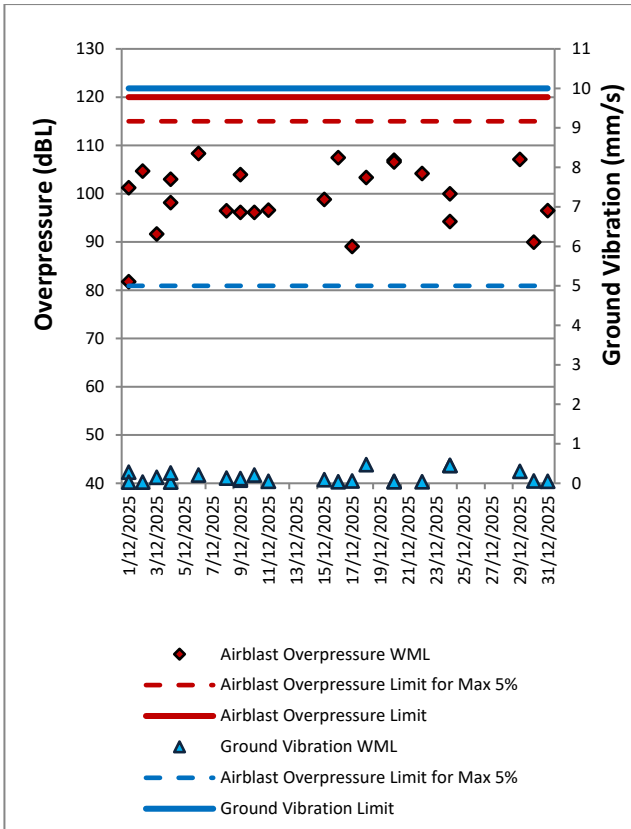
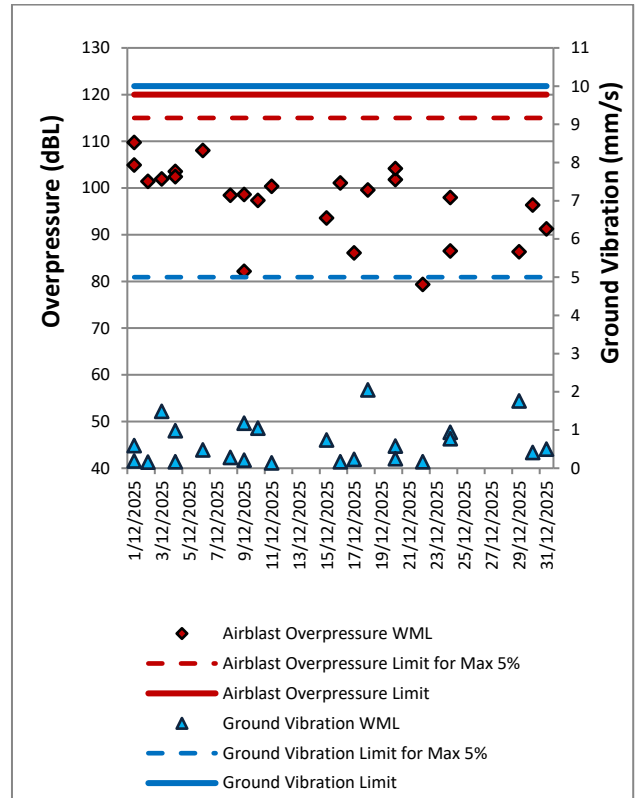
During the reporting period no blasts exceeded the 5mm/s criteria for ground vibration, or the 115dB(L) threshold for airblast overpressure.

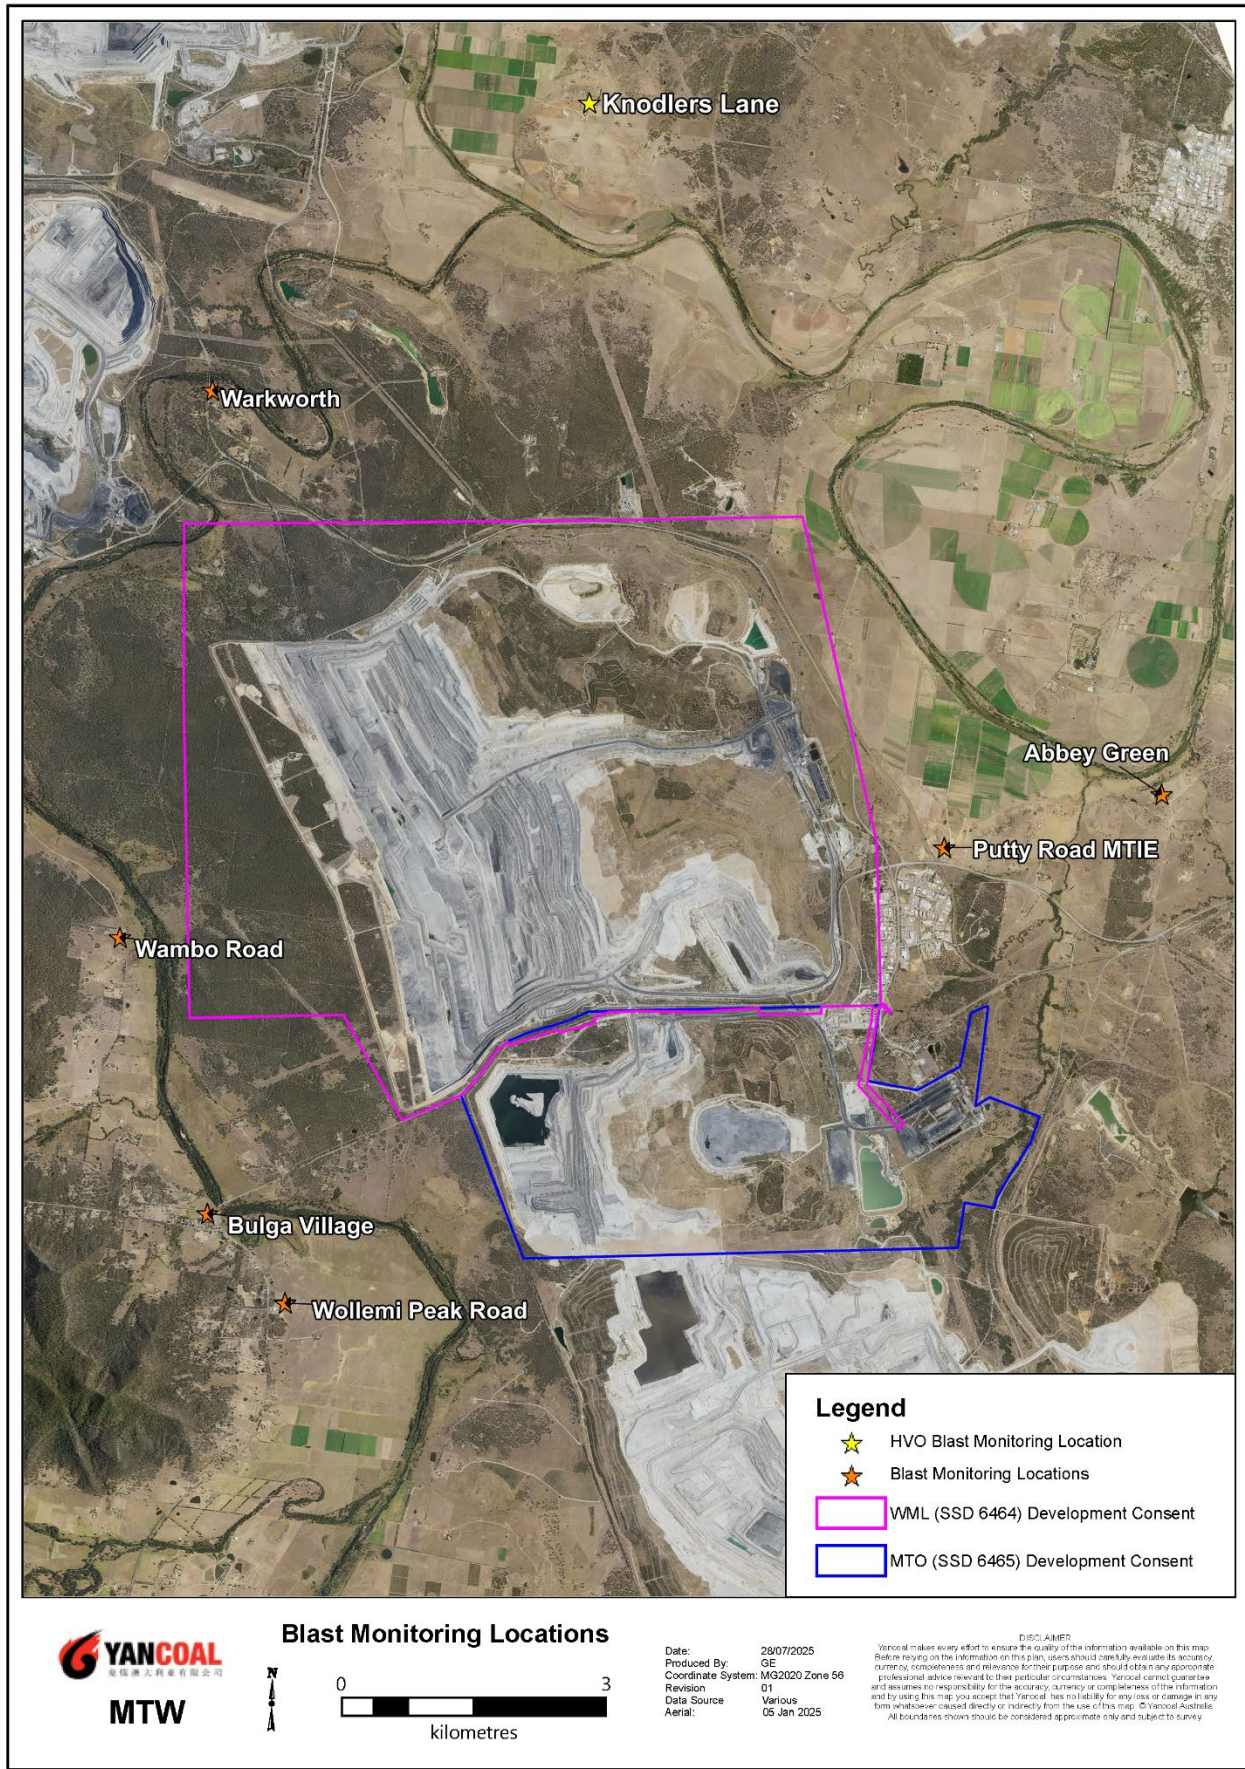
Figure 72: MTW Blast Monitoring Location Plan

The location of these monitors can be found in **Figure 72**.

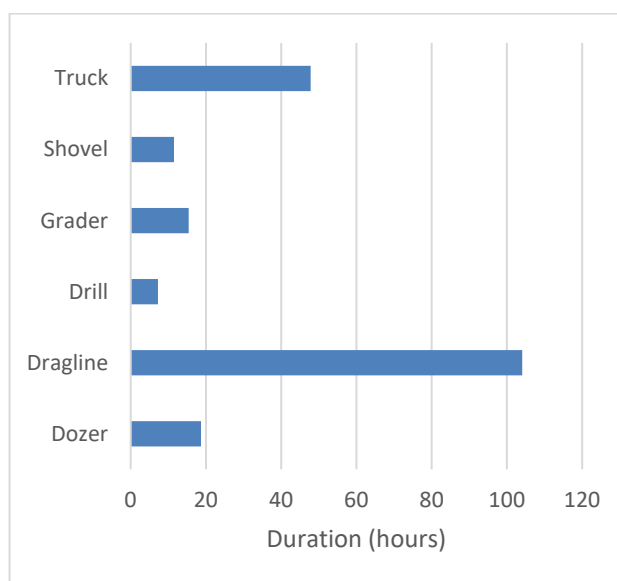
**Figure 74: Operational Downtime by Equipment Type – December 2025**

During December, a total of 205 hours of equipment downtime was logged in response to environmental events such as dust, noise and adverse meteorological conditions. Operational downtime by equipment type is shown in **Figure 74**.
