Mount Thorley Warkworth

2023 Annual Review

Mount Thorley Warkworth (MTW) is an integrated operation of two open cut coal mines, Warkworth Mining Limited (WML) and Mount Thorley Operations (MTO). This Annual Review reports on the environmental performance of MTW for the period 1 January 2023 to 31 December 2023.

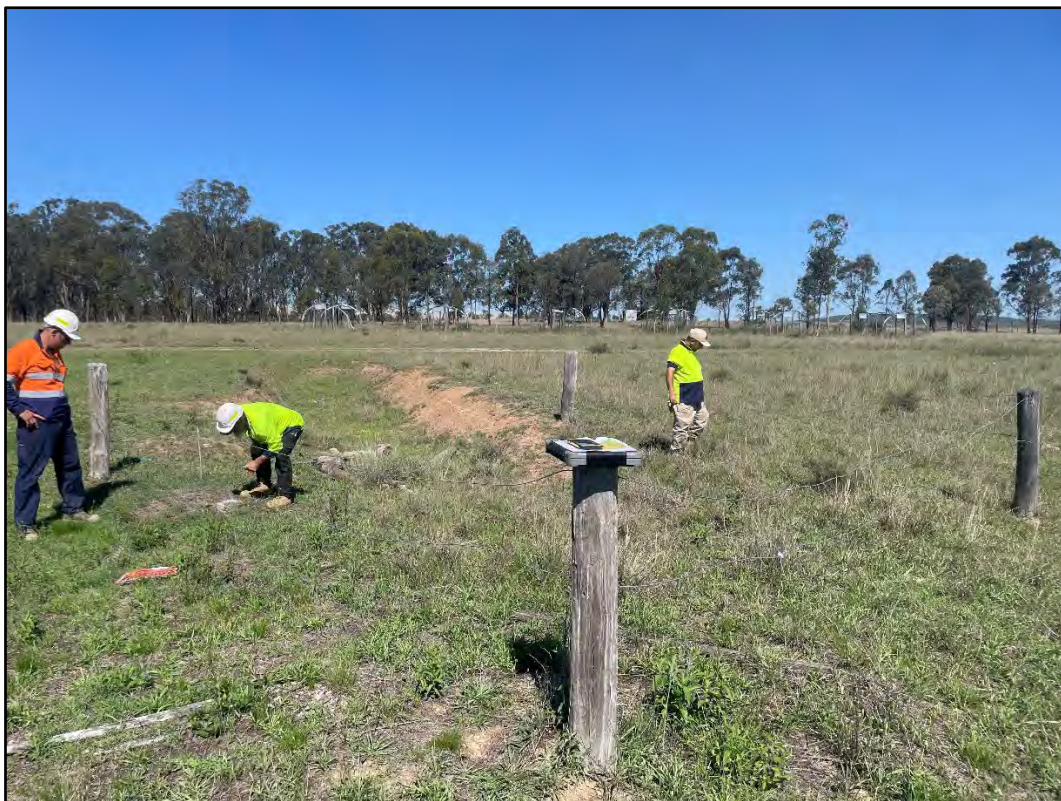
Site: MTW-178

View across previously fenced MTW-178, located over rubbish-filled ditch

Management of rubbish by hand

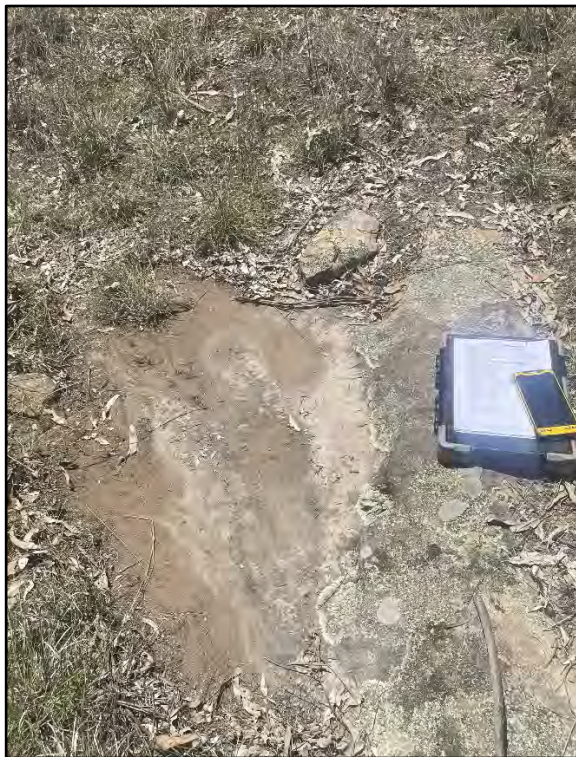
These are grinding grooves sites located within the WBACHCA. MTW-268 is located on the bank of a lagoon channel of Wollombi Brook, while MTW-266, MTW-267 and Site 1 GG is located above the creek bank on a grassy plain. At each site, grooves were located on sandstone boulders after the team cleared away accumulated soil and detritus.

Grooves on sandstone outcrop at MTW-267

It is likely that more grooves are located in the vicinity of the grooves identified during this audit. It is recommended that each site is revisited and the soil/vegetative accumulation carefully removed from the immediate vicinity by hand and with brooms. This will aid in the preservation of the grooves by removing the possibility of moisture retention within the

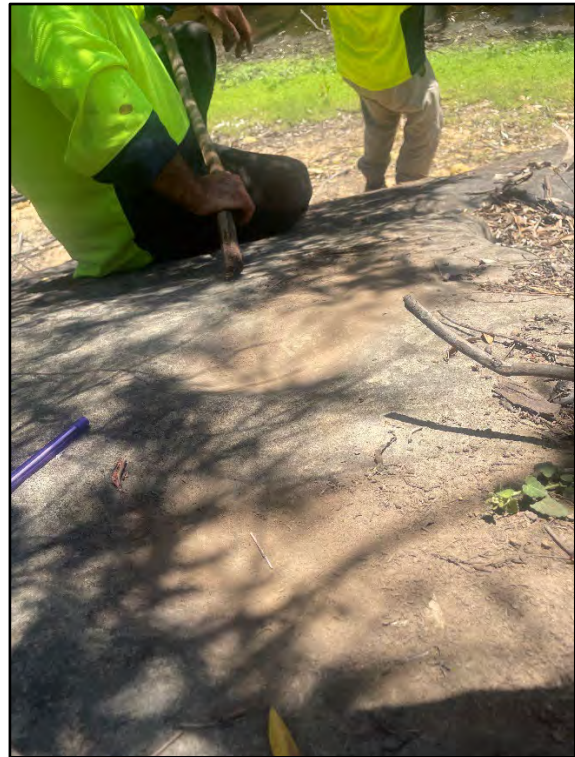
Grooves on sandstone boulder at MTW-268

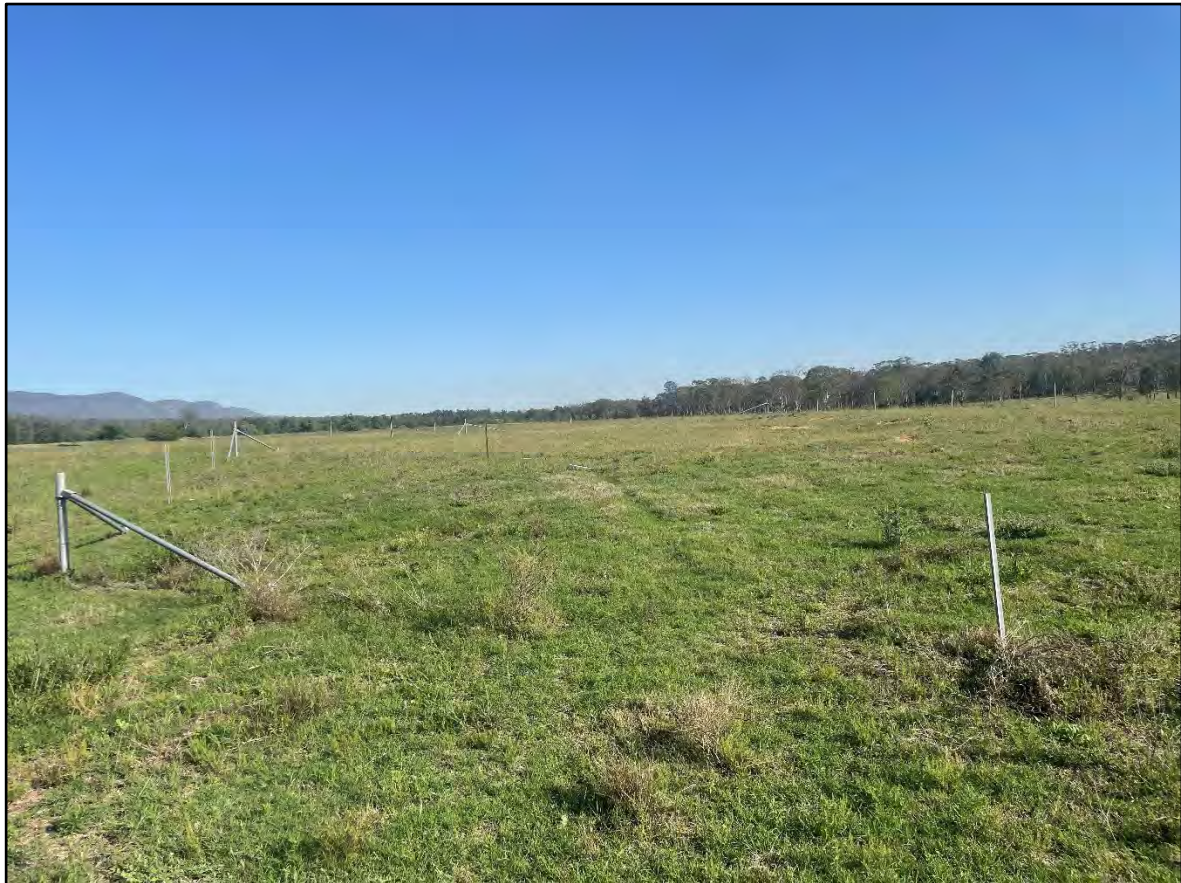
Sites: RPS WB2

This site is located on land bounded by Wollombi Brook, Putty Rd and the WBACHCA. Upon inspection the site was found to have been fenced in the past but as it was not recorded for MTW, its contents are unknown. The site was covered in thick ground cover and no artefacts were located during the inspection. It is recommended that the AHIMS site card be requested in order to add relevant details to the MTW ACH sites database that will better assist relocation attempts during a future audit.

View north across WB2 fenced area

Amend site extents to include new finds

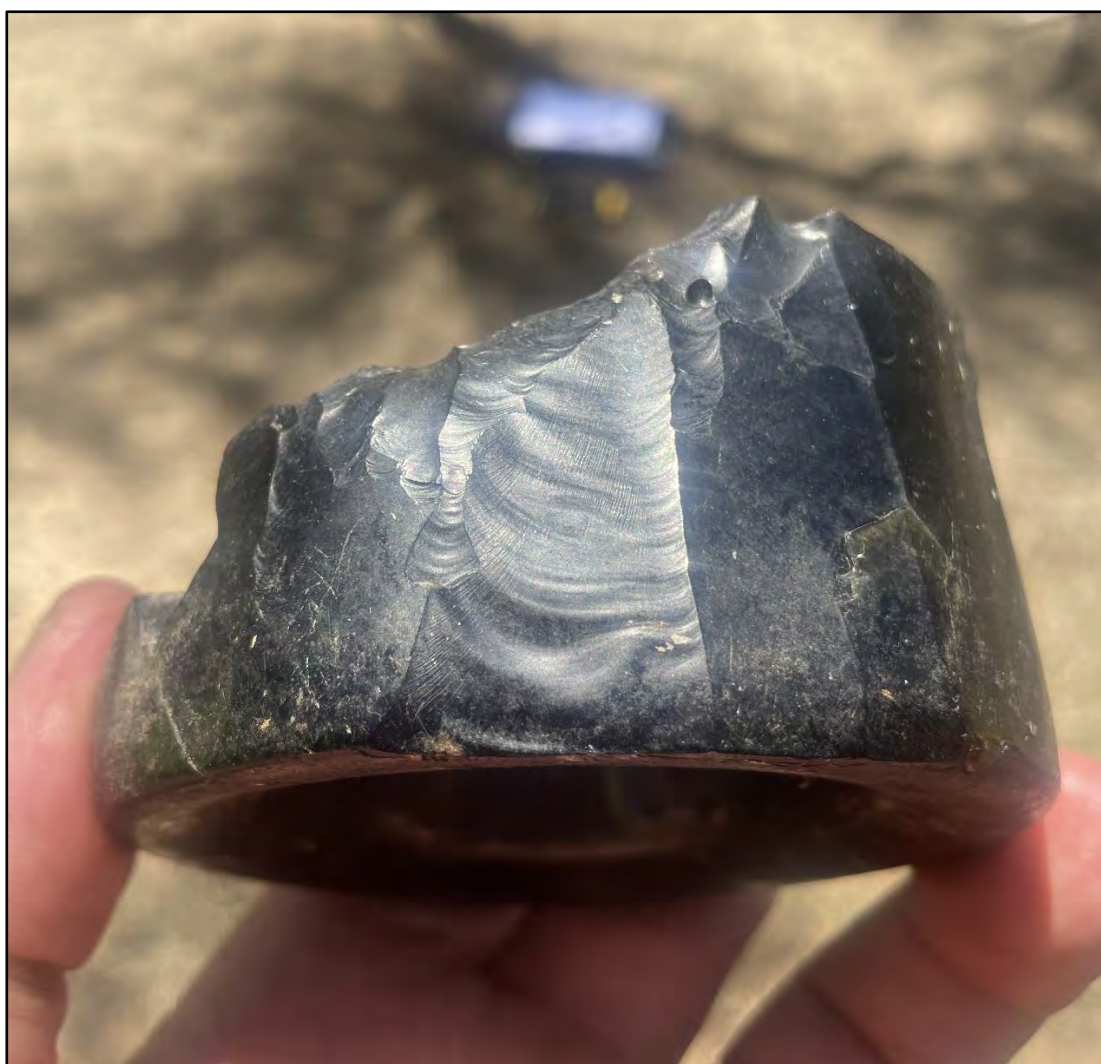
Significant Site Highlight: MTW-19

This site consists of a bottle base that has likely been flaked by humans in the past. The bottle base is a dark green-black colour and very thick. It appears to have been used as a core from which to remove flakes rather than a tool in itself.

MTW-19 bottle base core showing regular longitudinal flake scars

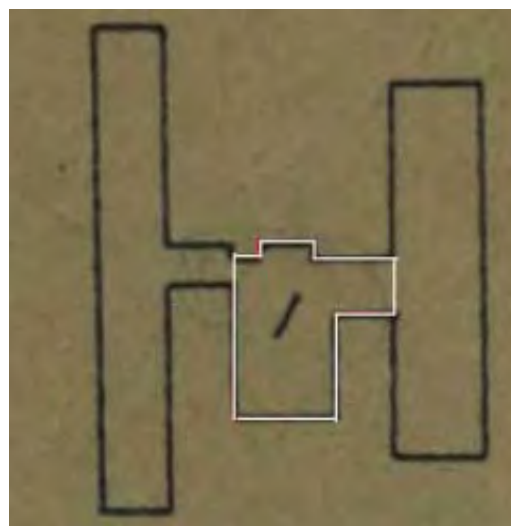
Remaining structure

The building is currently structurally unsound, with a number of timber elements either missing or in a deteriorated state. Corrugated asbestos roof sheeting is also missing in some places, and damaged and in poor condition where it remains. Much of the corrugated iron sheeting

is corroded. Brickwork is also cracking in a number of locations resulting in movement outward, loss of mortar and loss of bricks along the southern and eastern elevations.

As a result, a number of structural recommendations were outlined by ERM in the CMP developed for the site in 2012. These recommendations were not intended to return the building to a serviceable state, rather they sought to do the minimum required to allow safe access to the building to prevent significant damage, and also allow safe access for asbestos removal and internal inspection of the building in the short to medium term.

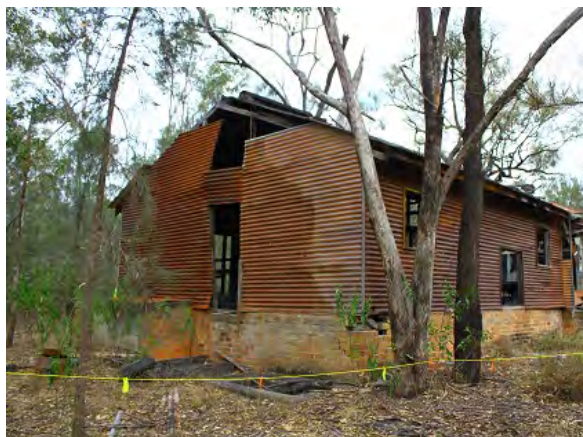
View to mess from south-east (2012)

The remnant building is “L” shaped in plan with brick and concrete footings. During the original assessment conducted by ERM in November 2012 (which informed the CMP) the building was noted as being in poor condition with trees physically impacting on the building fabric, and some minor settlement issues resulting in cracking and failing brickwork. The western section of the building was the most intact part, retaining the original timber frame, corrugated asbestos cement roof sheeting and walls clad with corrugated iron sheeting.

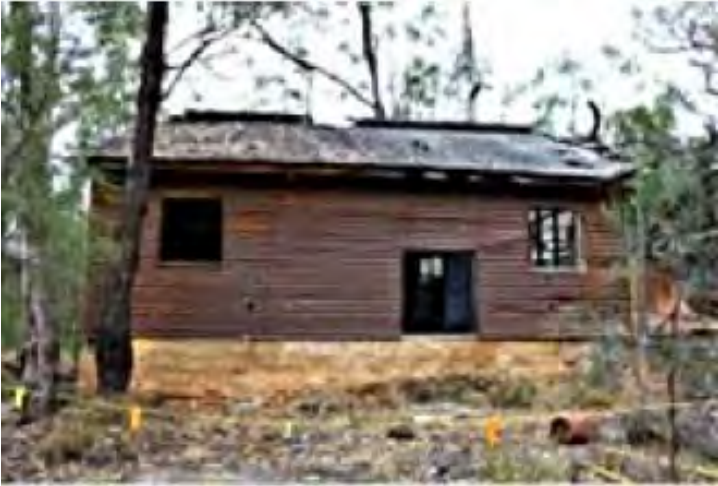
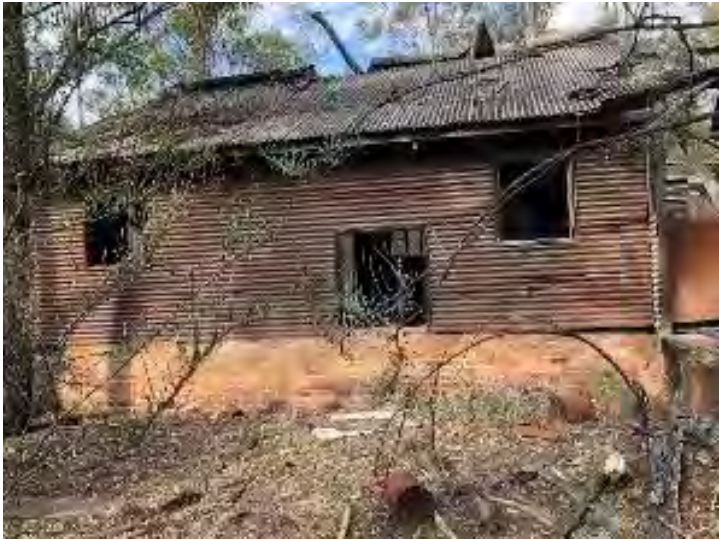
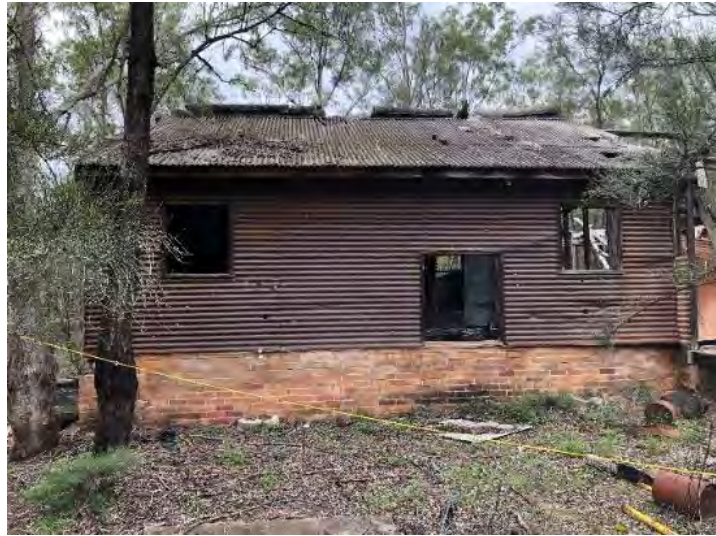
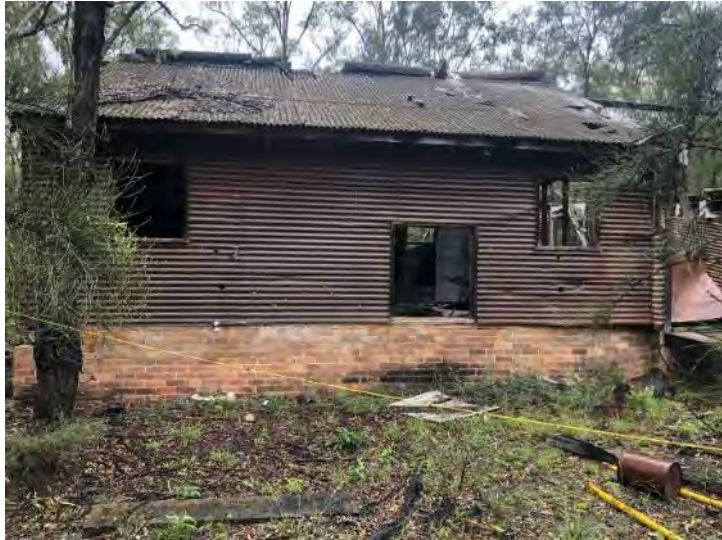
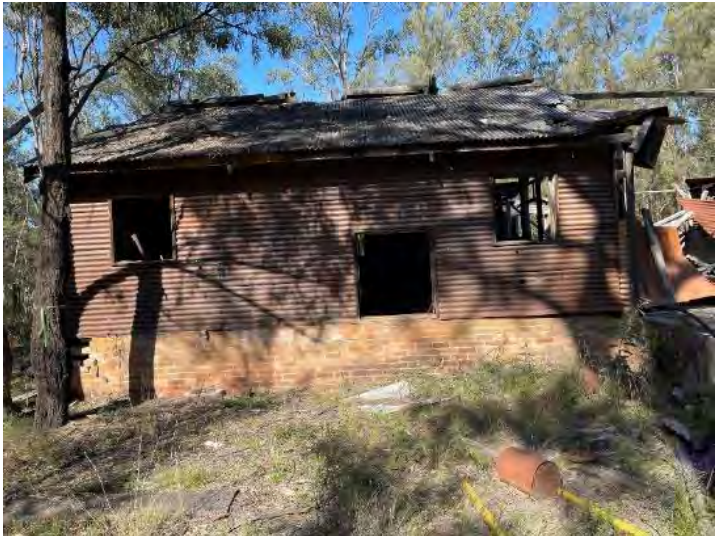
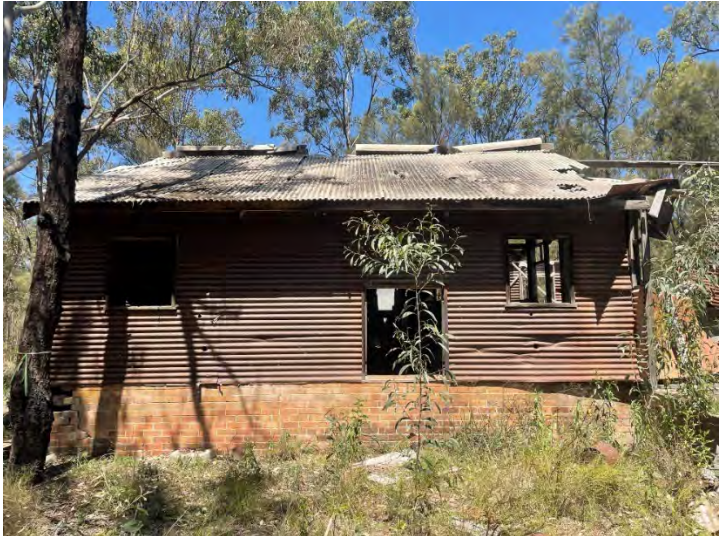
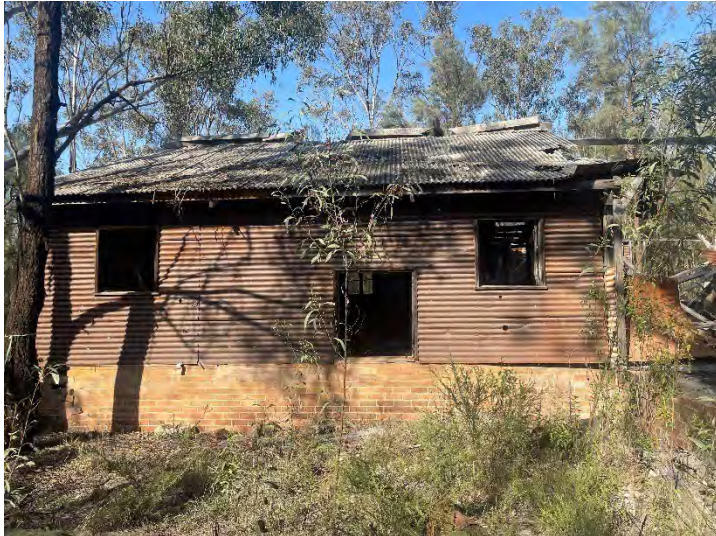
2021	2022	2023	<u>East elevation</u>

<p>2012-18: no discernible change – note fallen branch from tree on western side.</p> <p>2018-20 (Mar): no discernible change – fallen branch has moved.</p> <p>Mar 2020 – Dec 2020: no discernible change.</p> <p>Dec 2020 – 2021: no discernible change.</p> <p>2021-2022: no discernible change.</p> <p>2022-2023: no discernible change.</p>

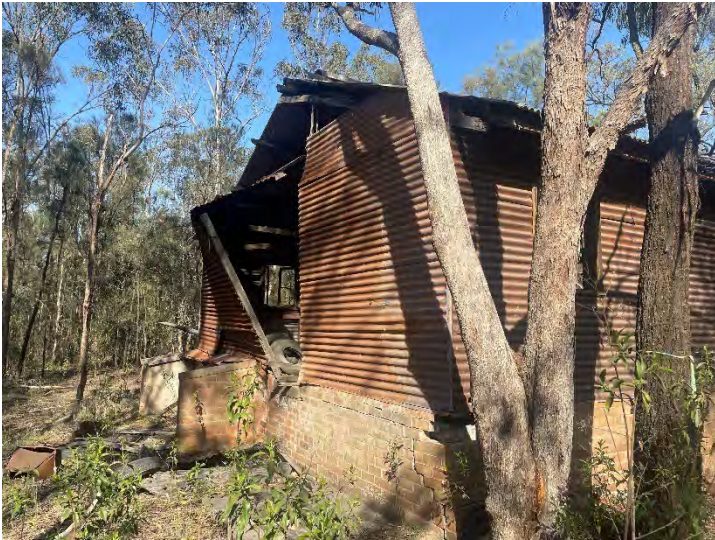
2021	2022	2023	<u>South-east elevation</u>

<p>2012-18: evidence of increased bow to southern wall.</p> <p>2018-20 (Mar): bow in wall appears to have increased.</p> <p>Mar 2020 – Dec 2020: bow in wall continues to increase.</p> <p>Dec 2020 – 2021: gap in bowing has increased.</p> <p>2021-2022: no discernible change.</p> <p>2022-2023: bow in wall continues to increase.</p>

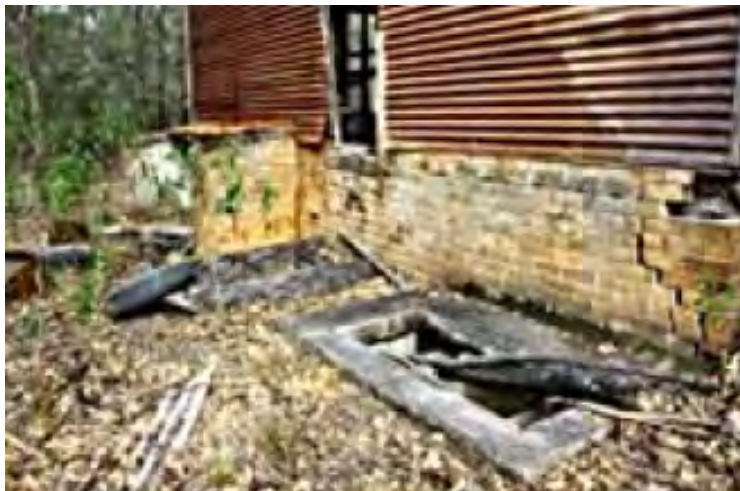
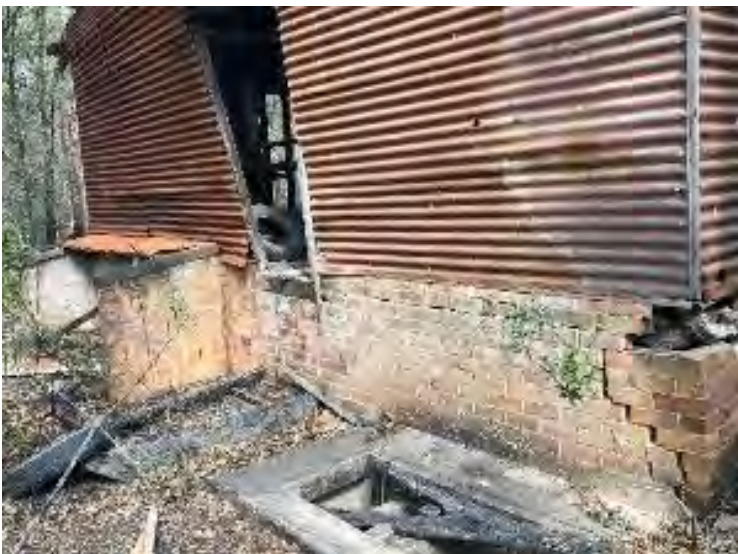
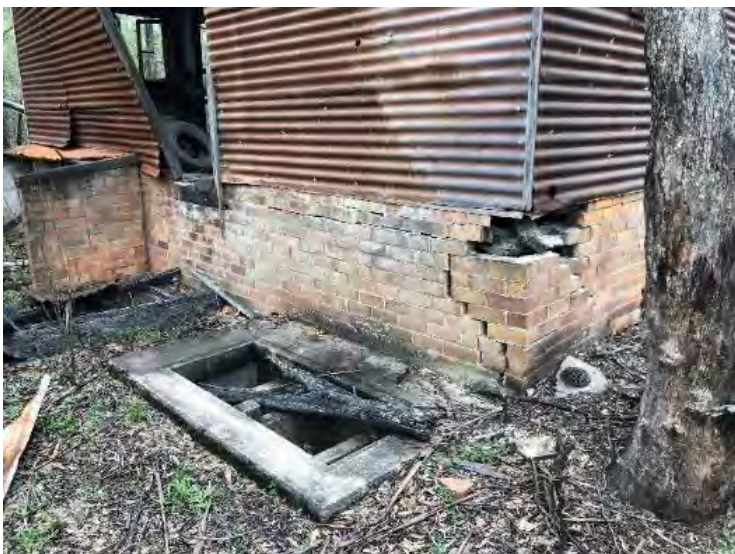
2021	2022	2023	<p><u>Grease trap at south end of building</u></p> <p>2012-18: shows bow to south wall.</p> <p>2018-20 (Mar): shows increased bow to south wall.</p> <p>Mar 2020 – Dec 2020: shows increasing bowing of south wall, and example of new termite monitoring system in bottom right of picture.</p> <p>Dec 2020-2021: shows increasing bowing of south wall.</p> <p>2021-2022: potential subsidence at broken brick corner.</p> <p>2022-2023: some increased movement at cracked corner</p>

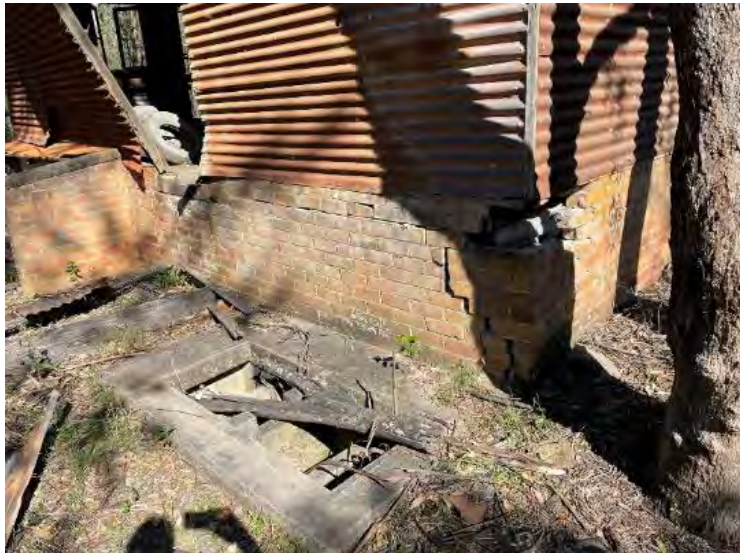
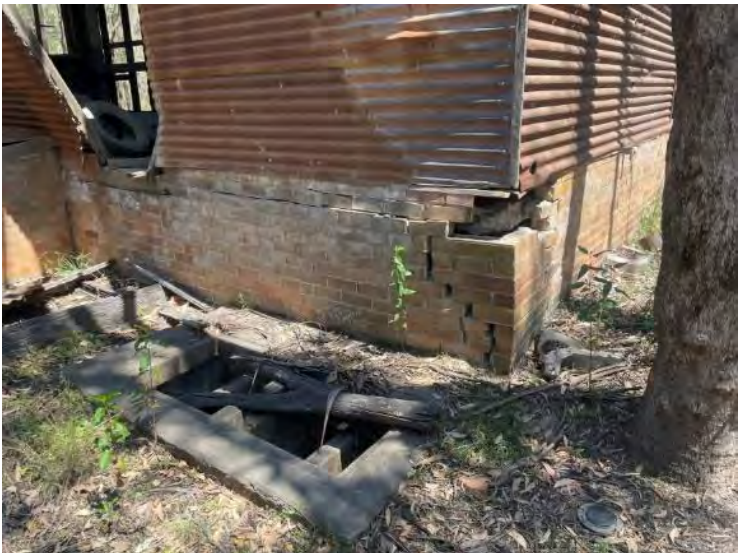
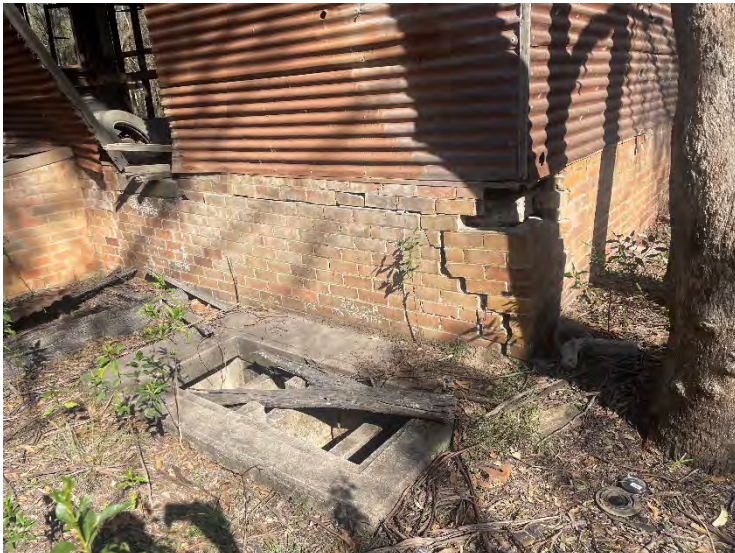
2021	2022	2023	<p><u>Storage area at south end of building</u></p> <p>2012-18: further slight collapse of storage area.</p> <p>2018-20 (Mar): shows loosening of corrugated iron wall sheeting due to bowing in wall.</p> <p>Mar 2020 – Dec 2020: no discernible change.</p> <p>Dec 2020-2021: no discernible change.</p> <p>2021-2022: no discernible change</p> <p>2022-2023: further separation of corrugated iron wall sheeting due to bowing in wall.</p>

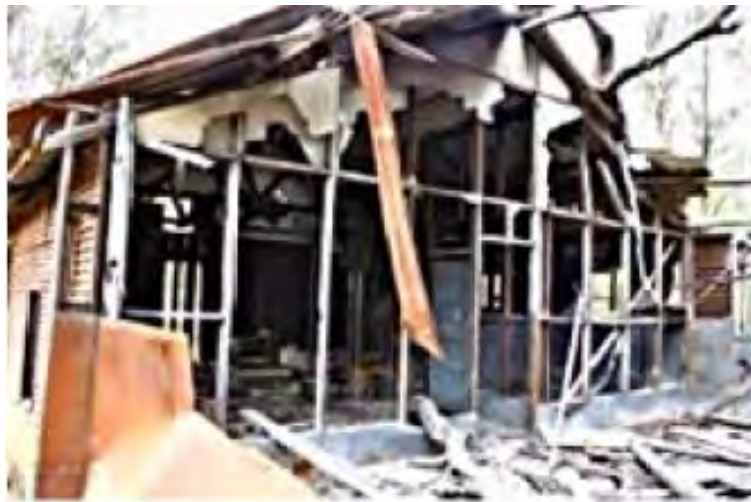
2021	2022	2023	<p><u>View to interior of south end of building, view from east</u></p> <p>2012-18: shows increased collapse over open kitchen area.</p> <p>2018-20 (Mar): shows further minor deterioration of asbestos panelling.</p> <p>Mar 2020 – Dec 2020: no discernible change.</p> <p>Dec 2020 – 2021: no discernible change.</p> <p>2021-2022: no discernible change</p> <p>2022-2023: some movement of fallen timbers</p>

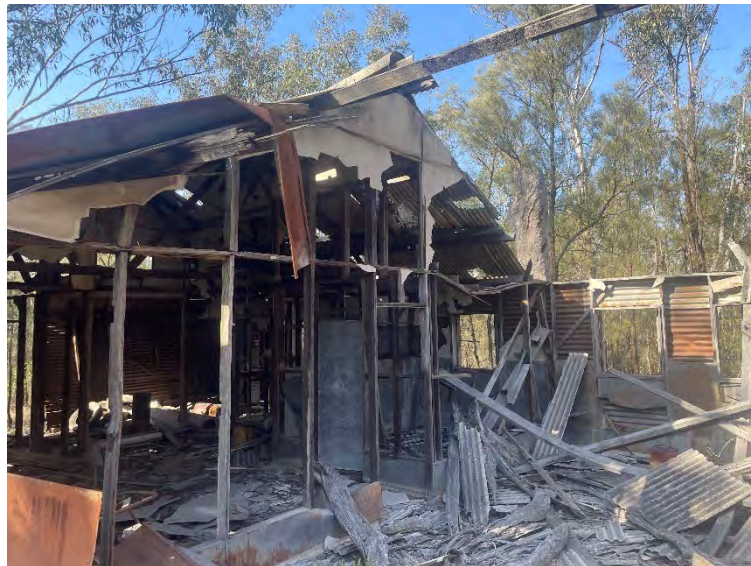
2021	2022	2023	<u>Showing west interior space</u>
 	 	 	<p>2012-18: no discernible change.</p> <p>2018-20 (Mar): no discernible change.</p> <p>Mar 2020 – Dec 2020: no discernible change.</p> <p>Dec 2020 – 2021: no discernible change.</p> <p>2021-2022: no discernible change</p> <p>2022-2023: no discernible change</p>

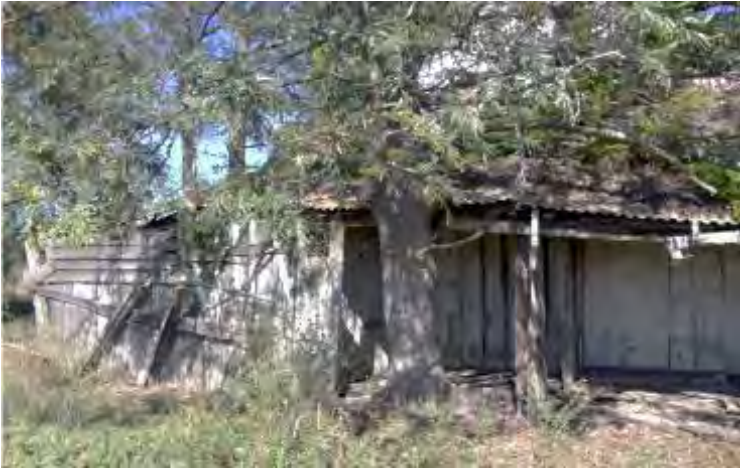
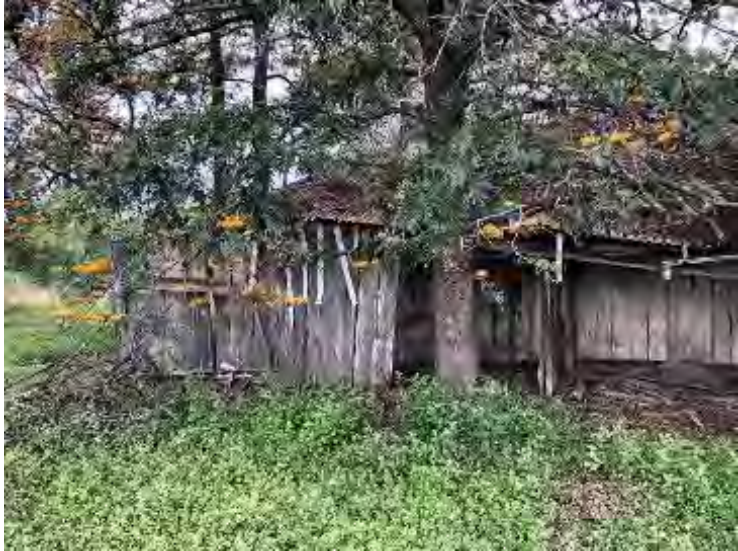
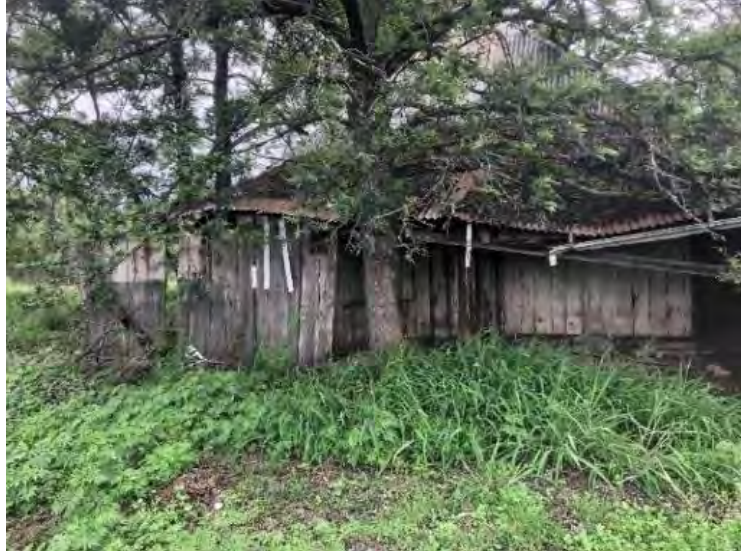
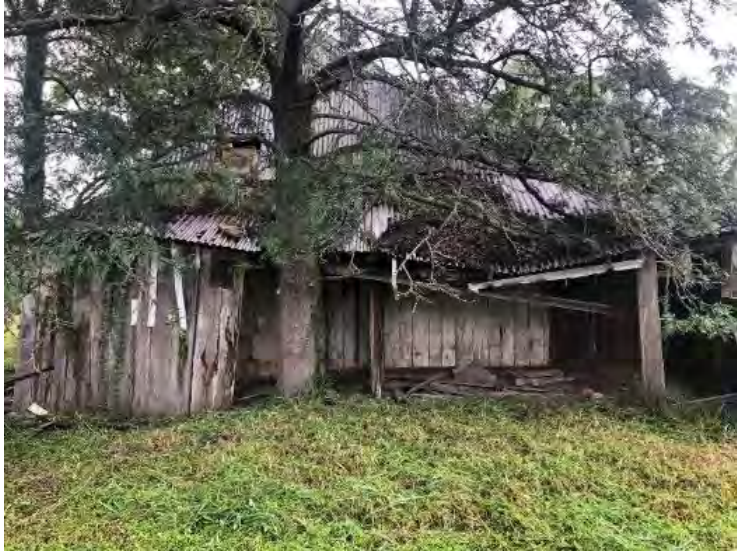
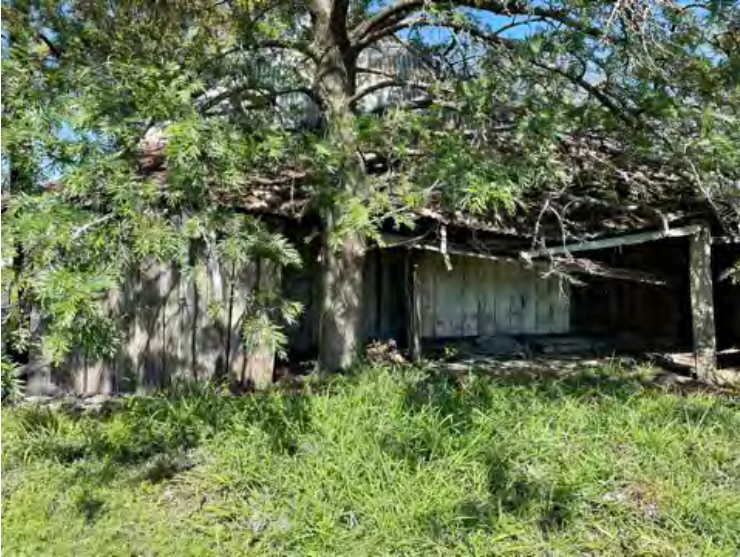
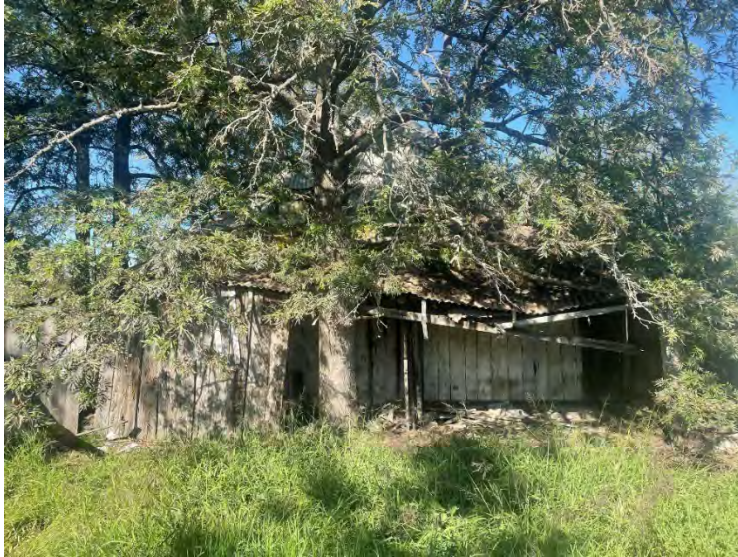
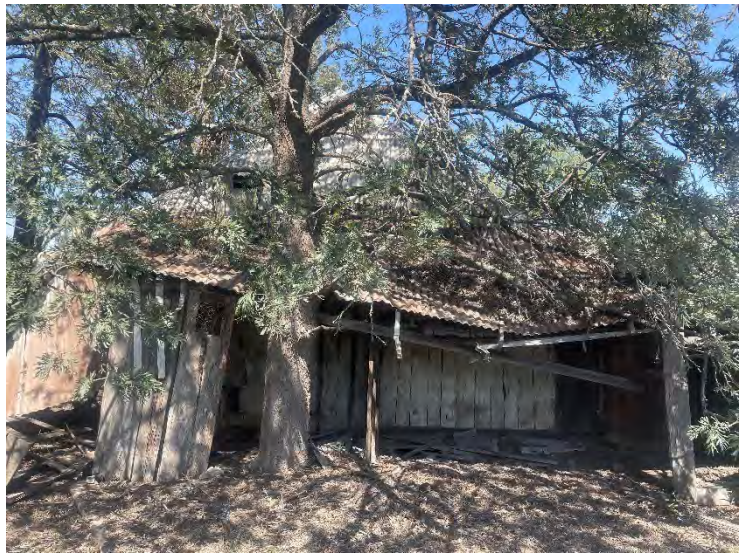
2021	2022	2023	<u>Eastern elevation</u>

<p>2014-8: no discernible change.</p> <p>2018-20 (Mar): roof slumping appears to have increased.</p> <p>Mar 2020-Dec 2020: heavy leaf litter on roof persists. Positively, vegetation clearing surrounding the house is occurring regularly.</p> <p>Dec 2020–2021: tree growth and associated leaf litter/structural impacts increasing.</p> <p>2021-2022: tree growth increasing with associated deterioration of roof integrity.</p> <p>2022-2023: tree growth continues and southern section of timber wall/skillion has collapsed.</p>

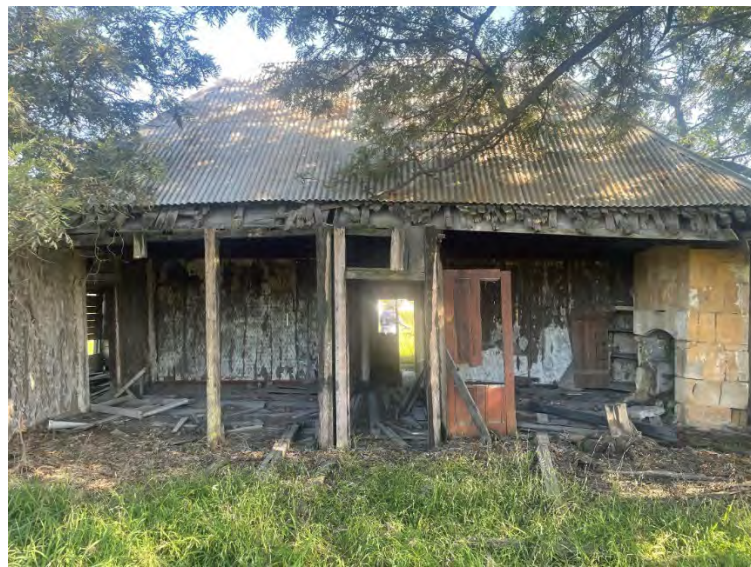
2021	2022	2023	<u>Southern elevation doorway</u>
 	 	 	<p>2014-8: door has been removed.</p> <p>2018-20 (Mar): no discernible change.</p> <p>Mar 2020-Dec 2020: no discernible change.</p> <p>Dec 2020 – 2021: no discernible change.</p> <p>2021-2022: fallen timber to right of door jamb.</p> <p>2022-2023: door timber fallen across hallway.</p>

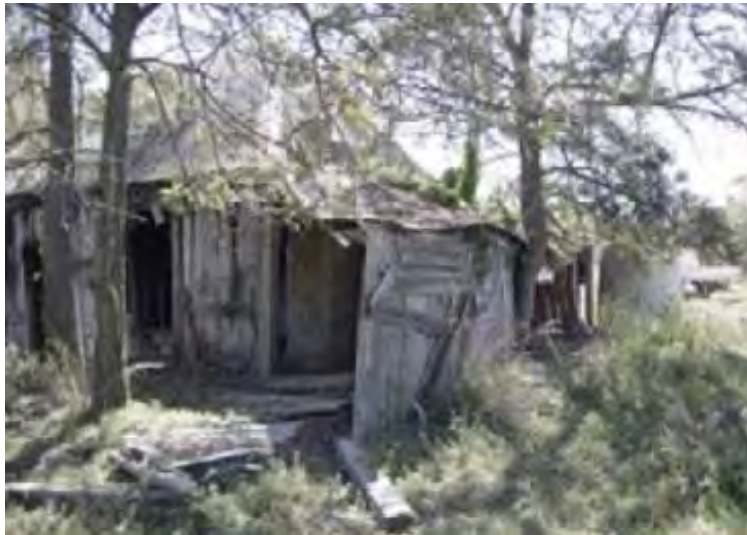
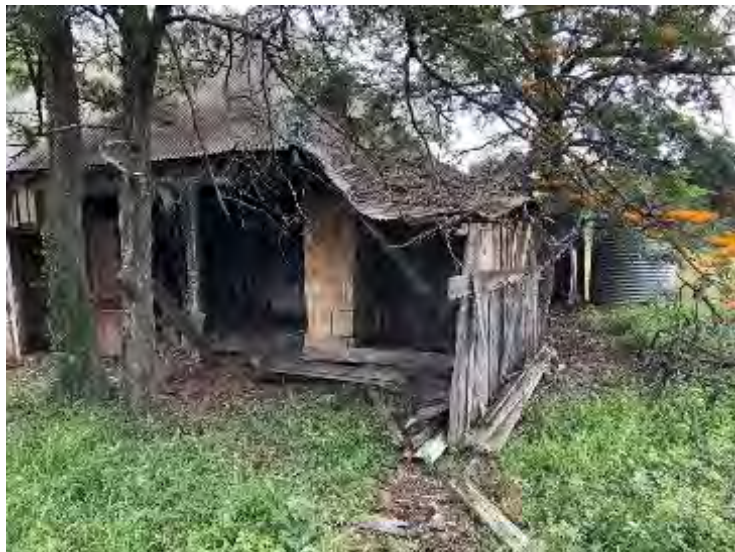
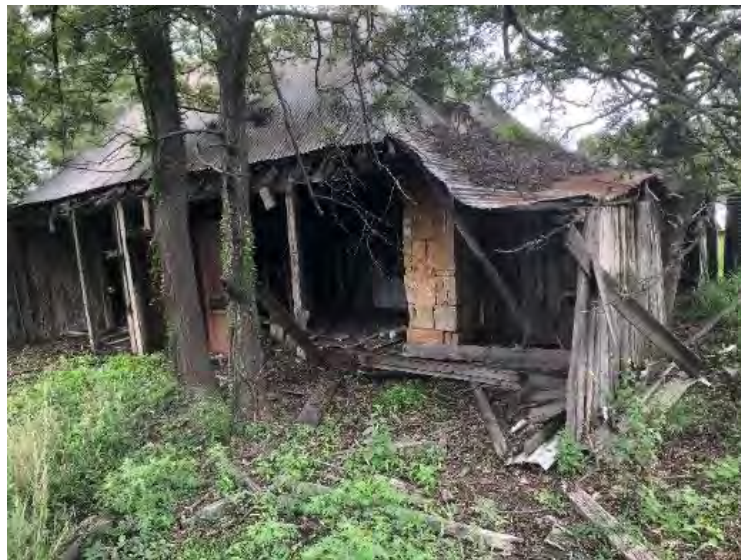
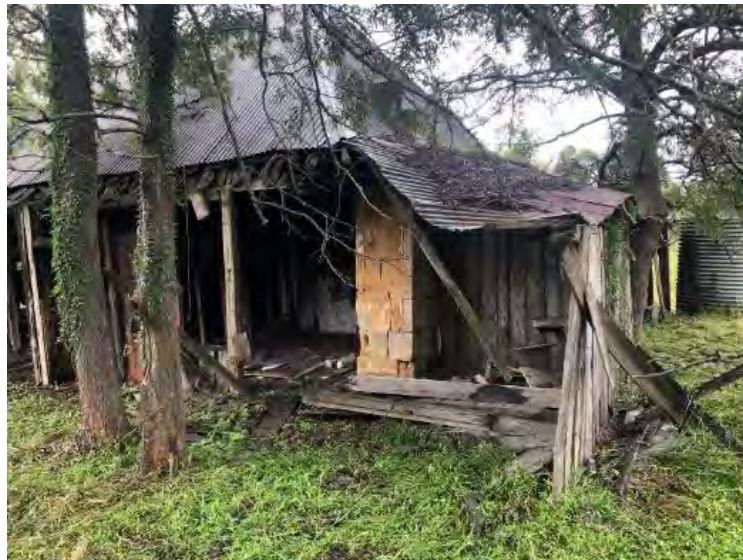
2021	2022	2023	<p>South-eastern corner</p> <p>2014-8: vertical slabs have been removed causing further collapse of roof.</p> <p>2018-20 (Mar): further deterioration of eastern wall.</p> <p>Mar 2020-Dec 2020: heavy leaf litter on roof persists.</p> <p>Dec 2020 – 2021: heavy leaf litter on roof persists.</p> <p>2021-2022: chimney slumping and separated from ceiling; back veranda roof also slipping.</p> <p>2022-2023: south-east wall and skillion roof collapsed. 3° - 4.5° lean to the east on chimney.</p>

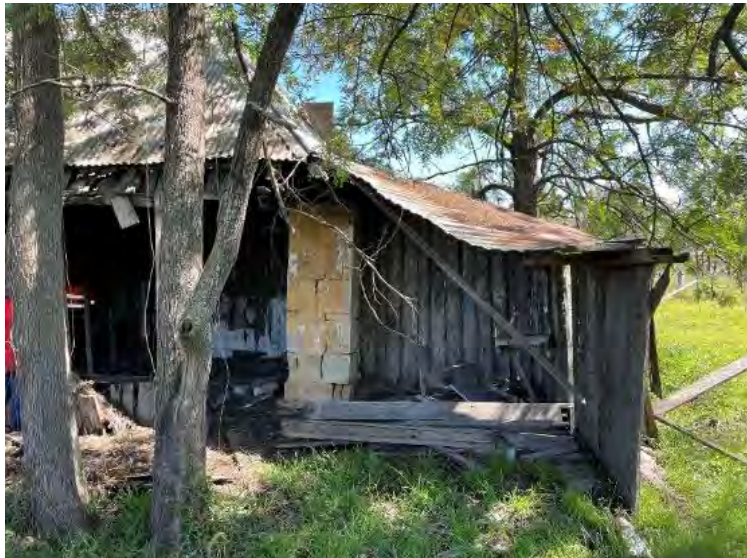
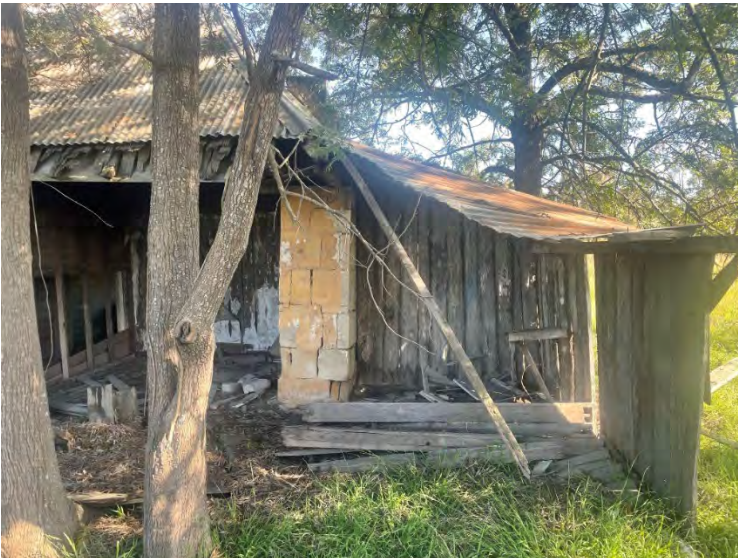
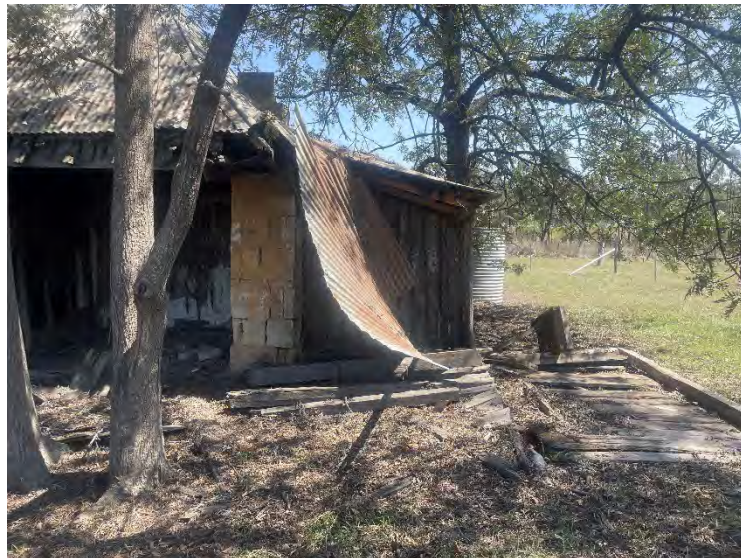
2021	2022	2023	<p><u>Eastern side</u></p> <p>2014-8: debris has been cleaned and stored and a weed removal program conducted. The house area has also been fenced.</p> <p>2018-20 (Mar): further deterioration of eastern wall and regrowth of weeds.</p> <p>Mar 2020-Dec 2020: no discernible change.</p> <p>Dec 2020 – 2021: no discernible change.</p> <p>2021-2022: apparent increased deformation of eastern roof line.</p> <p>2022-2023: south-east wall and skillion roof collapsed</p>

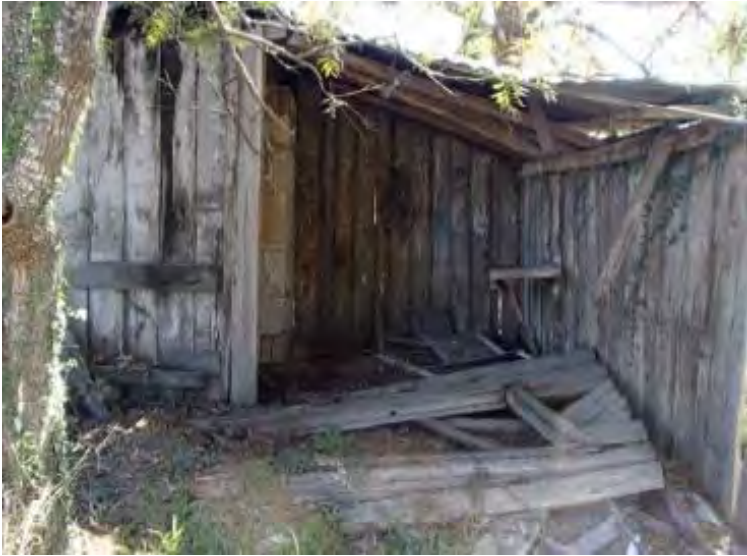
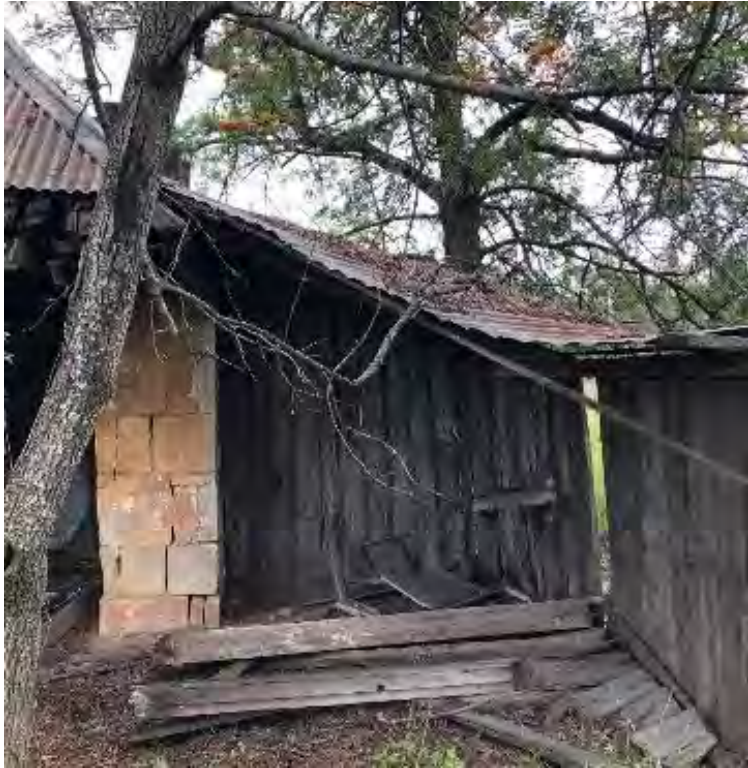
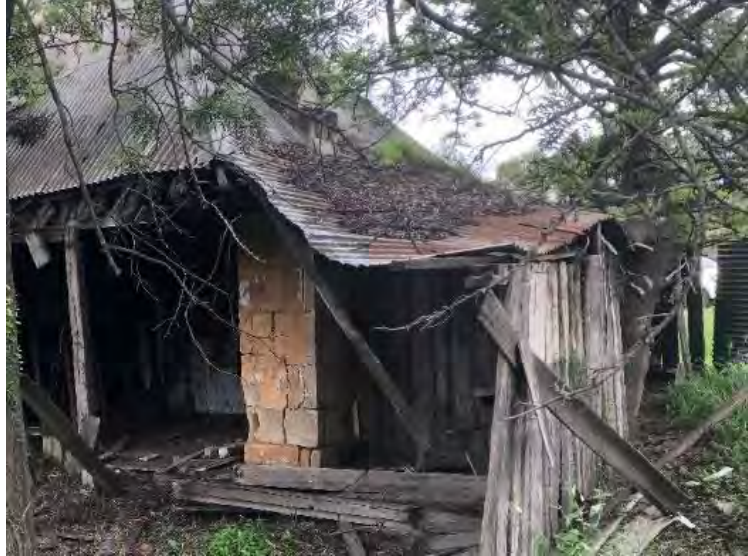
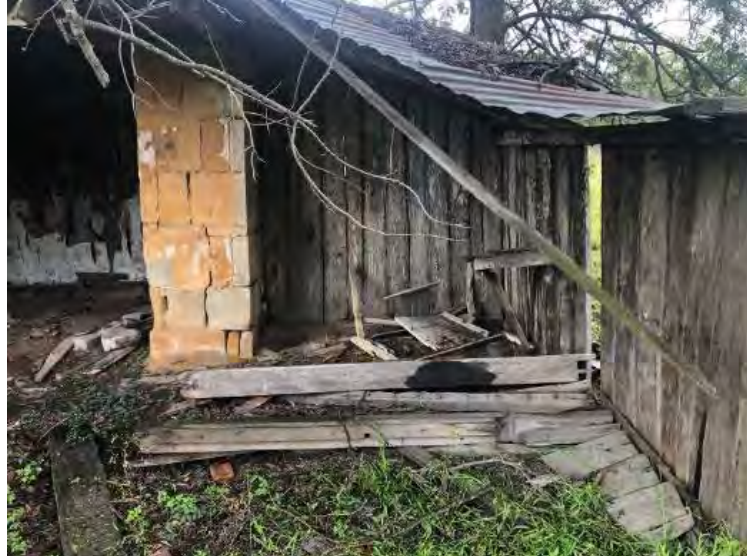
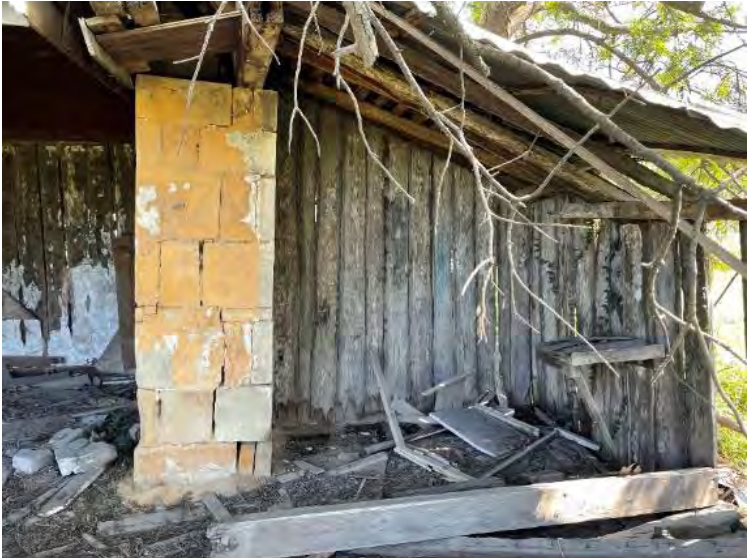
2021	2022	2023	<u>South-east corner</u>

<p>2014-8: shows removal of vertical slabs from southern wall, and some from eastern wall, and further collapse of roof.</p> <p>2018-20 (Mar): further roof slumping and deterioration of eastern wall.</p> <p>Mar 2020-Dec 2020: no discernible change.</p> <p>Dec 2020 – 2021: further deterioration of eastern wall.</p> <p>2021-2022: movement of roofing timbers, subsidence in chimney blocks, bottom left corner.</p> <p>2022-2023: total collapse of side wall and roof</p>

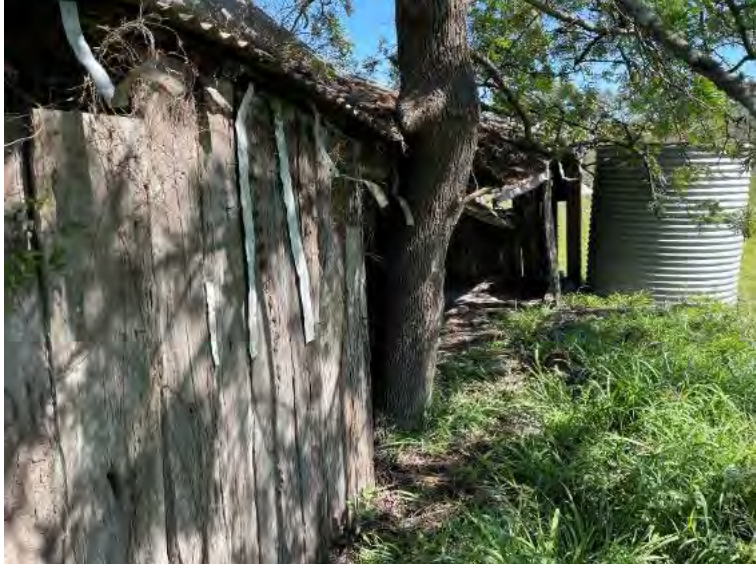
2021	2022	2023	<u>Eastern elevation</u>

<p>2014-8: possible further collapse of crossbeam and guttering.</p> <p>2018-20 (Mar): tree continues to impact eastern roof line.</p> <p>Mar 2020-Dec 2020: increased impact on roofline by tree branches.</p> <p>Dec 2020 – 2021: tree continues to impact eastern side.</p> <p>2021-2022: veranda roof now considerably buckled in middle, with separation of timber members occurring.</p> <p>2022-2023: tree continues to impact eastern side, with wall collapse shown at near left.</p>
