Mount Thorley Warkworth

2023 Annual Review

Mount Thorley Warkworth (MTW) is an integrated operation of two open cut coal mines, Warkworth Mining Limited (WML) and Mount Thorley Operations (MTO). This Annual Review reports on the environmental performance of MTW for the period 1 January 2023 to 31 December 2023.

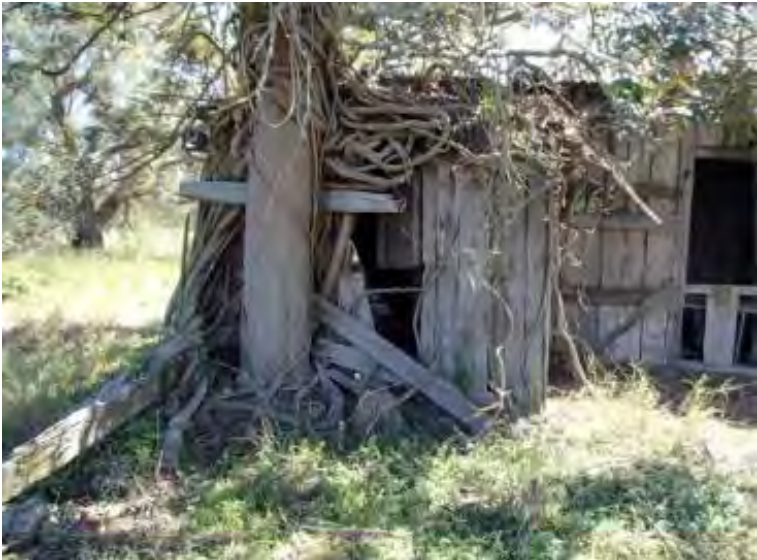
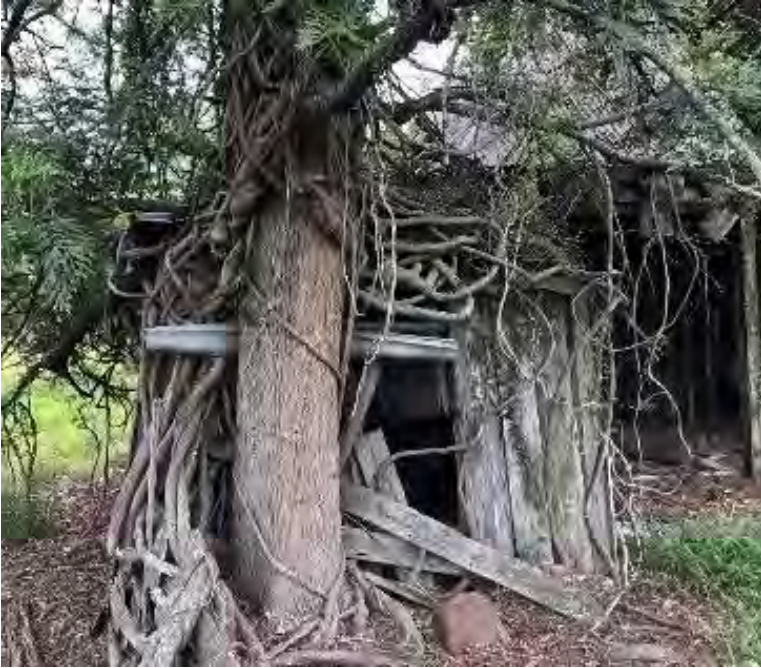
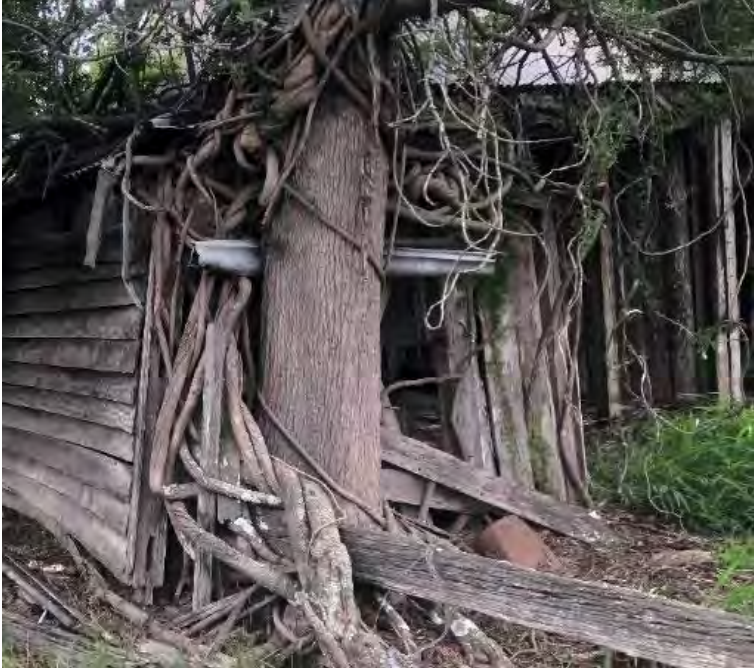
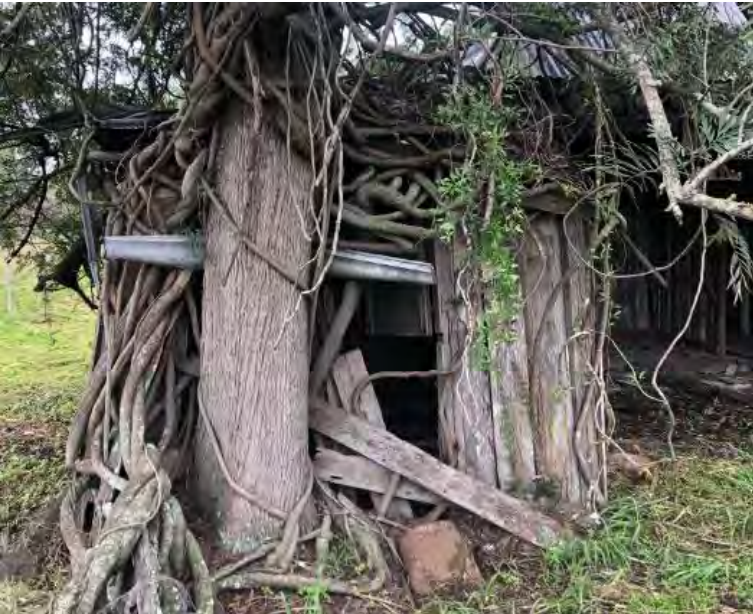
2014	2018	2020 (Mar)	2020 (Dec)

2021	2022	2023	<u>Northern elevation</u>
 	 	 	<p>2014-8: slumping of veranda along edge beam.</p> <p>2018-20 (Mar): no discernible change.</p> <p>Mar 2020-Dec 2020: grass/weed growth encroaching over veranda floor.</p> <p>Dec 2020 – 2021: no discernible change.</p> <p>2021-2022: peppercorn has been pruned; termite damage is increased within veranda uprights.</p> <p>2022-2023: increased splitting to fourth verandah post from right</p>

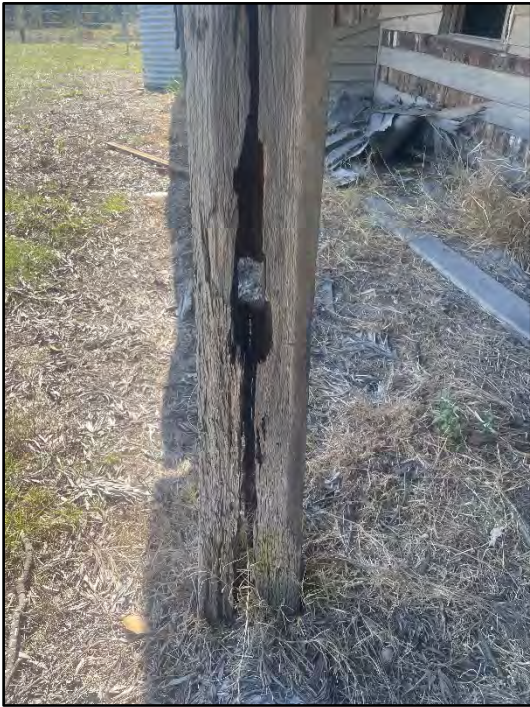
Additional northern verandah upright affected by termites and/or rot

The verandah uprights are all severely weakened through termite activity or rot and require bolstering to aid in support of the roof. This also the case along the eastern roofline, where slumping is continuing with the absence of any vertical support along this wall line.

4. Propping of the northern, eastern and southern roof lines should occur without delay to prevent any collapse caused by removed/damaged uprights; and

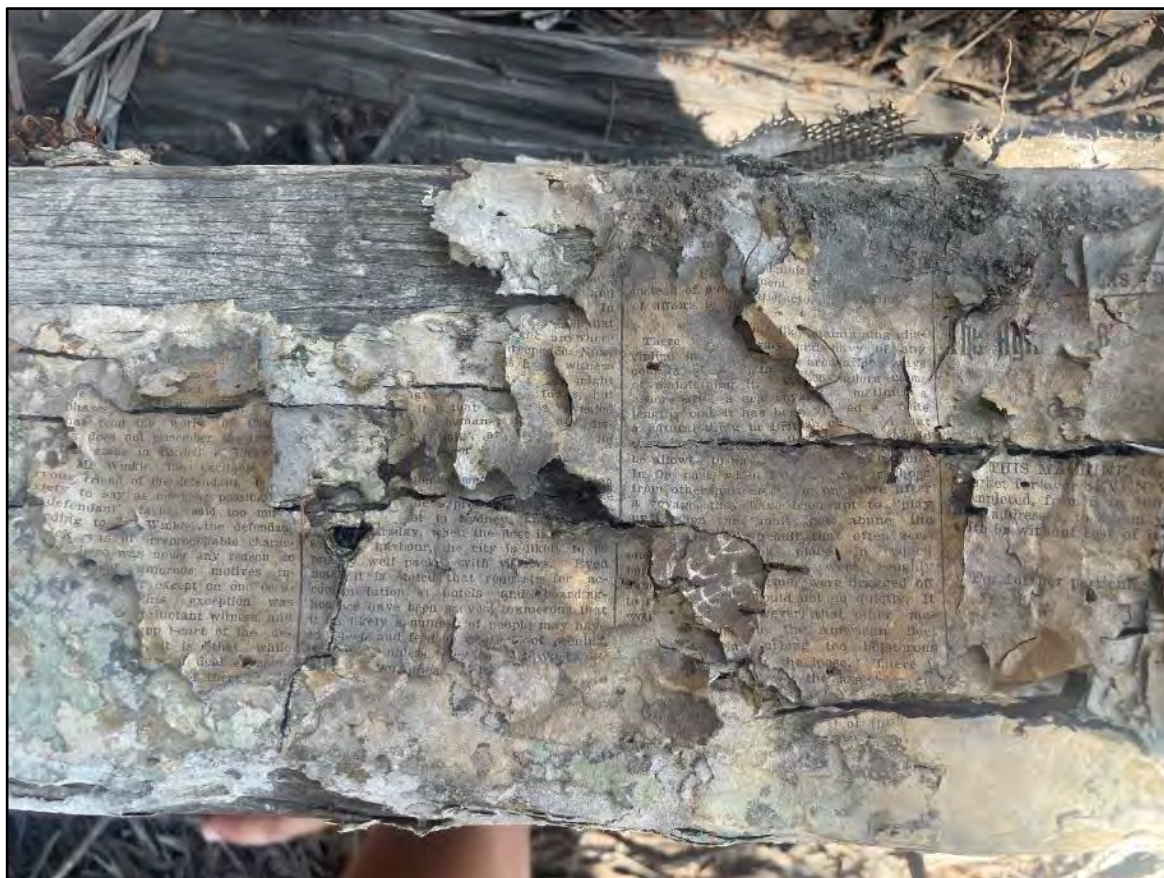
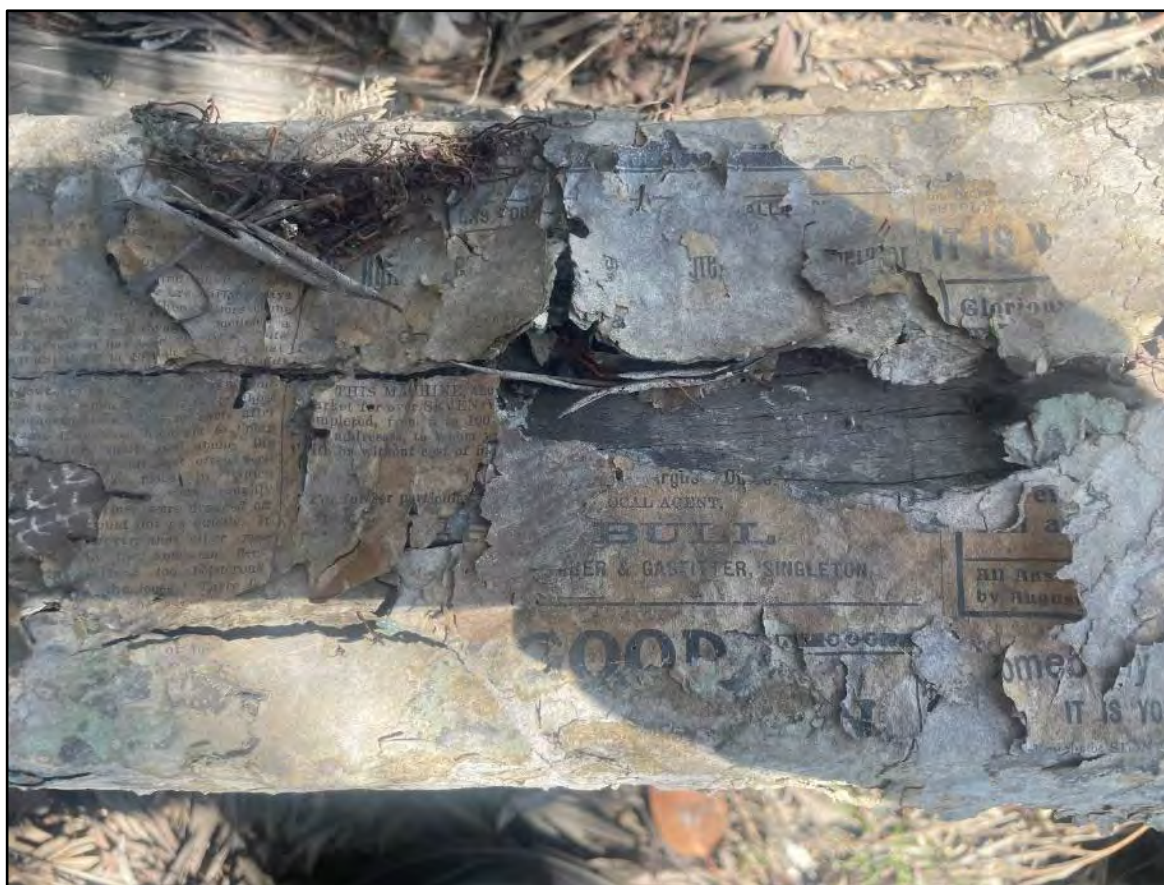
It should also be noted that the collapse of the south-eastern section of wall has also exposed some portions of old newspaper that had been adhered to one piece of wood that once served as shelving in this room. The newspaper appears to be one of several layers that have been used as coverings over the years. A search of the National Library of Australia's Trove newspaper database conducted by CHAG member Lyn MacBain revealed that the paper originated from p.7 of the August 15 1908 edition of the Singleton Argus, making these fragments 115 years old. Recommendations on their care and conservation are outlined below.

Fragments of the August 15 1908 Singleton Argus recovered from the collapsed wall

5. The wooden piece containing the remnant newspaper fragments should be removed from the site as soon as possible in order to preserve the remaining fabric. The piece should be stored inside and in constant temperature conditions at low humidity and in dark conditions. It should be stored so as to be protected from vermin and pests, and personnel involved should avoid touching the fragments, especially with bare hands. Prior to removal, in situ photographs should be taken of the piece and its relationship to the other fallen timbers in order to record its contextual provenance. These

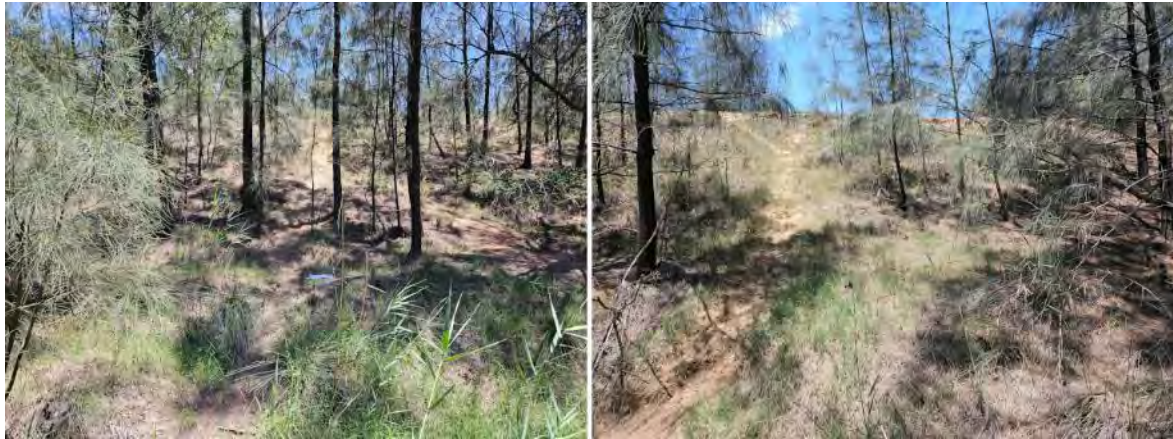
Figure 6: Site BM35 left bank (left) and right bank (right).

The animal track that crosses the site at BM35 (**Figure 6**) remains exposed and an active source of fine clayey silt to the creekline, as does the erosion scar along the upper right-hand bank (**Figure 7**). Couch grasses were noted to have colonised colluvial sediments at the base of the channel walls.

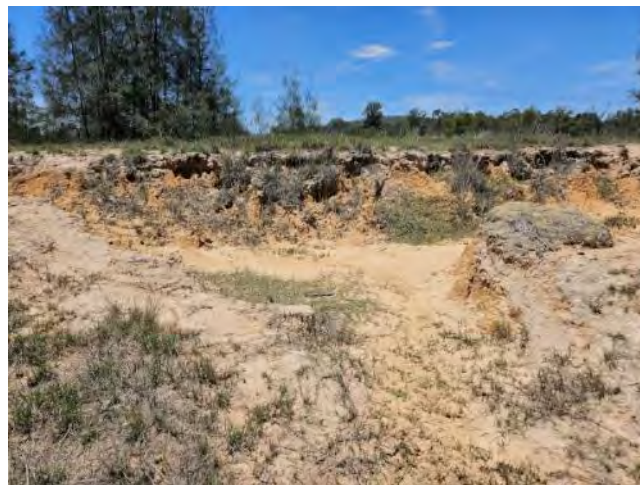
Figure 7: Erosion scar along the upper right-hand bank.

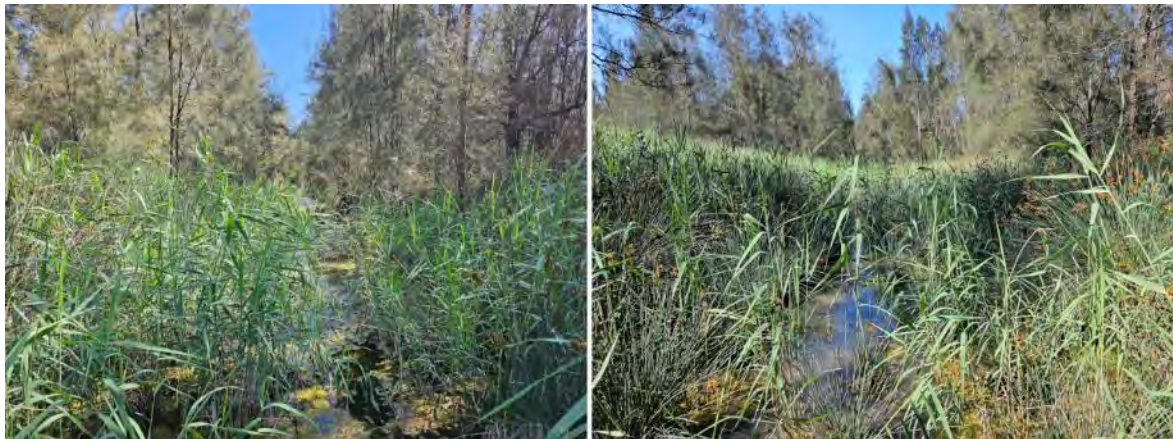
When compared to the previous survey in 2022, the instream and bank edge spiny rush and common reed stands at BM34 had proliferated in 2023 (**Figures 8 and 9**), however there was no change to the ‘Vegetation on drainage line floor’ category was already assigned to the highest category score. The channel pools supported other macrophytes (sago pondweed (*Stuckenia pectinata*), rushes *Juncus usitatus*), charophytes and regular occurrences of fat hen (*Chenopodium album*) along the waters edge.

Figure 9: Looking upstream in site BM34 (left) and downstream (right) in 2023. Note the increase in macrophyte growth when compared to 2022 (**Figure 8**).

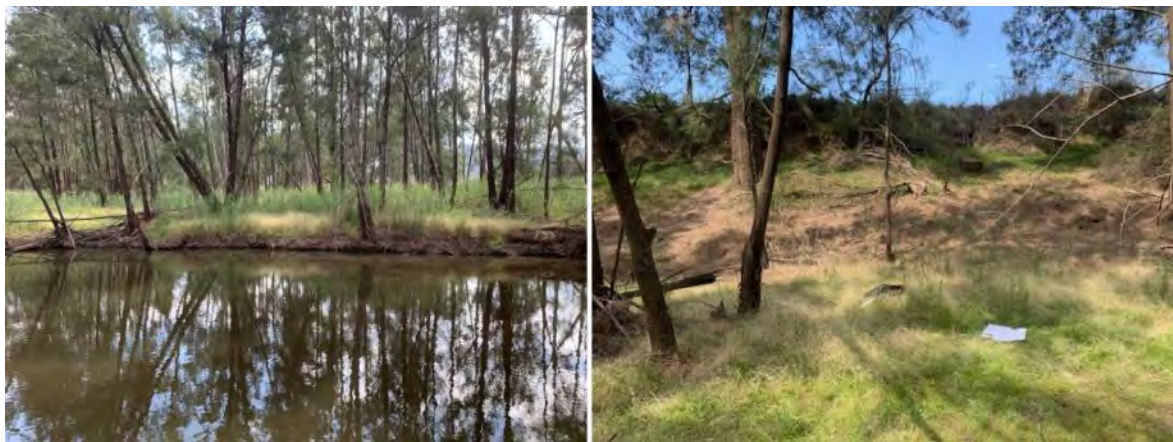
Figure 12: Site BM37 left bank (left) and right bank (right).

The upper channel bank walls and entry points for lateral runoff maintain some active erosional features (gully erosion, undercutting- see **Figure 12** right hand side), however many of the points are likely historical (from cattle access prior to fencing) or exacerbated from flood event scouring.

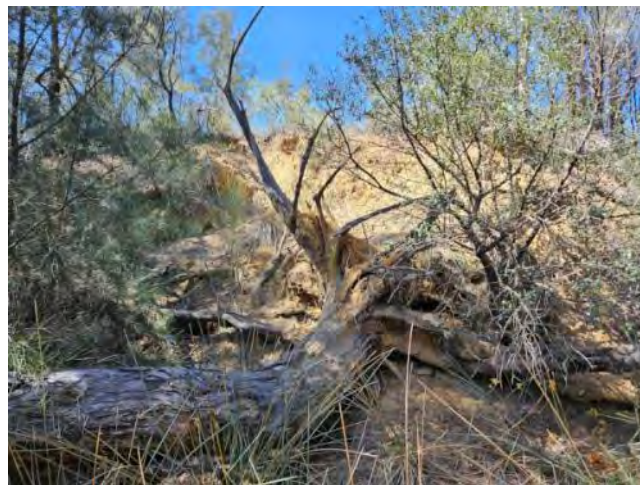
An erosion scar exists along the upper right-hand bank with a void created by a fallen tree stump (**Figure 17**). The scar remains exposed and active however there appears to be minimal contribution of channel wall sediments to the creek, and in 2023 there were new swamp-oak saplings that were noted to have colonised the void. Swamp-oak needles and other detrital reservoirs had accumulated along the drainage floor and walls which suggests that there had been no scouring flow events for some time.

Figure 17: Upper right-hand bank erosion exacerbated by a fallen tree.

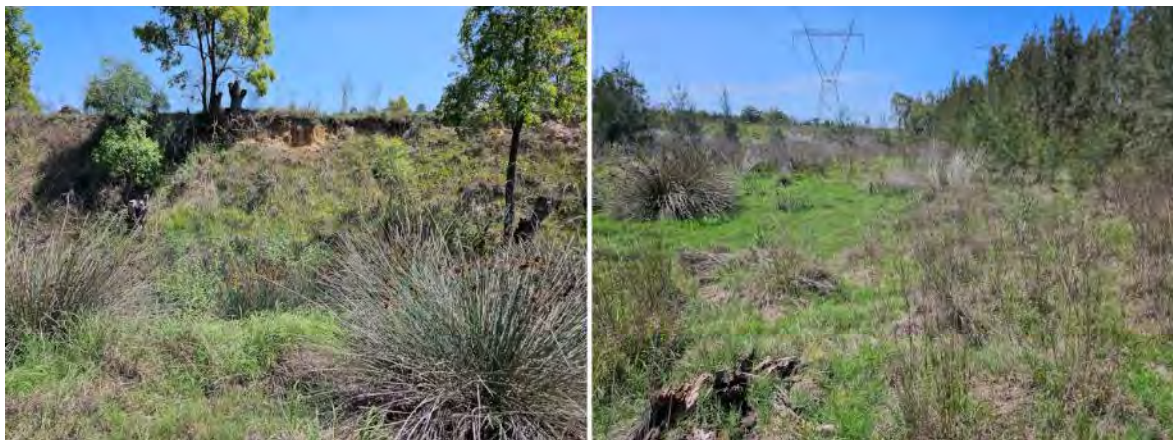
Figure 21: Site LC4 left bank (left) and right bank (right).

For the most part, a continuous assortment of groundcover species (grasses, shrubs and weeds) provide stabilisation for the channel floor and walls from stream flows or runoff. An exposed animal track traverses the channel from the left-hand bank which presents a localised source of erosion, which is bordered by an active erosion scar at the upper crest of the bank (**Figure 21** left-hand side).

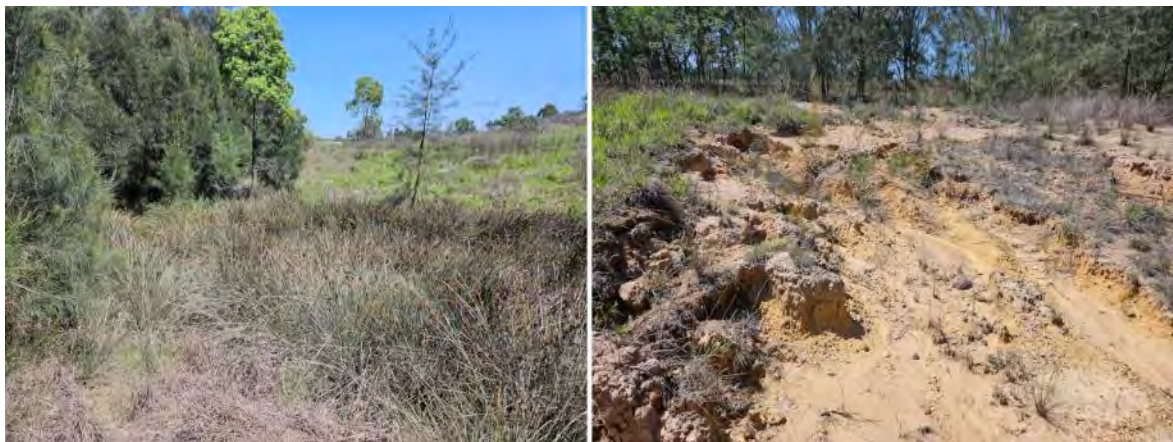
The upper right-hand bank contains an active erosion scar with rilling around its upper limits (**Figure 23**). While extent and condition of the exposure is consistent with the previous monitoring round, the accumulation of soft, fine sediments at the base of the slope and its colonisation by grasses and rushes does indicate that it's an active source of erosive material during wet weather events (**Figure 24**). There were some new swamp-oak saplings observed along the channel bank walls, and the instream and edge bank vegetation (grasses and rushes) had showed signs of minor growth since 2022.

Figure 23: Site LC5 left bank (left) and erosion scar (right).

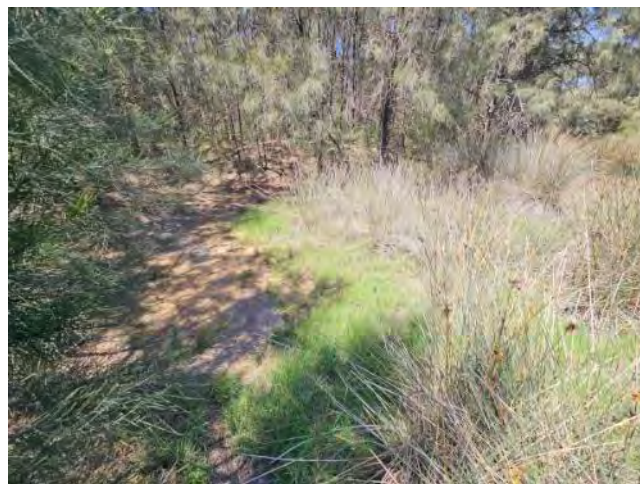
Figure 24: Couch grass colonising colluvial deposits (fine clayey sand) at the base of the right-hand bank, sourced from the erosion scar shown in **Figure 23**.

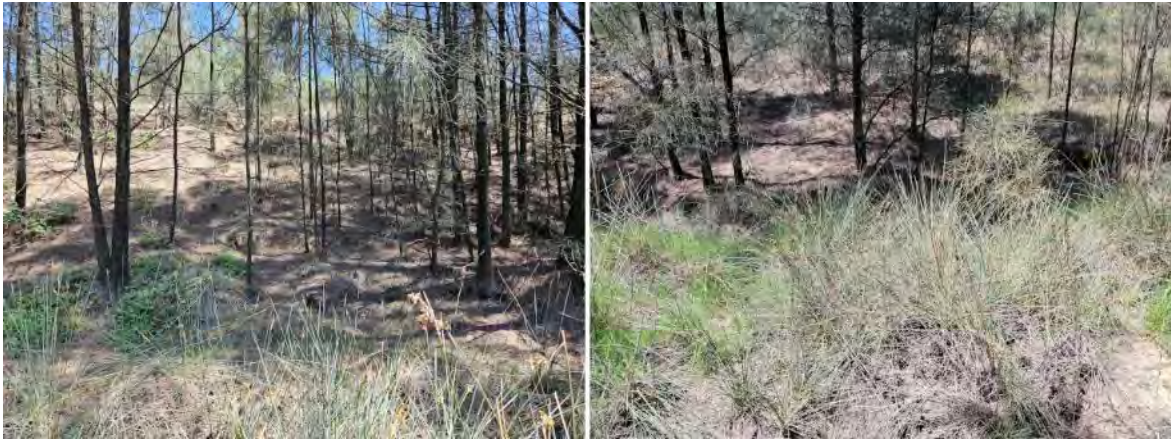
The swamp-oak riparian corridor is generally narrow, relatively dense and continuous and throughout the width of the channel with cleared pastures and rehabilitated mining land beyond the riparian strip (**Figure 26**). The upper right-hand bank contains a considerable erosion scar which remains an active source of fine sediment to the creekline (**Figure 27**). As noted at LC5, accumulated fine sediments at the base of the slopes have been colonised by couch grass which show signs of recent growth, as had spiny rushes which occupy the channel floor, however there are still bare patches with no vegetation (only swamp-oak needles) occupying much of the channel area, which limit the category score for ‘Vegetation on drainage line floor’ to 2, and resulted in a decrease in the overall CSIRO ESA score from 53 in 2022 to 50 in 2023.

Figure 26: Site LC6 left bank (left) and right bank (right).

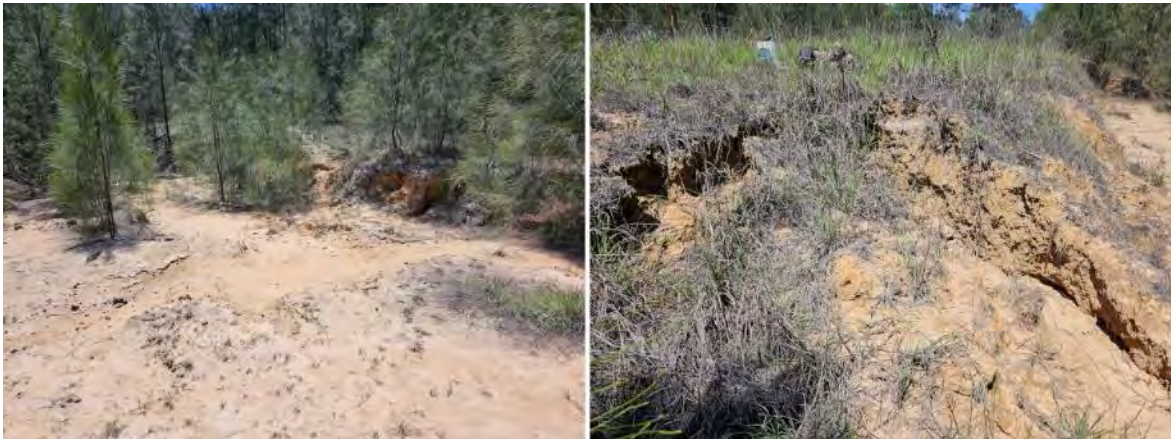
Figure 27: Bank erosion along upper right-hand bank at LC6.

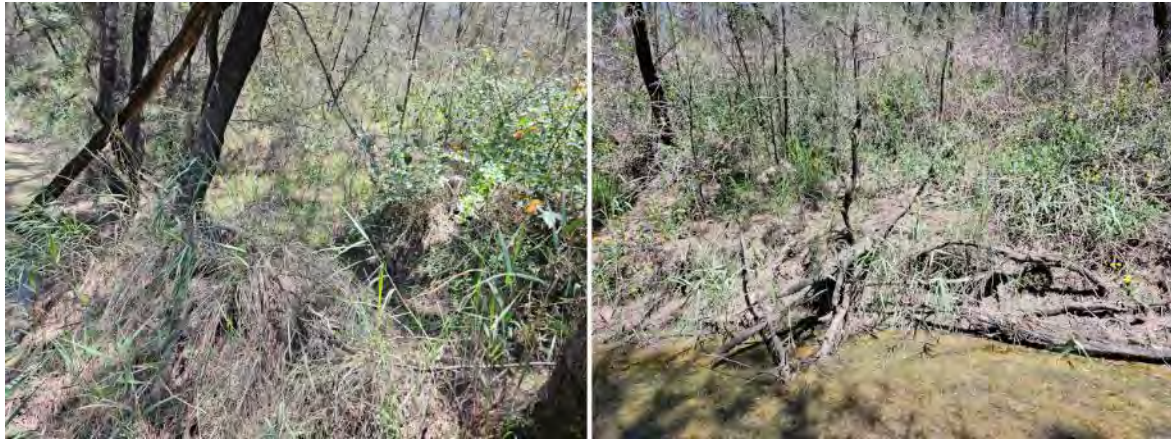
The riparian corridor comprises a continuous strip of swamp-oaks with scattered eucalypt in the overstorey and dense understorey, where lantana has proliferated since the previous survey in 2021 (**Figure 31**). The CSIRO ESA rating indicated that the site was *Potentially Stabilising* in 2023.

Figure 31: Site LC11 left bank (left) and right bank (right).

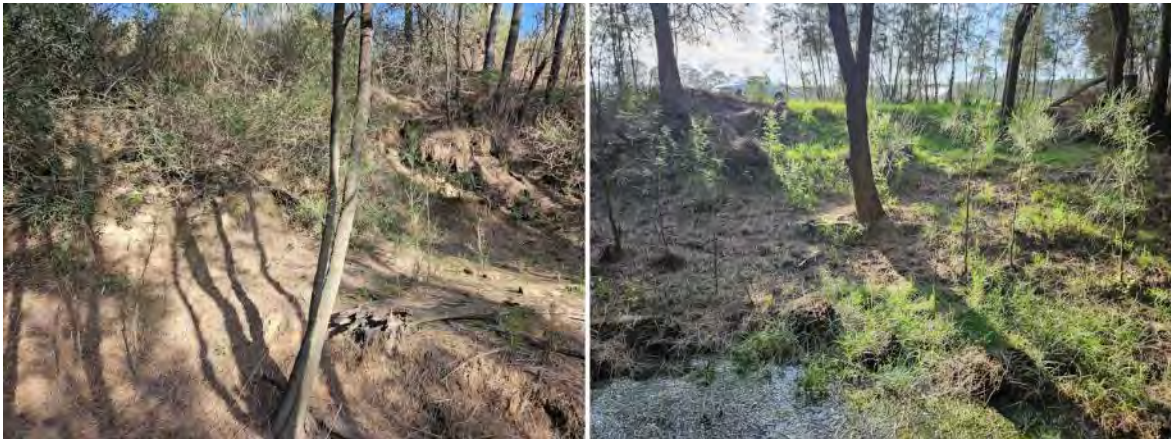
The channel at LC12 comprises a flat-bottomed meandering channel with moderate incision into the surrounding valley floor, which is bordered by moderately sloping and higher left-hand bank and shallow sloped bank along the right-hand side (**Figures 32 and 33**). At the time of survey surface waters were clear with visible trickling through the shallow constricted pool sections.

The previous monitoring round in 2022 noted that spiny rushes and common reeds at LC12 had died back, and while there was no indication of recovery for the 2023 survey, the reduction was insufficient to warrant reducing the category score for ‘Vegetation on drainage line floor’. Couch grasses and streaked arrow grass (*Triglochin striatum*) showed signs of localised renewed growth, however much of the drainage line floor and walls comprised bare ground smothered in a layer of swamp-oak needles during the 2023 survey (**Figures 32 and 33**). Cattle access the creekline at LC12 contributes to exposure of soil profiles through trampling, and there was a reduction in category score for ‘Nature of drainage line wall materials’ owing to an increase in the estimate of exposed soils along drainage line walls, and as a result, the LC12 CSIRO ESA score declined, and the overall site rating shifted from the lower limits of *Potentially Stabilising* to the upper limits of *Active* in 2023.

Figure 33: Site LC12 left bank (left) and right bank (right) in 2023.

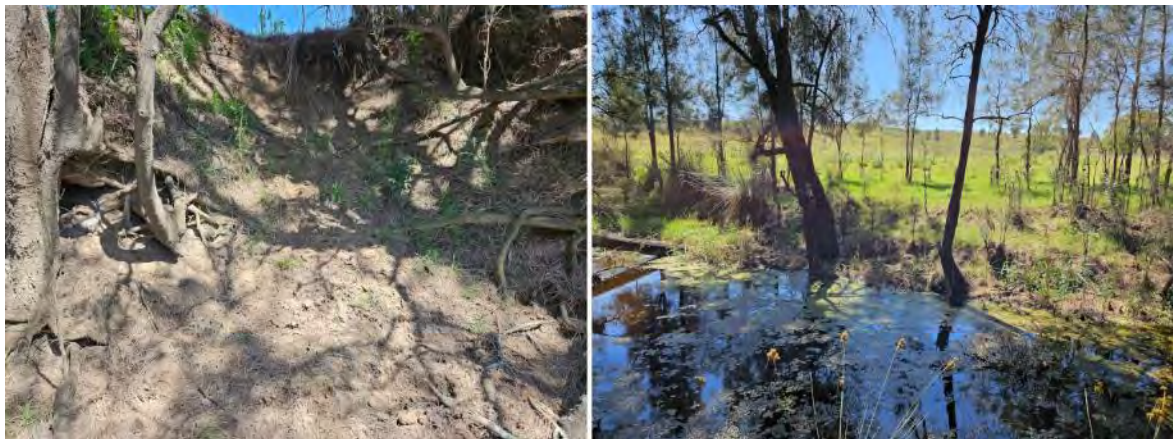
The drainage channel at LC8 comprises a steep, vertical bank along the western side and shallower sloped, stepped bank to the east, and both edges support a thin and continuous strip of riparian swamp-oak trees which are undercut in parts (**Figures 36 and 37**). Surface waters were clear and flowing through the site length for the 2023 survey.

The left-hand bank is steep and undercut however the mature riparian swamp-oaks provide sufficient stability to limit soil dispersal to minor localised losses on a year-to-year basis despite ongoing livestock access.

Figure 37: Site LC8 left bank (left) and right bank (right).

There was a reduction in category score for ‘Vegetation on drainage line walls’ as the condition of vegetation was more fitting of the rating 2 description, which contributed the reduction in overall CSIRO site score, however the rating remained as *Potentially Stabilising* in 2023.

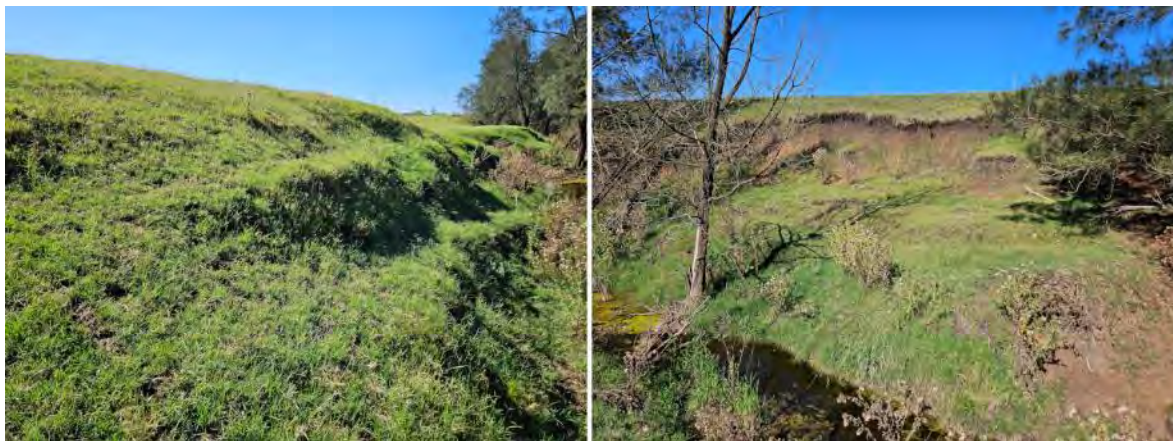
The creek channel at LC15 is incised into the surrounding valley floor at depths of 8 to 10m. The creekline contains moderately steep to near vertical sections of bank along both sides with bank undercutting and stepped bank walls prevalent throughout the section as a result of livestock access and fluvial processes (**Figures 42 and 43**). Surface waters were generally clear with low flow through the site, and filamentous green alga was abundant in the creek pools.

Despite the groundcover vegetation (pasture grasses and weeds) showing a recovery from the degraded condition encountered in 2022, the 'Vegetation on drainage line' category score was reduced for the 2023 survey (from 3 to 2), as the 2023 condition was more suited to the relevant category description. A re-assessment of the 'Shape of drainage line cross-section' resulted in an improved category score, which resulted in an unchanged overall CSIRO ESA score and rating which remained as *Stable* in 2023.

Figure 43: LC15 left bank (left) and right bank (right).

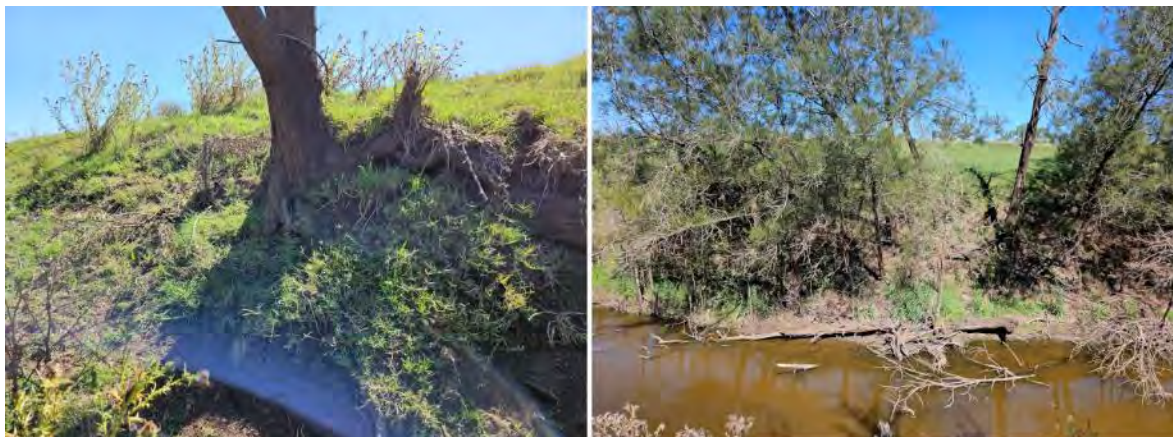
Figure 45: Looking along the left-hand bank at LC13 (left) and right bank (right).

The sloped drainage channel walls show signs of frequent usage by livestock with minor stepped banks however for the most part, the only areas of active erosion are limited to isolated patches along the upper left-hand bank and along the waters edge. There were slight increases in groundcover vegetation (pasture grasses, thistle, fleabane) along both banks compared to the previous survey however it was insufficient to warrant an increase to the highest category score for ‘Vegetation on drainage line walls’. The LC13 site CSIRO ESA rating remained unchanged in 2023 (*Potentially Stabilising*).

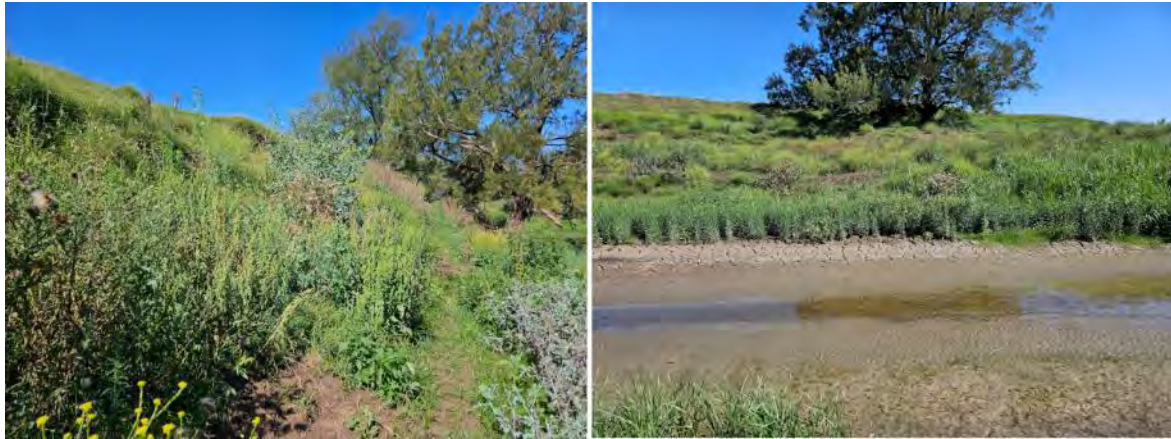
Figure 45: Looking along the left-hand bank at LC16 (left) and right-hand bank (right).

Whilst the mud deposits remain throughout the site length channel basin, groundcover vegetation along the channel walls was very dense, comprising pasture grasses and weed growth, including thistle (*Cirsium vulgare*), sowthistle (*Sonchus oleraceus*), thistle, green cestrum (*Cestrum parqui*), purple top, dock (*Rumex sp*), Buchan weed (*Hirschfeldia incana*). Along the lower bank walls, emergent macrophytes were continuous at the water's edge (common reed, tall spikerush and slender knotweed).

Mass failure occurs along the upper right-hand bank with an exposed soil profile and active erosional features (most likely a scour hole left from a tree root mass), and the left bank contains stepped banks with infrequent undercutting isolated to heights of less than 1m. A re-evaluation of the 'Shape of drainage line cross-section' resulted in an improved category score and overall CSIRO ESA score in 2023, however the CSIRO rating within the limits of *Active* in 2023.
