**RE: MOOLARBEN COAL COMPLEX – UG4 LONGWALLS 401 TO 407 END OF PANEL REPORT**

Secondary extraction of LW407 was completed in January 2026. Accordingly, MCO has prepared a UG4 LW401-407 End of Panel Report (refer to **Enclosure 1**), which presents monitoring data, describes observed impacts during mining of LW401-407 and compares these results to predictions and relevant performance measures and performance indicators as described in the approved UG4 LW401-408 Extraction Plan.

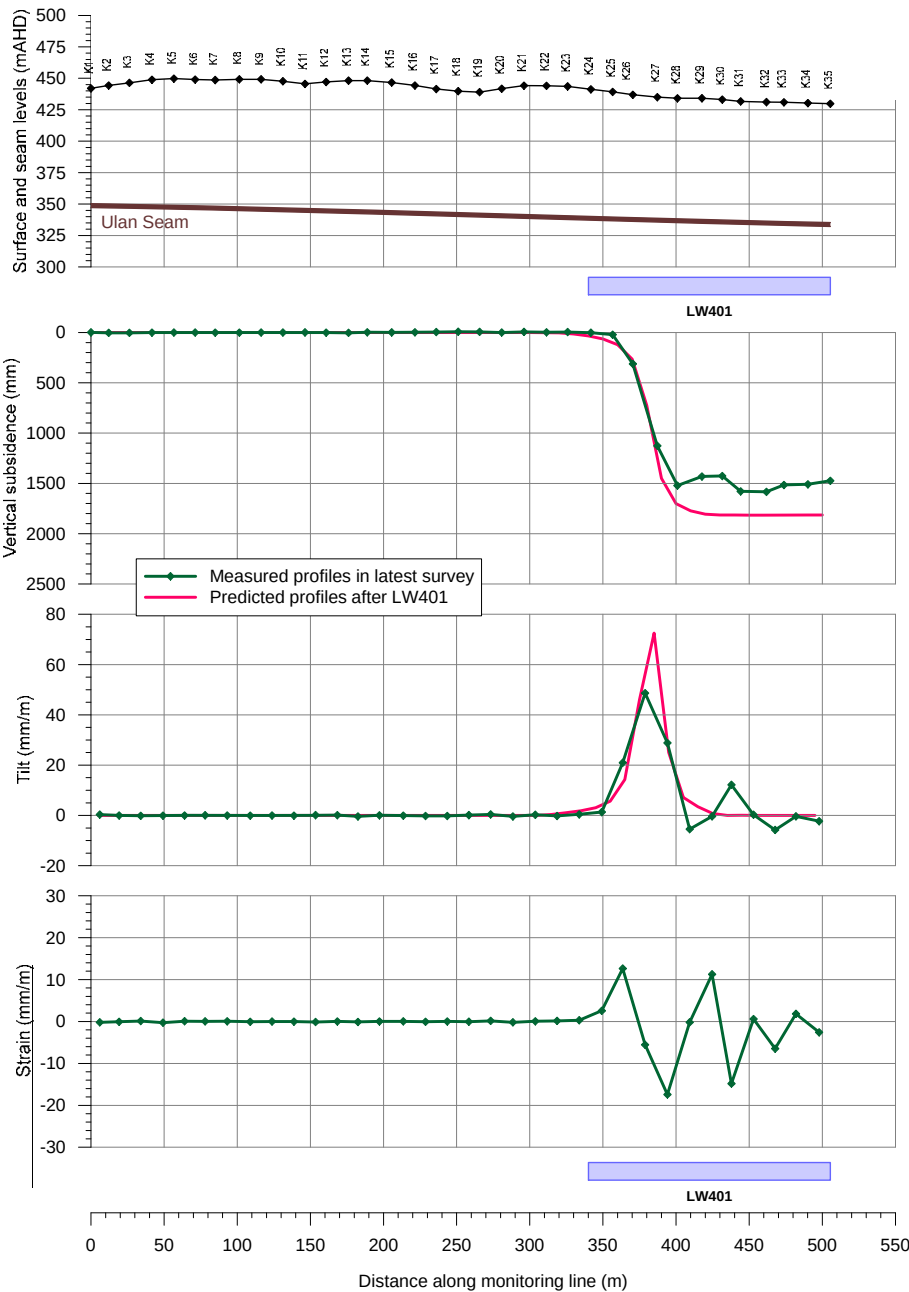
Fig. 2.1 Measured and predicted vertical subsidence, tilt and strain along the K Line

The measured profile of vertical subsidence reasonably matches the predicted profile with the magnitude of the measured vertical subsidence less than that predicted. The magnitude of the maximum measured final tilt (i.e. dark green line in Fig. 2.1) also reasonably coincides with the maximum predicted tilt.

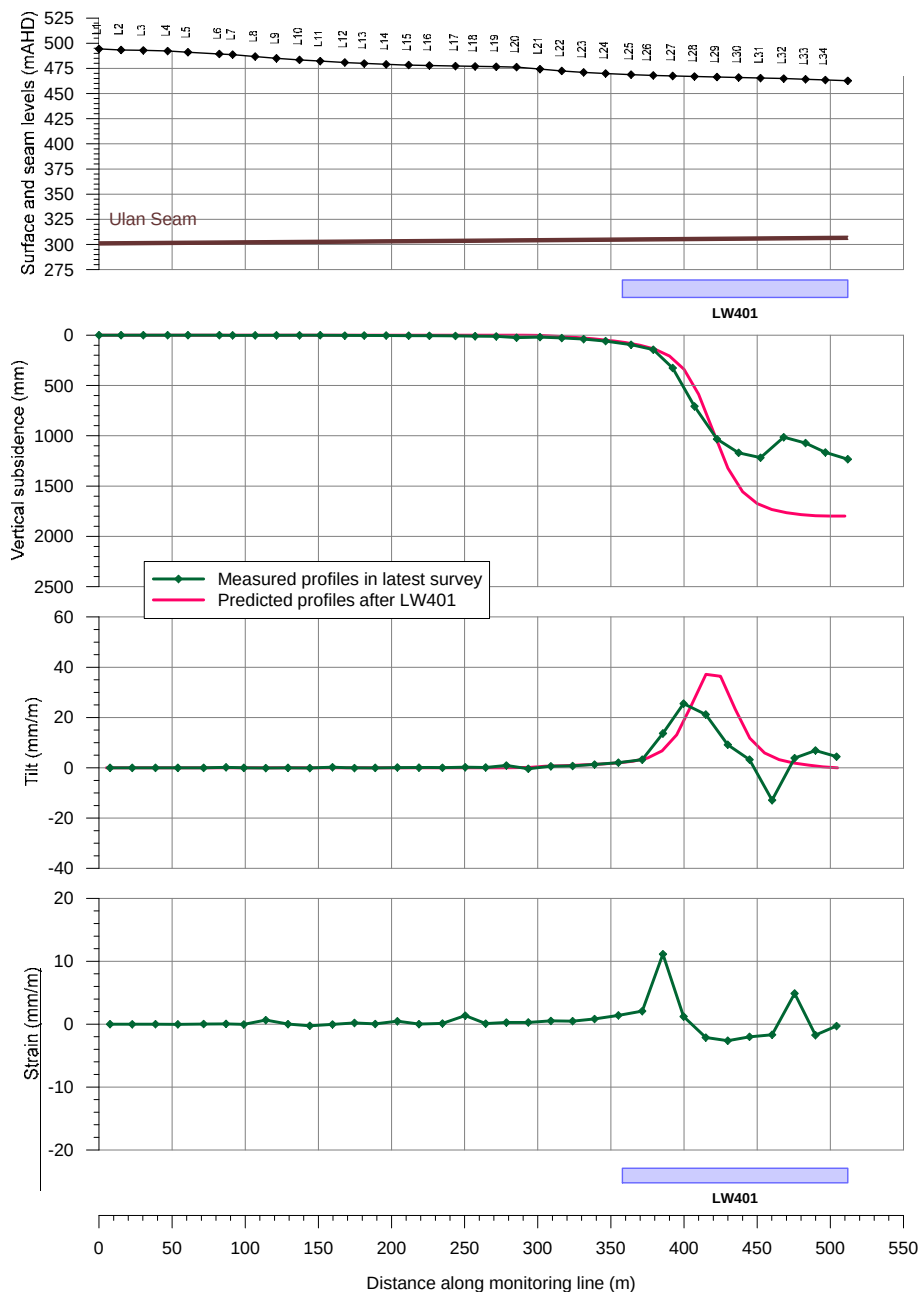
**Fig. 2.2 Measured and predicted vertical subsidence, tilt and strain along the L Line**

The maximum measured vertical subsidence of 1,233 mm is less than the maximum predicted value of 1,800 mm. The ratio of the maximum measured to maximum predicted vertical subsidence is 0.69. The vertical subsidence near the commencing end of LW401 is greater than predicted due to the measured profile occurring slightly further to the west than the predicted profile.

It is considered that the ground movements measured along the L Line are consistent with the predictions provided in Report No. MSEC1165, which supported the LW401-408 Extraction Plan.

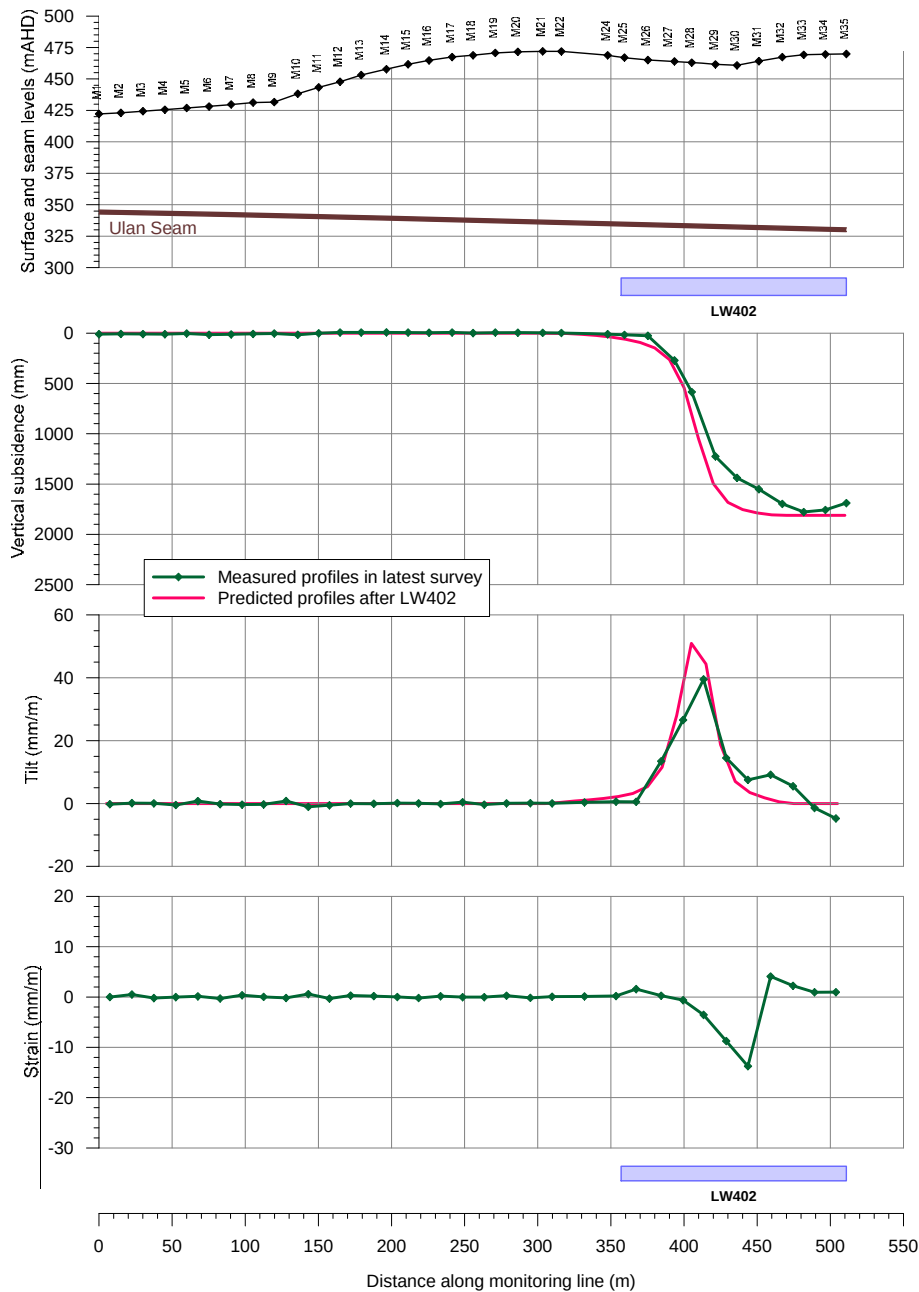
**Fig. 2.3 Measured and predicted vertical subsidence, tilt and strain along the M Line**

The measured profile of vertical subsidence reasonably matches the predicted profile with the magnitude of the measured vertical subsidence less than that predicted. The magnitude of the maximum measured final tilt (i.e. dark green line in Fig. 2.3) also reasonably coincides with the maximum predicted tilt.

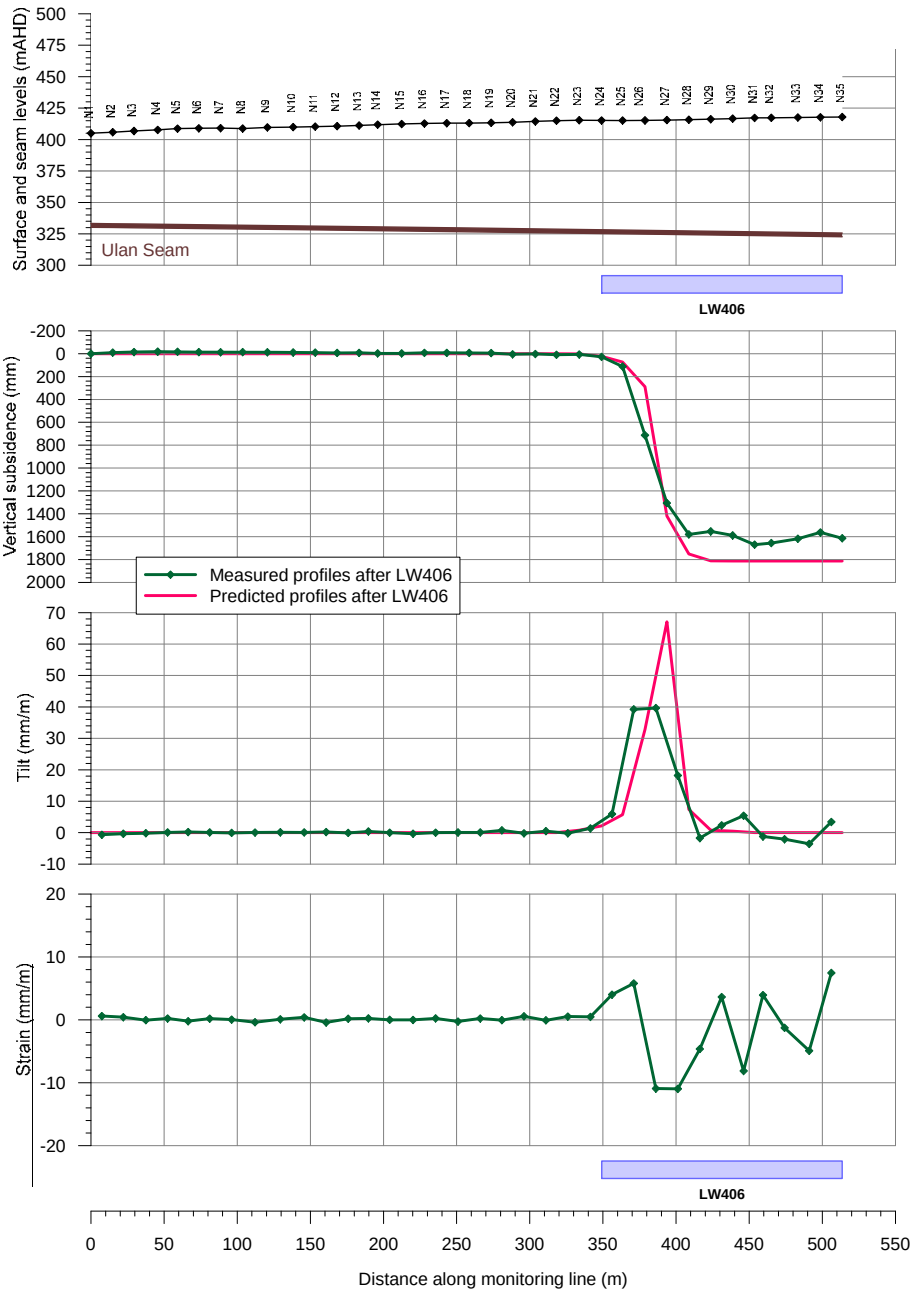
Fig. 2.4 Measured and predicted vertical subsidence, tilt and strain along the N Line

The profiles of measured and predicted vertical subsidence, tilt and strain along the N Line due to the extraction of LW401-406 are shown in Fig. 2.4. The measured profiles of vertical subsidence and tilt reasonably match the predicted profiles.

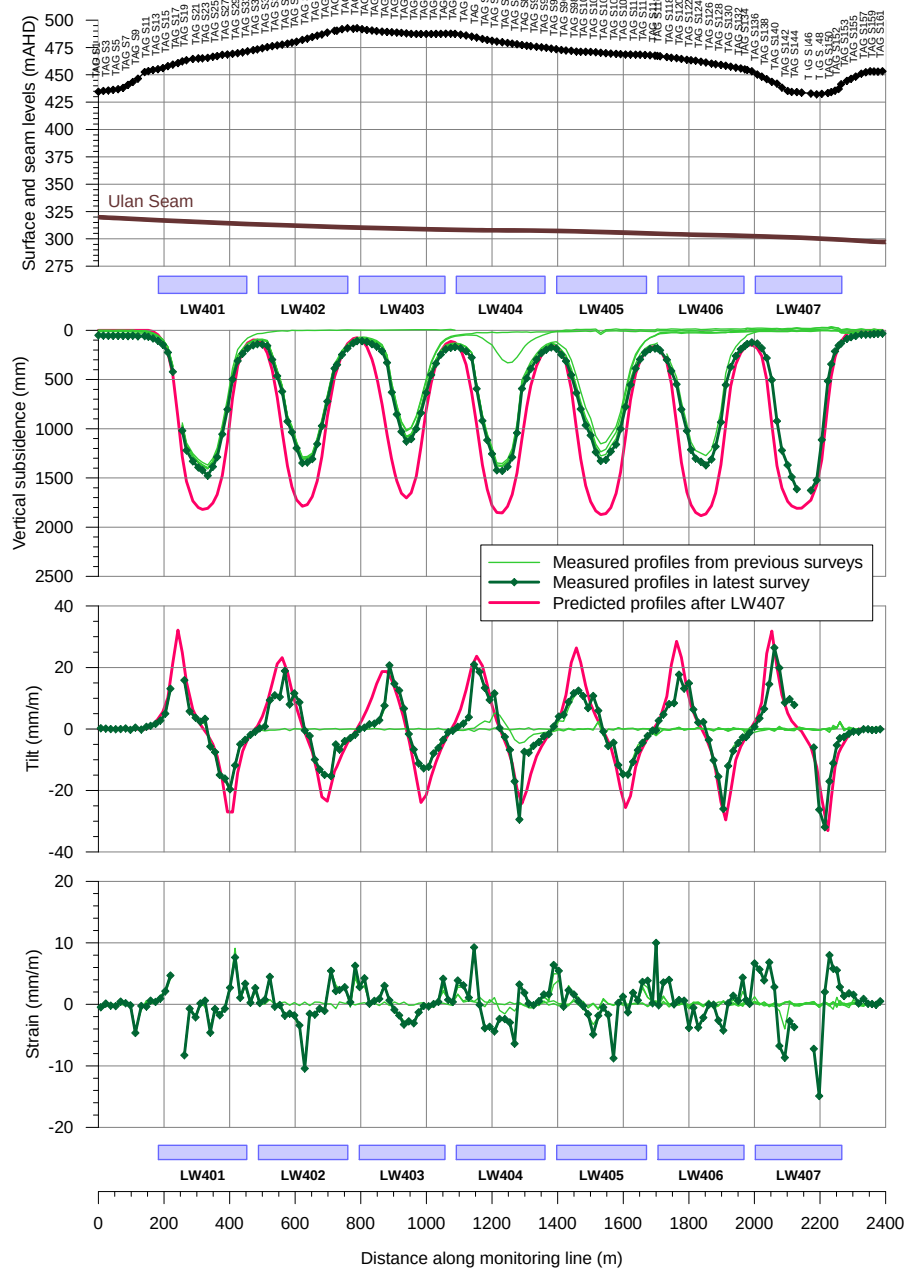
**Fig. 2.5 Measured and predicted vertical subsidence, tilt and strain along the S Line**

The greater than predicted compressive strain is not significant at higher values of strain and shallow mining conditions. The greater than predicted compressive strain has not resulted in exceedance of performance measures or Trigger Action Response Plan (TARP) triggers.

It is considered that the ground movements measured along the S Line are consistent with the predictions provided in Report No. MSEC1165, which supported the LW401-408 Extraction Plan.

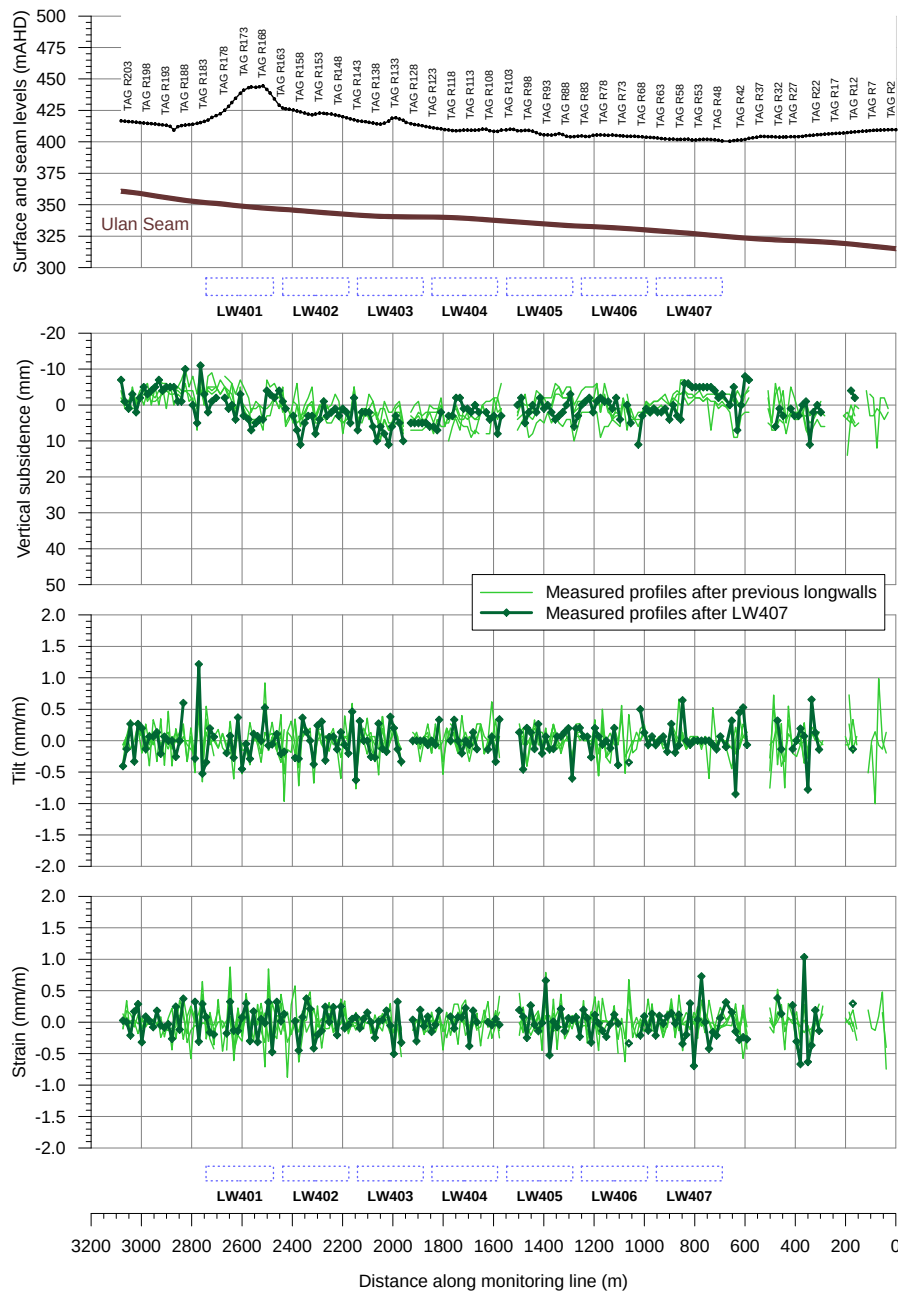
**Fig. 2.6 Measured vertical subsidence, tilt and strain along the R Line**

The profiles of measured vertical subsidence, tilt and strain along the R Line due to LW401-407 are shown in Fig. 2.6. Only low-level vertical subsidence within the level of survey accuracy was measured along the R Line. It is noted that several survey marks have been disturbed or damaged due to the vehicles along Ulan Road.

It is considered that the ground movements measured along the R Line are consistent with the predictions provided in Report No. MSEC1165, which supported the LW401-408 Extraction Plan.

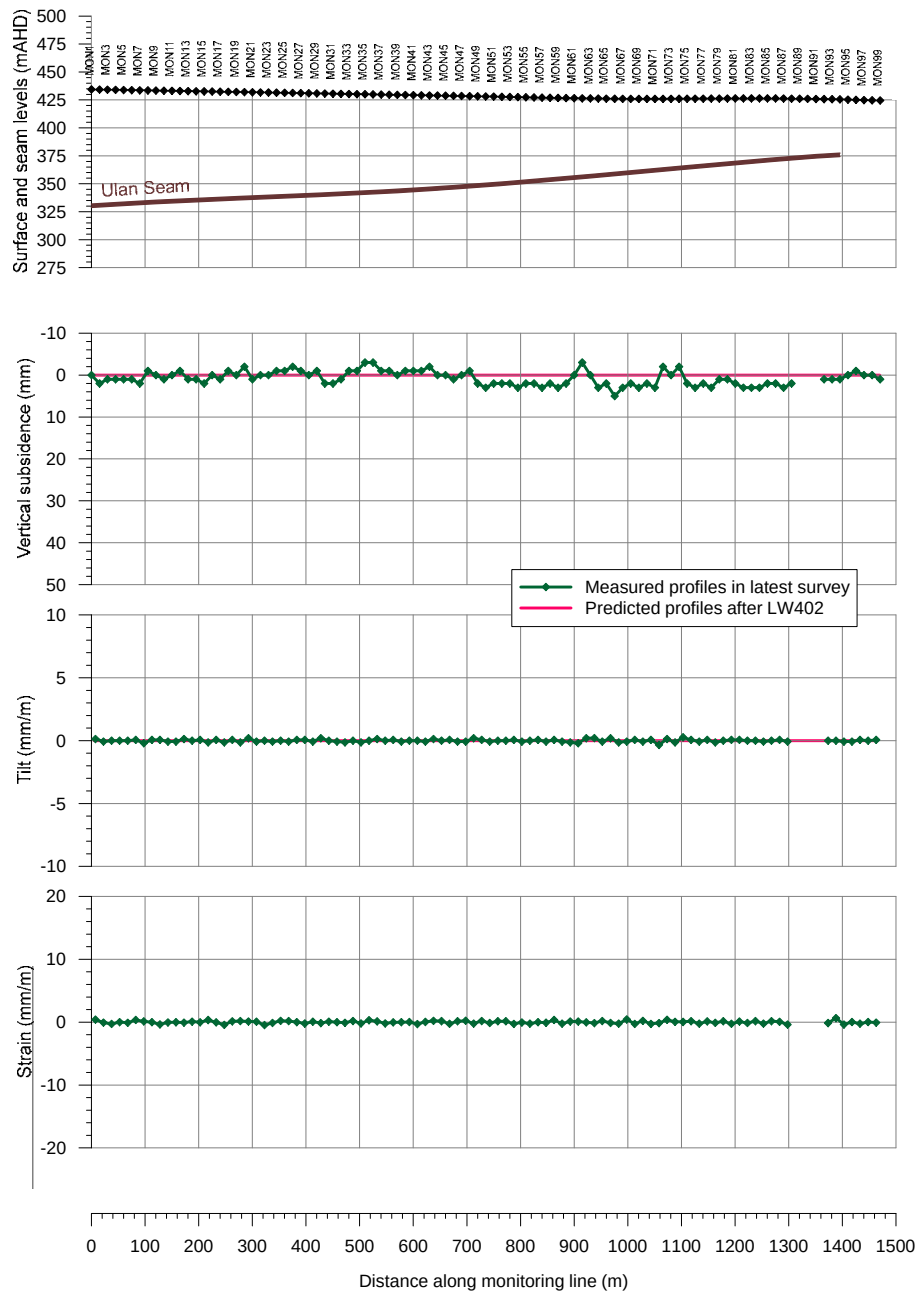
**Fig. 2.7 Measured vertical subsidence, tilt and strain along the ARTC2 Line**

The profiles of measured vertical subsidence, tilt and strain along the ARTC2 Line are shown in Fig. 2.7. Only low-level vertical subsidence within the level of survey accuracy was measured along the ARTC2 Line. The maximum subsidence was less than 5 mm.

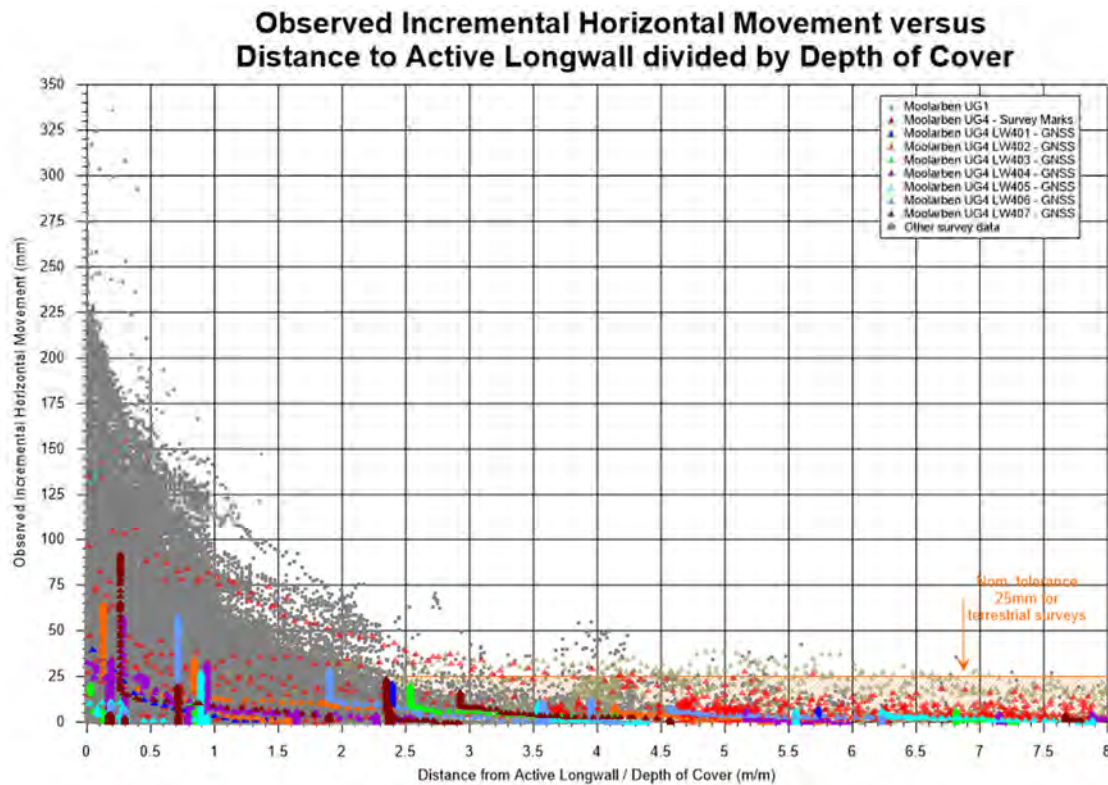
**Fig. 2.11** Observed incremental horizontal movement versus distance to active longwall divided by depth of cover

It can be seen in Fig. 2.11 that MCC survey data is generally within the range of data from other regions in NSW. The majority of the GNSS monitoring data points indicates horizontal movements significantly less than the upper limits of the observed data.

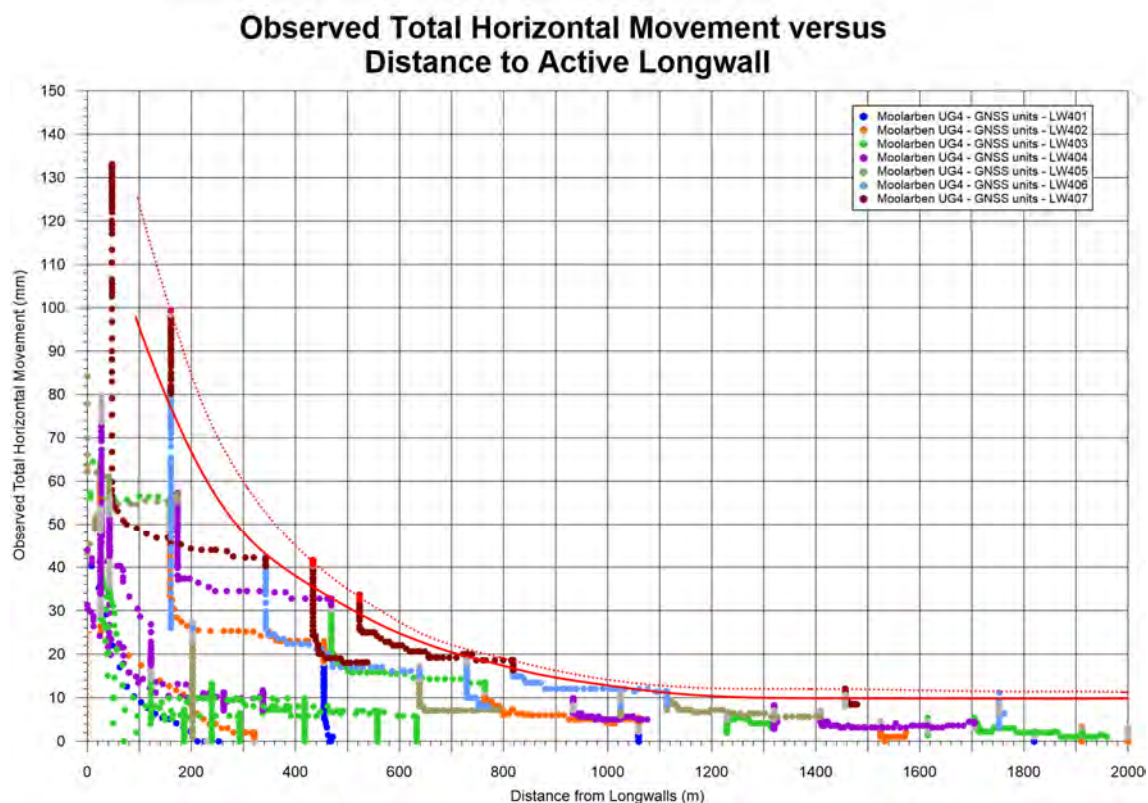
**Fig. 2.12 Observed total horizontal movement versus distance to active longwall – UG4 GNSS**

The accumulated total horizontal movement data in Fig. 2.12 shows the observed total far-field horizontal movement data ahead of the advancing UG4 longwalls. A red dashed upper bound line shown in Fig. 2.12 identifies the maximum observed total far-field horizontal movements for UG4. A red solid upper bound line shown in Fig. 2.12 represents a previous update to the data conducted in June 2025. It can be seen that the maxima have increased slightly from June 2025 to March 2026, which is expected at low magnitudes of movement and the accumulation of data.

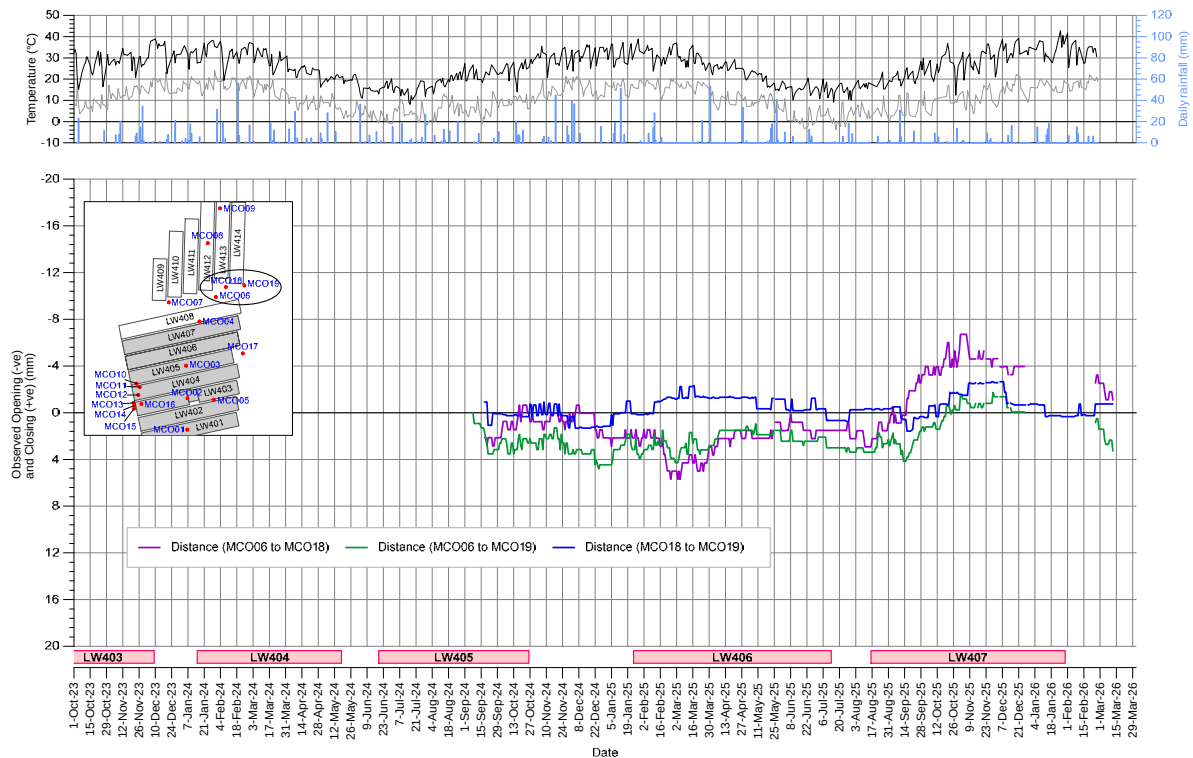
**Fig. 2.15 Total observed opening and closure movements at CL3**

The data presented in Fig. 2.15 represents the observed differential movements between the GNSS units since LW405, following the installation of MCO18 and MCO19. The observed differential movements showed minor development of opening during the extraction of LW407, with a maximum of -7 mm between MCO06 and MCO18. This magnitude of differential movement is small and within the limits of accuracy of the GNSS units. Given horizontal movements were observed at these GNSS units, it is considered that the observed minor opening is accurately represented. On this basis, no changes to predictions are required.

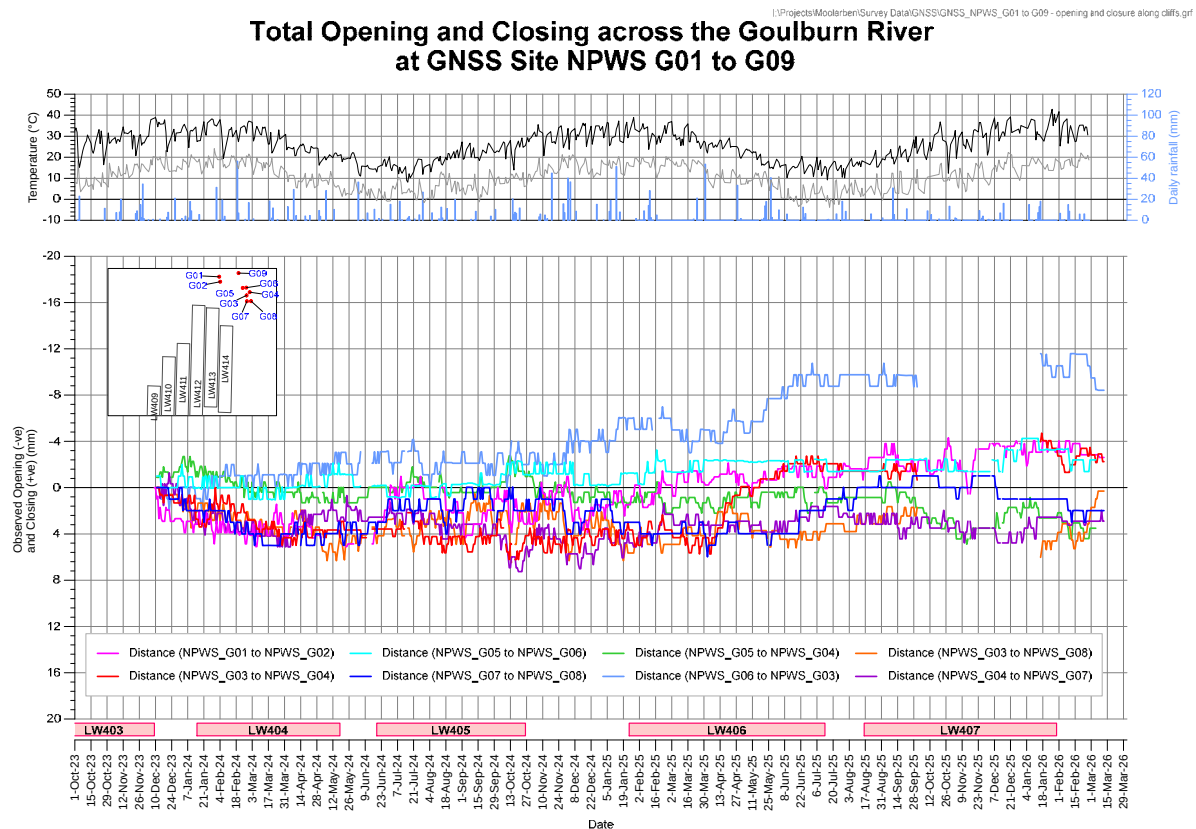
**Fig. 2.16** Total observed opening and closure across the Goulburn River near The Drip and Corner Gorge

With the exception of NPWS\_G06 to NPWS\_G03, the observed opening and closing movements across the Goulburn River vary from 7 mm to -4 mm, with the data predominantly within the limits of accuracy of the GNSS units. An opening movement of -11 mm was observed between NPWS\_G06 to NPWS\_G03 during the extraction of LW407. Given no similar movements were observed across the Goulburn River between the other GNSS units at Goulburn River Gorge, it is considered that this data is not representative of the overall opening/closing movements observed. A repair was carried out to NPWS\_G03; therefore, accuracy of the data prior to the repair may have been impaired.

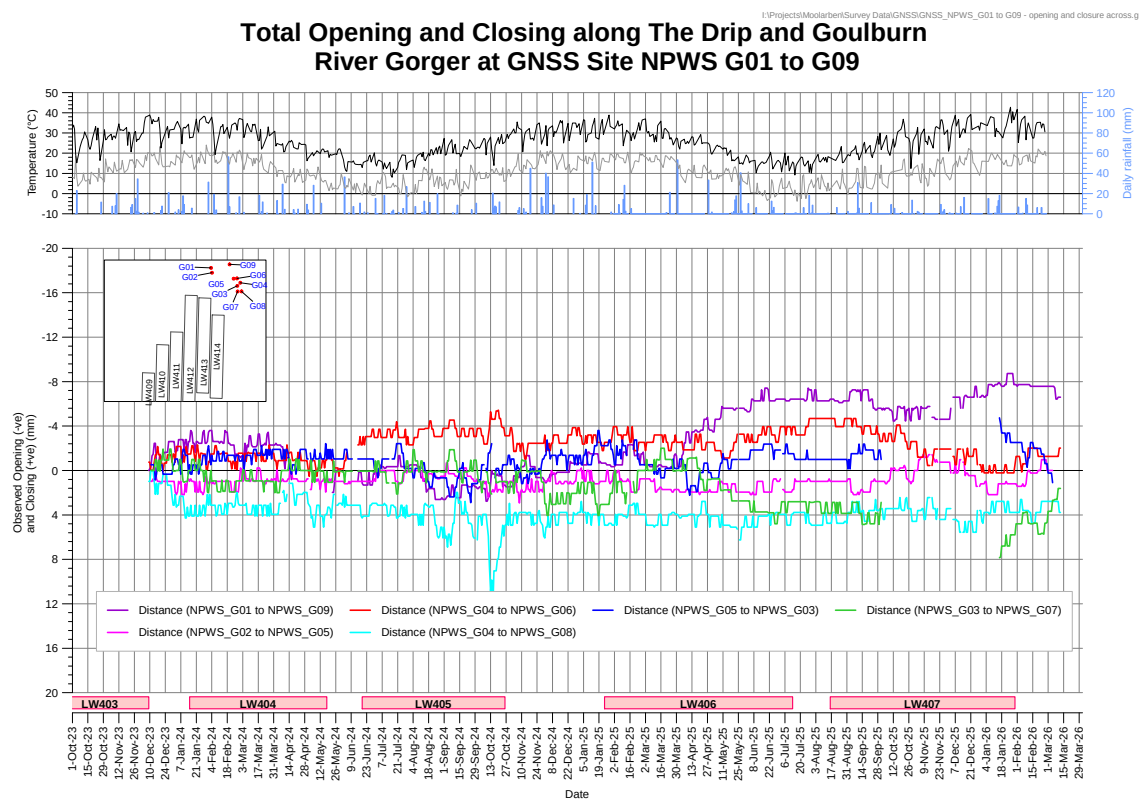
**Fig. 2.17** Total observed opening and closure along cliffs at The Drip and Corner Gorge

The observed opening and closing movements along the alignments of The Drip and Goulburn River Gorge Goulburn River vary from 12 mm to -9 mm, with the data predominantly within the limits of accuracy of the GNSS units. The maximum observed closure of 12 mm is shown as a spike in the data of NPWS\_G04 to NPWS\_G08 and is likely do to a short term loss of accuracy. The maximum opening of -9 mm occurs between NPWS\_G01 to NPWS\_G09. Given no similar movements were observed between the other GNSS units, it is considered that this data is not representative of the overall opening/closing movements observed. A repair was carried out to NPWS\_G09; therefore, accuracy of the data prior to the repair may have been impaired. On this basis, no changes to predictions are required.

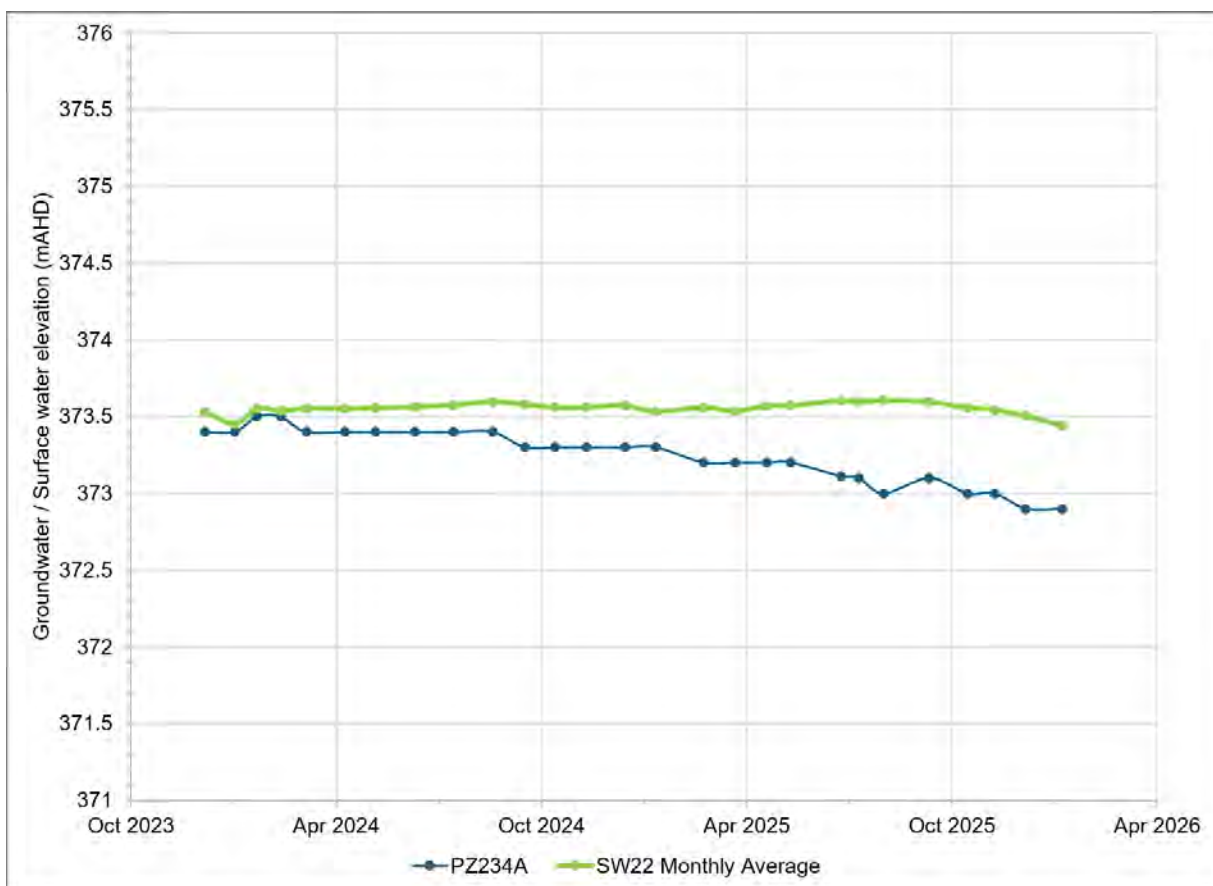
Figure 3.4 PZ234A / SW22 water level comparison

The declining groundwater level trend observed at PZ234A is not related to the UG4 mining activities but rather a higher responsiveness of the aquifer to climate conditions at this location due to drier periods below rainfall averages. This is supported by the absence of observed impacts at monitoring bore PZ236C, which is located closer to the active mine footprint and a similar declining trend observed at the nearby monitoring bore PZ105C, where the long-term groundwater level time series is aligned with the CRD (Section 3.2).

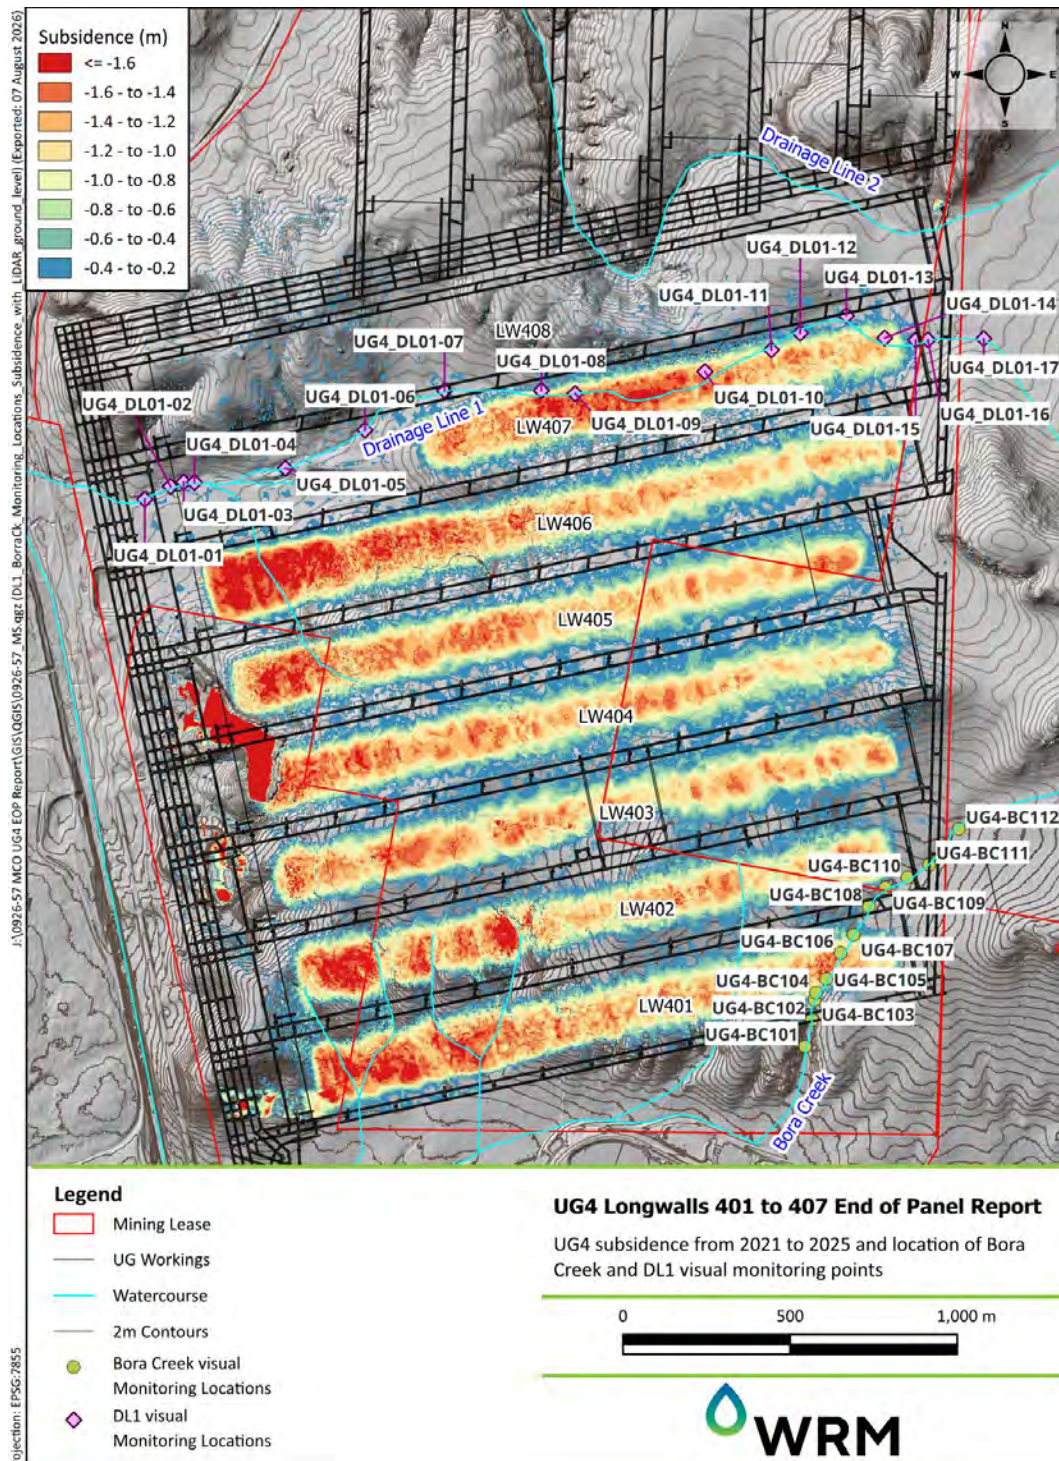
**Figure 4.1 UG4 subsidence from 2021 to 2025 and location of Bora Creek and DL1 visual monitoring points**

Bora Creek was directly undermined by LW401 to LW402 between July 2022 and March 2023. Figure 4.1 shows a comparison of Lidar ground levels for Bora Creek between February 2021 (i.e. pre-mining) and December 2024 (i.e. post-mining).

- visual inspections from 12 monitoring sites show minor cracking at some locations, consistent with Extraction Plan predictions.
- potential headcut observed at BC105, however this area experienced reduction in grade due to subsidence (see Figure 4.2), therefore any change in erosion characteristics is due to natural variability and is not mining related.

DL1 was directly undermined by LW407 between August 2025 and January 2026. Figure 4.1 shows a comparison of Lidar ground levels for DL1 between February 2021 (i.e. pre-mining) and December 2025 (i.e. during mining).

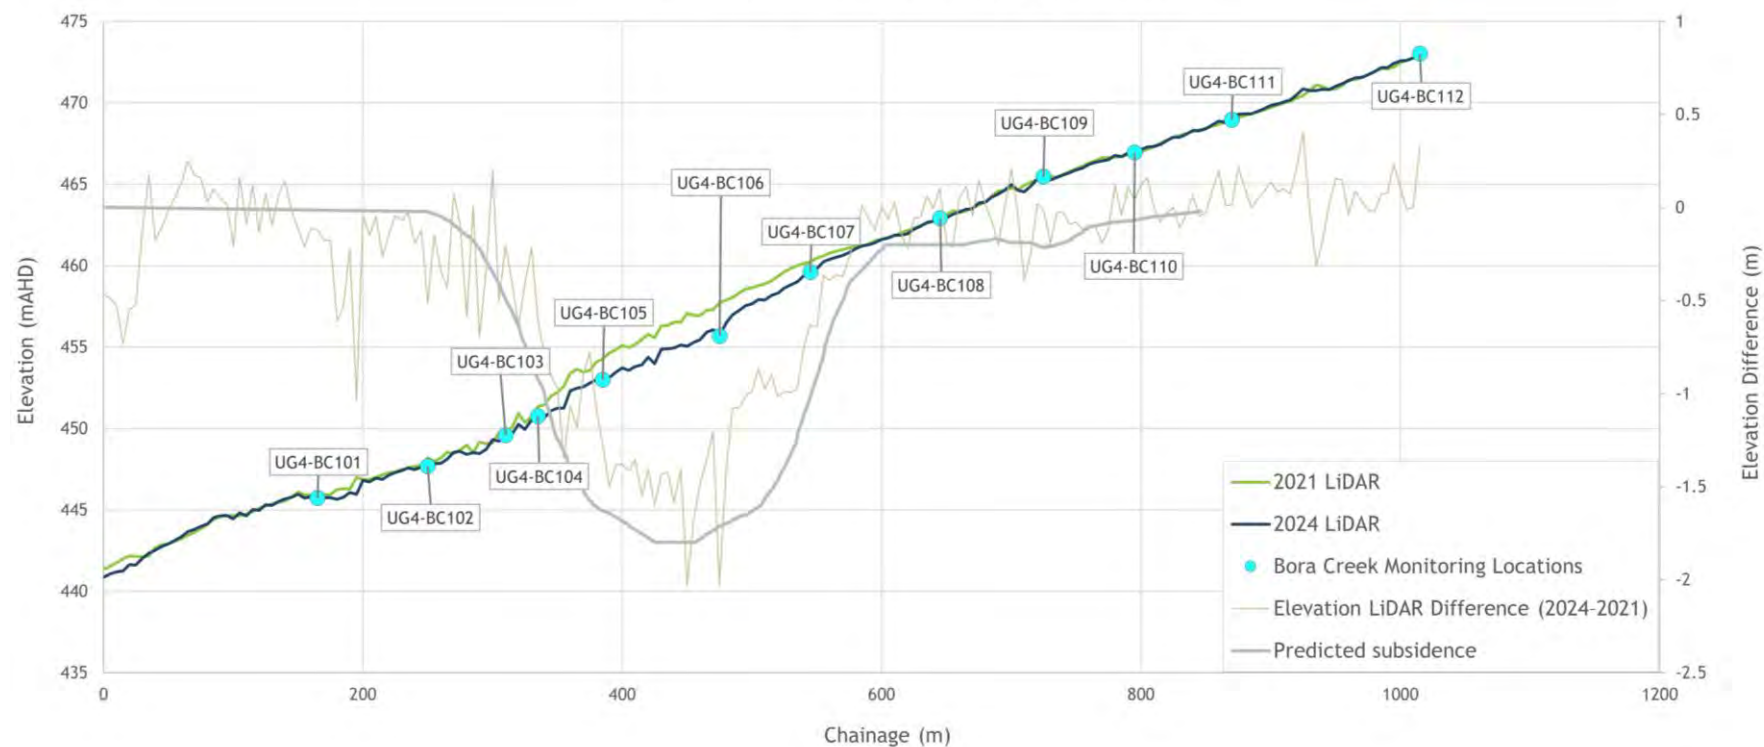
**Figure 4.2 Bora Creek longitudinal section**

Figure 4.2 shows a longitudinal section of Bora Creek between the 2021 and 2024 Lidar, including subsidence predictions from MSEC (2021). The locations of monitoring points along Bora Creek are shown in Figure 4.1 and Figure 4.2. The extent and magnitude of subsidence is consistent with the predictions.

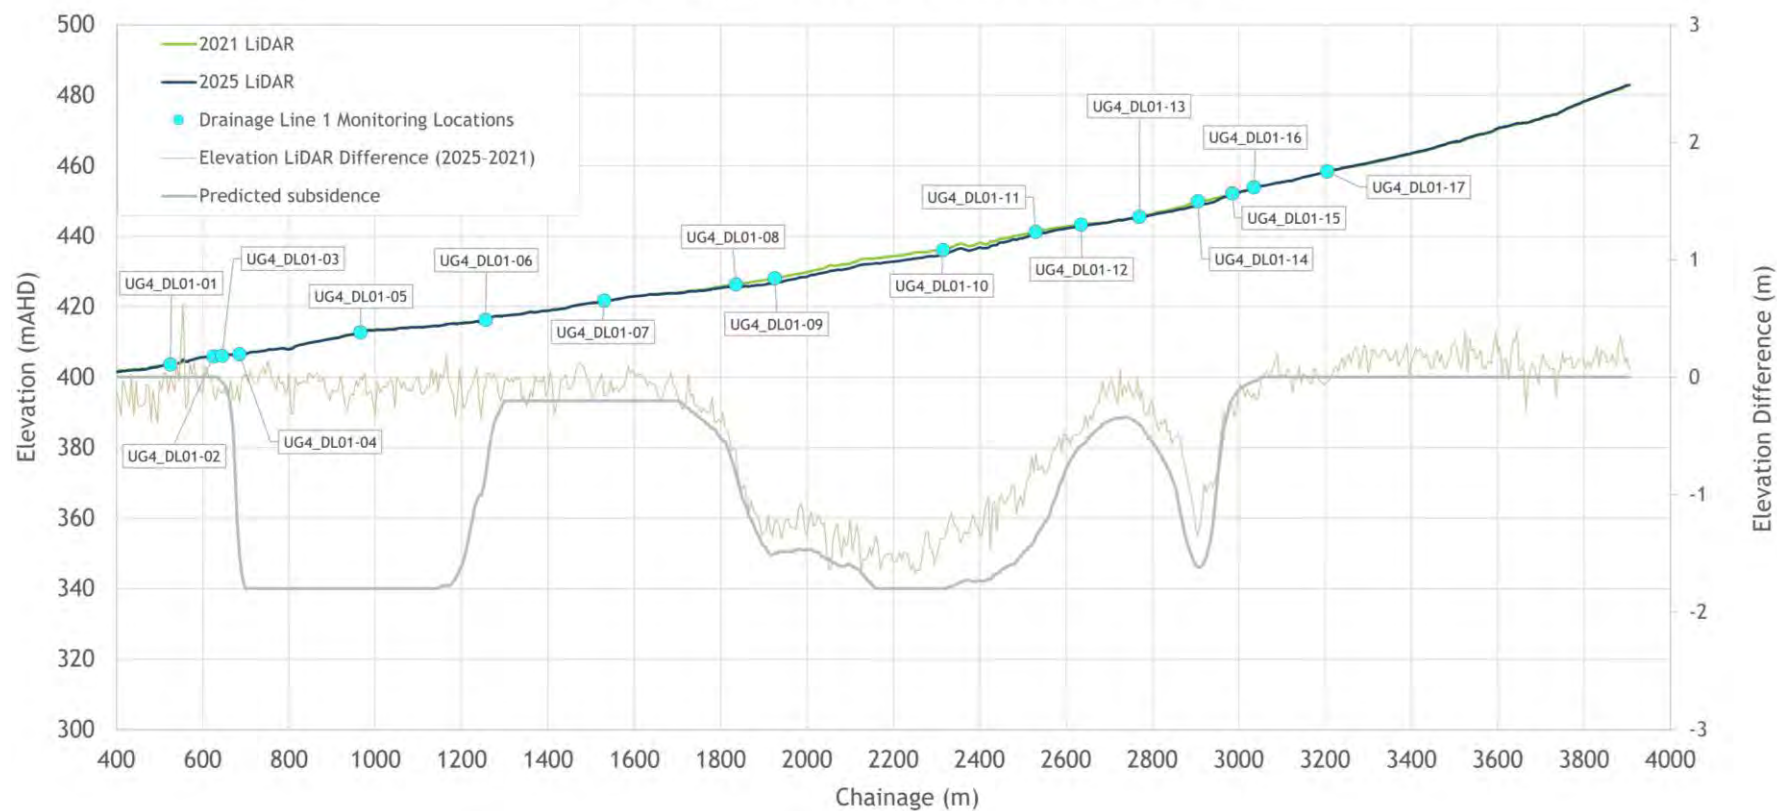
**Figure 4.3 DL1 longitudinal section**

Figure 4.3 shows a longitudinal section of DL1 from the 2021 and 2025 Lidar, including subsidence predictions from MSEC (2021). The locations of monitoring points along DL1 are shown in Figure 4.1. The extent and magnitude of subsidence are consistent with the predictions, noting that mining of LW407 was partially complete at the time of the Lidar survey (therefore observed subsidence around DL01-05 has not yet been recorded).

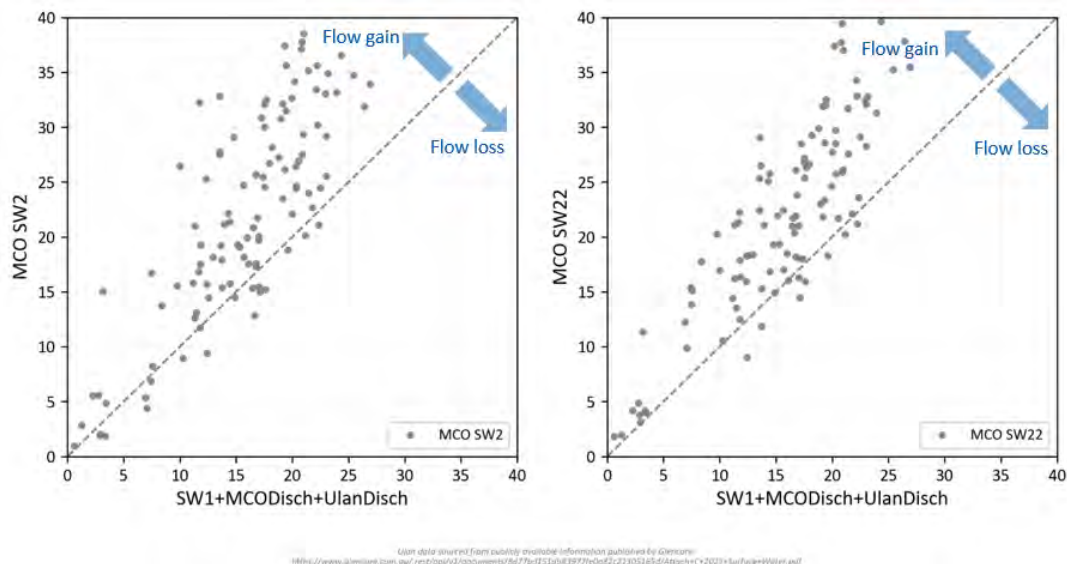
Figure 4.6 7-day average flow volume (ML/d) at Goulburn River gauges Ulan SW01 (+ treated water discharges from Ulan and MCO) and MCO SW02, MCO SW22, Dec 2023 to Dec 2025

Figure 4.6 compares 7-day total flow from Ulan SW01 and treated water discharges from Ulan Mine and MCO (horizontal axis) with flow at the downstream MCO SW02 and SW22 gauges (vertical axis). If there was no gain or loss of flow along the reach between the Ulan SW01 and MCO SW02/SW22 gauges, then the points would plot along the diagonal equivalence line (noting that some variability would be expected due to limited accuracy of rating curves). Points would plot below the line if the reach was losing flow, and above the line if the reach was gaining flow.

The plotted points show that there is generally a gain in flow along this reach (i.e. adjacent to LW401-408), as would be expected with increasing catchment area and inflows from Bora Creek and DL1. Some points show a minor flow loss (less than 3 megalitres per day [ML/d]) consistent with normal seepage and evaporation loss under dry conditions.

MCO SW02 and MCO SW22 are located upstream and downstream respectively of The Drip. Allowing for the accuracy of stream flow recording (typically of the order of +/- 20 percent [%]) the data shows no loss of flow along the Goulburn River from upstream of UG4 to downstream of The Drip.

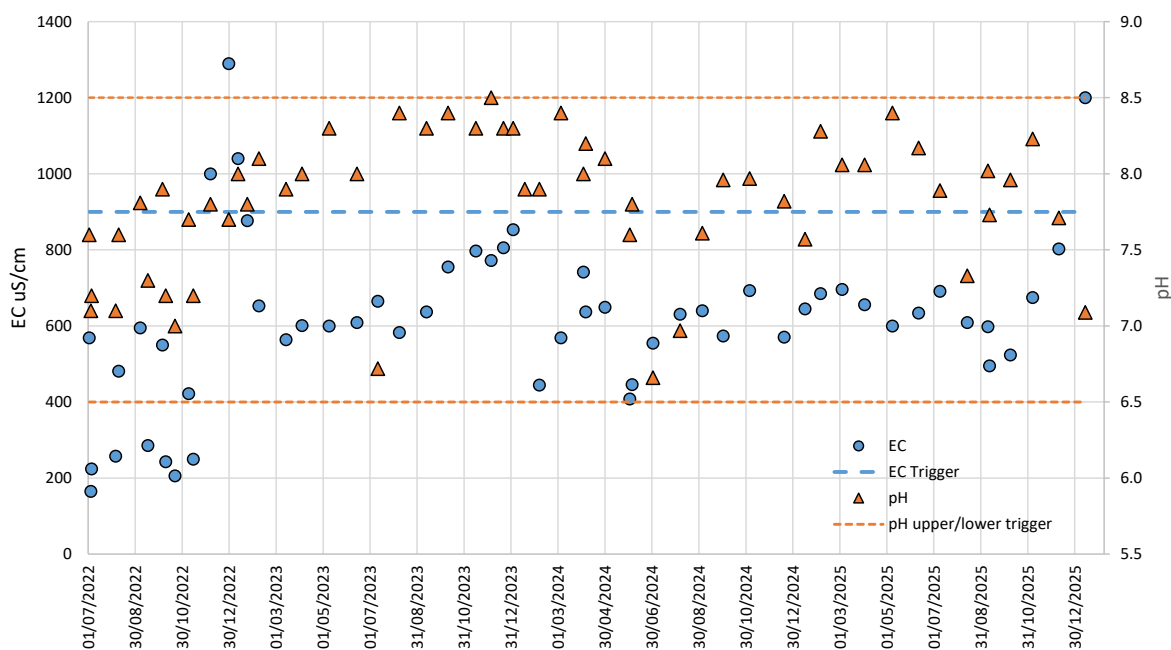
**Figure 4.4 Goulburn River water quality, pH & EC – MCO SW01**

Figure 4.4 shows a time series of recorded electrical conductivity (EC) and pH in the Goulburn River at MCO SW01 from monthly and event sampling, compared to the trigger investigation levels. Turbidity values are shown in Figure 4.5:

- All pH values are within the upper and lower trigger levels.
- The data shows one trigger event (two consecutive monthly values exceeding the trigger level) for EC in December 2022/January 2023 (Figure 4.7). Monitoring data from the upstream site, MCO SW12 (see Figure 3.1) shows EC values up to 1,270  $\mu\text{S}/\text{cm}$  in December 2022 and 1500  $\mu\text{S}/\text{cm}$  in January 2023. This indicates that the elevated EC values in December 2022/January 2023 were due to high EC from the upstream catchment and were not caused by extraction of LW401 to LW407.
