**RE: MOOLARBEN COAL COMPLEX – UG4 LONGWALLS 401 TO 407 END OF PANEL REPORT**

Secondary extraction of LW407 was completed in January 2026. Accordingly, MCO has prepared a UG4 LW401-407 End of Panel Report (refer to **Enclosure 1**), which presents monitoring data, describes observed impacts during mining of LW401-407 and compares these results to predictions and relevant performance measures and performance indicators as described in the approved UG4 LW401-408 Extraction Plan.

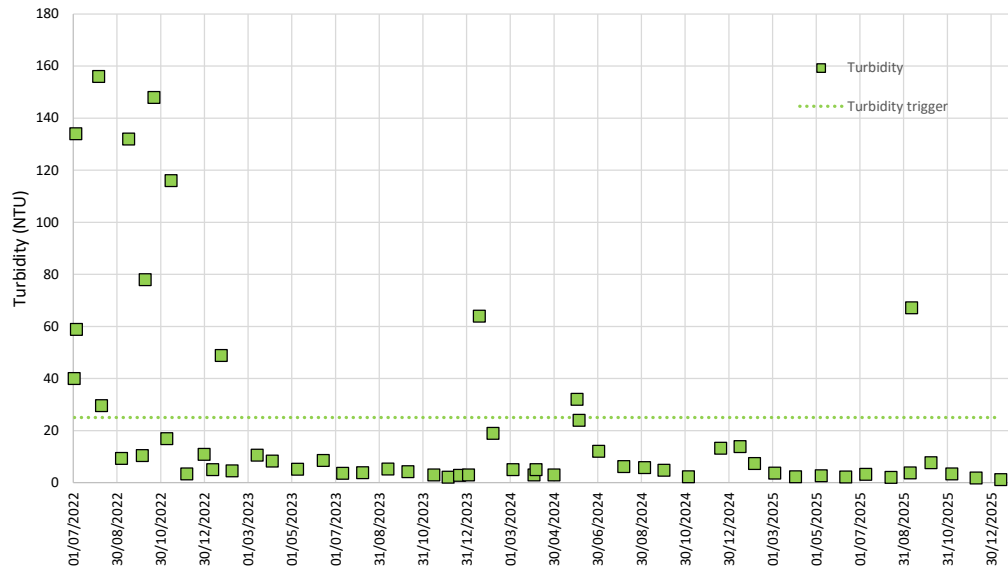
Figure 4.5 Goulburn River water quality, turbidity – MCO SW01

- The data shows one trigger event (two consecutive monthly values exceeding the trigger level) in July/August 2022 (Figure 4.8). This corresponded to a period of high rainfall during the reporting period. Monitoring data from MCO SW12 (see Figure 3.1) show up to 163 NTU between July and August 2022. This indicates that the elevated turbidity values in 2022 were due to high turbidity from the upstream catchment and were not caused by extraction of LW401 to LW407.

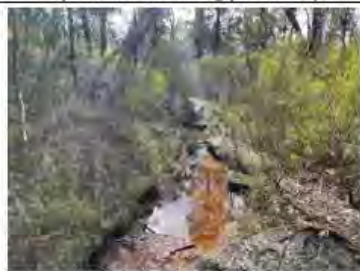
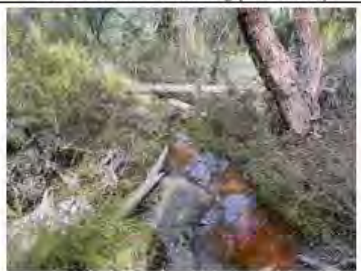
| Upstream – Pre-mining (29 June 22) | Downstream – Pre-mining (29 June 22) |

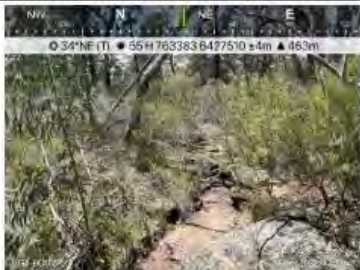
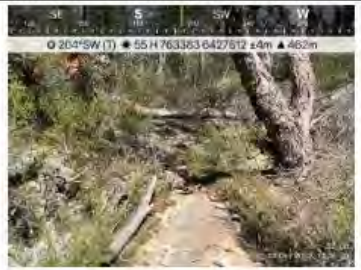
| Upstream – Pre-mining (29 June 22) | Downstream – Pre-mining (29 June 22) |
|---|---|
| Upstream – Post-mining LW401 (18 October 22) | Downstream – Post-mining LW401 (18 October 22) |

| <p><b>Post Mining Conditions:</b></p> <p><b>18 October 22:</b> Site dry where previously trickling. Vegetation consistent with previous. Minor cracking and slabbing of creek bed evident. Evidence of high velocity flow events scouring creek bed. Evidence of freshly broken cobbles being transported downstream. Observations consistent with the MSEC (2021) predictions of fracturing, dilation and buckling of the bedrock and that a portion of surface water flow could be diverted into the strata below the beds.</p> | |
| <p>Erosion in stream bed with potential to develop into active head cut upstream of UG4-BC105 (~763,411mE; 6,427,551mN) was noted.</p> | |

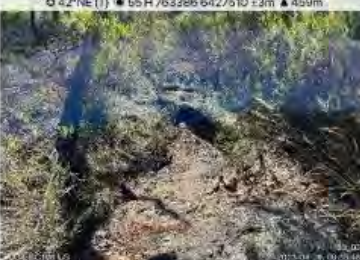
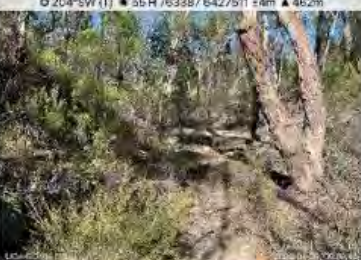
| Upstream – Post-mining LW402 (26 April 23) | Downstream – Post-mining LW402 (26 April 23) |

| <p><b>26 April 23:</b> Site dry. Channel conditions and vegetation consistent with previous considering seasonal conditions. Minor cracking and slabbing of creek bed consistent with previous. Observations consistent with the MSEC (2021) predictions of fracturing, dilation and buckling of the bedrock and that a portion of surface water flow could be diverted into the strata below the beds.</p> <p>Location of potential head cut upstream of UG4-BC105 consistent.</p> | |

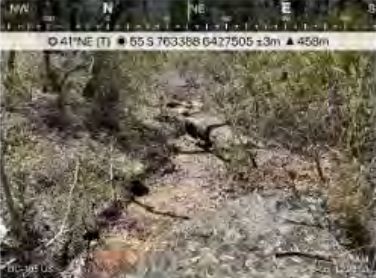
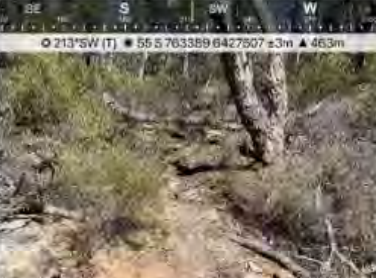
| <p><b>Upstream – Post-mining LW402 (6 October 23)</b></p> | <p><b>Downstream – Post-mining LW402 (6 October 23)</b></p> | <p><b>6 October 23:</b> Site dry. Channel conditions and vegetation consistent with previous. Minor cracking and slabbing of creek bed consistent with previous. Observations consistent with the MSEC (2021) predictions of fracturing, dilation and buckling of the bedrock and that a portion of surface water flow could be diverted into the strata below the beds.</p> <p>Location of potential head cut upstream of UG4-BC105 consistent with previous.</p> |

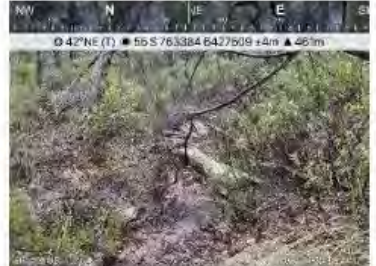
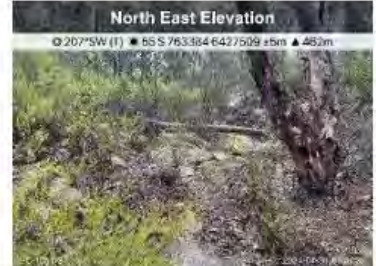
| <p><b>Upstream – Post-mining LW402 (30 April 24)</b></p> | <p><b>Downstream – Post-mining LW402 (30 April 24)</b></p> <p><b>North East Elevation</b></p> | <p><b>30 April 24:</b> Site dry. Channel conditions and vegetation consistent with previous. Minor cracking and slabbing of creek bed consistent with previous. Observations consistent with the MSEC (2021) predictions of fracturing, dilation and buckling of the bedrock and that a portion of surface water flow could be diverted into the strata below the beds.</p> <p>Location of potential head cut upstream of UG4-BC105 consistent with previous. Burrow evident in base on river right of head cut.</p> |

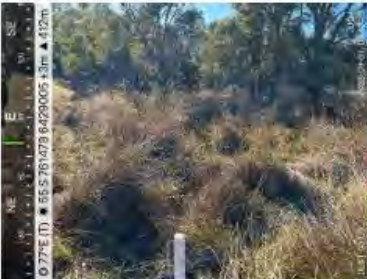
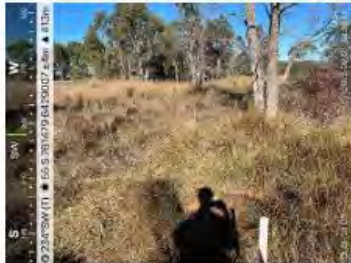
<table><tr><td>Site</td><td>UG4_DL01-03</td><td>Date</td><td>1/09/23</td><td>E (m)</td><td>761.480</td><td>N (m)</td><td>6.429.008</td></tr><tr><td colspan="4">Scour US of DL01-03. Dry with bank scours.</td><td colspan="4">Pre-Mining</td></tr></table>

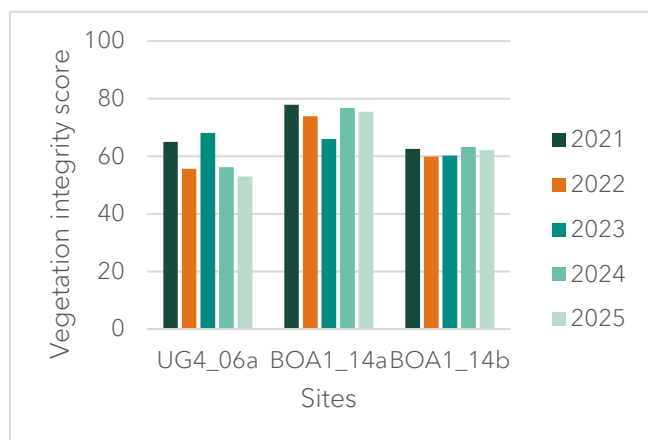
Chart 21: VIS at UG4\_06a and associated reference sites (2021-25)

The VIS in UG4\_06a fluctuated between 2021 to 2025 resulting in an overall decrease. Fluctuations were also observed in reference site BOA1\_14a over the same period, however the VIS in 2025 is still similar to that from 2021. Reference site BOA1\_14b remained relatively consistent over the same period (Chart 21).

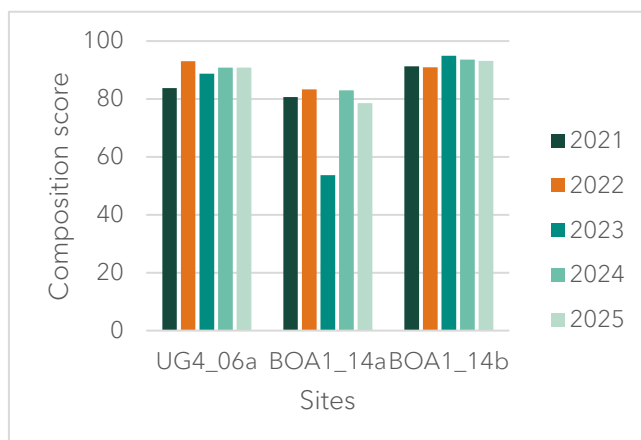
Chart 22: Composition scores at UG4\_06a and associated reference sites (2021-25)

The composition scores in UG4\_06a and reference site BOA1\_14b remained relatively consistent. A marked decrease and increase was observed in reference site BOA1\_14a between 2022 and 2023 and 2023 and 2024, respectively (Chart 22). This was driven by a reduction in forb richness.

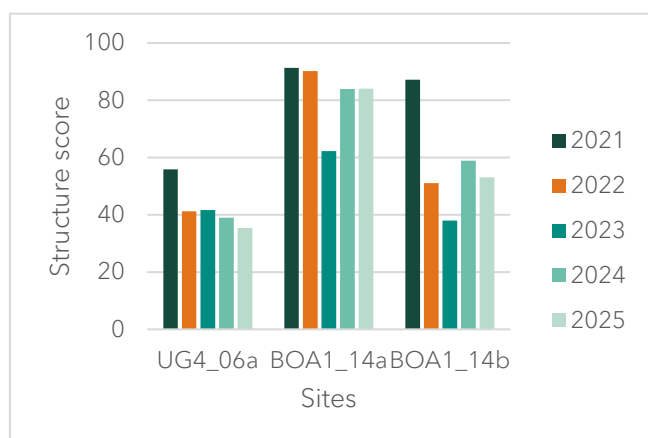
Chart 23: Structure scores at UG4\_06a and associated reference sites (2021-25)

The structure score in UG4\_06a decreased moderately from 2021 to 2022, driven by a reduction in grass cover, with marginal decreases observed from 2023 to 2025. A marked decrease and increase was observed in reference site BOA1\_14a between 2022 and 2023 and 2023 and 2024, respectively (Chart 23). This was driven by a reduction in shrub cover and an increase in canopy cover, respectively.

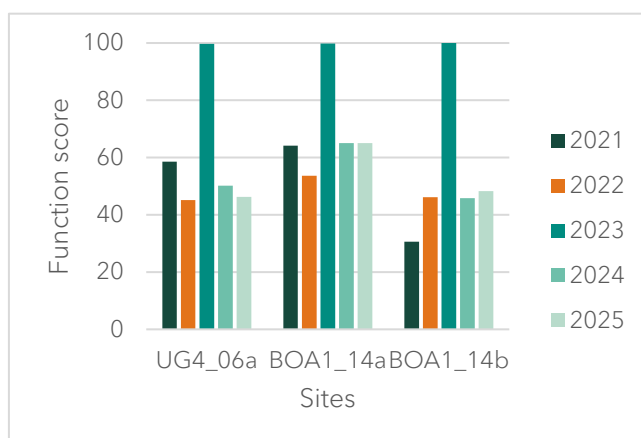
Chart 24: Function scores at UG4\_06a and associated reference sites (2021-25)

The function scores in UG4\_06a fluctuated significantly from 2022 to 2025. However, the fluctuations observed were consistent with results at both reference sites (Chart 24).

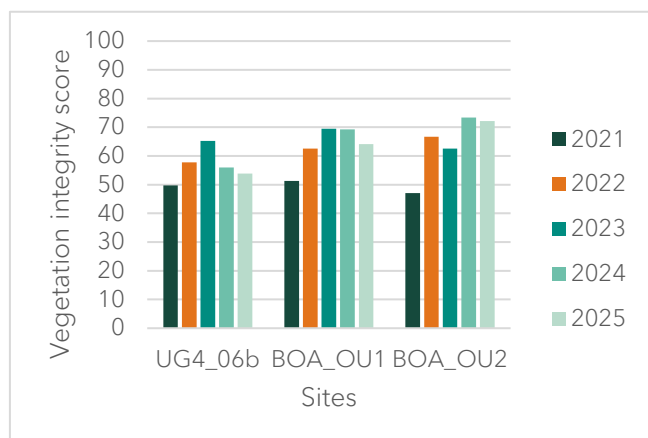
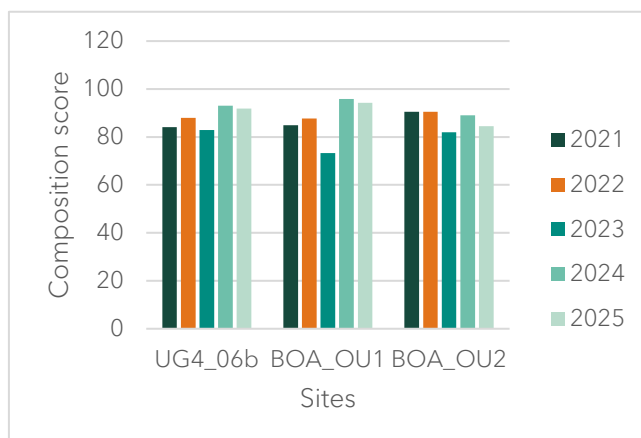
Chart 25: VIS at UG4\_06b and associated reference sites (2021-25)

Chart 26: Composition scores at UG4\_06b and associated reference sites (2021-25)

Fluctuations in the VIS and composition scores in UG4\_06b were comparable to those observed in the reference sites (Chart 25, Chart 26).

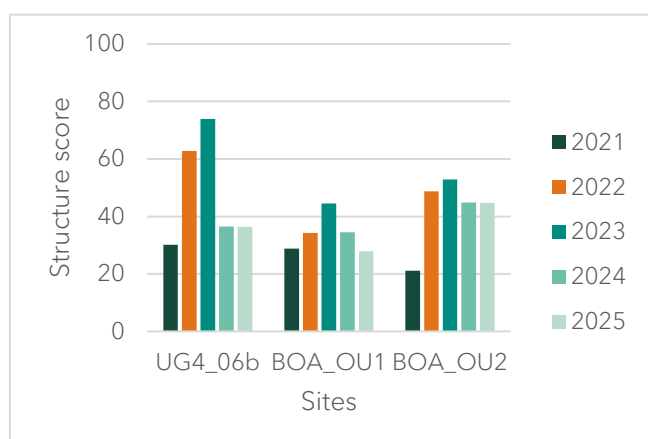
Chart 27: Structure scores at UG4\_06b and associated reference sites (2021-25)

The structure scores in UG4\_06b increased markedly between 2021 and 2022, which may have been influenced by above average rainfall over this period (Annex 1), and decreased markedly between 2023 and 2024 driven by an increase and a decrease in canopy cover, respectively. Similar moderate fluctuations were observed in the reference sites (Chart 27).

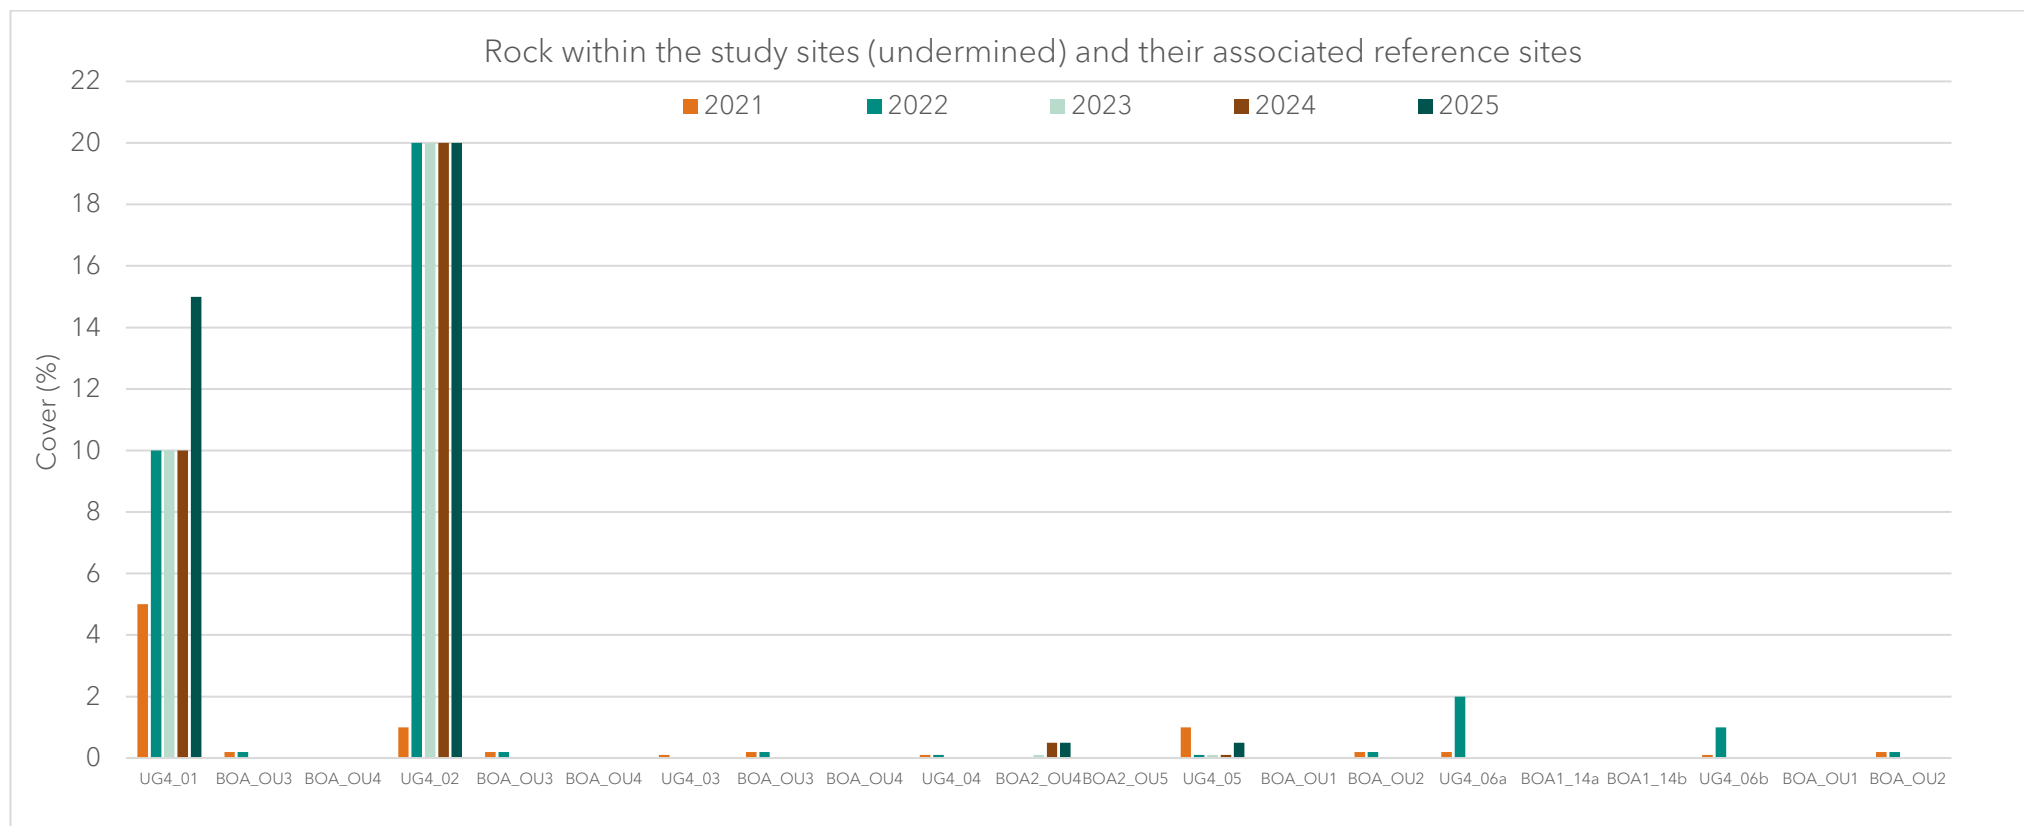
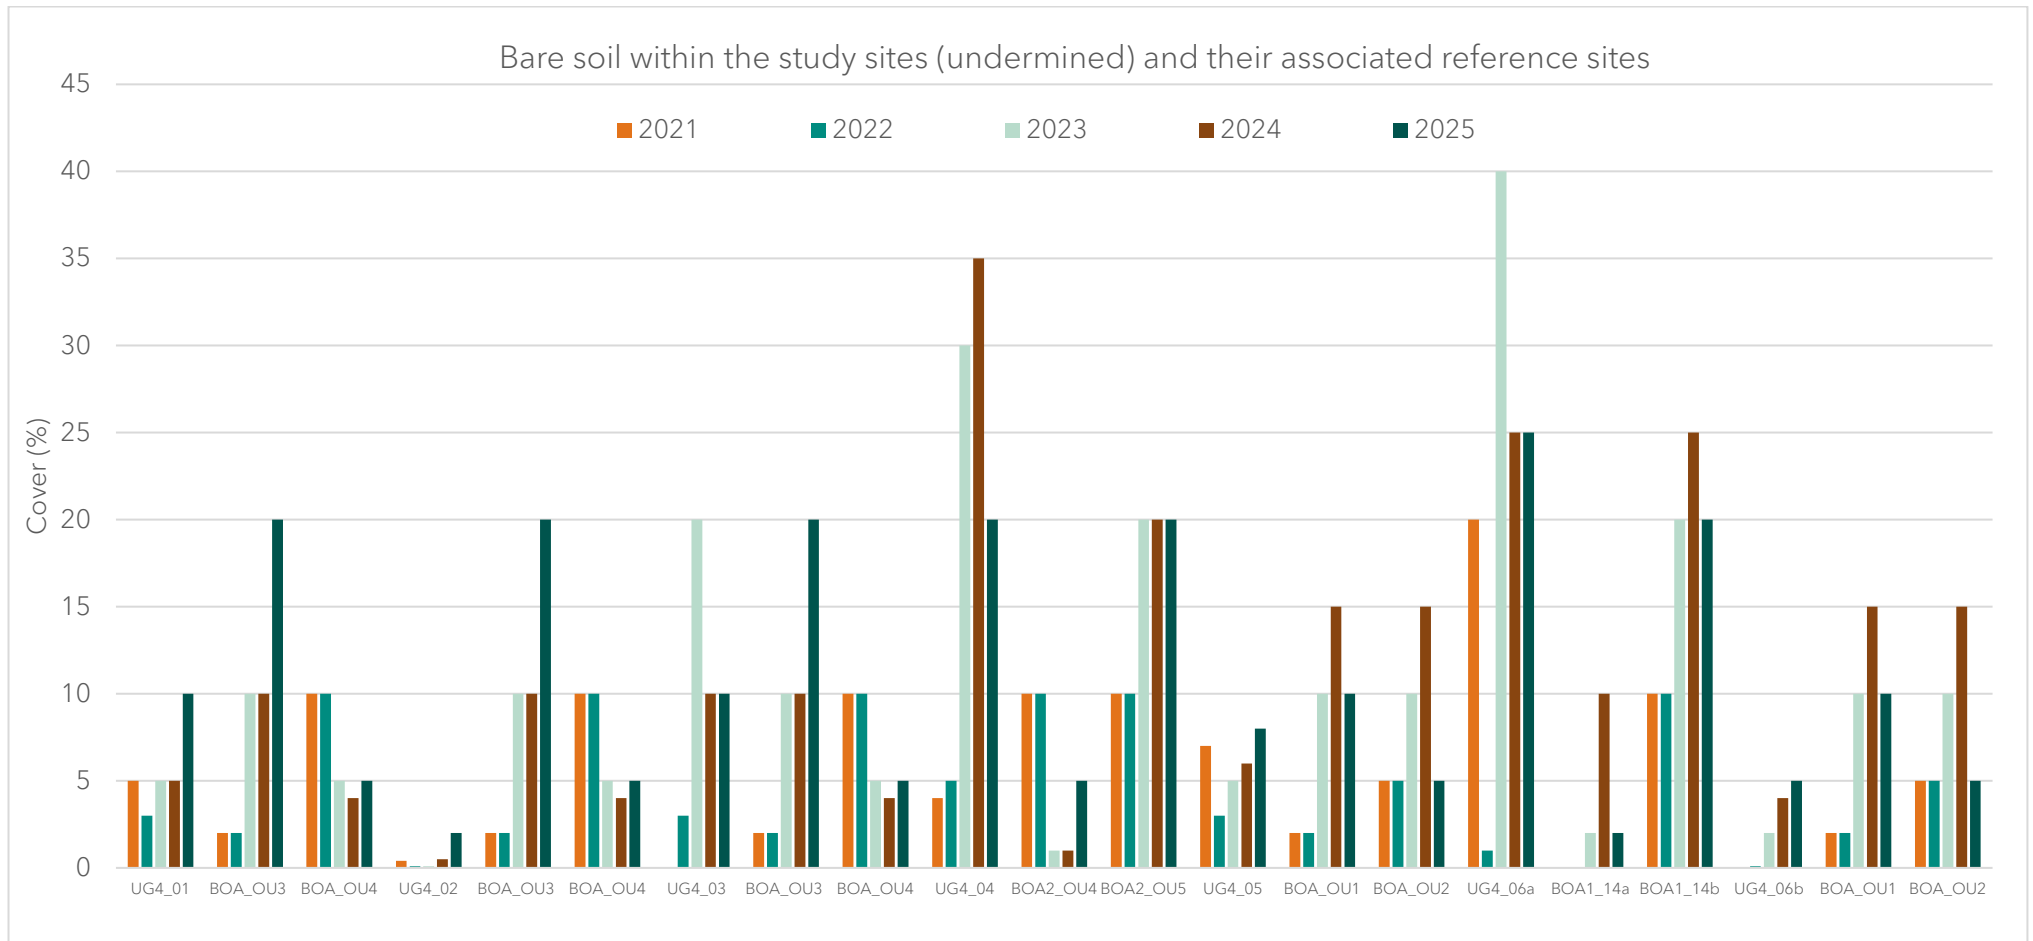
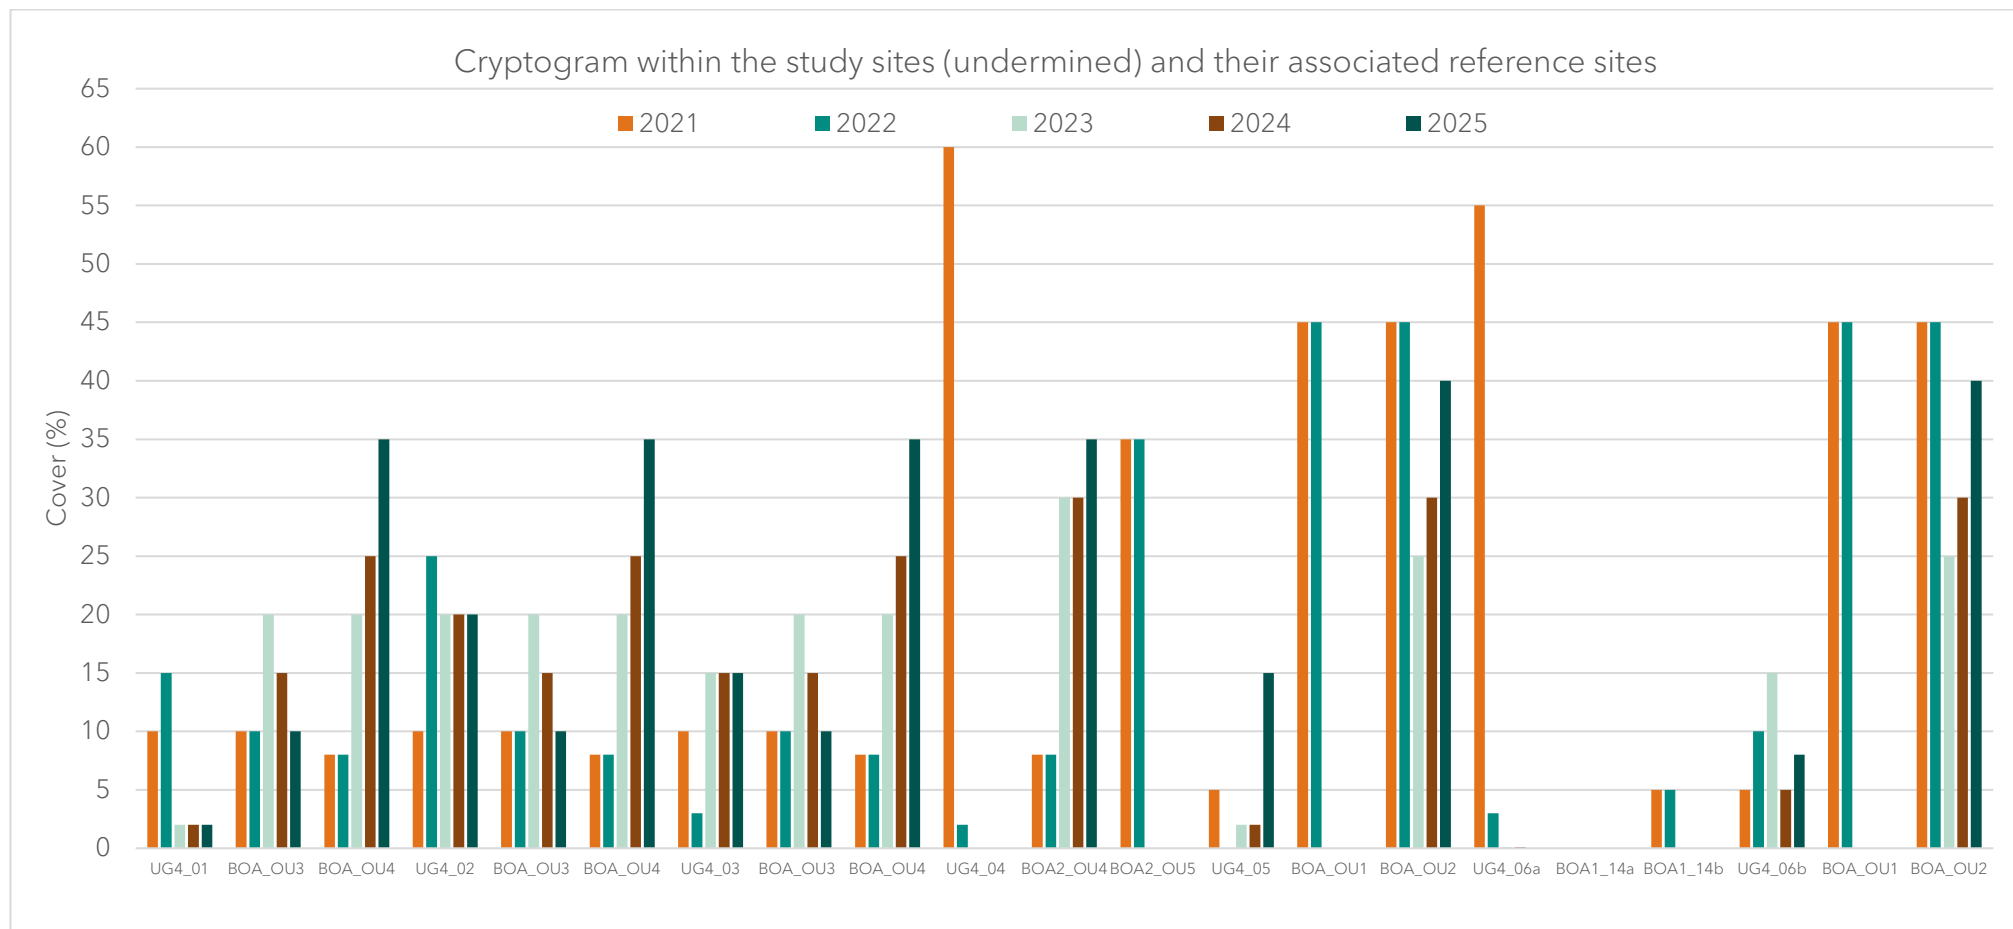
Chart 29. A comparison of the rock cover (%) in the study sites (undermined) and their associated reference sites from 2021 – 2025

Chart 30. A comparison of the bare soil cover (%) in the study sites (undermined) and their associated reference sites from 2021 - 2025

Chart 31. A comparison of the cryptogram cover (%) in the study sites (undermined) and their associated reference sites from 2021 - 2025

Cryptogram cover (primarily Coral Lichen *Pulchrocladia retipora*) remained relatively consistent in UG4\_02, UG4\_03, and UG4\_06b between 2021 and 2025. UG4\_01 experienced a moderate decrease in 2023 which was also observed in 2024 and 2025, while the associated reference sites experienced moderate increases in cover. A marked decrease in cover was observed in UG4\_04 in 2022, decreasing further to no cover in 2023-2025. This reduction may have been influenced by a reduction in yearly rainfall since 2022 (Annex 1), as a marked decrease was also observed in the associated reference site BOA2\_OU5. In UG4\_05, a moderate increase in cryptogram cover was observed in 2025 which was also observed in the associated reference site BOA\_OU2. In UG4\_06a, cryptogram cover decreased markedly from 2021 to 2025, which was also observed in both associated reference sites (Chart 31). This reduction may have also been influenced by a reduction in yearly rainfall since 2022 (Annex 1)

The increase in the cover of bare soil and the fluctuation of cryptogram cover observed was likely due to natural variation, driven by the wetter than average conditions experienced in 2022 followed by drier conditions in 2023-2025 (Annex 1).

Overall, fluctuations in the cover of rock, bare soil and cryptogram cover observed from 2021 to 2025 in the study sites (undermined) were consistent with those observed in the associated reference sites (Chart 29 to Chart 31). The fluctuations observed were also consistent with the study sites (not undermined) and their associated reference sites (Annex 2, Chart 55 to Chart 57). Due to this, the fluctuations and/or trends observed are therefore considered to be due to natural variation (i.e., rainfall) and/or observer bias. These observations suggest that underground mining has not had a discernible impact on the ground cover attributes recorded in the study sites (undermined).

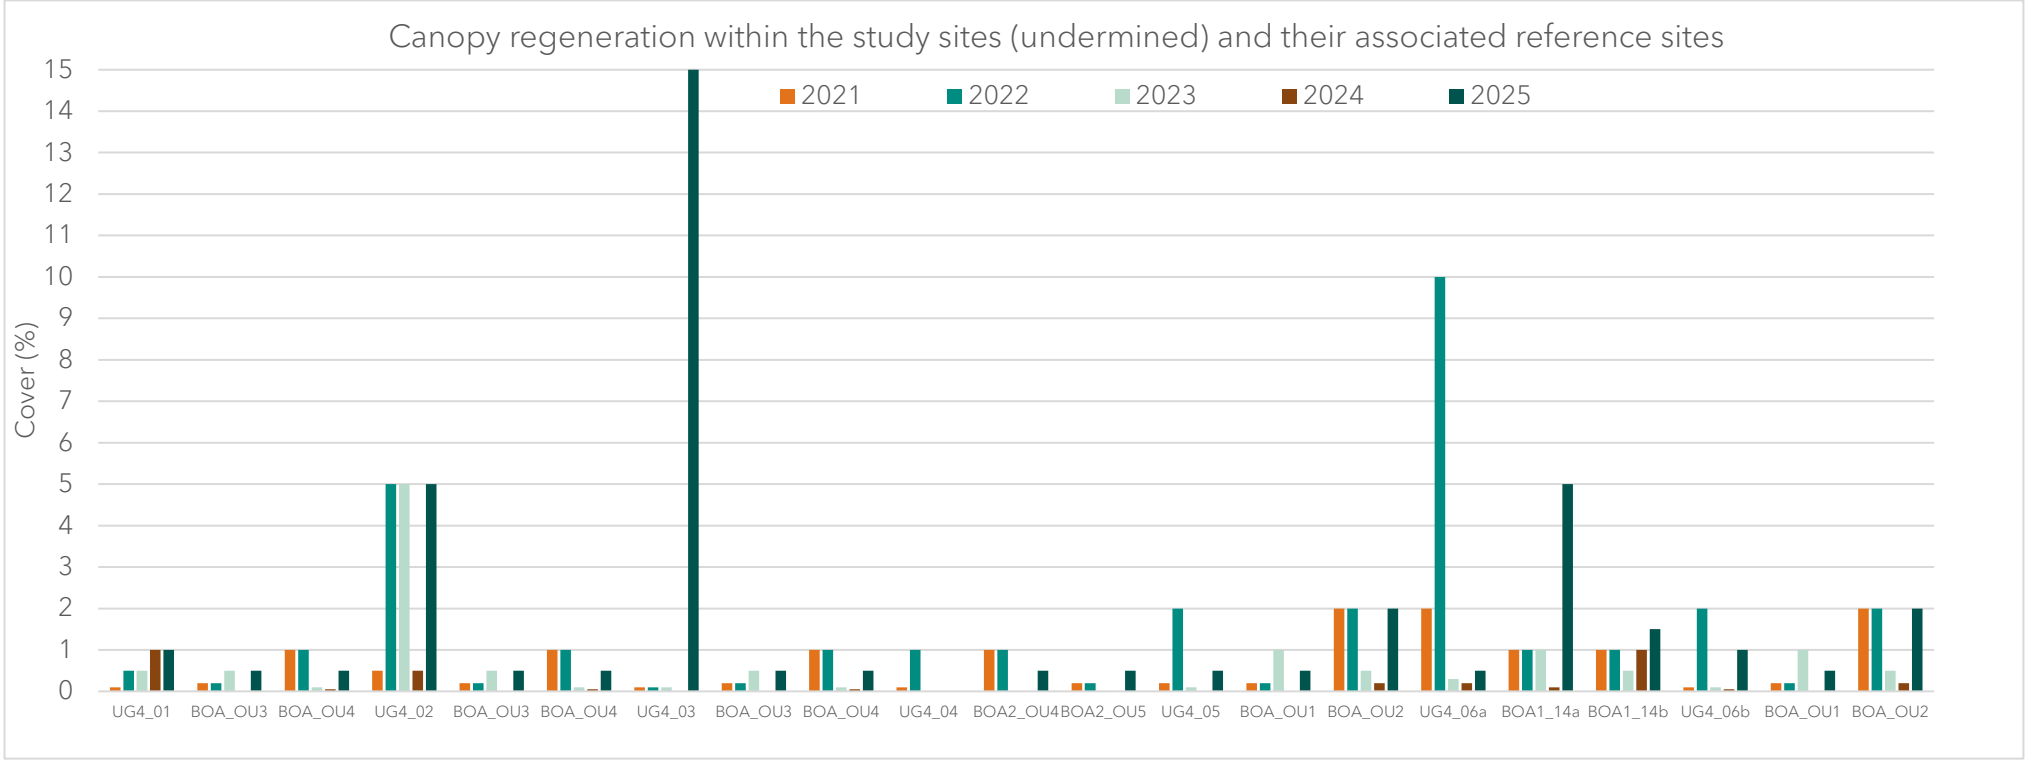
Chart 32. A comparison of the cover (%) of canopy regeneration in the study sites (undermined) and associated reference sites from 2021 - 2025

Canopy regeneration cover was between 0 – 5% from 2021 to 2025 except for UG4\_03 and UG4\_06a. UG4\_01, UG4\_04 and UG4\_06b experienced marginal fluctuations, with larger fluctuations observed in UG4\_02, UG4\_03, UG4\_05 and UG4\_06a. UG4\_02 decreased in canopy regeneration cover in 2024, which was also observed in the associated reference sites, but then returned to pre-existing levels in 2025 across all three sites. In UG4\_03, canopy regeneration cover remained at almost 0% for most years until 2025 when it increased to 15%. UG4\_05 also decreased in cover in 2023, remained low in 2024, and then increased again in 2025, with similar decreases and then increases in cover also observed in the associated reference sites. Both UG4\_06a and UG4\_06b (and their reference sites) all experienced an increase in canopy regeneration cover from 2024 to 2025 (Chart 32).

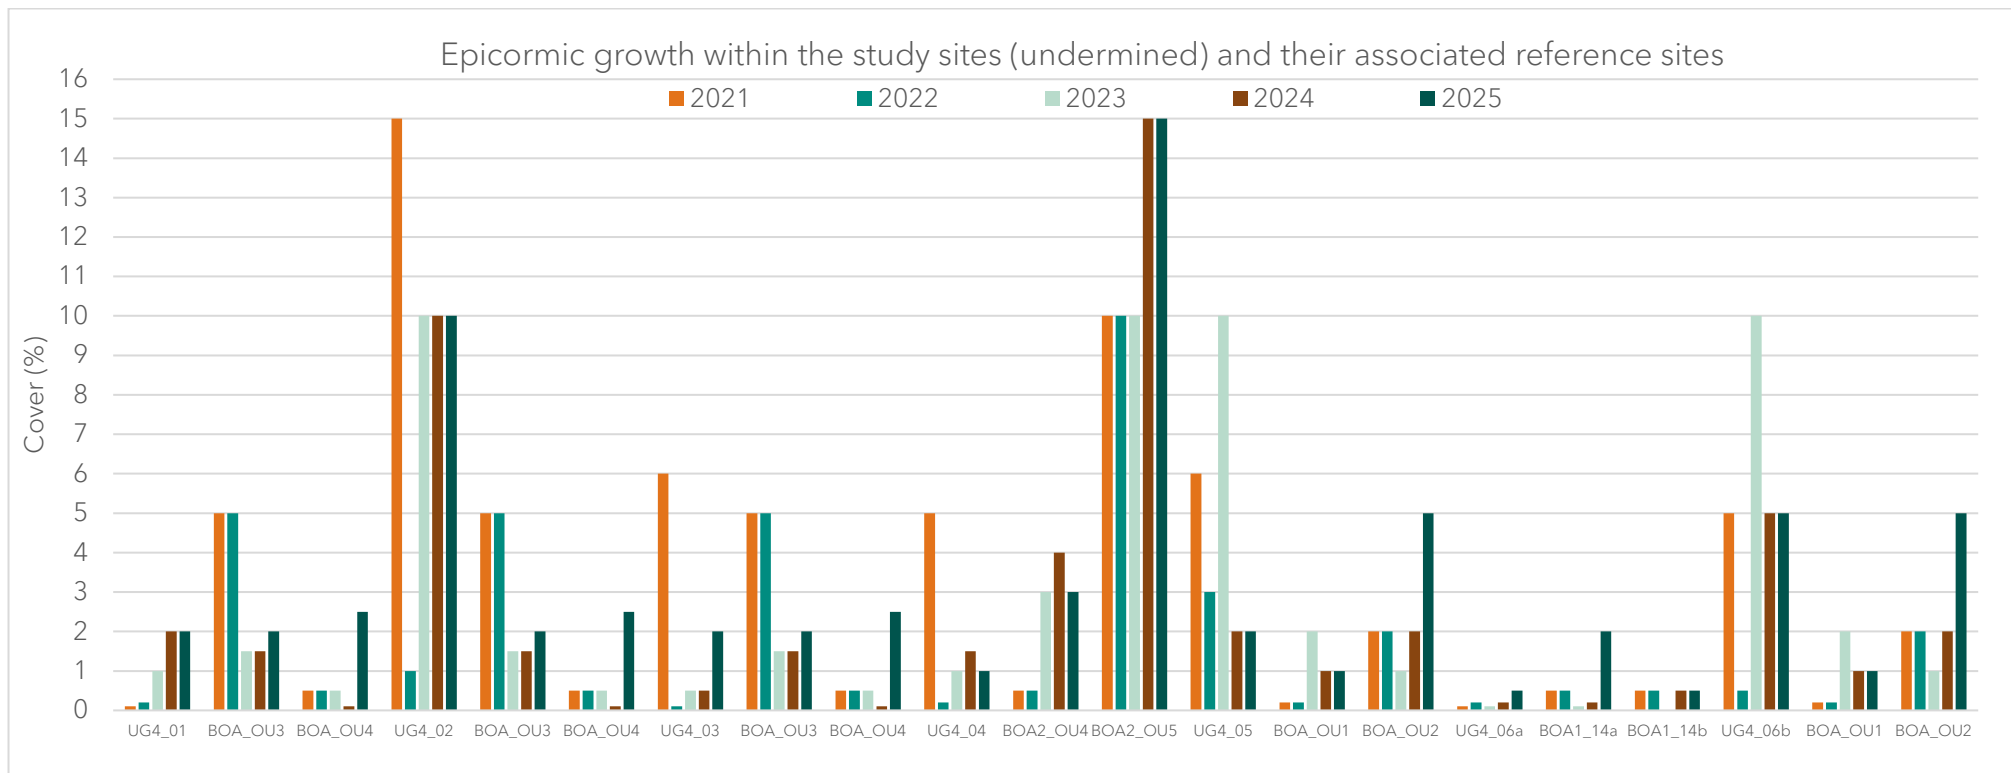
Chart 33. A comparison of the cover (%) of epicormic growth in the study sites (undermined) and associated reference sites from 2021 – 2025

Epicormic growth cover was between 0.1 and 15% from 2021 to 2025 and experienced the largest fluctuations of the measured canopy stress attributes in both the study sites and reference sites. UG4\_01 experienced marginal increases (+0.1 to +1%), while the associated reference sites experienced marginal decreases (-0.4 to -3%) and increases (+0.5 to +2.4%). Moderate fluctuations were observed in UG4\_03 (-5.9 to +1.9%) representing an overall decrease in cover from 2021 to 2025, with decreases also observed in the associated reference sites (-0.4 to -3.5%). Moderate fluctuations were also observed in UG4\_04 (-4.8 to +0.8%) also representing an overall decrease in cover from 2021 to 2025, in contrast to the associated reference sites which both experienced an overall increase in cover. Marked fluctuations were observed in both UG4\_02 and UG4\_05 (-14 to +9% and -8 to +7%, respectively). However, these fluctuations also represented an overall decrease in cover from 2021 to 2025. Epicormic growth cover also decreased in one of UG4\_02 associated reference sites (BOA\_OU3), while UG4\_05 associated reference sites experienced an overall increase in cover or remained the same. Both UG4\_06a and UG4\_06b (and associated reference sites) all experienced an increase or plateau in epicormic growth cover from 2024 to 2025 back to or above pre-existing levels in 2021-2022 (Chart 33).

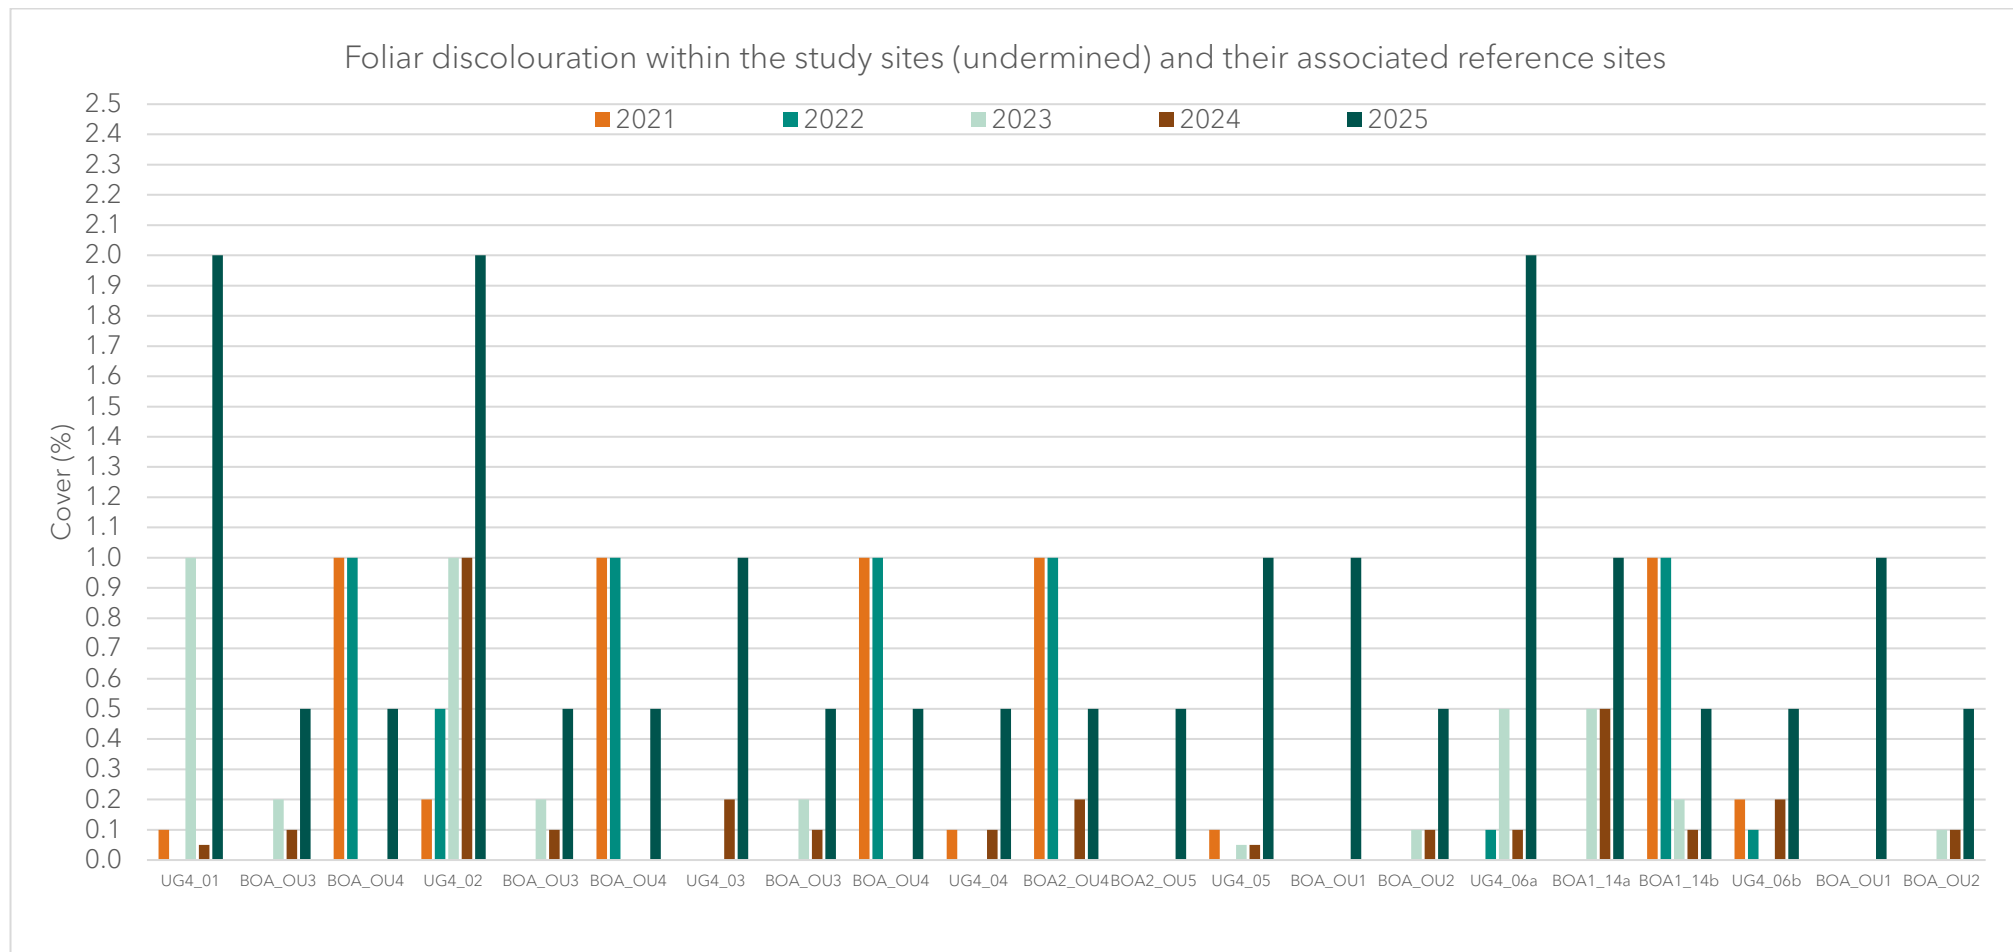
Chart 34. A comparison of the cover (%) of foliar discolouration in the study sites (undermined) and associated reference sites from 2021 – 2025

Foliar discolouration cover was between 0 and 1.5% and experienced marginal fluctuations remaining relatively consistent from 2021 to 2025. UG4\_01 cover fluctuated marginally (-0.95 to +1.45%) resulting in an overall increase in cover since 2021, which was also observed partially in the associated reference site BOA\_OU3. UG4\_02 steadily increased in cover of foliar discolouration from 2021 to 2025, while the associated reference site BOA\_OU3 also increased marginally from 2024-2025 (0.4%), and BOA\_OU4 experienced a decrease of 0.5% from 2021-2022 levels, but an increase from 2023-2024 levels. UG4\_03 increased in cover and an overall increase in cover was also observed in reference site BOA\_OU3. Reference site BOA\_OU4 fluctuated in cover but also experienced an increase in the 2024-2025 period. UG4\_04 marginally fluctuated (-0.1 to +0.4%) resulting in an increase since 2021, with the same observation appearing in the associated reference site BOA2\_OU5. UG4\_05 marginally fluctuated (-0.1 to +0.05) from 2021 to 2024; however, in 2025 a marked increase was observed. This marked increase was also reflected in the associated reference sites in 2025. Both UG4\_06a (-0.4 to +1.0%) and UG4\_06b (-0.1% to +0.3%) experienced alternate years of fluctuations, with foliar discolouration cover in 2025 being the highest year. An increase in cover in 2025 was also reflected in the associated reference sites (Chart 34).
