**RE: MOOLARBEN COAL COMPLEX – UG4 LONGWALLS 401 TO 407 END OF PANEL REPORT**

Secondary extraction of LW407 was completed in January 2026. Accordingly, MCO has prepared a UG4 LW401-407 End of Panel Report (refer to **Enclosure 1**), which presents monitoring data, describes observed impacts during mining of LW401-407 and compares these results to predictions and relevant performance measures and performance indicators as described in the approved UG4 LW401-408 Extraction Plan.

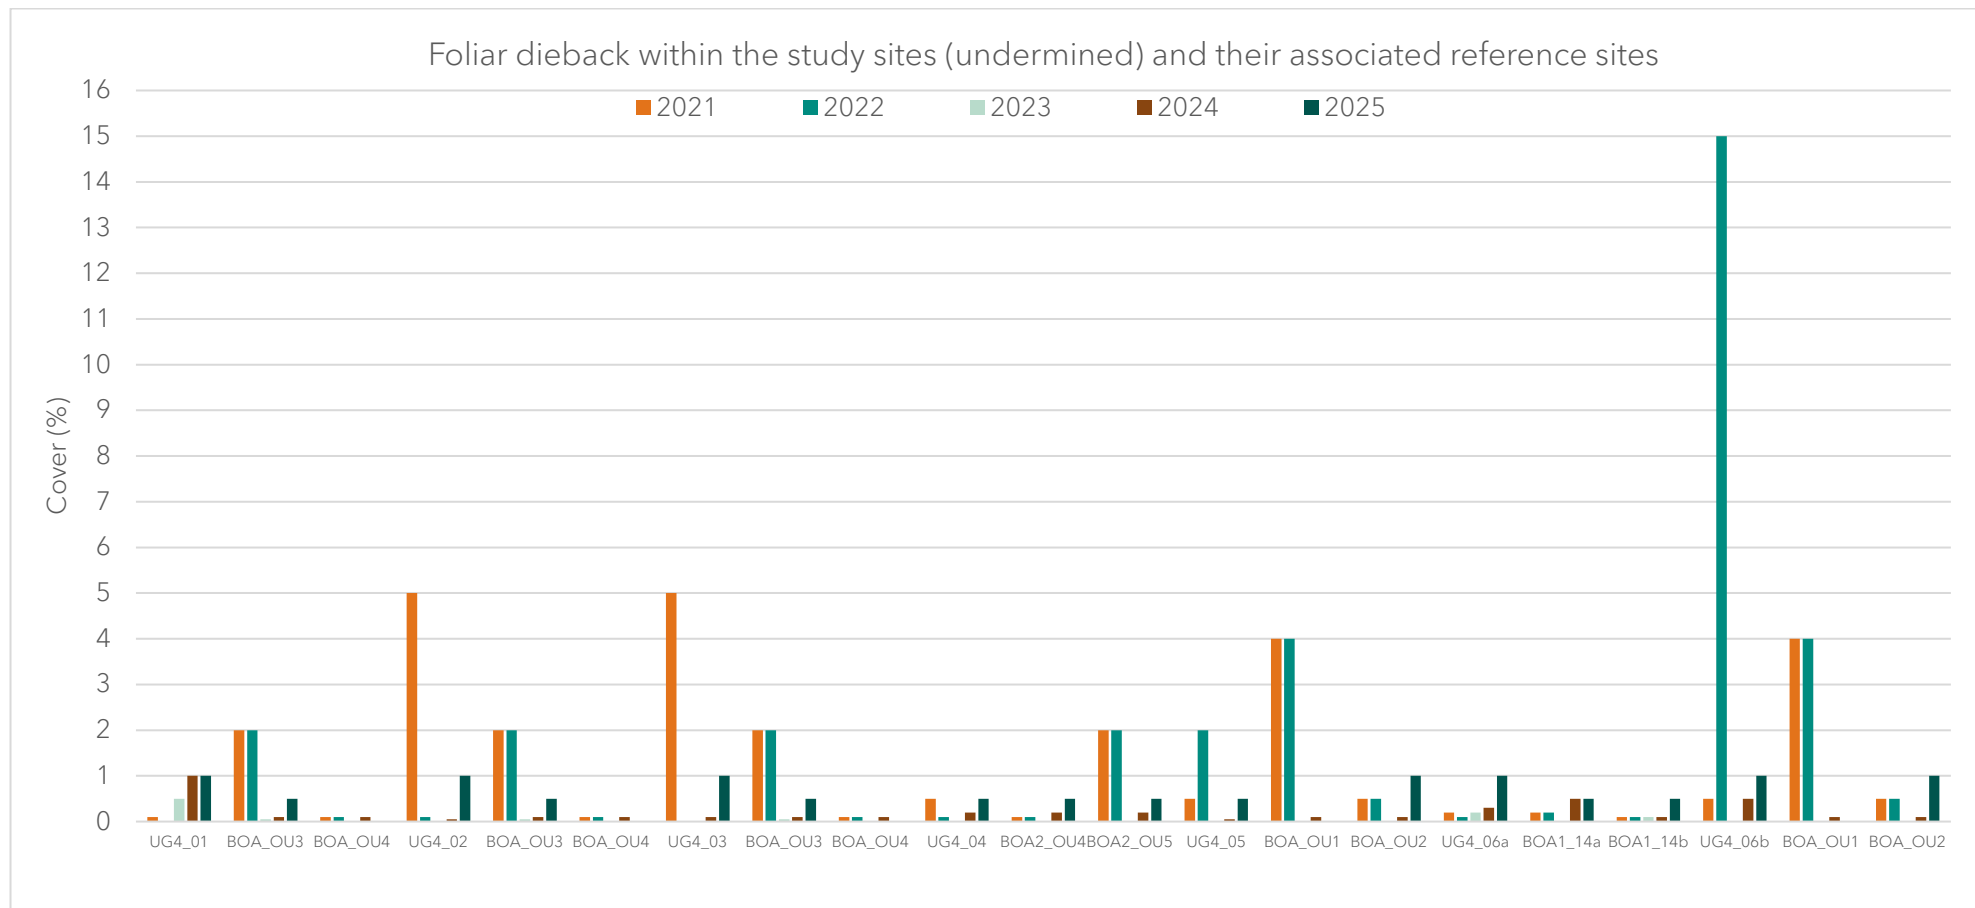
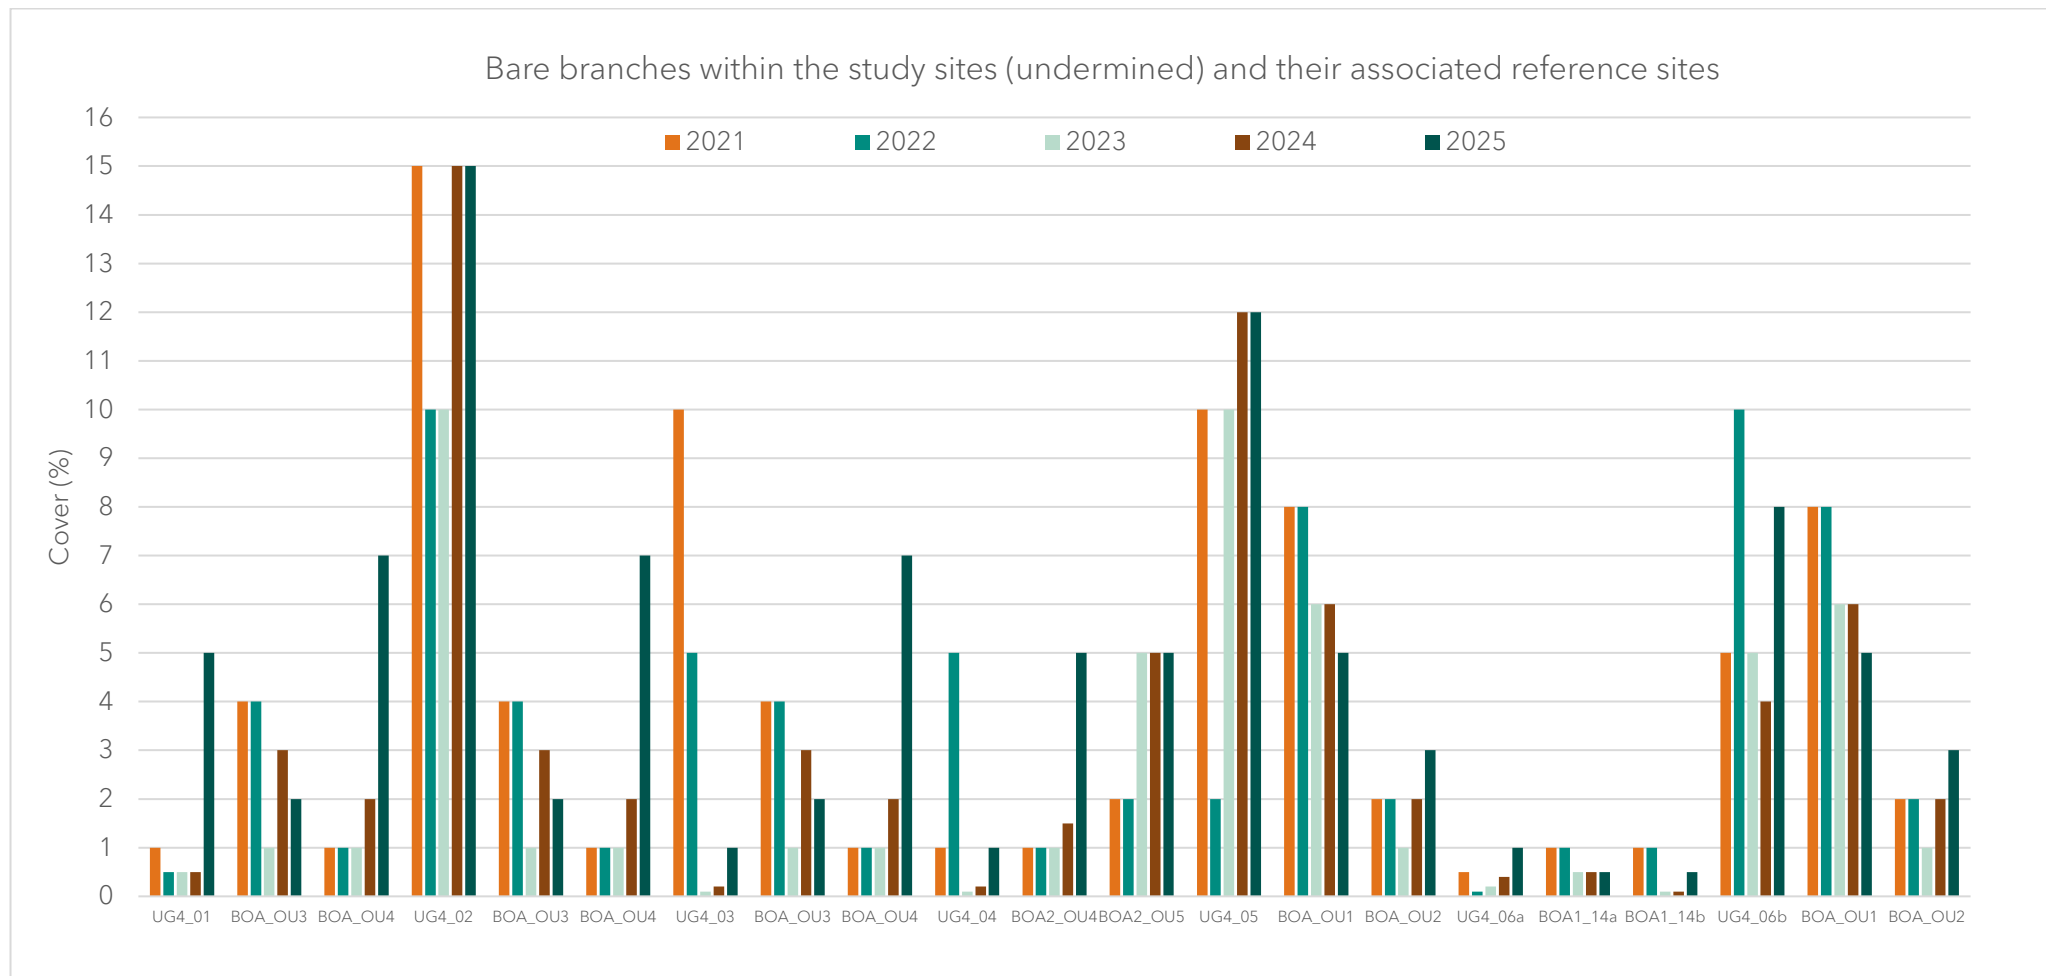
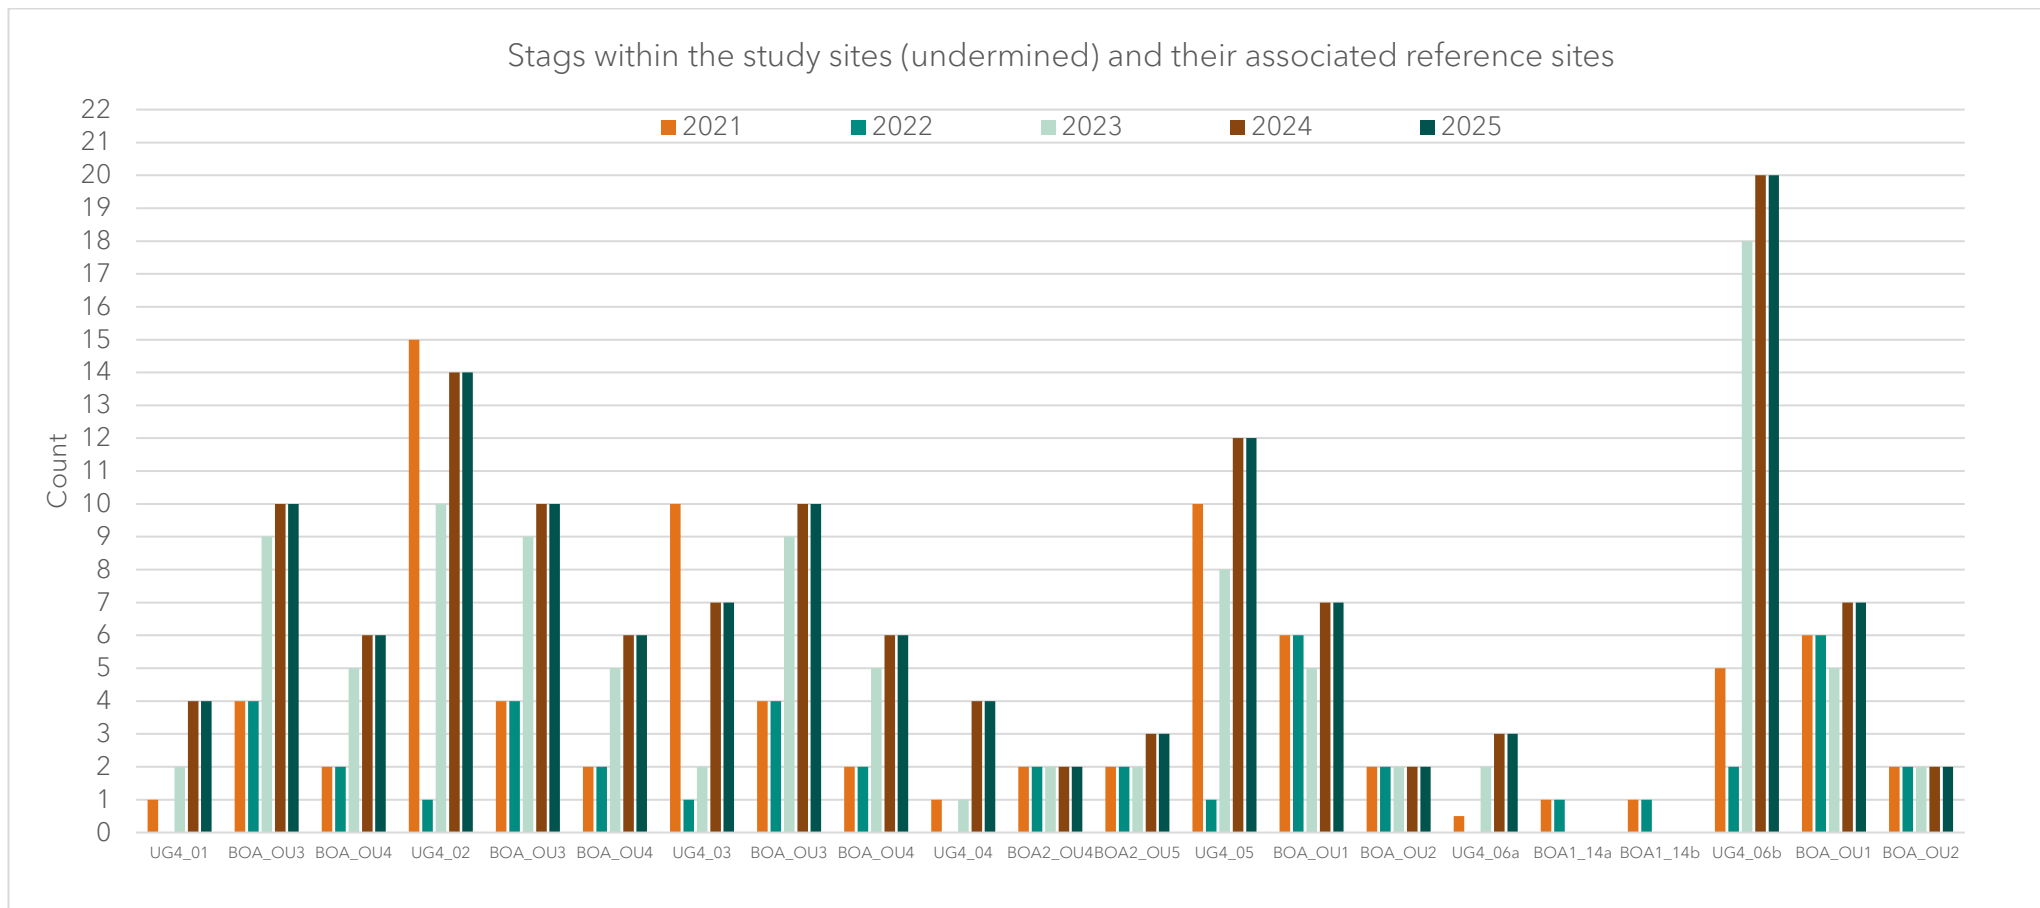
Chart 35. A comparison of the cover (%) of foliar dieback in the study sites (undermined) and associated reference sites from 2021 – 2025

Chart 36. A comparison of the cover (%) of bare branches in the study sites (undermined) and associated reference sites from 2021 – 2025

Chart 37. A comparison of the count of stags in the study sites (undermined) and associated reference sites from 2021 - 2025

The presence of epicormic growth, foliar discolouration, foliar dieback and bare branches observed in both the study sites and the references sites may be due to hydraulic failure as a result of the severe three-year drought, from 2017 to 2019, in eastern New South Wales (NSW) (Nolan et al. 2021; Losso et al. 2022). The drought was followed by above average rainfall from 2020 to 2022 (Annex 1, Table 8). Trees that survive drought induced canopy dieback are known to replace leaf area mainly by increased epicormic growth (Losso et al. 2022).

Overall, the fluctuations and/or trends observed from 2021 to 2025 in the study sites (undermined) were consistent or marginal compared to those observed in the associated reference sites (Chart 32 to Chart 37). This was also observed in the study sites (not undermined) and the associated reference sites (Annex 2, Chart 58 to Chart 63). Due to this, the fluctuations and/or trends observed are therefore considered to be due to natural variation and/or observer bias, in conjunction with drought induced impacts and followed by above average years of rainfall. These observations suggest that underground mining has not had a discernible impact on the canopy stress attributes recorded in the study sites (undermined).

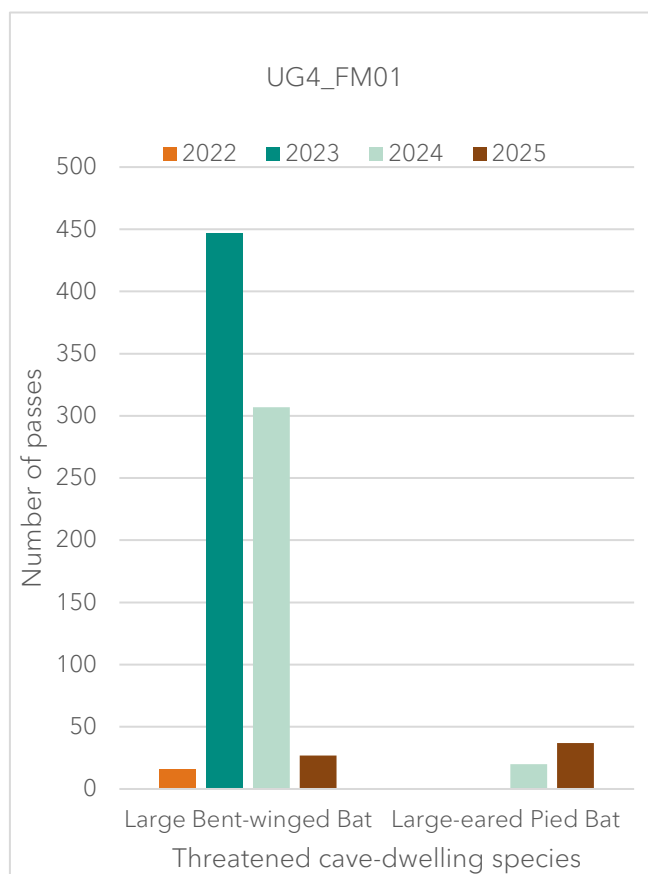
Chart 38: The number of passes of the threatened cave-dwelling microbat species in UG4\_FM01 (2022-25)

In UG4\_FM01, the Large Bent-winged Bat was recorded in 2022, 2023, 2024 and 2025, with the number of recorded passes markedly increasing from 16 to 447 from 2022 to 2023, respectively. The number of passes then decreased moderately to 307 in 2024, and markedly to 27 in 2025. The Large-eared Pied Bat was not recorded in 2022 or 2023; however, 20 passes were recorded in 2024 increasing marginally to 37 in 2025 (Chart 38). Visual evidence of subsidence, including extensive small cave and surface rock cracking and movement, has been observed in proximity to UG4\_FM01 since the commencement of LW403 undermining in 2022 (Table 2).

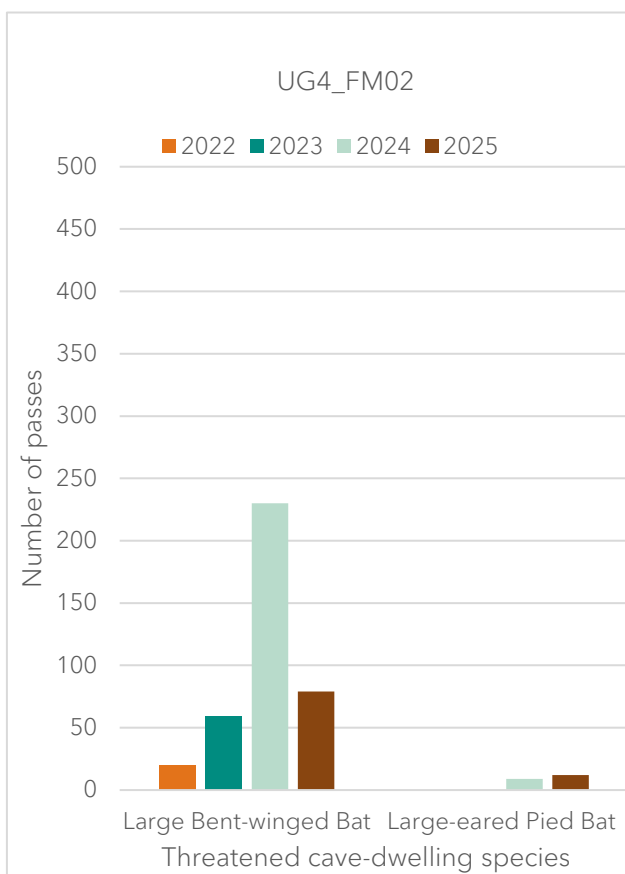
Chart 39: The number of passes of the threatened cave-dwelling microbat species in UG4\_FM02 (2022-25)

In UG4\_FM02, the Large Bent-winged Bat was recorded in 2022, 2023, 2024 and 2025 with the number of recorded passes increasing markedly from 20 to 59 to 230 in 2022, 2023 and 2024, respectively. The number of recorded passes then decreased markedly to 79 in 2025. The Large-eared Pied Bat was not recorded in 2022 or 2023; however, 9 passes were recorded in 2024 and marginally increased to 12 in 2025 (Chart 39). Visual evidence of subsidence, including extensive surface cracking, has been observed in proximity to UG4\_FM02 since the commencement of LW406 undermining in 2025 (Table 2).

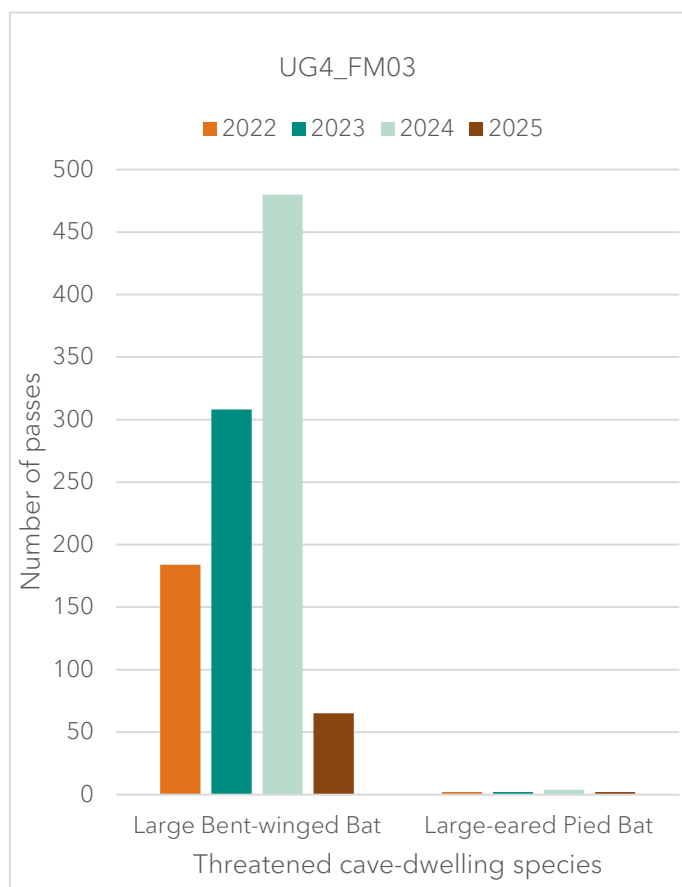
Chart 40: The number of passes of the threatened cave-dwelling microbat species in UG4\_FM03 (2022-25)

In UG4\_FM03, the Large Bent-winged Bat was recorded in 2022, 2023, 2024 and 2025 with the number of recorded passes increasing moderately from 184, to 308 to 480 in 2022, 2023 and 2024 respectively. The number of passes then markedly decreased to 65 in 2025. The Large-eared Pied Bat was also recorded in 2022, 2023, 2024 and 2025. The number of passes was 2 in both 2022 and 2023, increasing marginally to 4 in 2024 and decreasing marginally 2 passes in 2025 (Chart 40). There is no visual evidence of subsidence in proximity to UG4\_FM03.

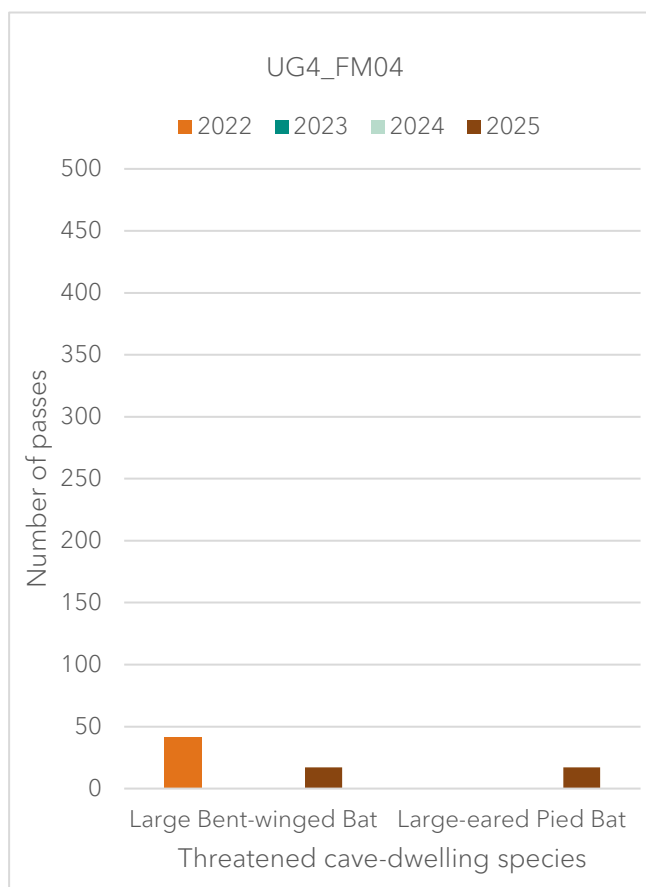
Chart 41: The number of passes of the threatened cave-dwelling microbat species in UG4\_FM04 (2022-25)

In UG4\_FM04, data was only recorded in 2022 and 2025 due to ultrasonic recorder malfunctions (Niche 2024). The Large Bent-winged Bat was recorded in 2022 with 42 passes and 2025 with 17 passes. In 2022, there were no recorded passes for the Large-eared Pied Bat, and 17 passes were recorded in 2025 (Chart 42). There is no visual evidence of subsidence in proximity to UG4\_FM04.

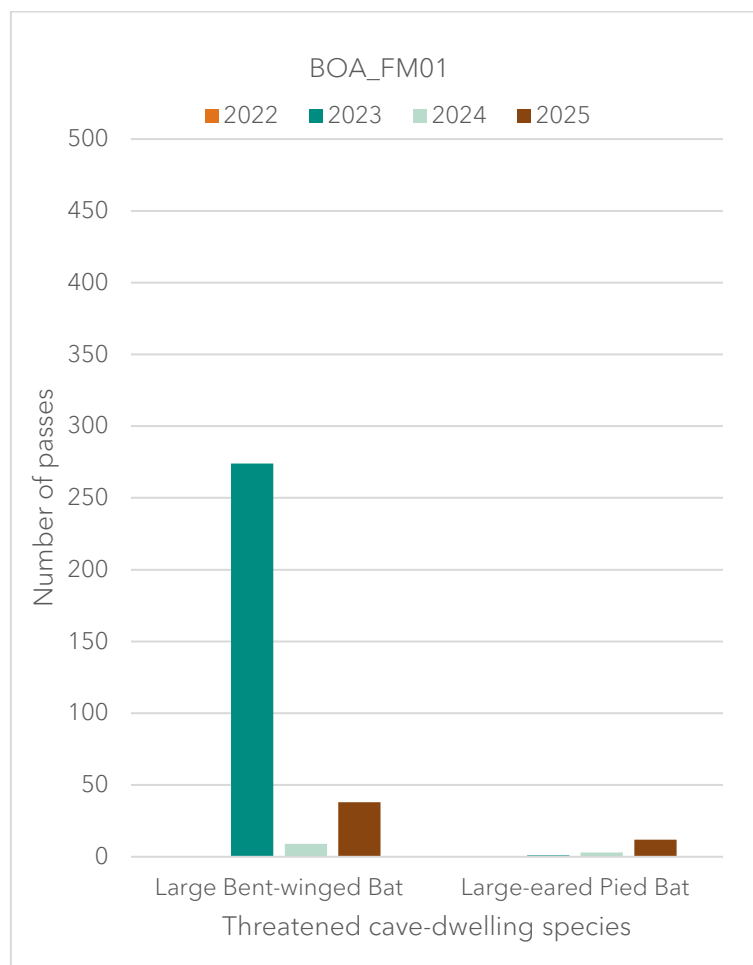
Chart 42: The number of passes of the threatened cave-dwelling microbat species in BOA\_FM01 (2022-25)

In BOA\_FM01 (the reference site), the Large Bent-winged Bat was not recorded in 2022. In 2023, 2024 and 2025 the species was recorded with the number of passes 274, markedly reducing to 9 and marginally increasing to 38, respectively. Similarly, the Large-eared Pied Bat was not recorded in 2022 and in 2023, 2024 and 2025 the number of passes for the species was 1, marginally increasing to 3 and 12, respectively (Chart 41). There is no visual evidence of subsidence in proximity to BOA\_FM01.

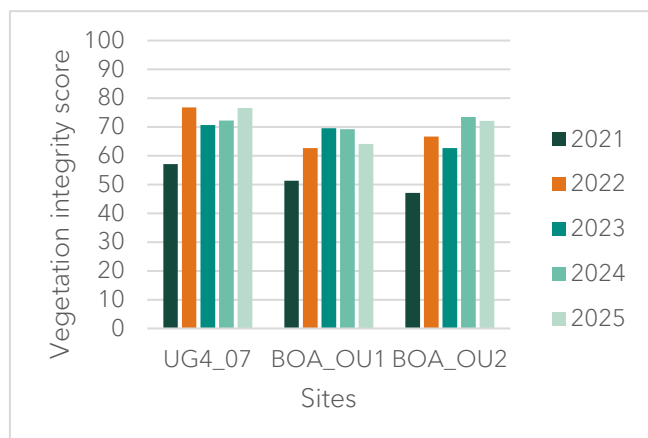
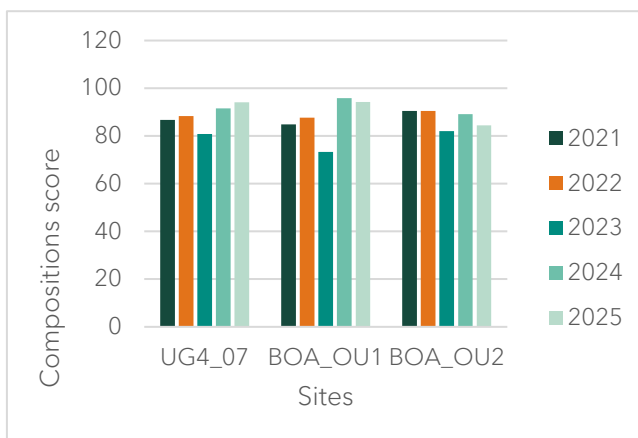
Chart 43: VIS at UG4\_07 and associated reference sites (2021-25)

Chart 44: Composition scores at UG4\_07 and associated reference sites (2021-25)

Fluctuations in the VIS and composition scores in UG4\_07 were comparable to those observed in the reference sites (Chart 43, Chart 44).

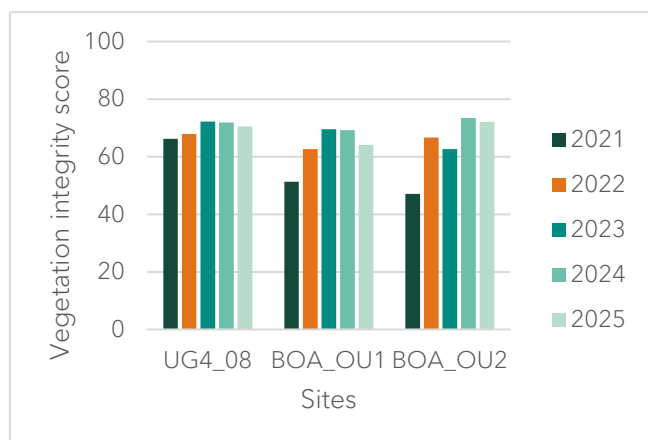
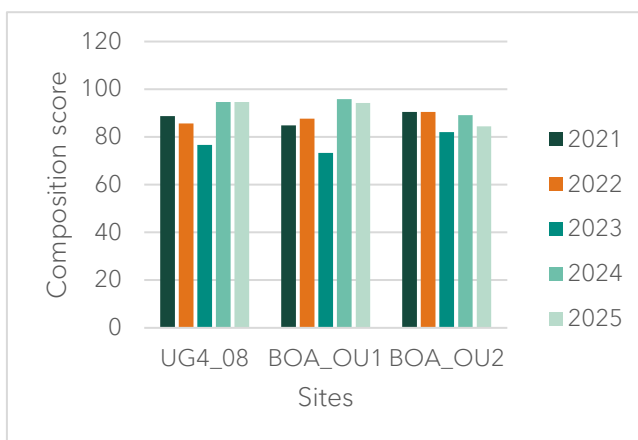
Chart 47: VIS at UG4\_08 and associated reference sites (2021-25)

Chart 48: Composition scores at UG4\_08 and associated reference sites (2021-25)

Fluctuations in the VIS and composition scores in UG4\_08 were comparable to those observed in the reference sites (Chart 47, Chart 48).

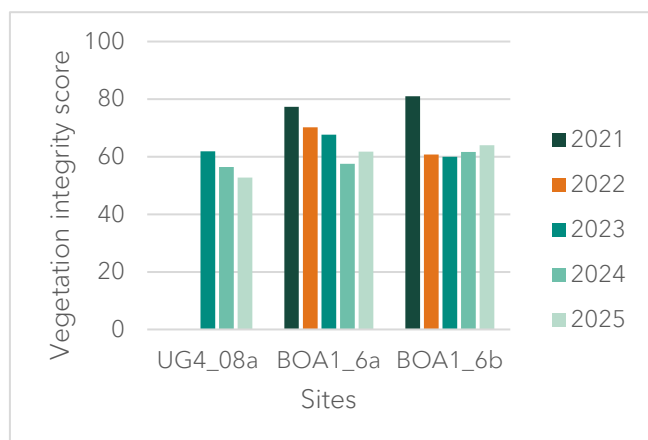
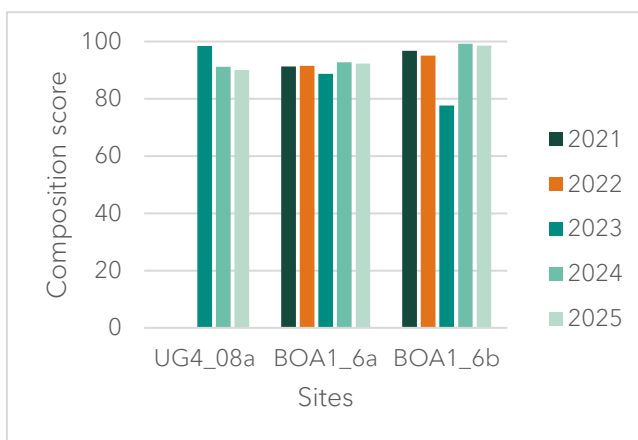
Chart 51: VIS at UG4\_08a and associated reference sites (2021-25)

Chart 52: Composition scores at UG4\_08a and associated reference sites (2021-25)

Monitoring of UG4\_08a only began in 2023. The VIS and composition scores in UG4\_08a experienced fluctuations comparable to that of the reference sites (Chart 51, Chart 52).

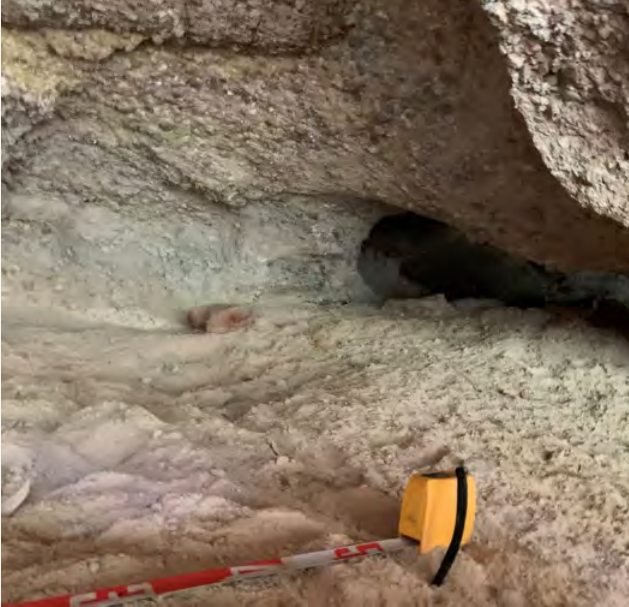
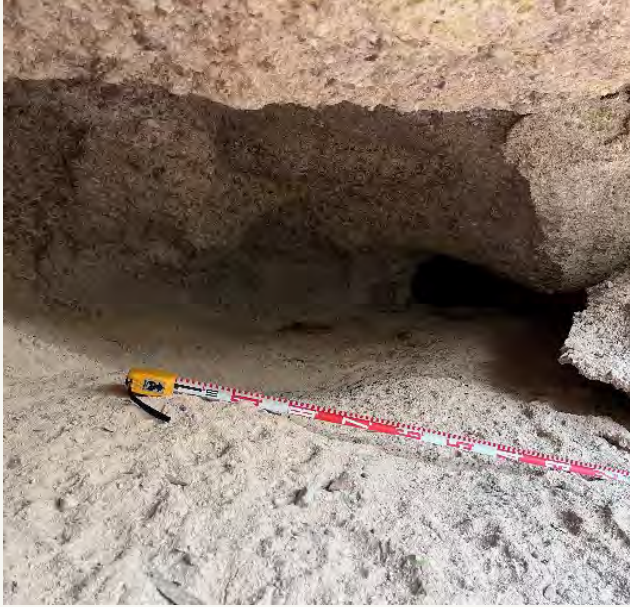
During the post-mining inspection undertaken in December 2025, major collapse of the shelter opening was observed. Cracking throughout the shelter was evident, with a large (>50 centimetres [cm]) vertical crack identified to the far right of the shelter. The results of the monitoring inspection are detailed in Table 2 below, and Plate 1 to Plate 12 show the monitoring photographs and comparison images for the site.

| Baseline recording (Nov 2022) | Post-mining recording (Dec 2025) |
|---|---|
| <p>Plate 5: Detail of rear wall at S1MC358b (AHIMS ID#36-3-3305) with graffiti and fresh exfoliation. Photo taken on 21 November 2022.</p> | <p>Plate 6: Interior of shelter with collapsed block. Photo taken on 11 December 2025.</p> |

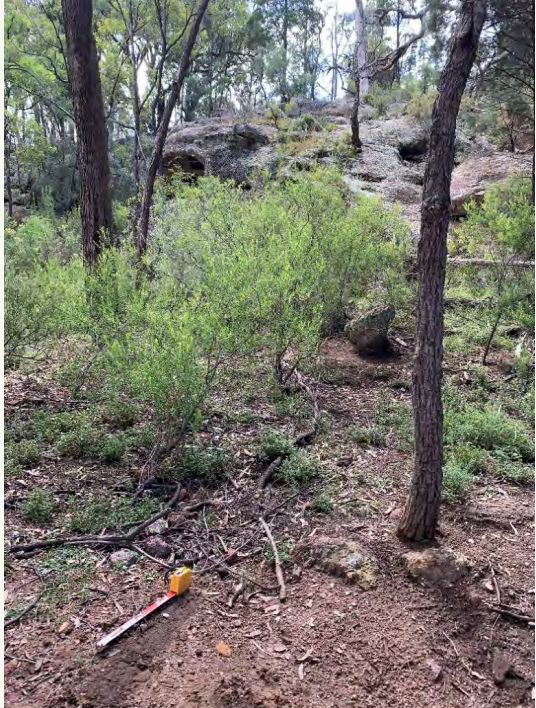
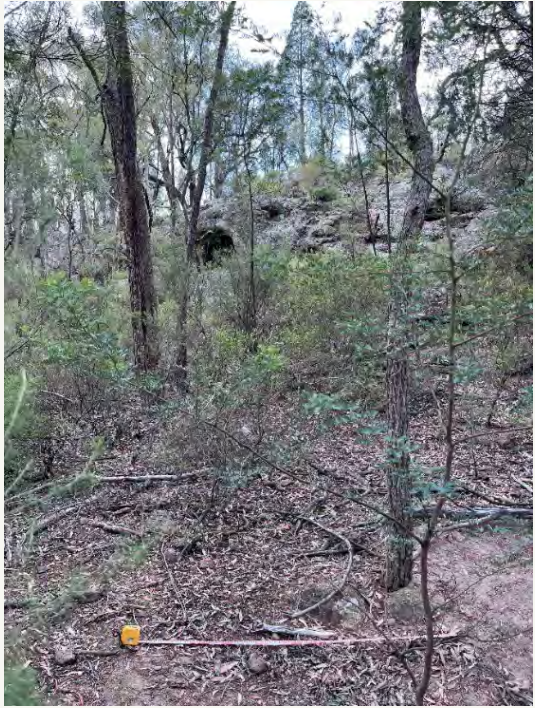
| Baseline recording (Nov 2022) | Post-mining recording (Dec 2025) |
|---|---|
| <p>Plate 9: View from location of quartz flake to S1MC358b (AHIMS ID#36-3-3305) shelter. Photo taken on 21 November 2022.</p> <p><i>No prior baseline photographs available.</i></p> | <p>Plate 10: View from location of quartz flake to S1MC358b (AHIMS ID#36-3-3305) shelter. Photo taken on 11 December 2025.</p> <p>Plate 11: Major fissure cracking located within the Southeast shelter opening of the site. Crack extends across the southeast portion of shelter roof, back wall and floor. Photo taken on 11 December 2025.</p> |

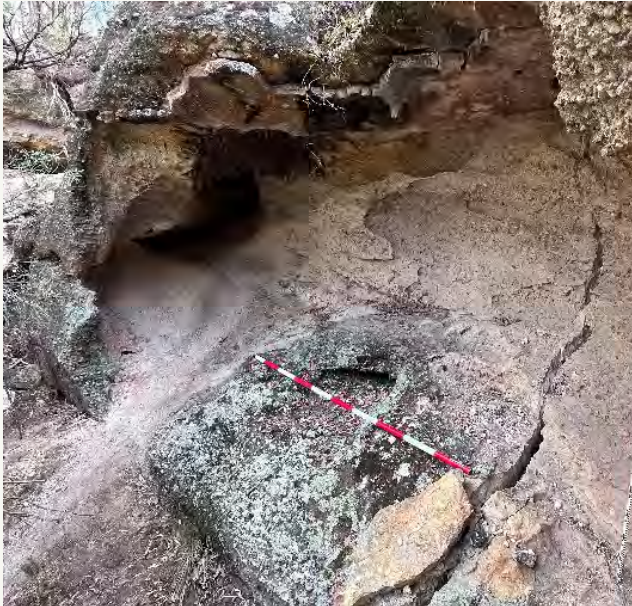
| Baseline recording (Nov 2022) | Post-mining recording (Dec 2025) |
|---|---|
| <p data-bbox="164 421 606 454"><i>No prior baseline photographs available.</i></p> | <div data-bbox="810 421 1444 1025"></div> <p data-bbox="810 1037 1393 1122">Plate 12: View of major fissure cracking located within the Southeast shelter from the south of the shelter opening. Photo taken on 11 December 2025.</p> |

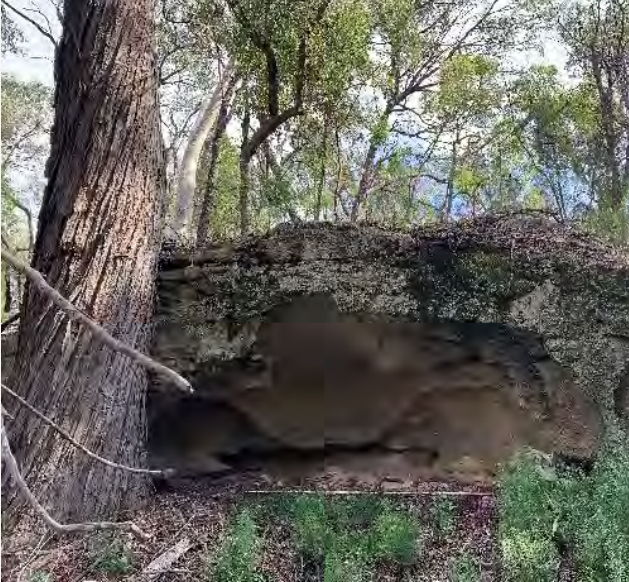
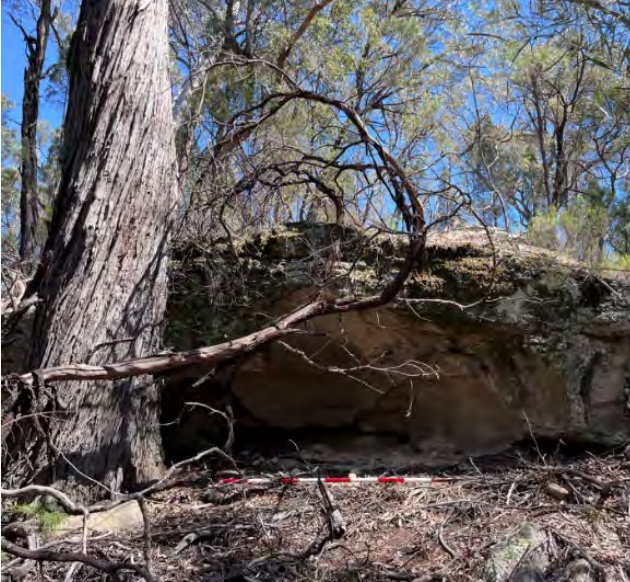
| Baseline recording (November 2022) | Post-mining recording (Dec 2025) |
|---|---|
| <p data-bbox="165 1012 796 1106">Plate 13: General photo of site S1MC468 (AHIMS ID#36-3-3801), facing north. Photo taken on 28 November 2022.</p> | <p data-bbox="812 1041 1444 1106">Plate 14: General photo of site S1MC468 (AHIMS ID#36-3-3801), facing north. Photo taken on 9 December 2025.</p> |

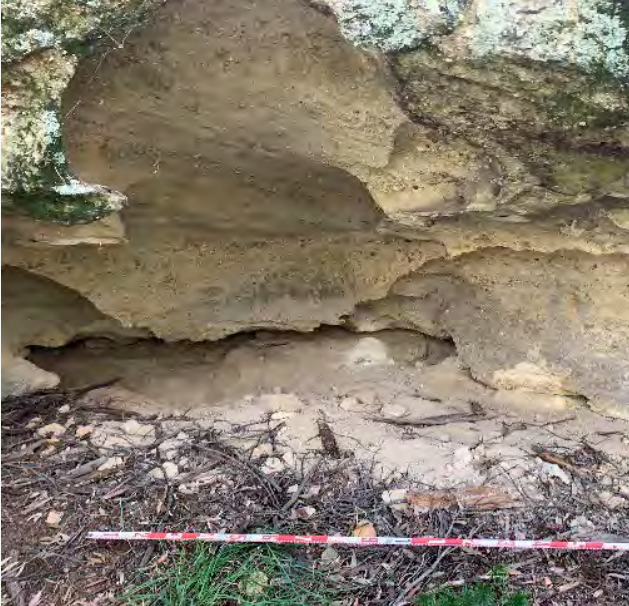
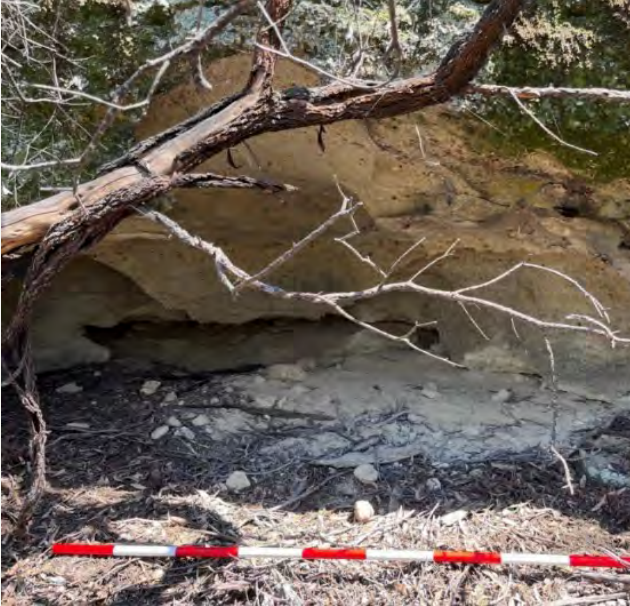
During the post-mining inspection undertaken in December 2025, the site demonstrated existing blockfall and fissuring. A crack was observed lining the rear boundary of the rock and continues in an east-west direction. The results of the monitoring inspection are detailed in Table 3 below, and Plate 13 to Plate 16 show the monitoring photographs and comparison images for the site.

| Baseline recording (November 2022) | Post-mining recording (Dec 2025) |
|---|---|
| <p data-bbox="165 1729 796 1816">Plate 15: General photo of site S1MC468 (AHIMS ID#36-3-3801), facing north. Photo taken on 28 November 2022.</p> | <p data-bbox="812 1729 1444 1816">Plate 16: General photo of site S1MC468 (AHIMS ID#36-3-3801), facing north. Crack shown to right behind twigs of branch. Photo taken on 9 December 2025.</p> |

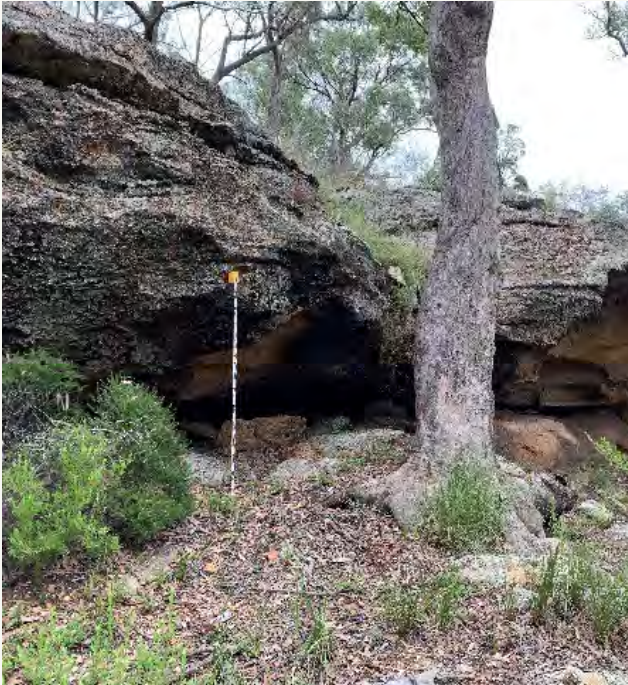
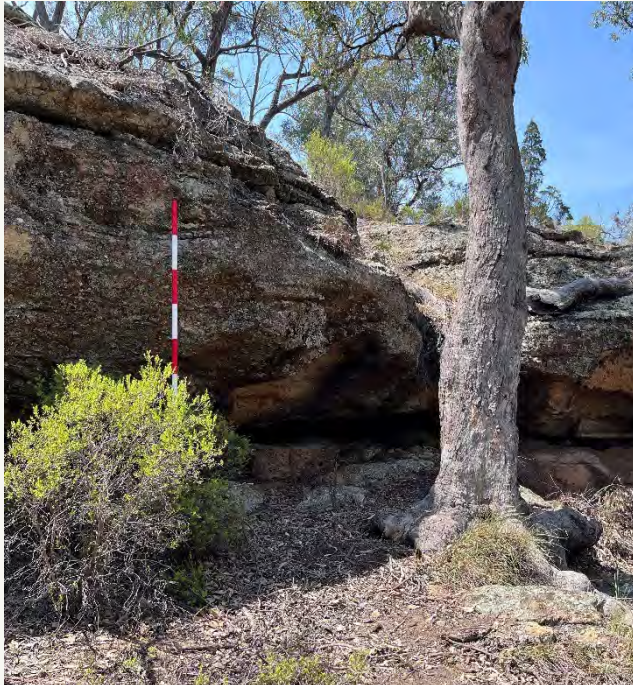
During the post-mining inspection undertaken in December 2025, a new fissure 1 – 2 cms wide was found on the northern end of the eastern shelter's interior which has impacted its roof. The results of the monitoring inspection are detailed in Table 4 below, and Plate 17 to Plate 36 show the monitoring photographs and comparison images for the site.

| Baseline recording (Nov 2021) | Post-mining recording (Dec 2025) |
|---|---|
| <p data-bbox="164 1115 794 1205">Plate 17: General photo of site S1MC475 (AHIMS ID#36-3-3786), facing south-east. Photo taken on 21 November 2021.</p> | <p data-bbox="809 1115 1444 1205">Plate 18: General photo of site S1MC475 (AHIMS ID#36-3-3786), facing south-east. Photo taken on 10 December 2025.</p> |

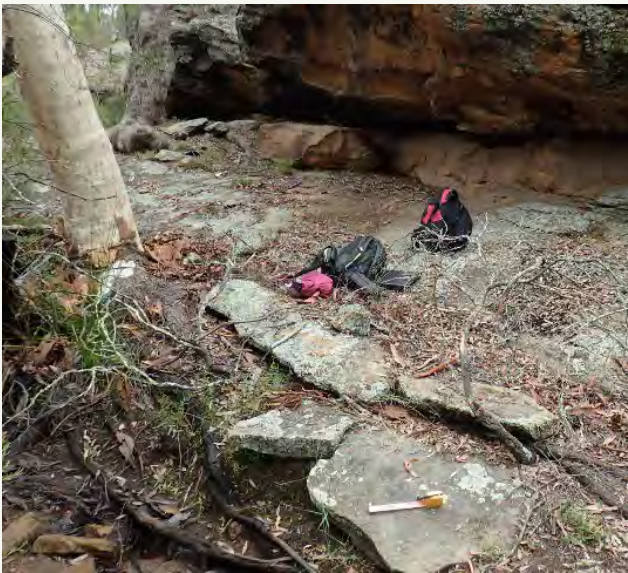
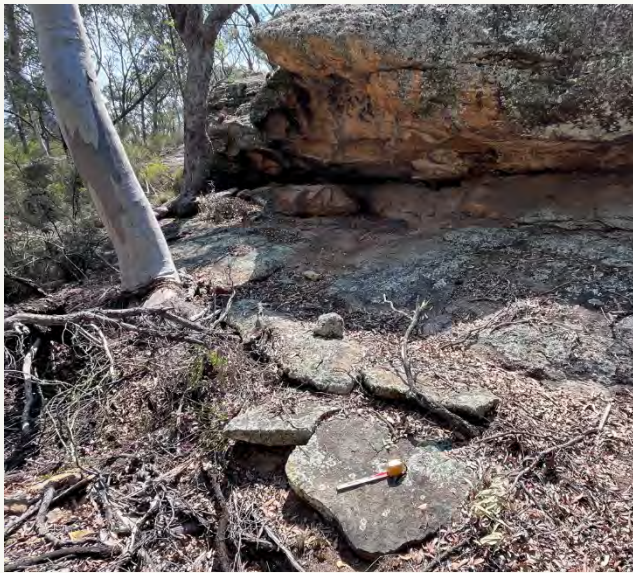
| Baseline recording (Nov 2021) | Post-mining recording (Dec 2025) |
|---|---|
| <p data-bbox="164 1796 794 1881">Plate 19: Location of Grinding Groove relative to Rock Shelter, site S1MC475 (AHIMS ID#36-3-3786), facing north-east. Photo taken on 21 November 2021.</p> | <p data-bbox="809 1796 1444 1881">Plate 20: Location of Grinding Groove relative to Rock Shelter, site S1MC475 (AHIMS ID#36-3-3786), facing north-east. Photo taken on 10 December 2025.</p> |

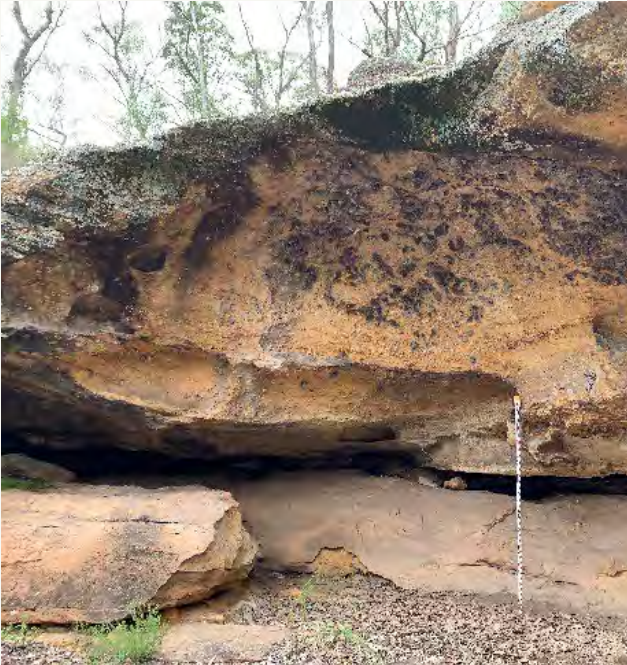
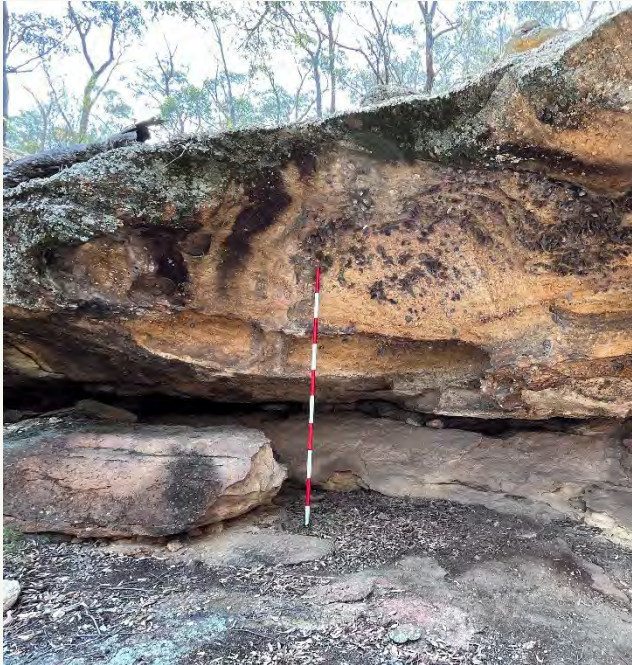
| Baseline recording (Nov 2021) | Post-mining recording (Dec 2025) |
|---|---|
| <p data-bbox="165 1093 794 1182">Plate 21: General photo of site S1MC475 (AHIMS ID#36-3-3786), facing north-east. Photo taken on 21 November 2021.</p> | <p data-bbox="810 1093 1444 1182">Plate 22: General photo of site S1MC475 (AHIMS ID#36-3-3786), facing north-east. Photo taken on 10 December 2025.</p> |

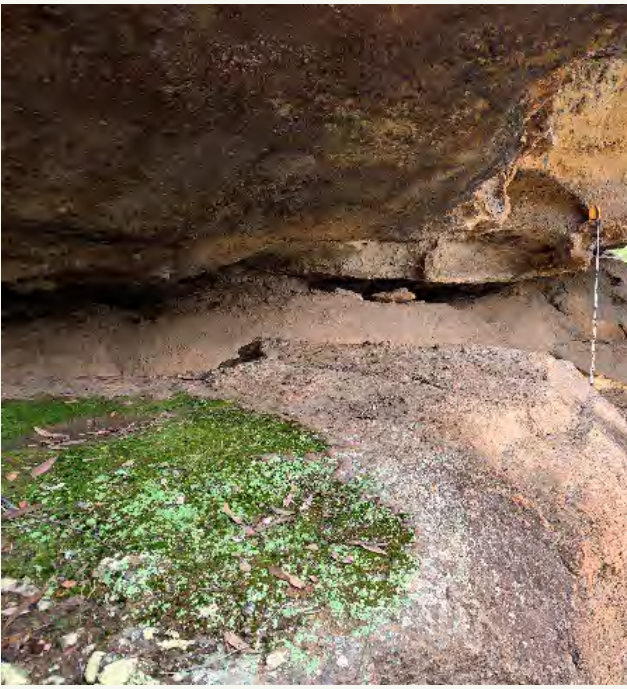
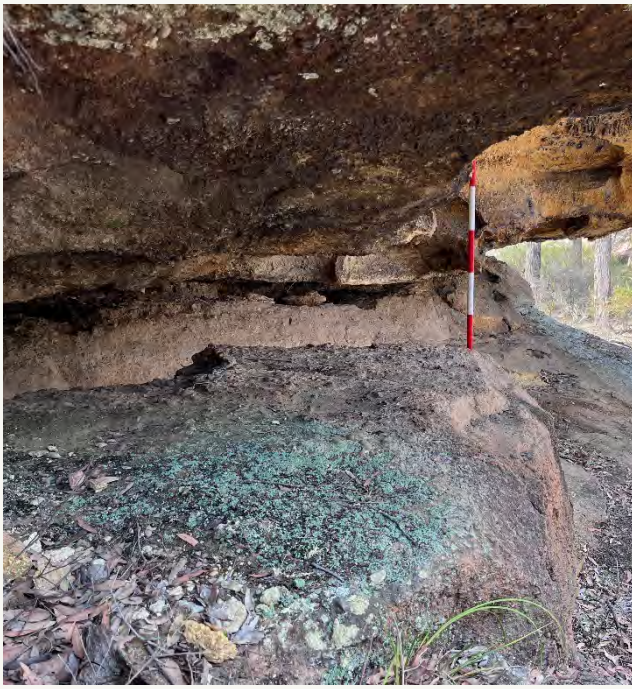
| Baseline recording (Nov 2021) | Post-mining recording (Dec 2025) |
|---|---|
| <p data-bbox="165 1888 794 1966">Plate 23: General photo of site S1MC475 (AHIMS ID#36-3-3786), facing south-east. Photo taken on 21 November 2021.</p> | <p data-bbox="810 1888 1444 1966">Plate 24: General photo of site S1MC475 (AHIMS ID#36-3-3786), facing south-east. Photo taken on 10 December 2025.</p> |

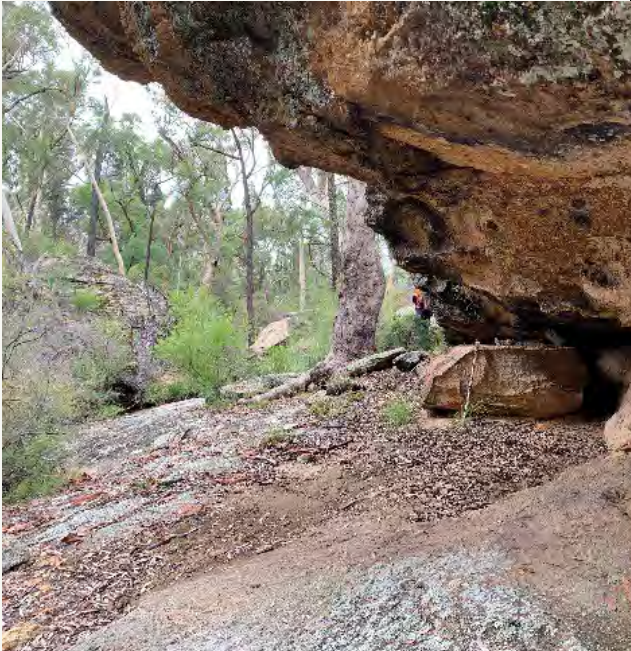
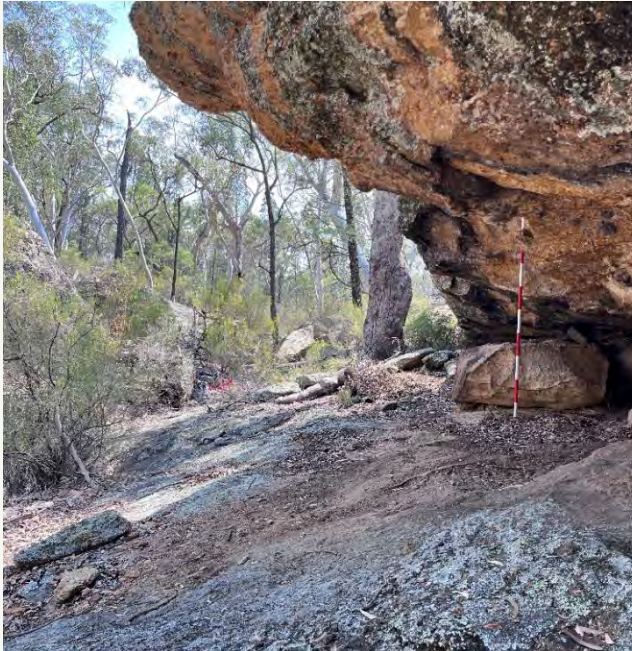
| Baseline recording (Nov 2021) | Post-mining recording (Dec 2025) |
|---|---|
| <p>Plate 25: General photo of site S1MC475 (AHIMS ID#36-3-3786), facing north-west. Photo taken on 21 November 2021.</p> | <p>Plate 26: General photo of site S1MC475 (AHIMS ID#36-3-3786), facing north-west. Photo taken on 10 December 2025.</p> |

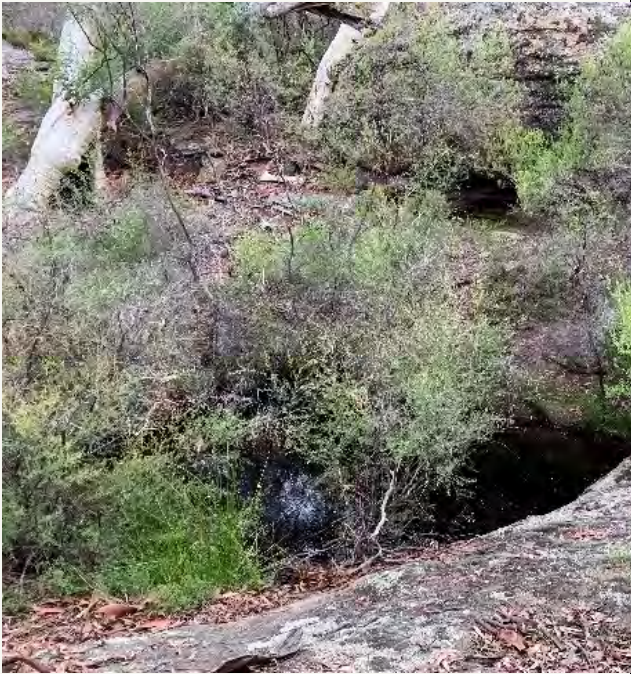
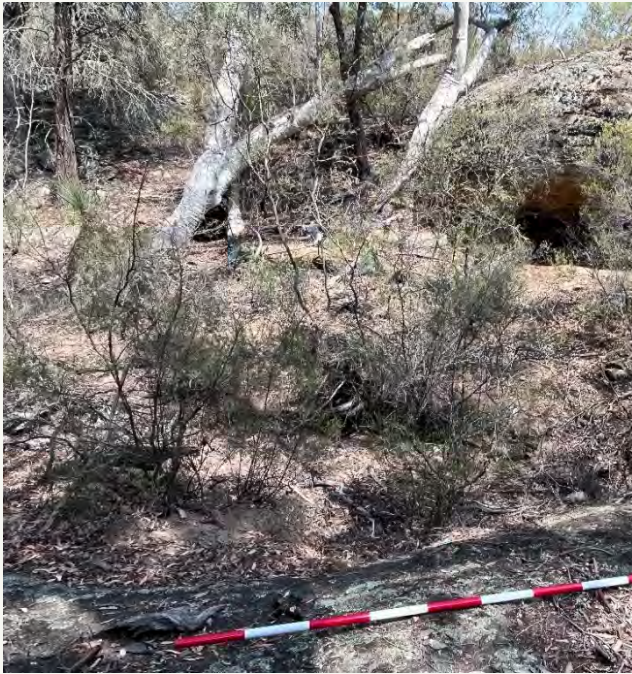
| Baseline recording (Nov 2021) | Post-mining recording (Dec 2025) |
|---|---|
| <p>Plate 27: General photo of site S1MC475 (AHIMS ID#36-3-3786), facing north-west towards overhang containing artefact. Photo taken on 21 November 2021.</p> | <p>Plate 28: General photo of site S1MC475 (AHIMS ID#36-3-3786), facing north-west towards overhang containing artefact. Photo taken on 10 December 2025.</p> |

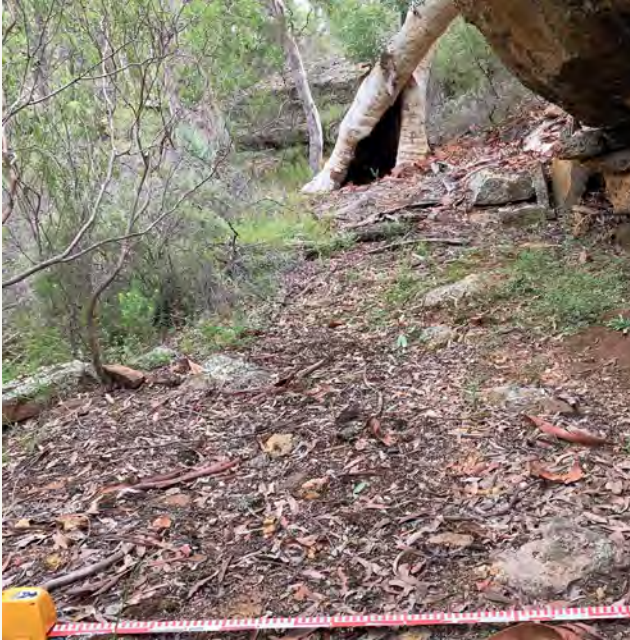
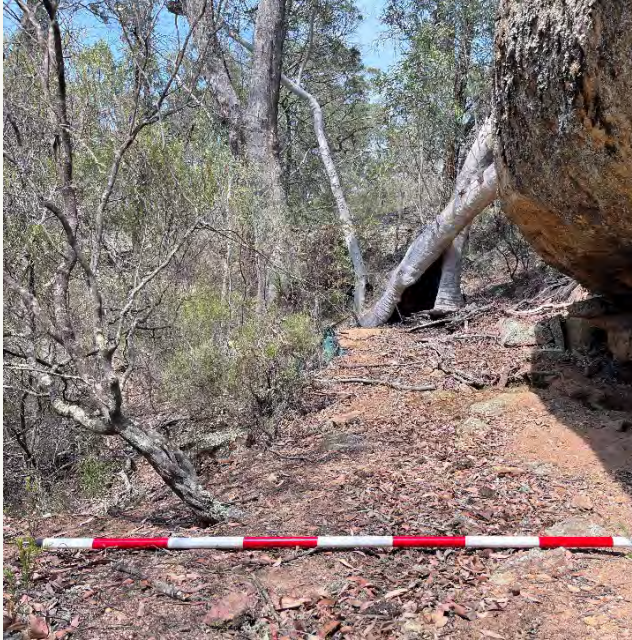
| Baseline recording (Nov 2021) | Post-mining recording (Dec 2025) |
|---|---|
| <p data-bbox="164 1070 796 1160">Plate 29: Site S1MC475 (AHIMS ID#36-3-3786) (north), containing stone artefact, facing south-west. Photo taken on 21 November 2021.</p> | <p data-bbox="810 1070 1444 1160">Plate 30: Site S1MC475 (AHIMS ID#36-3-3786) (north), containing stone artefact, facing south-west. Photo taken on 10 December 2025.</p> |
