**RE: MOOLARBEN COAL COMPLEX – UG4 LONGWALLS 401 TO 407 END OF PANEL REPORT**

Secondary extraction of LW407 was completed in January 2026. Accordingly, MCO has prepared a UG4 LW401-407 End of Panel Report (refer to **Enclosure 1**), which presents monitoring data, describes observed impacts during mining of LW401-407 and compares these results to predictions and relevant performance measures and performance indicators as described in the approved UG4 LW401-408 Extraction Plan.

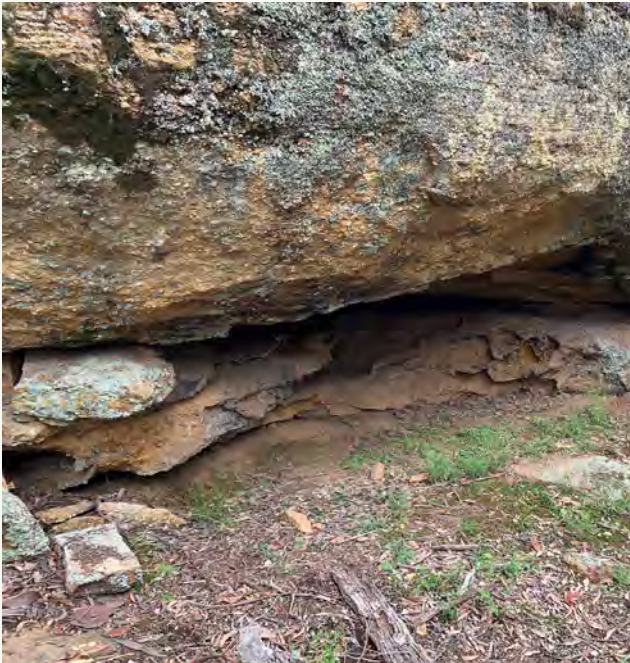
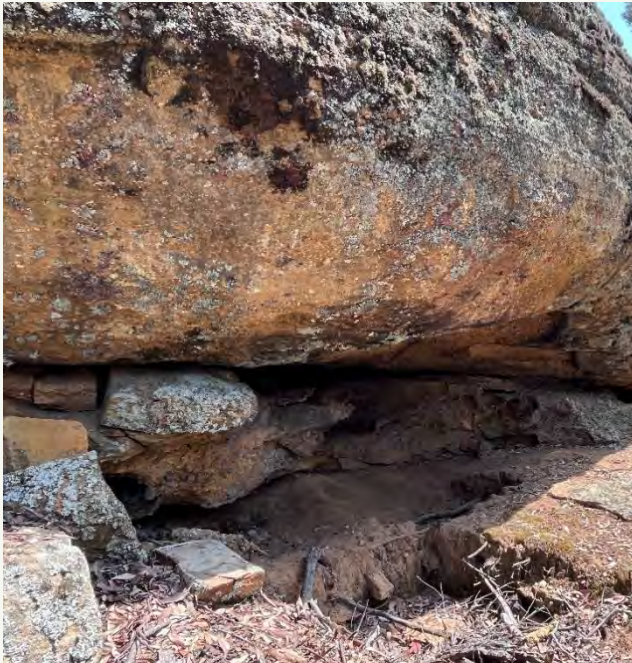
| Baseline recording (Nov 2021) | Post-mining recording (Dec 2025) |
|---|---|
| <p data-bbox="164 1841 796 1933">Plate 31: Site S1MC475 (AHIMS ID#36-3-3786) (north), containing stone artefact, facing north-east. Photo taken on 21 November 2021.</p> | <p data-bbox="810 1841 1444 1933">Plate 32: Site S1MC475 (AHIMS ID#36-3-3786) (north), containing stone artefact, facing north-east. Open pits in foreground. Photo taken on 10 December 2025.</p> |

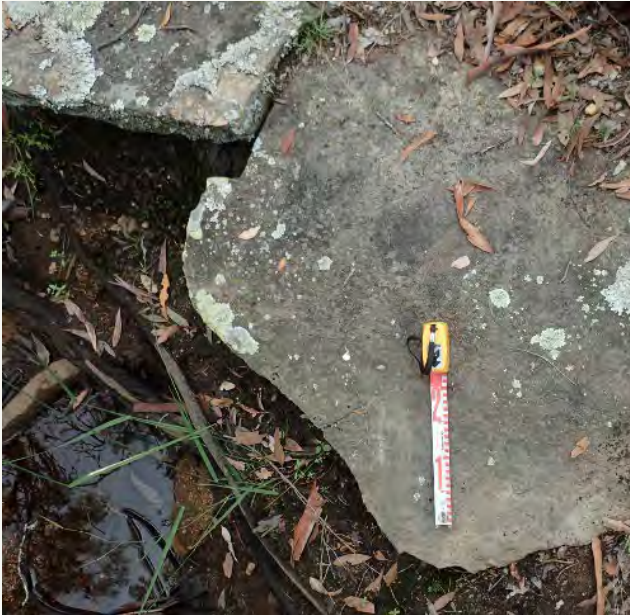
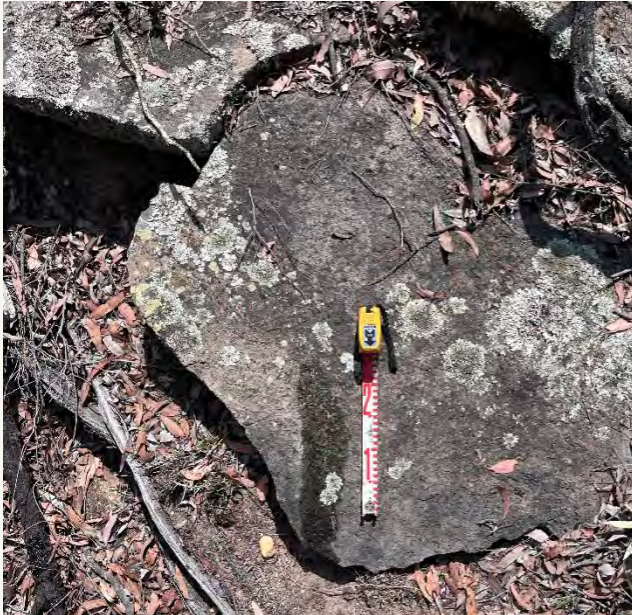
| Baseline recording (Nov 2021) | Post-mining recording (Dec 2025) |
|---|---|
| <p data-bbox="164 1043 796 1128">Plate 33: Grinding Groove at creeks edge of site S1MC475 (AHIMS ID#36-3-3786). Photo taken on 21 November 2021.</p> | <p data-bbox="810 1043 1444 1128">Plate 34: Grinding Groove at creeks edge of site S1MC475 (AHIMS ID#36-3-3786). Increased lichen on surface. Photo taken on 10 December 2025.</p> |

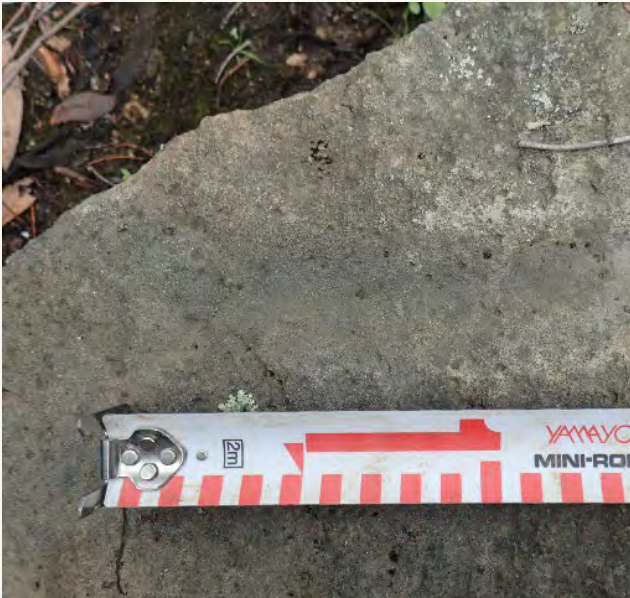
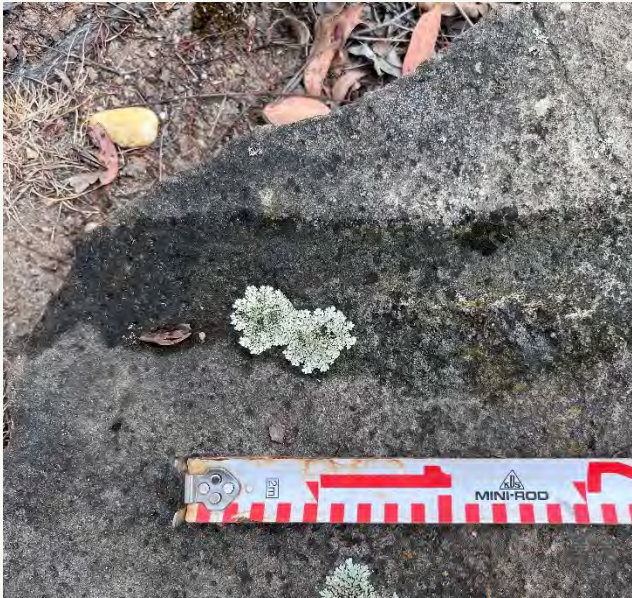
| Baseline recording (Nov 2021) | Post-mining recording (Dec 2025) |
|---|---|
| <p data-bbox="164 1751 796 1836">Plate 35: Grinding Groove at creeks edge at S1MC475 (AHIMS ID#36-3-3786). Photo taken on 21 November 2021.</p> | <p data-bbox="810 1751 1444 1836">Plate 36: Grinding Groove at creeks edge at S1MC475 (AHIMS ID#36-3-3786). Lichen in grinding groove. Photo taken on 10 December 2025.</p> |

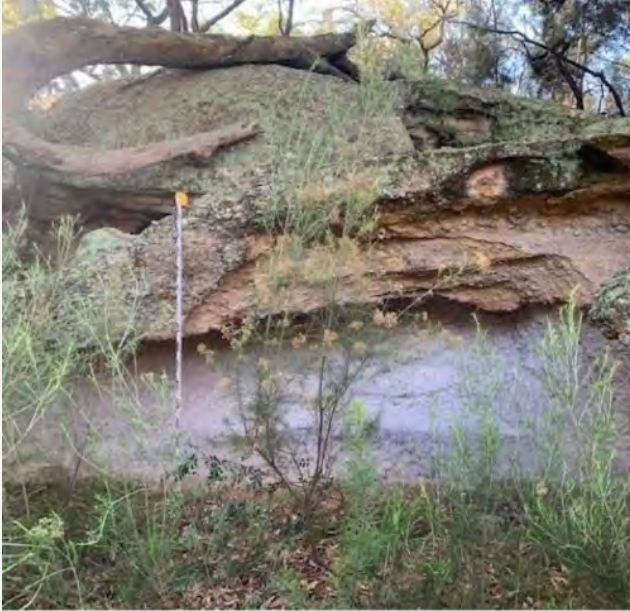
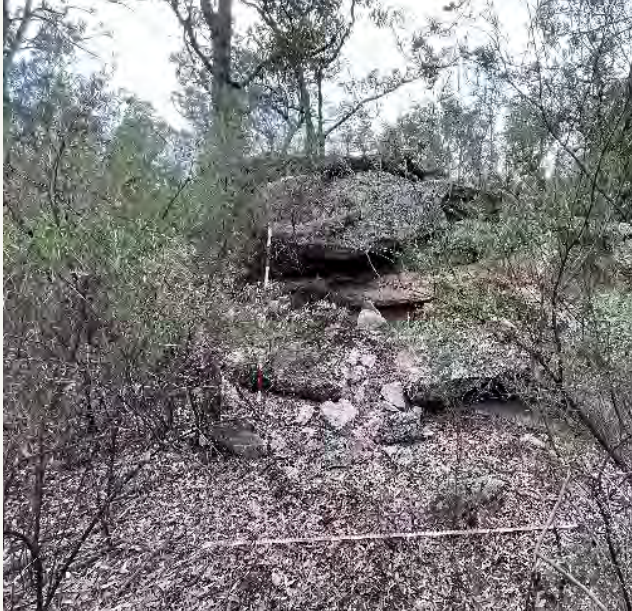
During the post-mining inspections undertaken in December 2025, major collapse of the shelter roof was observed caused by a large fissure in the south side of the shelter back wall. The results of the monitoring inspection are detailed in Table 5 below, and Plate 37 to Plate 50 show the monitoring photographs and comparison images for the site.

| AHIMS number | Site name | Results of monitoring inspection |
|---|---|---|
| 36-3-3788 | S1MC484 | <p>Shelter roof collapsed - total roof collapse with large fissure in the south side of the shelter back wall. Smaller fissure cracking in and around this larger crack shows this to be a weak point that failed. No obvious surface fissuring but potential for the weak point to line up with direction of subsidence cracking from nearby shelter, S1MC356b.</p> <p>PAD preserved under collapsed roof section. Some of the collapsed roof has remained intact, with some associated blockfall.</p> <p>Although these types of impacts can occur naturally at sandstone overhangs, the changes observed since the baseline inspection were attributed to mining subsidence as a result of an extraction of LW401-407, which is supported by the MSEC (2021) subsidence predictions.</p> <p><b><u>RAP comments recorded during S1MC484 site inspection:</u></b></p> <p>The RAP field representatives present during the monitoring inspection of the site did not submit comments regarding the management of the site.</p> |

| Baseline recording (Nov 2022) | Post-mining recording (Dec 2025) |
|---|---|
| <p data-bbox="164 1039 796 1126">Plate 37: General photo of site S1MC484 (AHIMS ID# 36-3-3788), facing north. Photo taken on 21 November 2022.</p> | <p data-bbox="810 1039 1444 1126">Plate 38: General photo of site S1MC484 (AHIMS ID# 36-3-3788) with shelter roof collapsed. Photo taken on 11 December 2025.</p> |

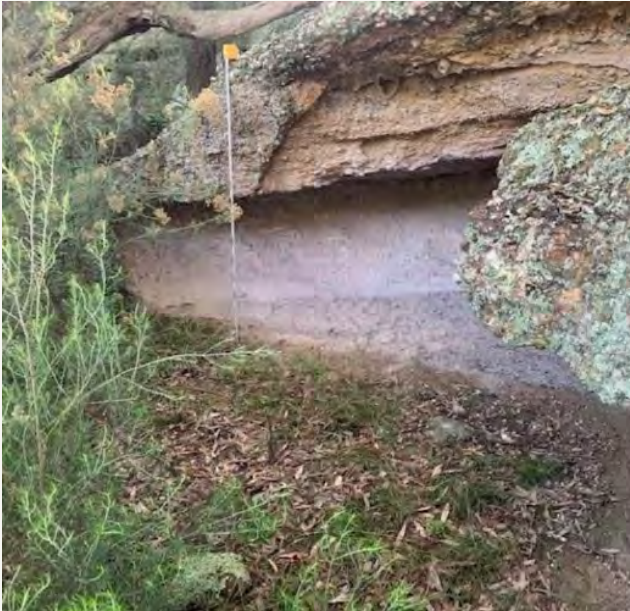
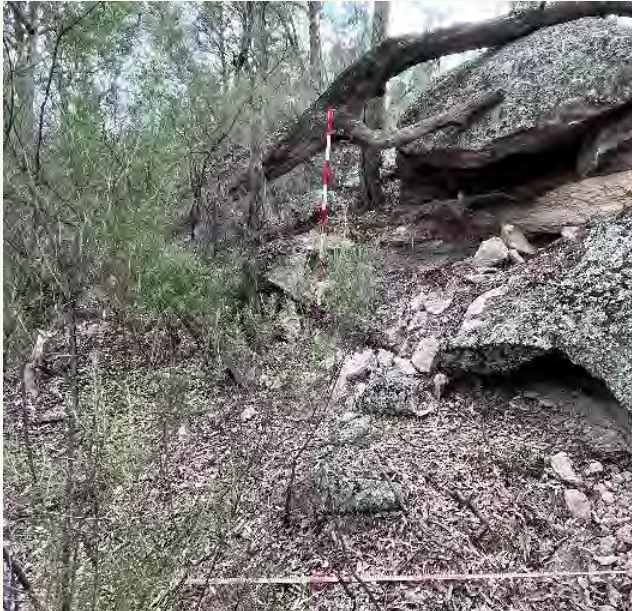
| Baseline recording (Nov 2022) | Post-mining recording (Dec 2025) |
|---|---|
| <p data-bbox="164 1760 796 1859">Plate 39 General photo of site S1MC484 (AHIMS ID#36-3-3788), facing north-east. Photo taken on 21 November 2022.</p> | <p data-bbox="810 1760 1444 1859">Plate 40: General photo of site showing roof collapse, facing north-east. Photo taken on 11 December 2025.</p> |

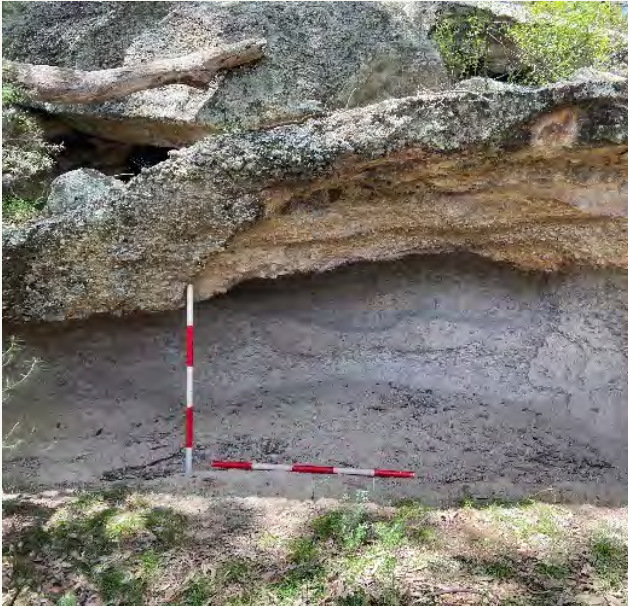
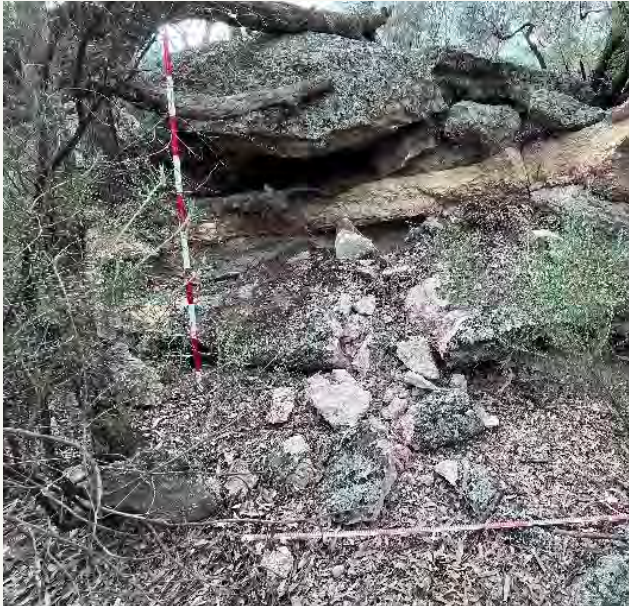
| Baseline recording (Nov 2022) | Post-mining recording (Dec 2025) |
|---|---|
| <p>Plate 41: General view of shelter area. Photo taken on 21 November 2022.</p> | <p>Plate 42: General view of shelter area with recent roof collapse. Photo taken on 11 December 2025.</p> |

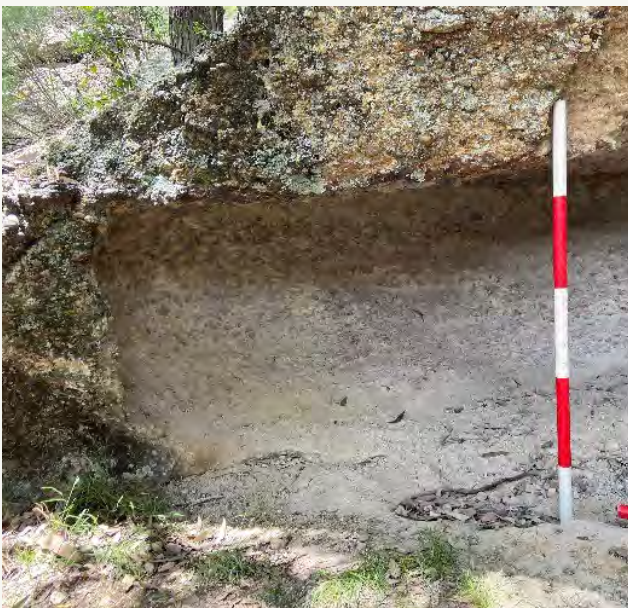
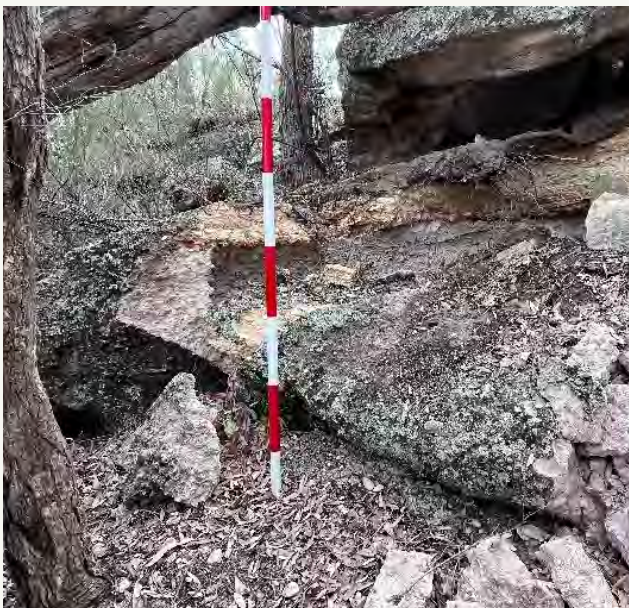
| Baseline recording (Nov 2022) | Post-mining recording (Dec 2025) |
|---|---|
| <p>Plate 43: Northern section of shelter view to the west. Photo taken on 21 November 2022.</p> | <p>Plate 44: Northern section of shelter affected by roof collapse, facing west. Photo taken on 11 December 2025.</p> |

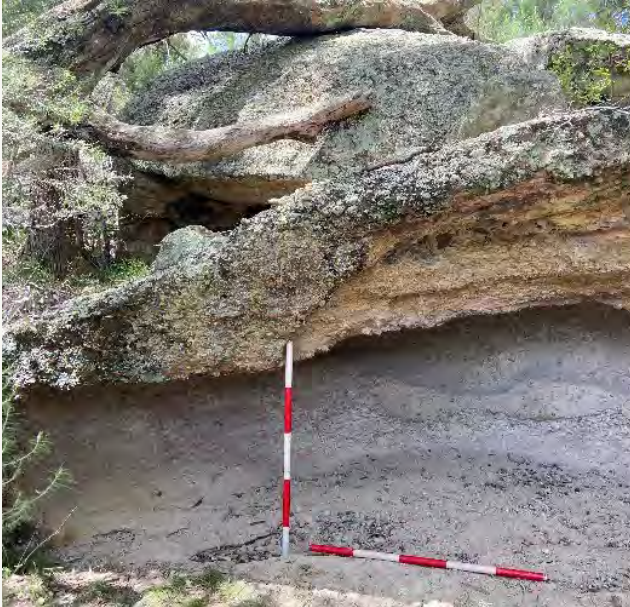
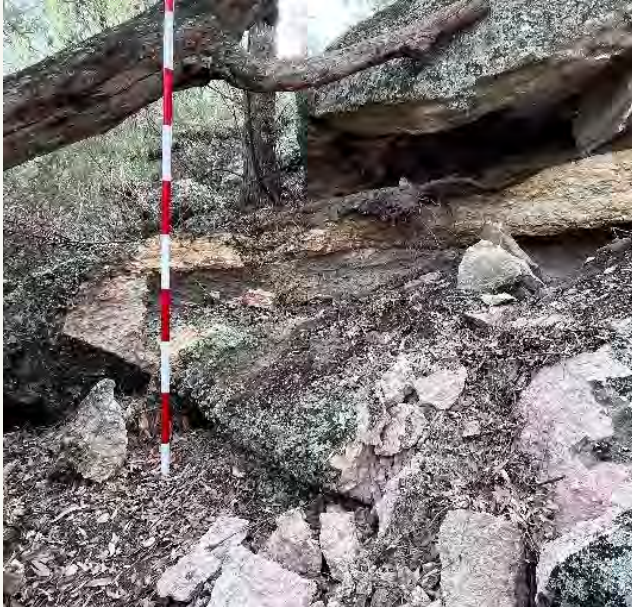
| Baseline recording (Nov 2022) | Post-mining recording (Dec 2025) |
|---|---|
| <p data-bbox="164 1032 796 1093">Plate 45 Northern area of shelter mid section, view to the west. Photo taken on 21 November 2022.</p> | <p data-bbox="810 1032 1444 1115">Plate 46: Northern area of shelter mid section affected by roof collapse, facing west. Photo taken on 11 December 2025.</p> |

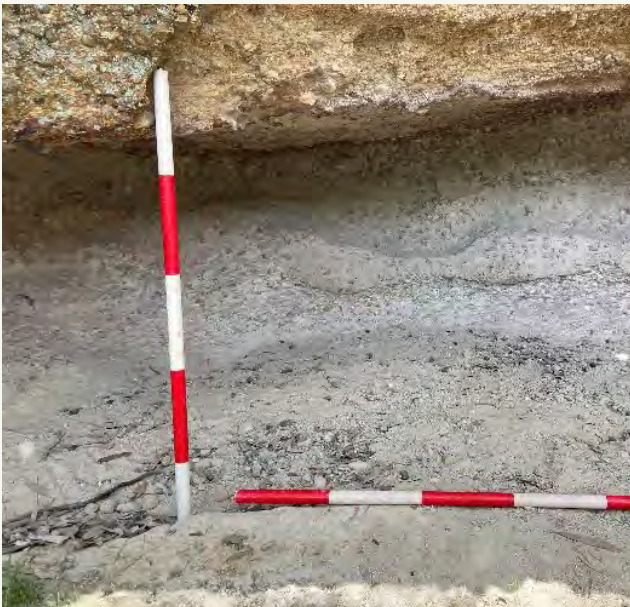
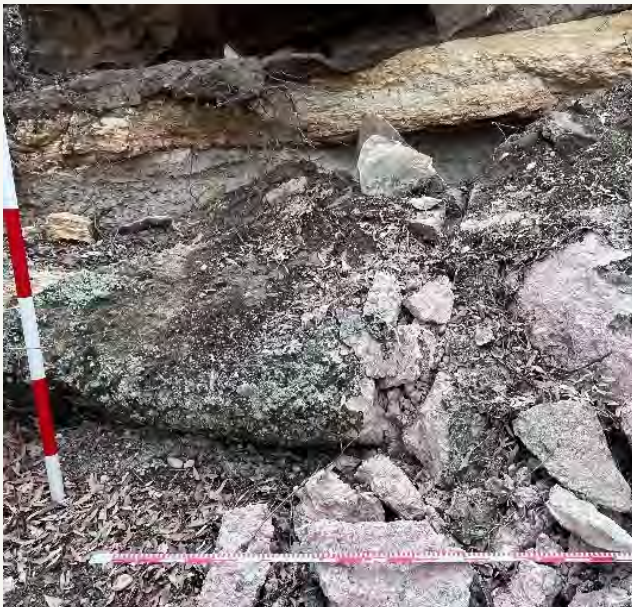
| Baseline recording (Nov 2022) | Post-mining recording (Dec 2025) |
|---|---|
| <p data-bbox="164 1747 796 1807">Plate 47: Midsection with deposit floor detail. Photo taken on 21 November 2022.</p> | <p data-bbox="810 1747 1444 1807">Plate 48: Midsection affected by roof collapse obscuring deposit floor detail. Photo taken on 11 December 2025.</p> |

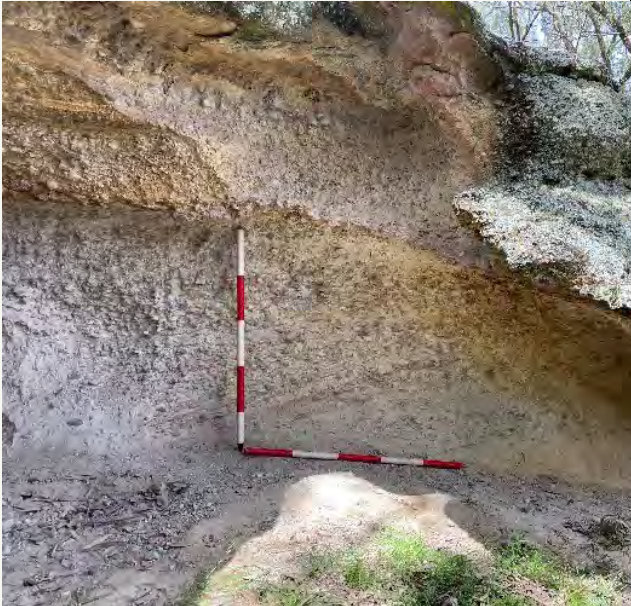
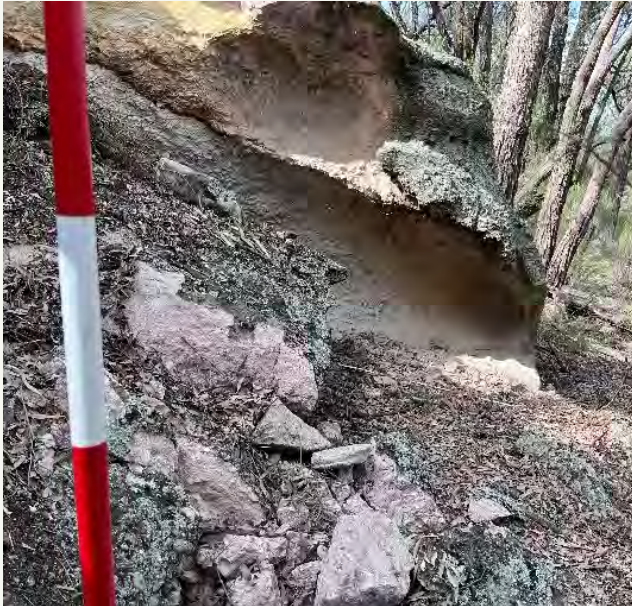
| Baseline recording (Nov 2022) | Post-mining recording (Dec 2025) |
|---|---|
| Plate 49: Southern end of shelter, wall and overhang exposure detail. Photo taken on 21 November 2022. | Plate 50: Southern end of shelter and wall affected by roof collapse debris. Photo taken on 11 December 2025. |

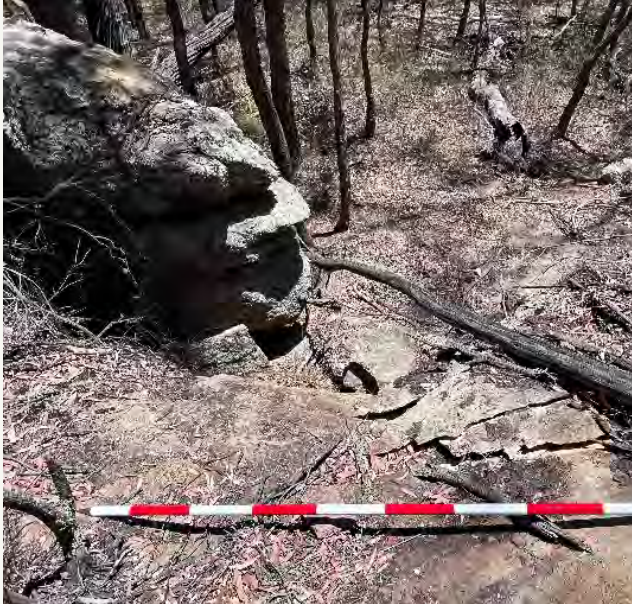
| AHIMS number | Site name | Results of monitoring inspection |
|---|---|---|
| 36-3-3793 | S1MC494 | <p>Minimal change to blockfall and weathering elements that affect the shelter. Fissuring noted. Some transverse fissuring can be seen on the shelter roof. Cracking was identified in front of the eastern overhang running in an east west direction. Other fissure cracks were found behind the top of rock that covers the top of the shelter. Other recent fissuring was also found to the east outside of the site (Plate 61).</p> <p>Although these types of impacts can occur naturally at sandstone overhangs, the changes observed since the baseline inspection were attributed to mining subsidence as a result of an extraction of LW401-407, which is supported by the MSEC (2021) subsidence predictions.</p> <p><b><u>RAP comments recorded during S1MC494) site inspection:</u></b></p> <p>The RAP field representatives present during the monitoring inspection of the site did not submit comments regarding the management of the site.</p> |

| Baseline recording (Nov 2022) | Post-mining recording (Dec 2025) |
|---|---|
| <p data-bbox="164 423 600 452"><i>No prior baseline photographs available</i></p> | <div data-bbox="810 423 1444 1025"></div> <p data-bbox="810 1034 1422 1120">Plate 62: Evidence of fissure cracks found on top of the rock that covers the shelter. Photo taken on 9 December 2025.</p> |

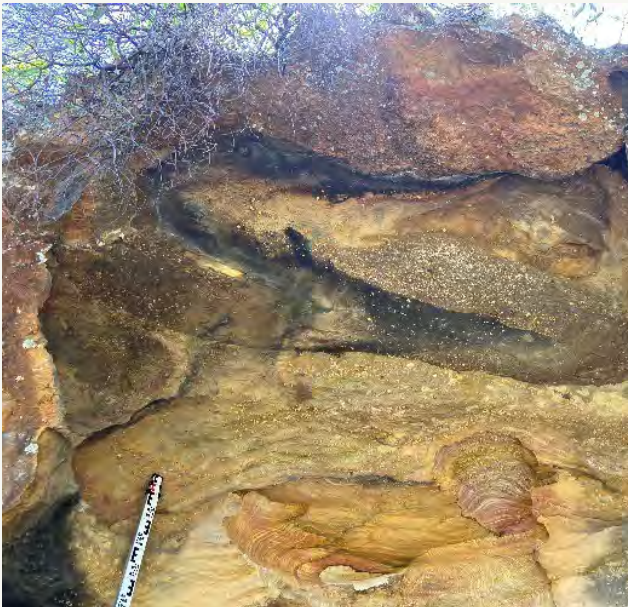
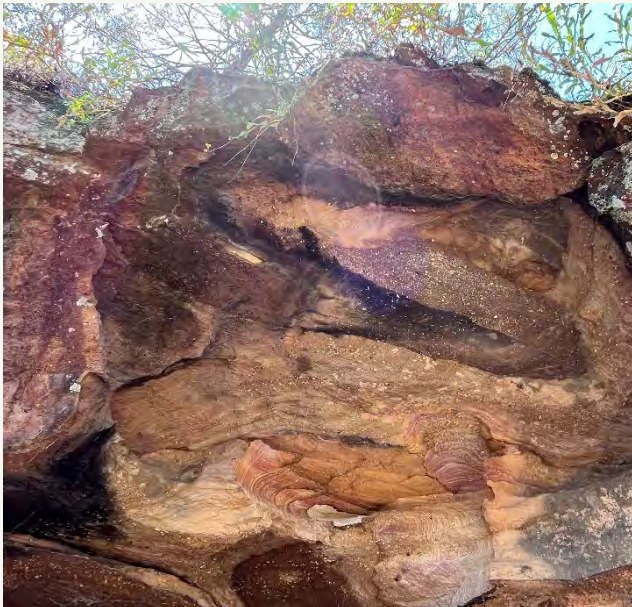
| Baseline recording (Nov 2022) | Post-mining recording (Dec 2025) |
|---|---|
| <p data-bbox="164 1753 794 1809">Plate 73: Midsection of site - roof interior details. Photo taken on 29 November 2022.</p> | <p data-bbox="810 1753 1444 1809">Plate 74: Midsection of site - roof interior details. Minor cracking in the midsection roof was apparent. Photo taken on 9 December 2025.</p> |

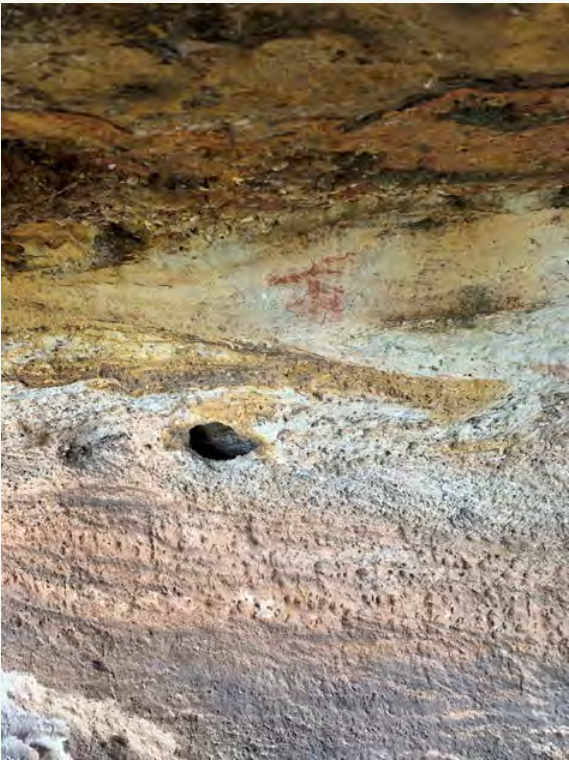
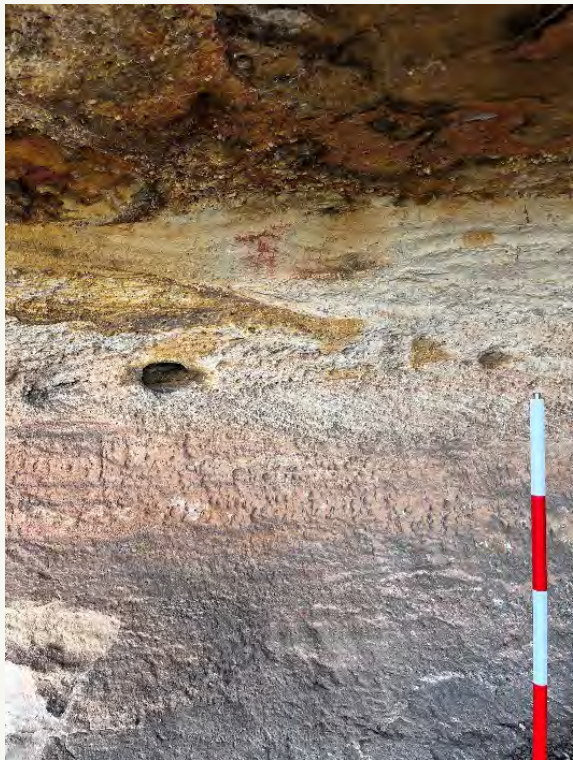
| AHIMS number | Site name | Results of monitoring inspection |
|---|---|---|
| 36-3-0042 | S1MC280 | <p>No mining or subsidence-related impacts to the site were observed, which is consistent with the MSEC (2021) subsidence predictions.</p> <p>Previously recorded fissures do not appear to have been impacted by subsidence related movement. A pre-existing crack located on the rear wall of the shelter contains increased modern soil deposition but shows no evidence of widening, propagation, or additional structural movement. The blockfall surface within the shelter retains a smooth polish consistent with previous assessments indicating food processing activity. Eight grinding grooves remain present on the blockfall/sandstone outcrop situated to the north of the shelter, arranged in three groupings (1, 4 and 3), and these features remain intact and unchanged. The art panel containing a hand stencil motif on the back wall also remains unchanged, with an additional iron oxide motif still visible near the central portion of the shelter wall.</p> <p>The post depositional conditions and environmental agents held relatively consistent since the baseline recording, with continuing waterwash damage evident. Graffiti documented during earlier inspections persists on sections of the roof and back wall. Charcoal and carbonisation remain evident on the roof surface. Waterwash continues to affect the exterior surfaces of the shelter and minor erosion, including areas of exfoliation and scalping, is visible on portions of the roof. Six stone artefacts were identified within the shelter and along the dripline during the inspection.</p> <p>Subsurface mitigation measures previously installed above the shelter remain in place. The stress relief cuts have begun to infill with sediment along the western lower wall. Additional channels visible across the upper and rear surfaces of the shelter appear consistent with previously installed drainage and subsidence relief works.</p> <p><b><u>RAP comments recorded during S1MC280 site inspection:</u></b></p> <p>The RAP field representatives present during the monitoring inspection of the site did not submit comments regarding the management of the site.</p> |

| Baseline recording (Mar 2021) | Post-mining recording (Dec 2025) |
|---|---|
| <p>Plate 87: Detail of iron oxide staining on rear wall of S1MC280; Ulan Creek 2 (AHIMS ID#36-3-0042). Photo taken on 17 March 2021.</p> | <p>Plate 88: Detail of iron oxide staining on rear wall of S1MC280; Ulan Creek 2 (AHIMS ID#36-3-0042). Photo taken on 11 December 2025.</p> |

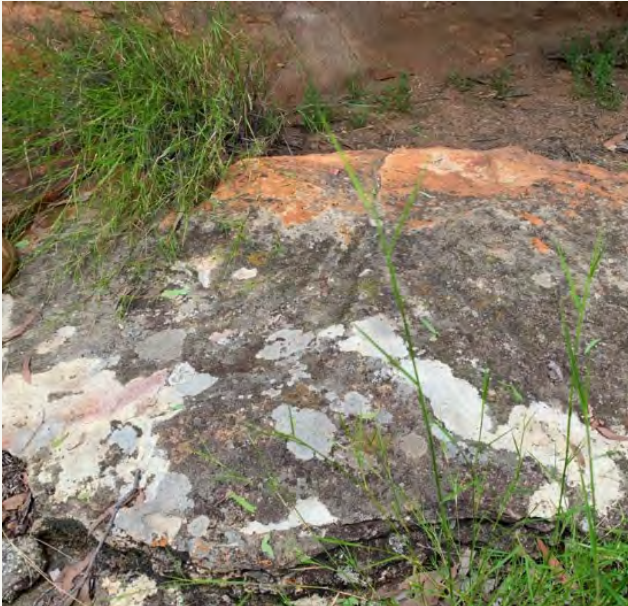
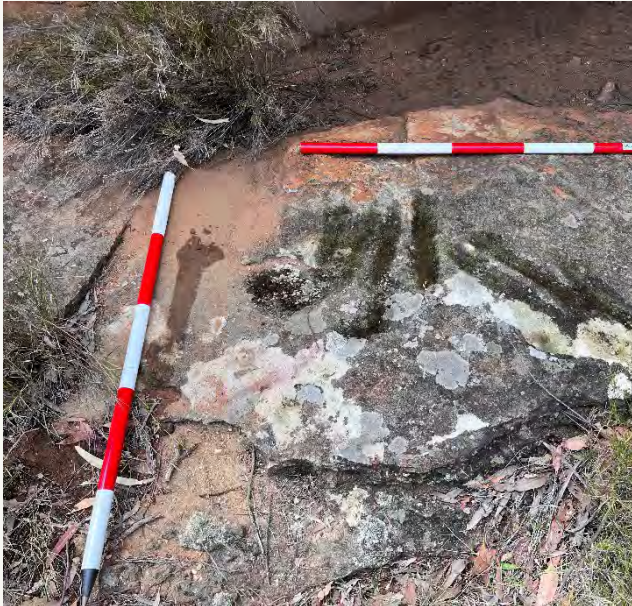
| Baseline recording (Mar 2021) | Post-mining recording (Dec 2025) |
|---|---|
| <p>Plate 89: Grinding groove detail at S1MC280; Ulan Creek 2 (AHIMS ID#36-3-0042). Photo taken on 17 March 2021.</p> | <p>Plate 90: Grinding groove detail at S1MC280; Ulan Creek 2 (AHIMS ID#36-3-0042). Photo taken on 11 December 2025.</p> |

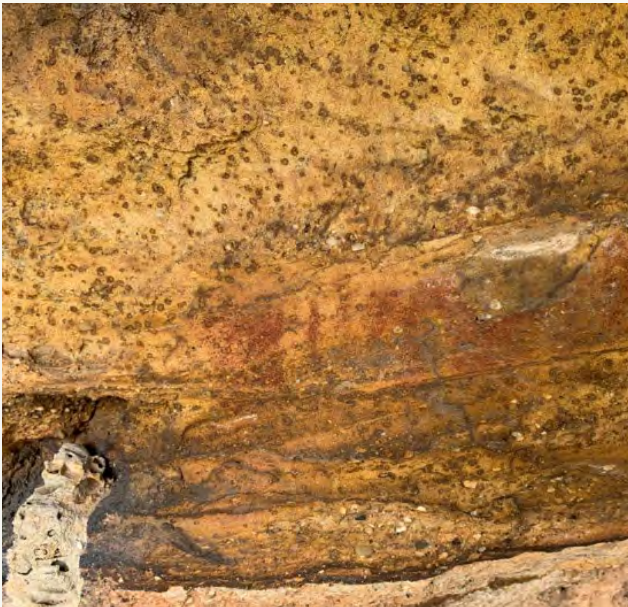
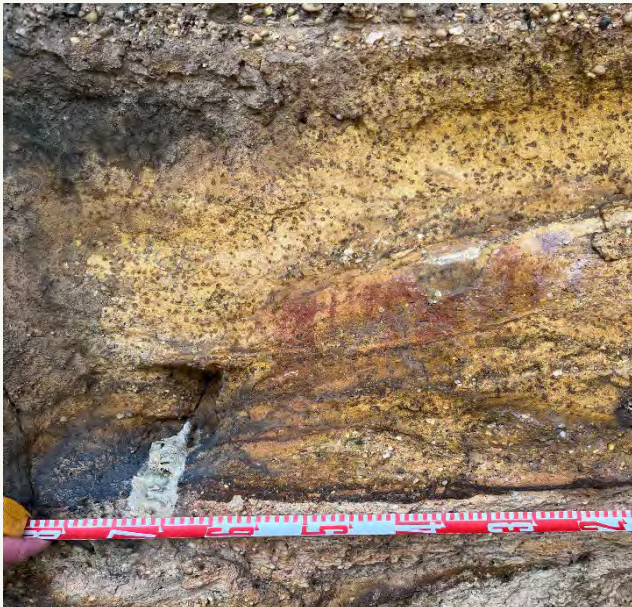
| Baseline recording (Mar 2021) | Post-mining recording (Dec 2025) |
|---|---|
| <p>Plate 91: S1MC280 (AHIMS ID#36-3-0042) hand stencil detail. Photo taken on 17 March 2021.</p> | <p>Plate 92: S1MC280 (AHIMS ID#36-3-0042) hand stencil motif detail, taken in December 2025. Photo taken on 11 December 2025.</p> |

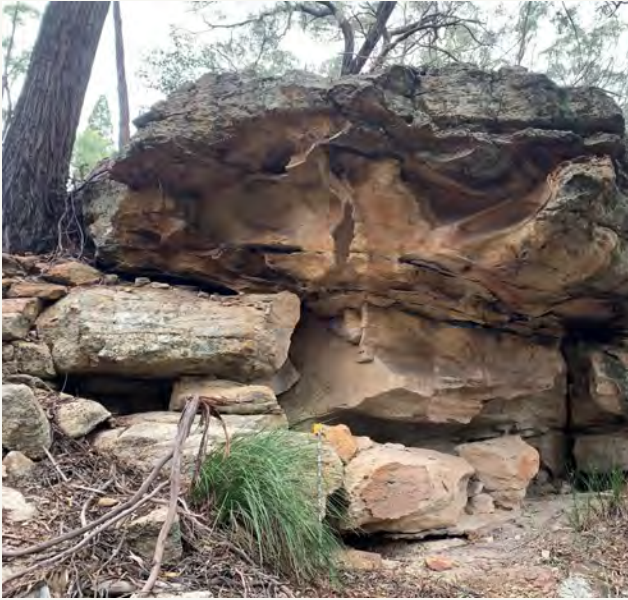
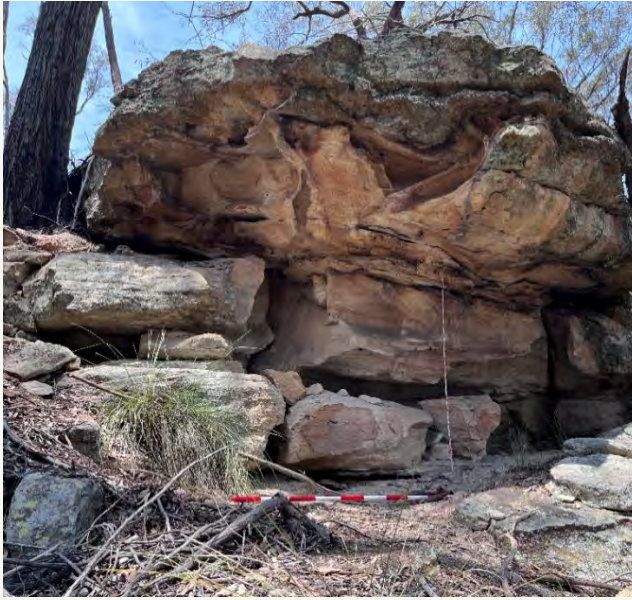
| AHIMS number | Site name | Results of monitoring inspection |
|---|---|---|
| 36-3-3803 | S1MC472 | <p>No mining or subsidence-related impacts to the site were observed, which is consistent with the MSEC (2021) subsidence predictions.</p> <p>Original inspection noted fissuring to the back wall of the shelter. No changes to the fissure as noted by the current inspection. This site was subject to salvage investigations in 2023 (three test pits), and the PAD was salvaged and backfilled within the shelter. Lack of current animal activity noted. No change to the previously noted erosion processes that affect the shelter. Fallen branches beside the shelter remain in the same location.</p> <p><b><u>RAP comments recorded during S1MC472 site inspection:</u></b></p> <p>The RAP field representatives present during the monitoring inspection of the site did not submit comments regarding the management of the site.</p> |

| Baseline recording (Nov 2022) | Post-mining recording (Dec 2025) |
|---|---|
| <p>Plate 93: S1MC472 (AHIMS ID#36-3-3803) general overview, facing northeast. Photo taken on 23 November 2022.</p> | <p>Plate 94: S1MC472 (AHIMS ID#36-3-3803) general overview, facing northeast. Photo taken on 10 December 2025.</p> |

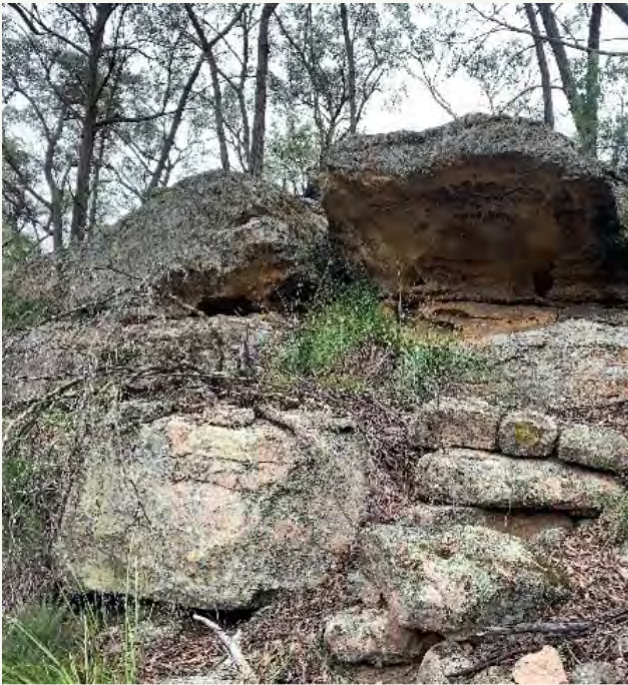
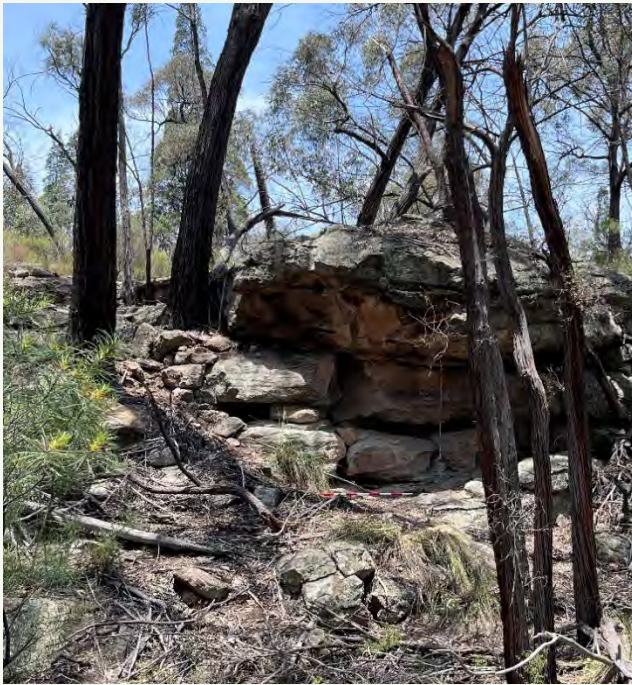
| Baseline recording (Nov 2022) | Post-mining recording (Dec 2025) |
|---|---|
| <p>Plate 95: S1MC472 (AHIMS ID#36-3-3803) general overview, facing northeast (Incorrect site photo taken of different site that was published in baseline report). Photo taken on 23 November 2022.</p> | <p>Plate 96: S1MC472 (AHIMS ID#36-3-3803) general overview, facing northeast (Incorrect site photo taken of different site that was published in baseline report). Photo taken on 10 December 2025.</p> |

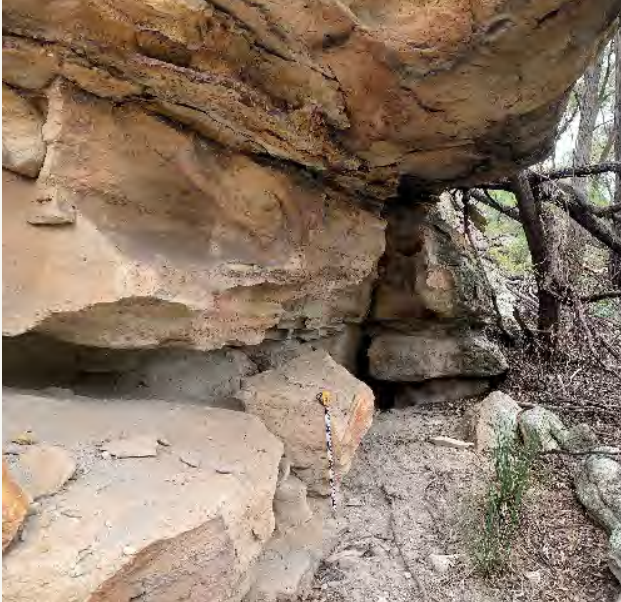
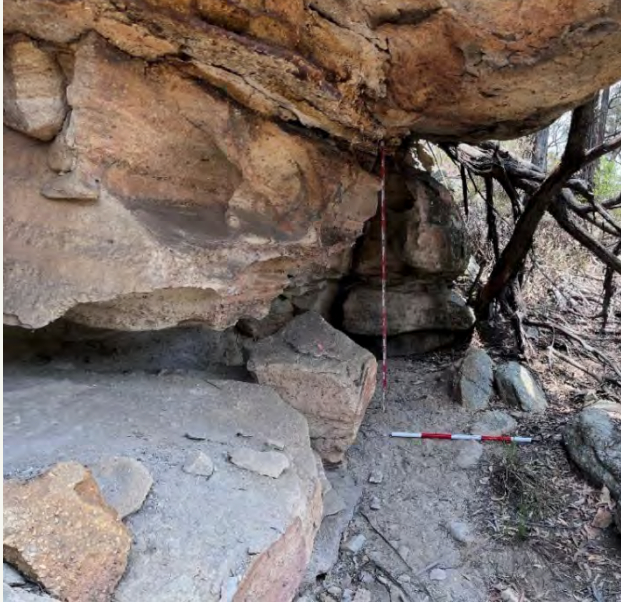
| Baseline recording (Nov 2022) | Post-mining recording (Dec 2025) |
|---|---|
| <p>Plate 97: S1MC472 (AHIMS ID#36-3-3803) general overview, facing east. Photo taken on 23 November 2022.</p> | <p>Plate 98: S1MC472 (AHIMS ID#36-3-3803) general overview, facing east. Photo taken on 10 December 2025.</p> |

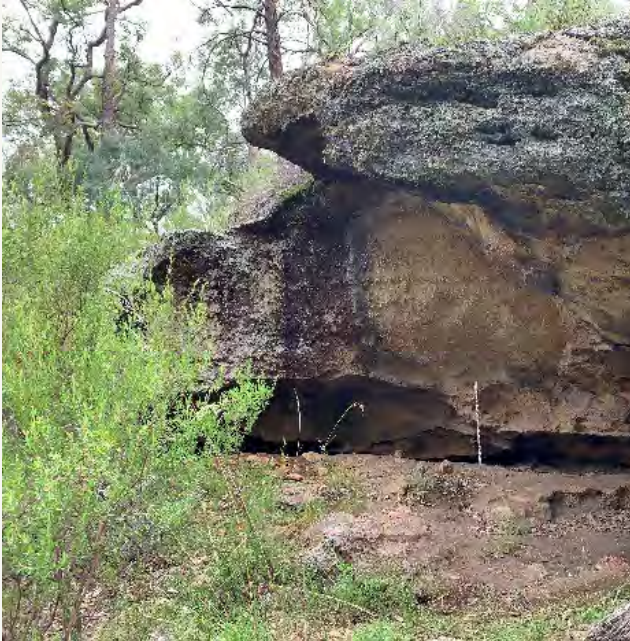
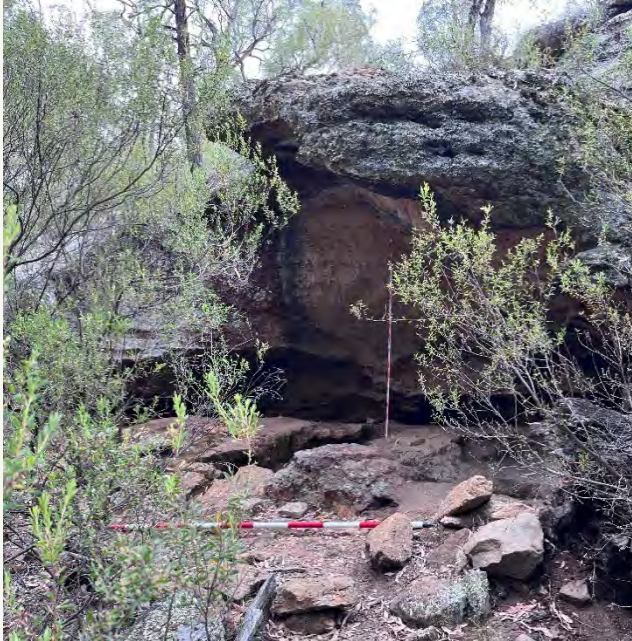
During the post-mining inspection undertaken in December 2025, the site demonstrated that minor fissuring that was observed previously may have increased on the rear wall and roof of the eastern and western shelter due to natural weathering patterns. The results of the monitoring inspection are detailed in Table 10 below, and Plate 101 to Plate 106 show the monitoring photographs and comparison images for the site.

| AHIMS number | Site name | Results of monitoring inspection |
|---|---|---|
| 36-3-3785 | S1MC474 | <p>No mining or subsidence-related impacts to the site were observed, which is consistent with the MSEC (2021) subsidence predictions.</p> <p>Minor fissuring that was observed previously may have increased on the rear wall and roof of the eastern and western shelter. This has been caused by the process of existing exfoliation already evident in the shelter. This shelter has been subjected to previous archaeological investigations of the recorded PAD. The entirety of the PAD has been removed from the shelter spaces. Two quartz artefacts were found within the vicinity of the shelter.</p> <p><b><u>RAP comments recorded during S1MC474 site inspection:</u></b></p> <p>The RAP field representatives present during the monitoring inspection of the site suggested it would be beneficial to backfill the areas where the PAD was excavated within the shelter spaces. The RAPs requested that backfill be sourced from the same location as the sieve backfill.</p> |

| Baseline recording (Nov 2021) | Post-mining recording (Dec 2025) |
|---|---|
| <p>Plate 101: General photo of site S1MC474 (AHIMS ID#36-3-3785), facing east. Stone artefacts eroding from dripline and visible at exposure around tree. Twin, stone floored shelter located to the south-east (right of frame). Photo taken on 30 November 2021.</p> | <p>Plate 102: General photo of site S1MC474 (AHIMS ID#36-3-3785), facing east. Photo taken on 10 December 2025.</p> |

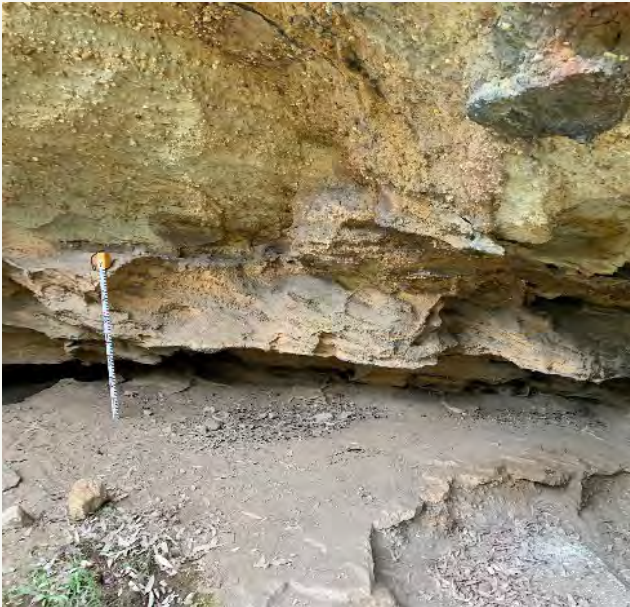
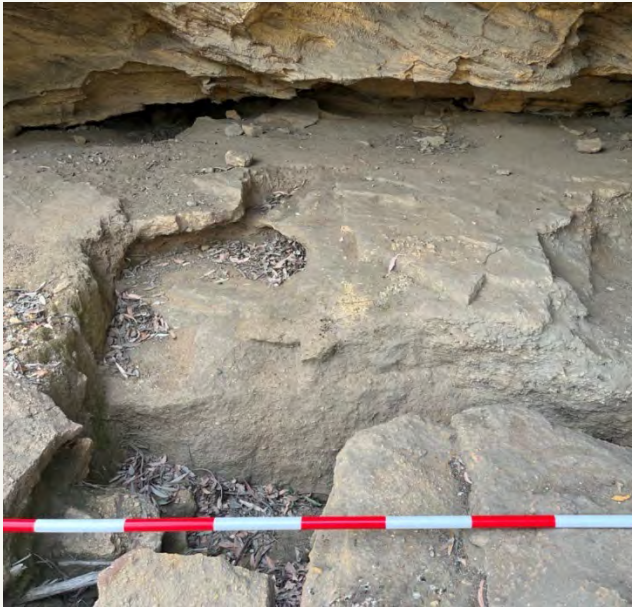
| Baseline recording (Nov 2021) | Post-mining recording (Dec 2025) |
|---|---|
| <p>Plate 103: General photo of primary overhang at S1MC474 (AHIMS ID#36-3-3785), facing east. Photo taken on 30 November 2021.</p> | <p>Plate 104: View of primary overhang and test excavation location at S1MC474. Photo taken on 10 December 2025.</p> |

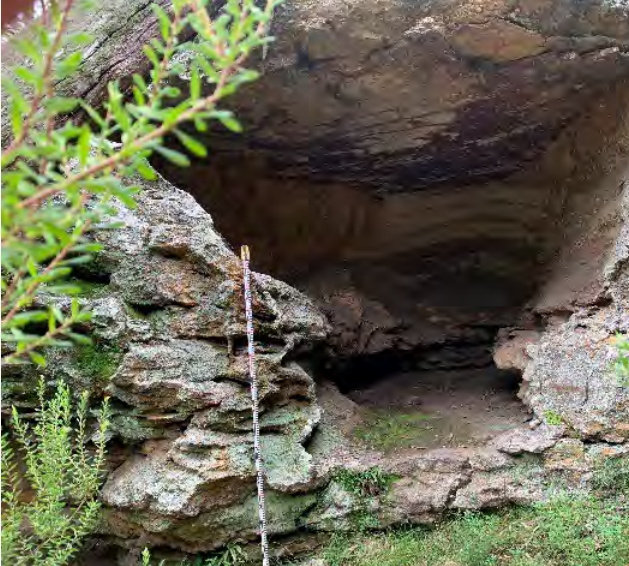
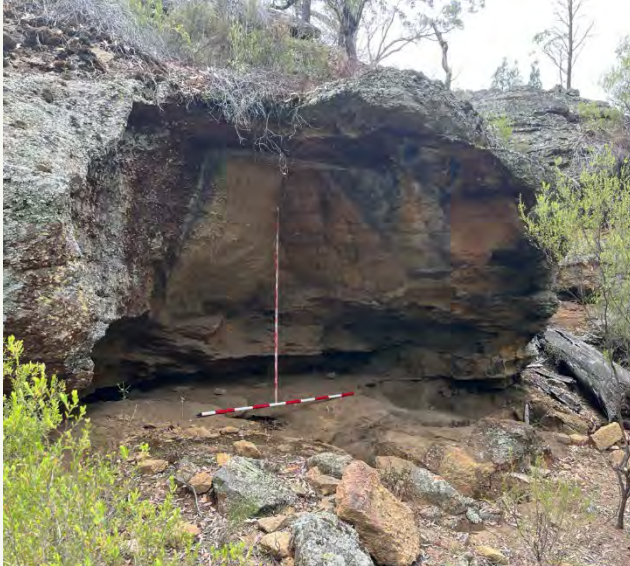
| Baseline recording (Nov 2021) | Post-mining recording (Dec 2025) |
|---|---|
| <p>Plate 105: General photo of twin shelter at S1MC474 (AHIMS ID#36-3-3785), facing east. Stone artefacts present at front of shelter. Photo taken on 30 November 2021.</p> | <p>Plate 106: View of S1MC474 (AHIMS ID#36-3-3785) facing south towards shelter from opposite angle to baseline photograph. Photo taken on 10 December 2025.</p> |

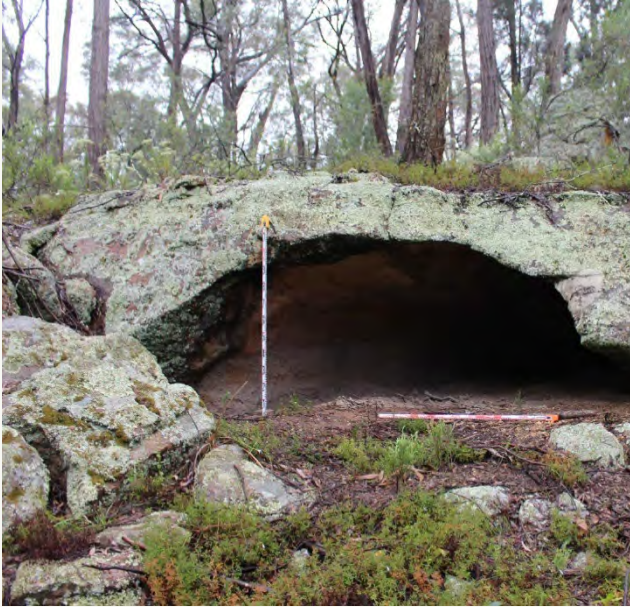
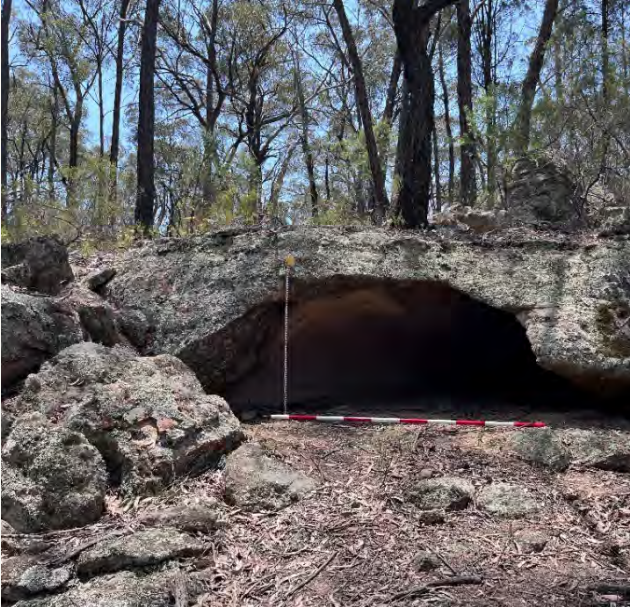
During the post-mining inspection undertaken in December 2025, minor roof fall and fissure cracking was observed in the interior western wall of the shelter. The results of the monitoring inspection are detailed in Table 11 below, and Plate 107 to Plate 114 show the monitoring photographs and comparison images for the site.

| AHIMS number | Site name | Results of monitoring inspection |
|---|---|---|
| 36-3-3790 | S1MC488 | <p>No mining or subsidence-related impacts to the site were observed, which is consistent with the MSEC (2021) subsidence predictions. The observed impacts to the site are natural in origin.</p> <p>Shelter was found with minimal change compared to the previous recording. One tibia bone was identified inside the shelter. The other animal bone and the artefact were not observed and may be buried within the deposit inside the shelter. Transverse cracking can be seen on the roof of the shelter and extends to the walls. Hornets and a nest were found inside the shelter. Another tibia bone was found in the dry drainage line outside the shelter.</p> <p><b><u>RAP comments recorded during S1MC488 site inspection:</u></b></p> <p>The RAP field representatives present during the monitoring inspection of the site did not submit comments regarding the management of the site.</p> |

| Baseline recording (Nov 2021) | Post-mining recording (Dec 2025) |
|---|---|
| <p data-bbox="164 1028 796 1113">Plate 107: General photo of site S1MC488 (AHIMS ID# 36-3-3790), facing north. Photo taken on 30 November 2021.</p> | <p data-bbox="812 1028 1444 1113">Plate 108: Shelter opening and structurally intact S1MC488 (AHIMS ID# 36-3-3790), facing north. Photo taken on 10 December 2025.</p> |

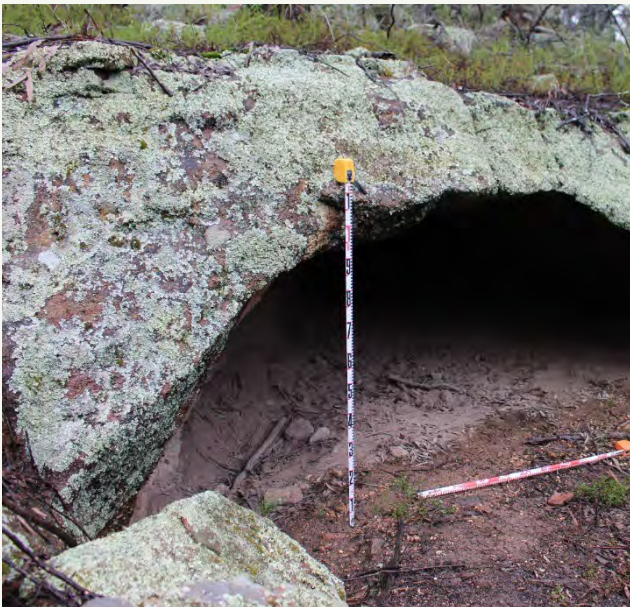
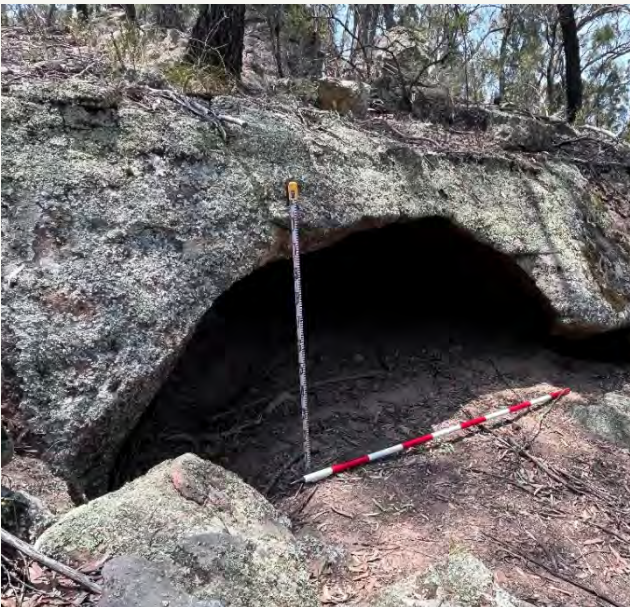
| Baseline recording (Nov 2021) | Post-mining recording (Dec 2025) |
|---|---|
| <p data-bbox="164 1742 796 1827">Plate 109: General photo of site S1MC488 (AHIMS ID# 36-3-3790), facing north. . Photo taken on 30 November 2021.</p> | <p data-bbox="812 1742 1444 1827">Plate 110: Close up of shelter dripline, facing north. Photo taken on 10 December 2025.</p> |
