**RE: MOOLARBEN COAL COMPLEX – UG4 LONGWALLS 401 TO 407 END OF PANEL REPORT**

Secondary extraction of LW407 was completed in January 2026. Accordingly, MCO has prepared a UG4 LW401-407 End of Panel Report (refer to **Enclosure 1**), which presents monitoring data, describes observed impacts during mining of LW401-407 and compares these results to predictions and relevant performance measures and performance indicators as described in the approved UG4 LW401-408 Extraction Plan.

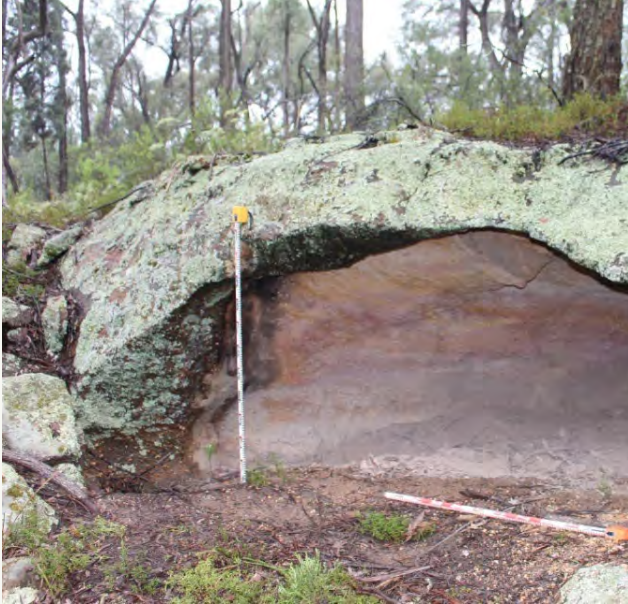
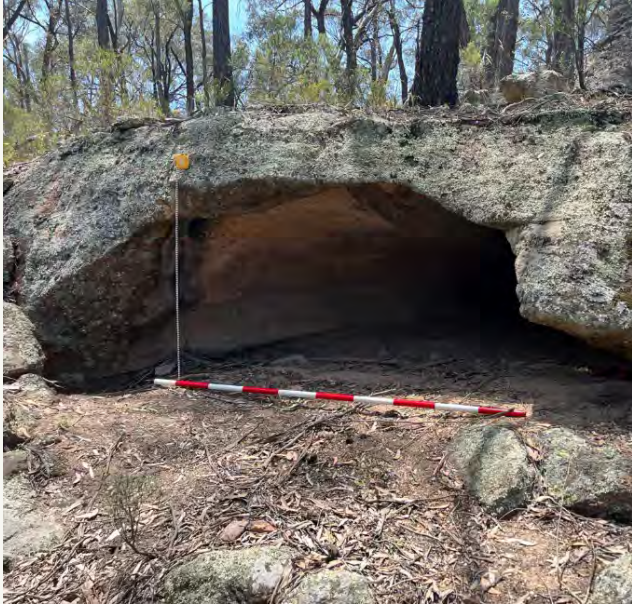
| Baseline recording (Nov 2021) | Post-mining recording (Dec 2025) |
|---|---|
| <p>Plate 111: Close up of the shelter interior at site S1MC488 (AHIMS ID# 36-3-3790), facing north west. Photo taken on 30 November 2021.</p> | <p>Plate 112: Close up of the shelter interior at site S1MC488 (AHIMS ID# 36-3-3790), facing north west. Photo taken on 10 December 2025.</p> |

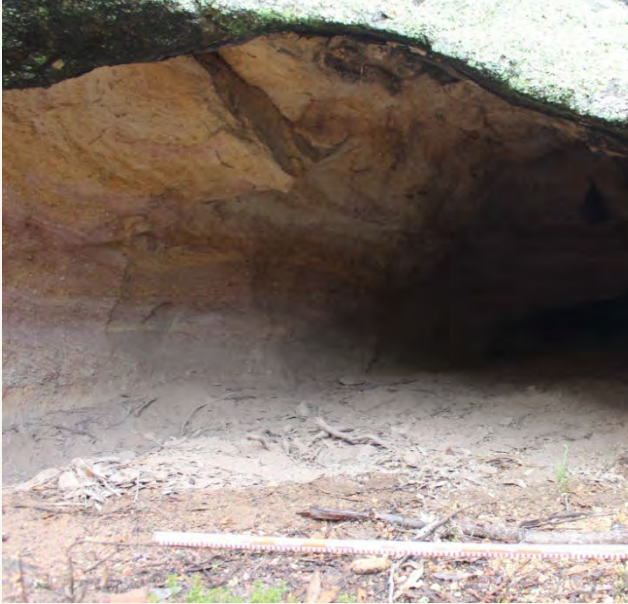
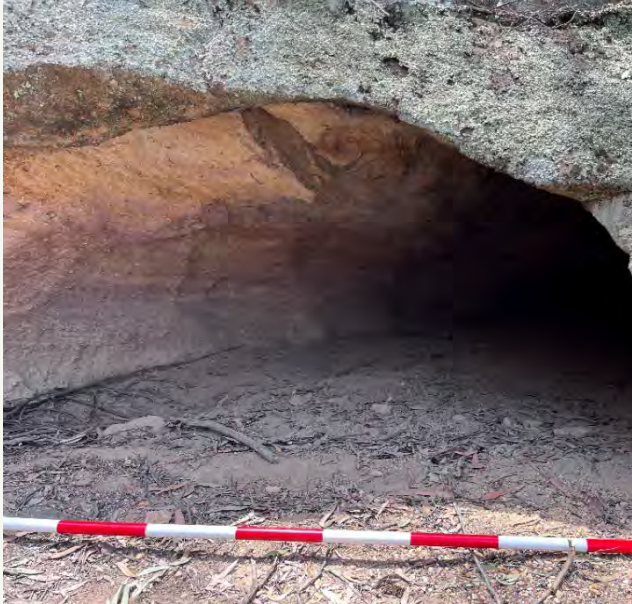
| Baseline recording (Nov 2021) | Post-mining recording (Dec 2025) |
|---|---|
| <p>Plate 113: Close up of the shelter interior at site S1MC488 (AHIMS ID# 36-3-3790), facing north. Photo taken on 30 November 2021.</p> | <p>Plate 114: Close up of interior, some reddening of interior suggests fire or chemical weathering processes. Photo taken on 10 December 2025.</p> |

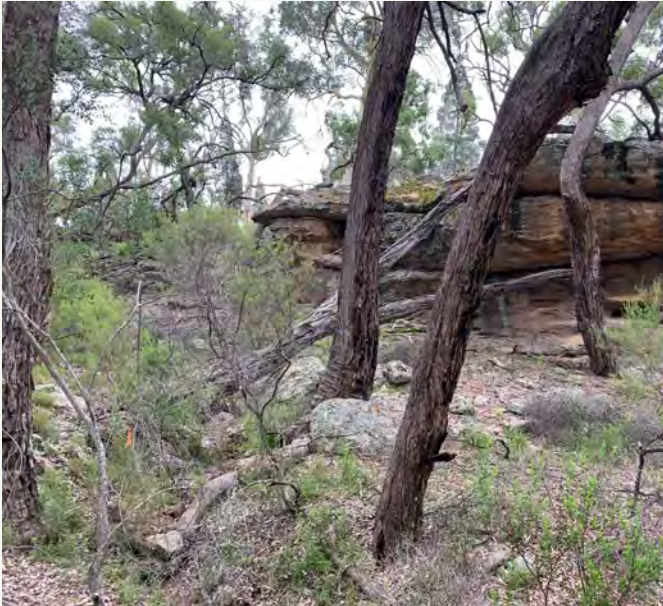
| AHIMS number | Site name | Results of monitoring inspection |
|---|---|---|
| 36-3-3792 | S1MC491 | <p>No mining or subsidence-related impacts to the site were observed, which is consistent with the MSEC (2021) subsidence predictions.</p> <p>Shelter may have experienced further deposition of sand on some of the rock benches within its interior as a result of weathering. Natural erosion processes including exfoliation, granular loss and waterwash have continued in between inspections. Also, lichen vegetation is confined to the western end of the shelter.</p> <p>Minor fissuring associated with exfoliation and granular loss can be observed on the roof of the shelter and parts of the rear wall. Area of previous waterwash from interior seepage within the shelter is no longer active as shown by dead vegetation. This may also be evident of a reduction of water or rainfall source. It also must be noted that the nearby Bora Creek was dry and did not have any running water at the time of the inspection. The shelter's condition remains the same from the previous inspection.</p> <p><b><u>RAP comments recorded during S1MC491 site inspection:</u></b></p> <p>The RAP field representatives present during the monitoring inspection of the site did not submit comments regarding the management of the site.</p> |

Plate 115: General photo of site S1MC491 (AHIMS ID# 36-3-3792), facing north-west. Photo taken on 2 December 2021.

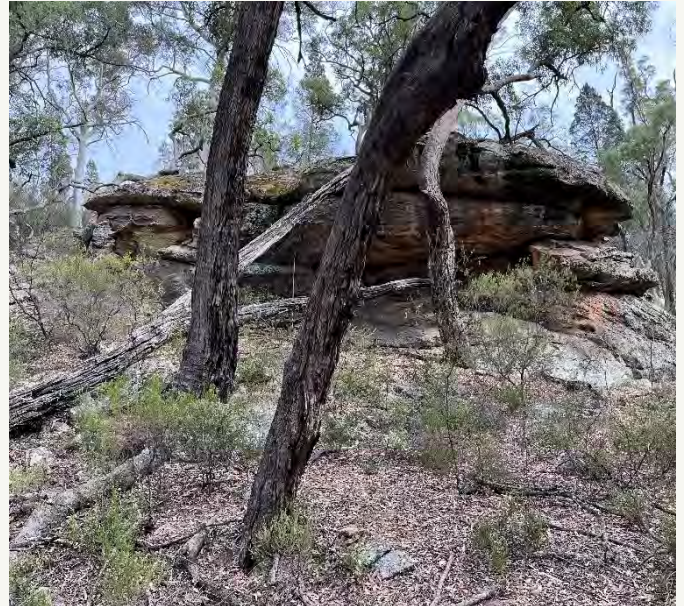
Plate 116: General photo of site S1MC491 (AHIMS ID# 36-3-3792), facing north-west. Photo taken on 10 December 2025.

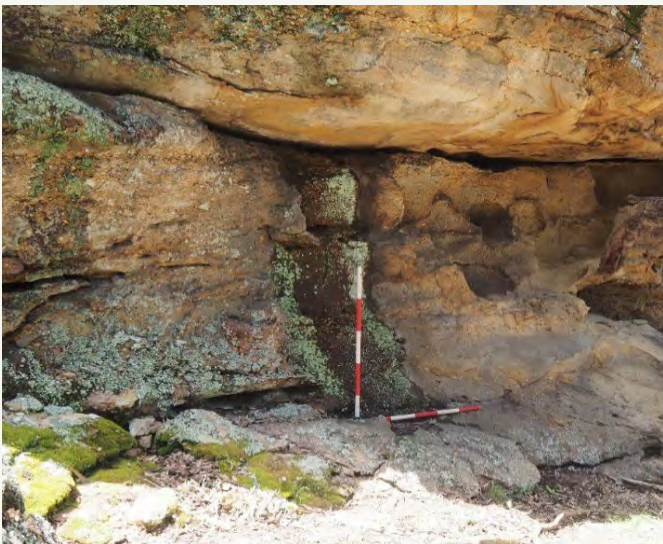
Plate 117: General photo of site S1MC491 (AHIMS ID# 36-3-3792), facing north. Photo taken on 2 December 2021.

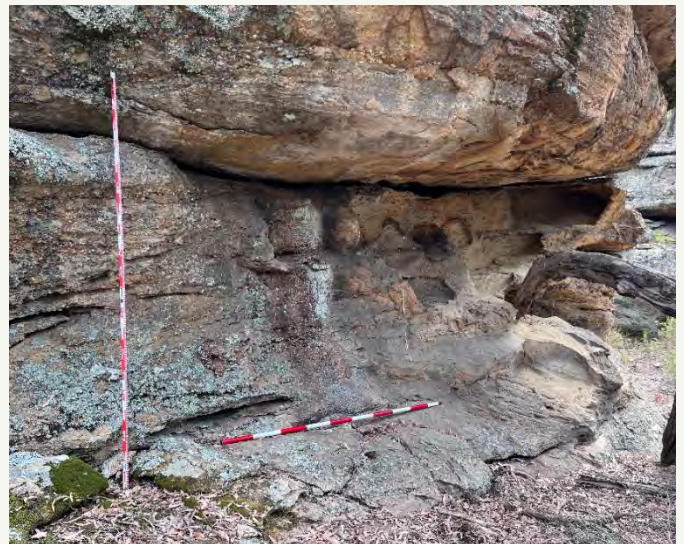
Plate 118: General photo of site S1MC491 (AHIMS ID# 36-3-3792), facing north. Photo taken on 10 December 2025.

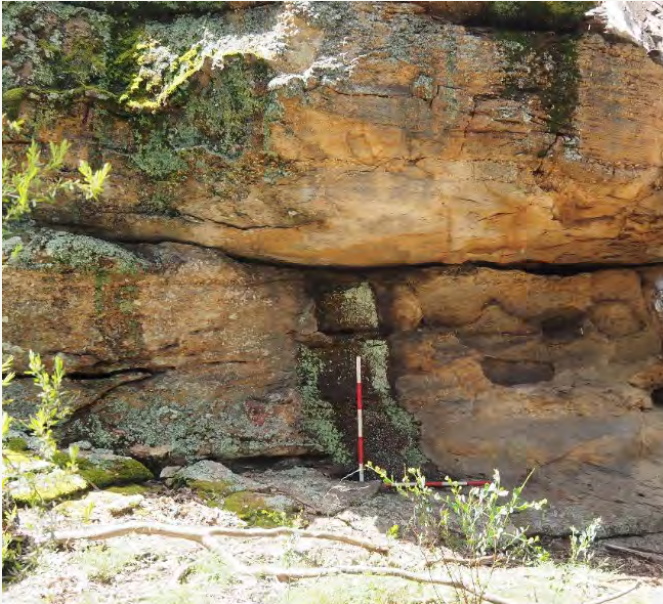
Plate 119: General photo of site S1MC491 (AHIMS ID# 36-3-3792), facing north. Photo taken on 2 December 2021.

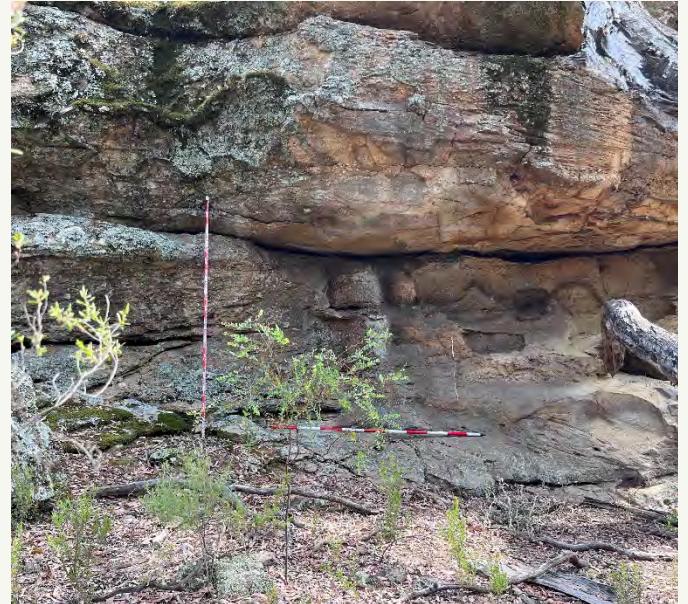
Plate 120: General photo of site S1MC491 (AHIMS ID# 36-3-3792), facing north. Photo taken on 10 December 2025.

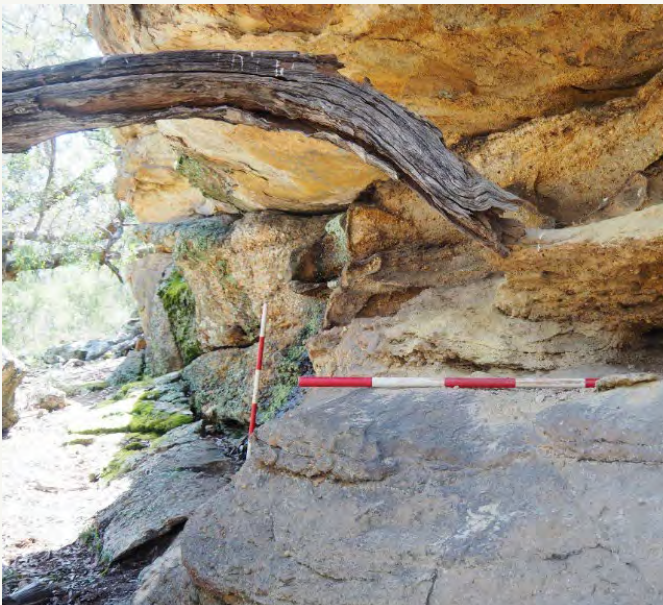
Plate 121: Close up of shelter interior at site S1MC491 (AHIMS ID# 36-3-3792), facing west. Photo taken on 2 December 2021.

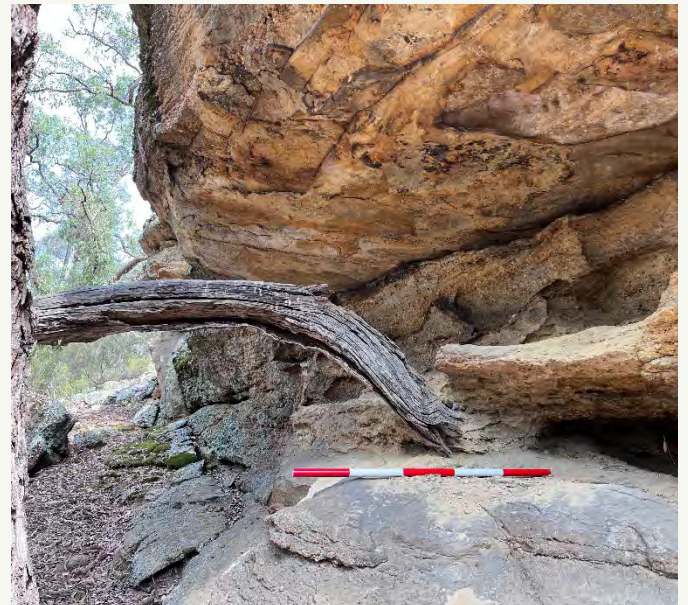
Plate 122: Close up of shelter interior at site S1MC491 (AHIMS ID# 36-3-3792), facing west. Photo taken on 10 December 2025.

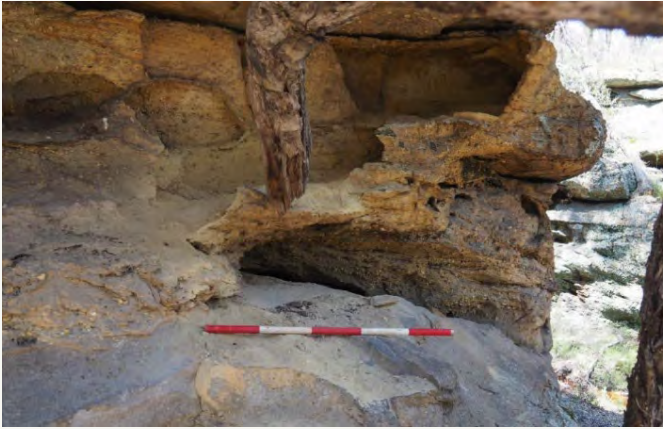
Plate 123: Close up of shelter interior at site S1MC491 (AHIMS ID# 36-3-3792), facing north-east. Photo taken on 2 December 2021.

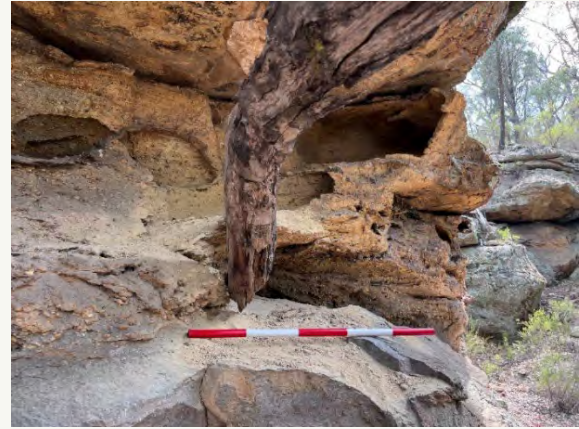
Plate 124: Close up of shelter interior at site S1MC491 (AHIMS ID# 36-3-3792), facing north-east. Photo taken on 10 December 2025.

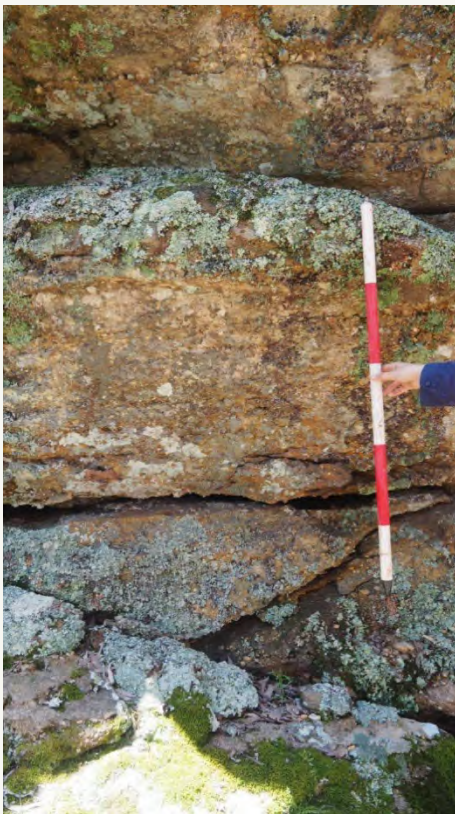
Plate 125: Close up of weathered sandstone at site S1MC491 (AHIMS ID# 36-3-3792), showing the salt/granular loss and microvegetals present. Photo taken on 2 December 2021.

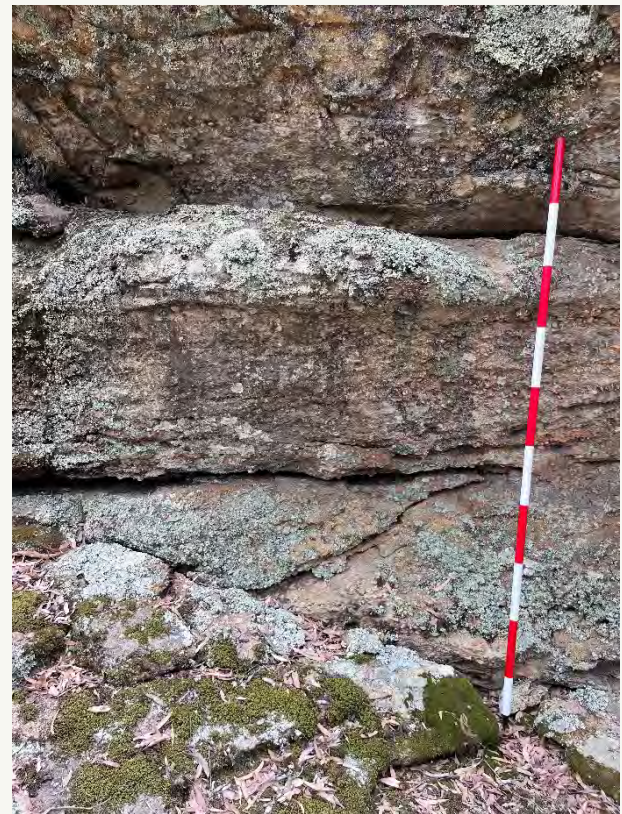
Plate 126: Close up of weathered sandstone at site S1MC491 (AHIMS ID# 36-3-3792), showing the salt/granular loss and microvegetals present. Photo taken on 10 December 2025.

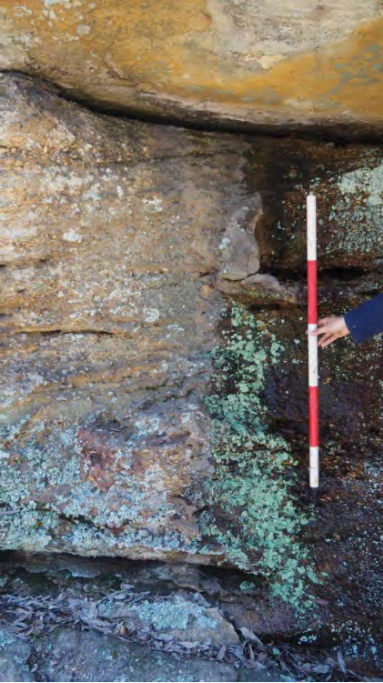
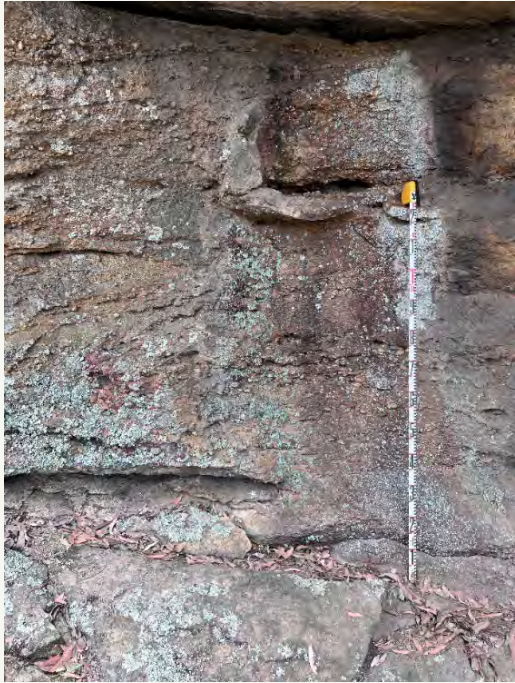
| Baseline recording (Dec 2021) | Post-mining recording (Dec 2025) |
|---|---|
| <p>Plate 127: Close up of shelter at site S1MC491 (AHIMS ID# 36-3-3792), showing an area of extensive waterwash. Photo taken on 2 December 2021.</p> | <p>Plate 128: Close up of shelter at site S1MC491 (AHIMS ID# 36-3-3792), showing an area of extensive waterwash. Photo taken on 10 December 2025.</p> |
