Ashton Coal Mine

RUM Longwalls 403 to 406

Extraction Plan

April 2025

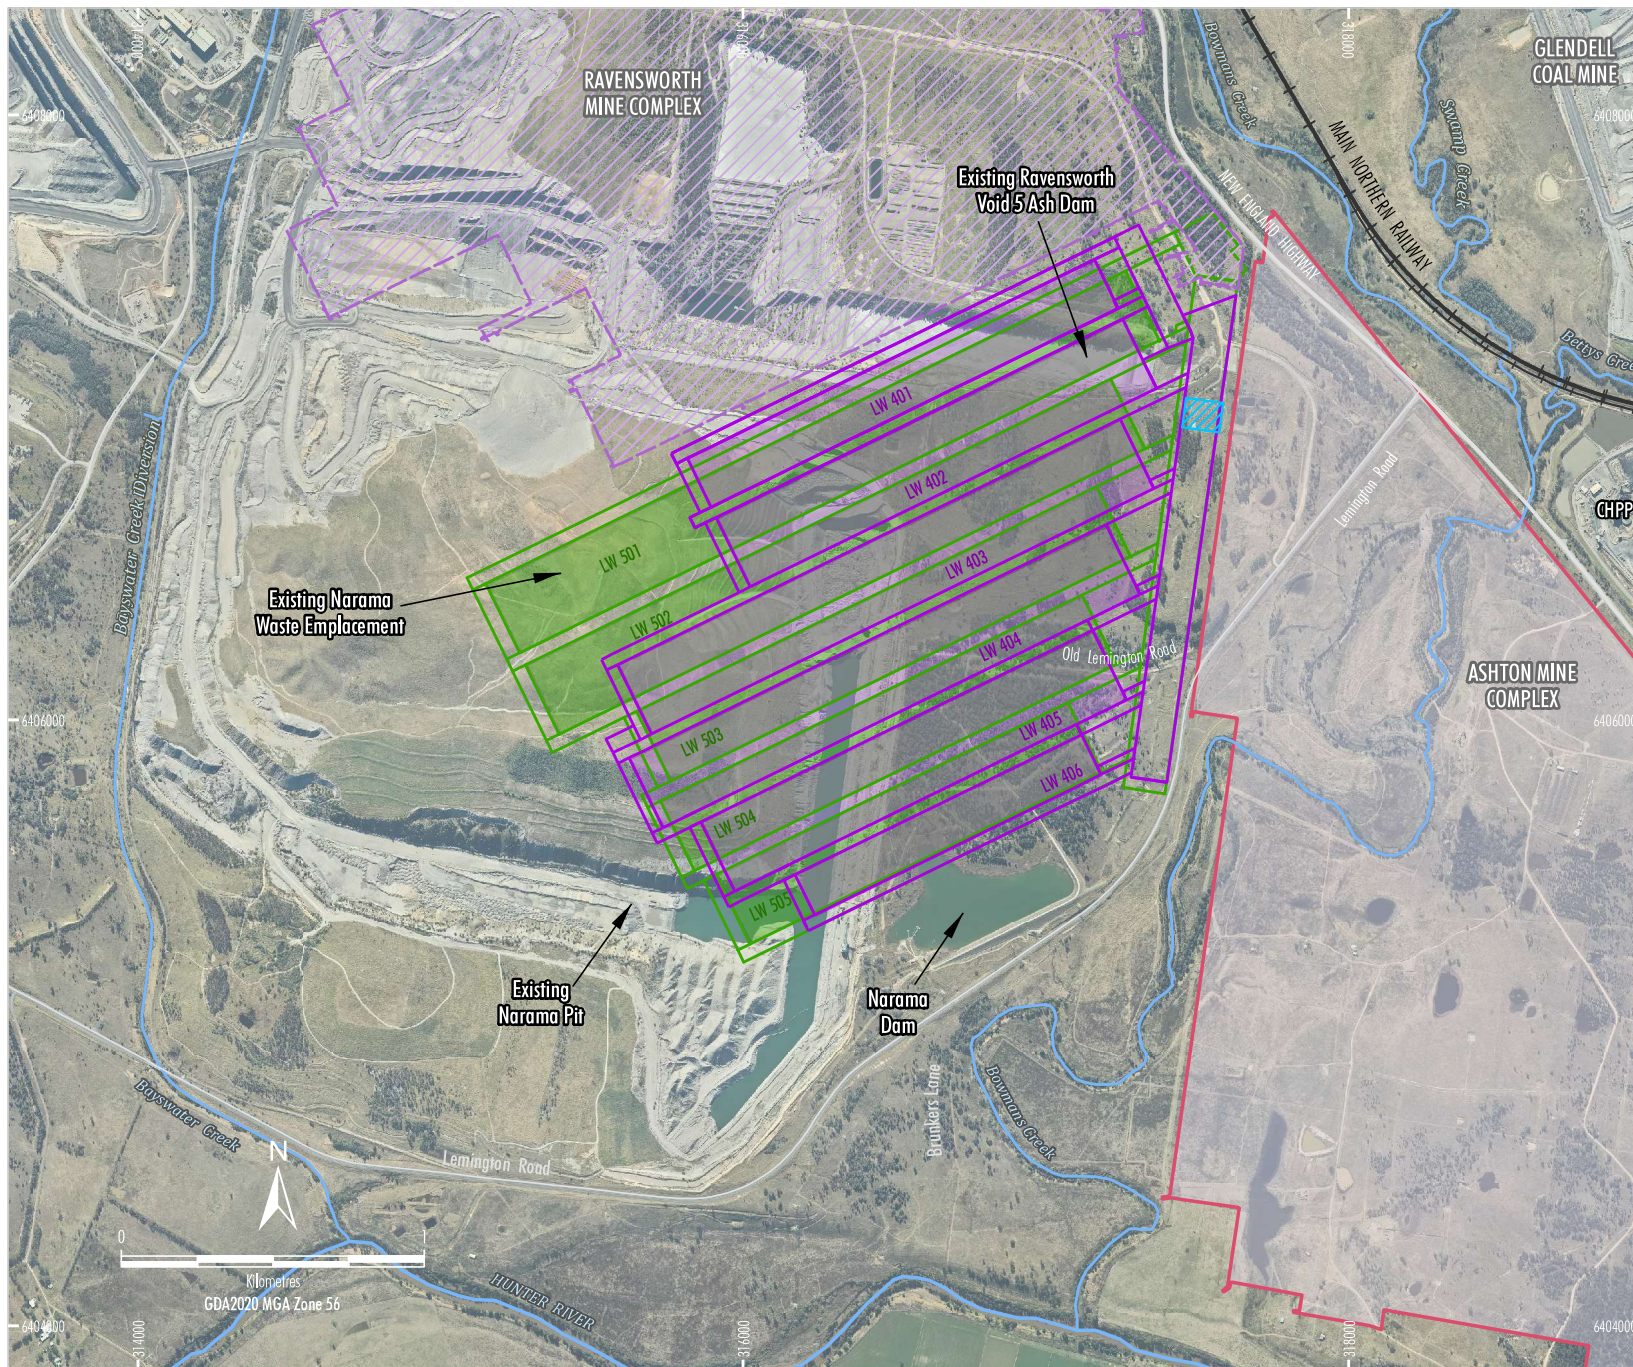
Figure 2

Ravensworth Underground Mine
 Approved General Arrangement

The RUM is approved for multi-seam longwall extraction, targeting two coal seams in descending order (Pikes Gully [PG] and Middle Liddell [MLD]) (**Figure 2**). Development Consent DA 104/96 approved mining by ACOL of six panels in the PG Seam and five panels in the MLD Seam. Following further detailed studies on the extraction layout, ACOL has decided to not mine Longwalls 401 and 402 in the PG Seam at this stage.

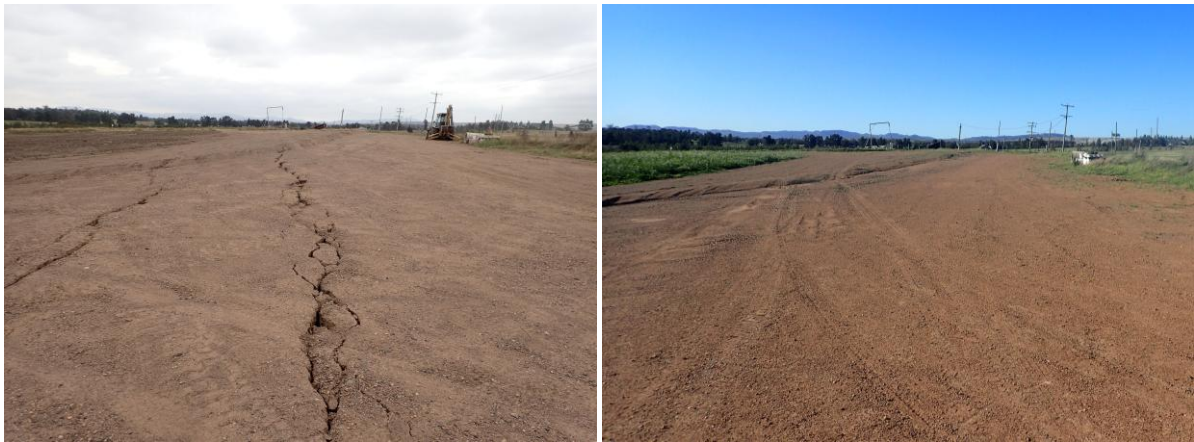
Photo 1: Example of subsidence cracking along stacked goaf edge and after crack remediation at the AUM

Significant cracking occurring around stacked edges has been successfully remediated using a variety of techniques including ripping, excavation and backfilling. Photographs of the impacts of subsidence along the stacked goaf edge as well as impacts after remediation are provided in **Photo 1** and **Photo 2**.

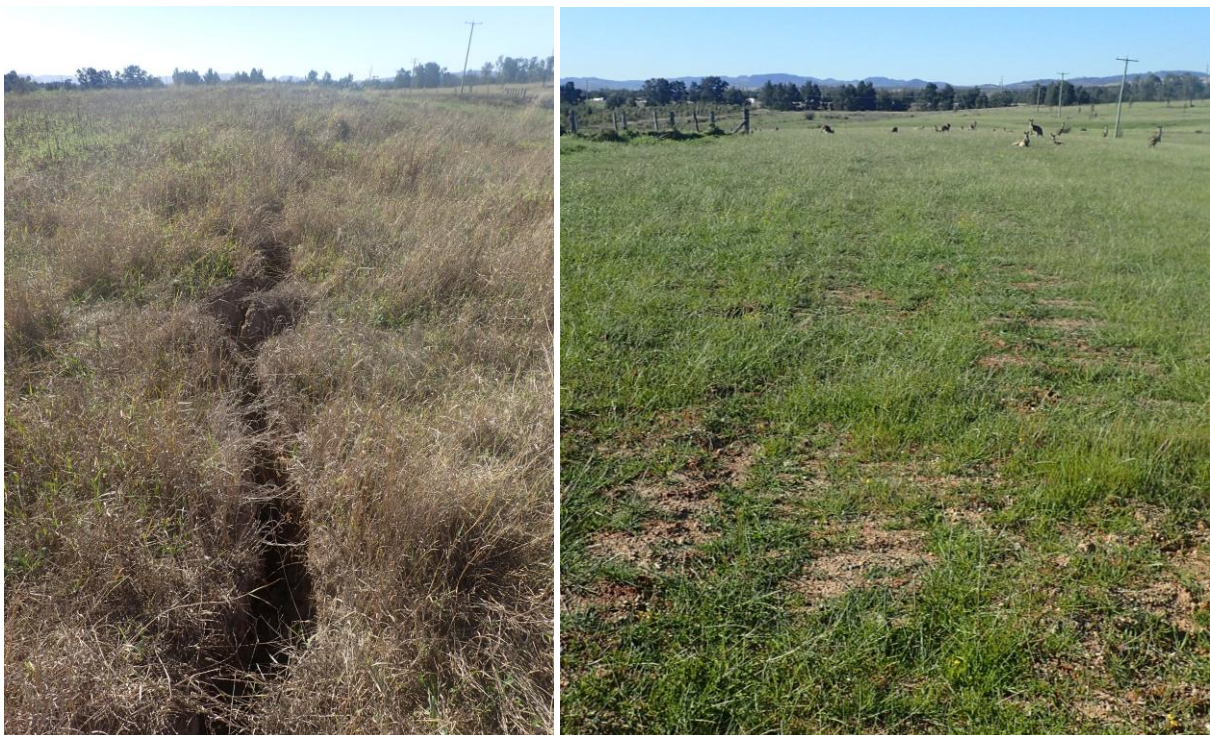
Photo 2: Example of subsidence cracking along stacked goaf edge and after crack remediation at the AUM
