Ravensworth Underground Mine – Longwalls 403 to 406

Transgrid Asset Management Plan

April 2025

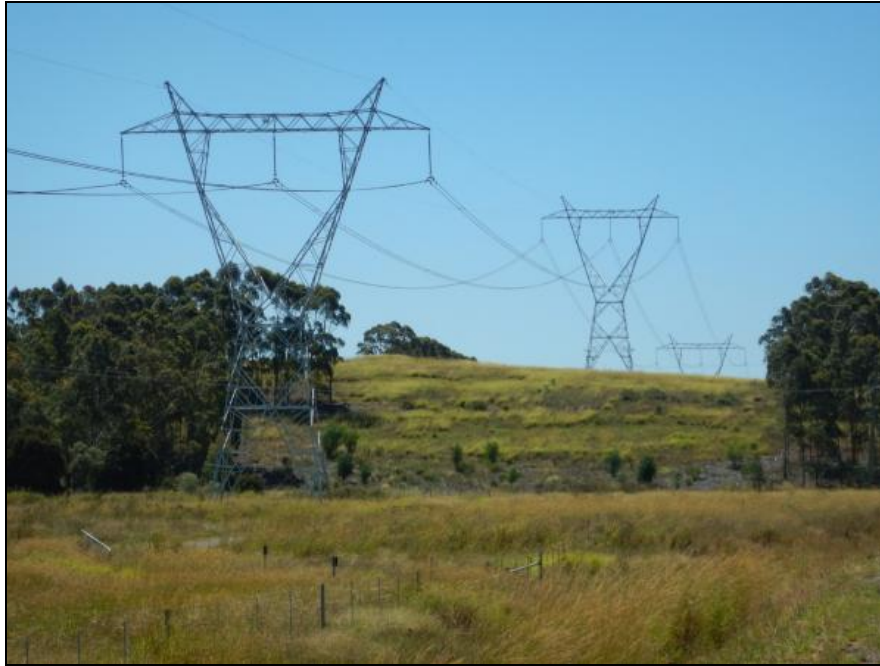
Plate 1: Transgrid 330 kV Transmission Line along Eastern boundary of the Study Area

The Transgrid 330 kV transmission line is located west of Lemington Road and traverses along the Eastern boundary of the Study Area. Two steel lattice towers (#38 and #39) that support the conductors are within the Study Area (**Plate 1**).
