**UG4 LONGWALLS 409 TO 414
BUILT FEATURES
MANAGEMENT PLAN
SADDLERS CREEK ROAD**

Document	Version	Issue Date	Status	Author
MCO_BFMP_SCR	3	April 2026	Approved	MCO

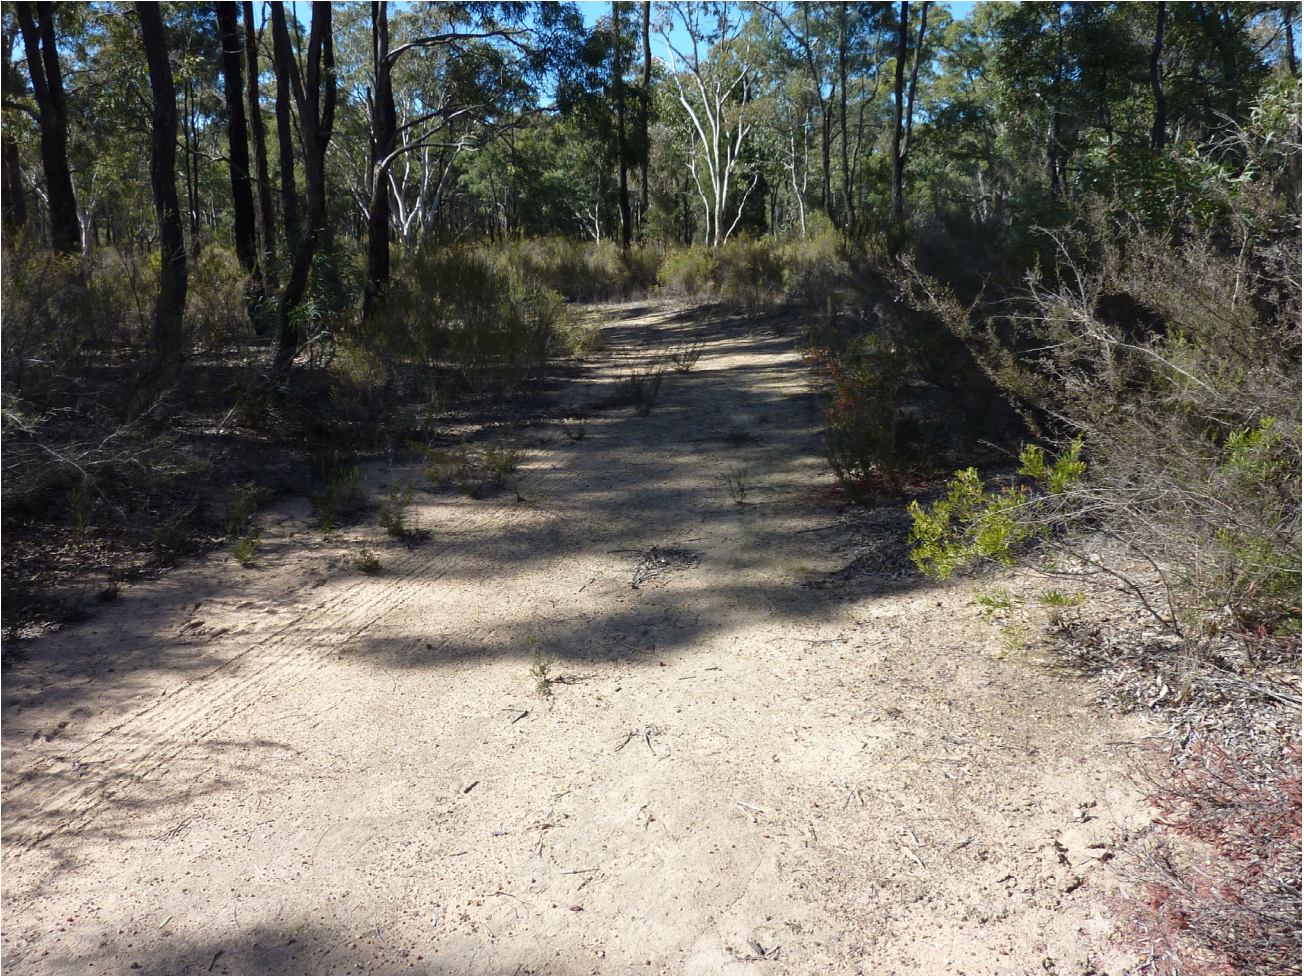
Figure 1 Saddlers Creek Road

Saddlers Creek Road is an unsealed dirt road that crosses the northern ends of Longwalls 412 to 414. A picture of Saddlers Creek Road is shown in Figure 1.

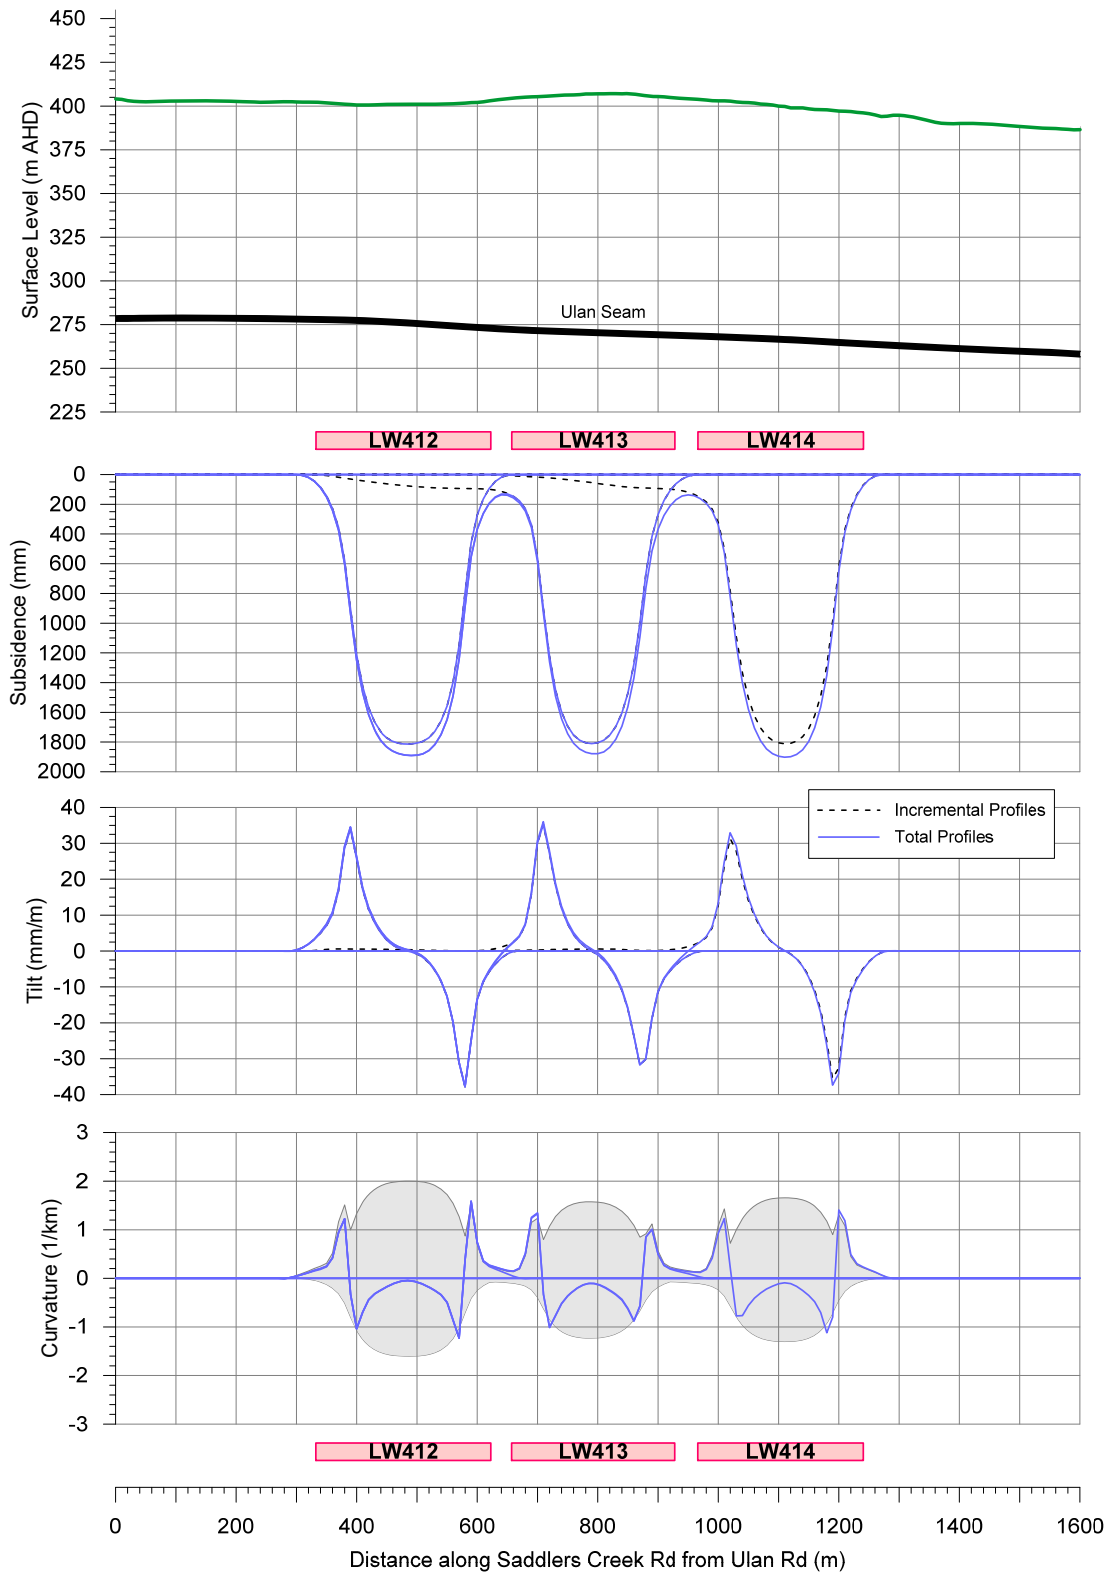
Figure 2 Predicted Profiles of Conventional Subsidence, Tilt and Curvature along Saddlers Creek Rd

Saddlers Creek Road will be mined beneath by Longwalls 412 to 414. The predicted profiles of vertical subsidence, tilt and curvature along Saddlers Creek Road, resulting from the extraction of Longwalls 409 to 414, are shown in Figure 2. The predicted incremental profiles along the prediction line, due to the extraction of each of the longwalls, are shown as dashed black lines. The predicted total profiles along the prediction line, after the extraction of each of the longwalls based on the Extraction Plan Layout, are shown as solid blue lines.

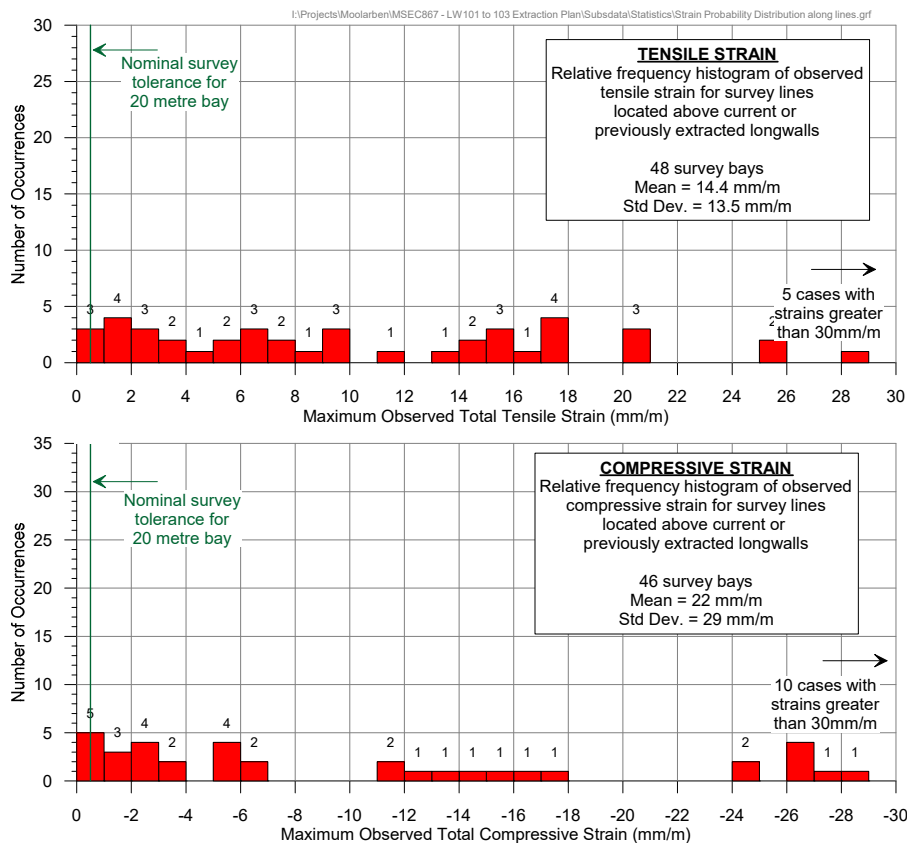
Figure 3 Distributions of Measured Maximum Tensile and Compressive Strains Anywhere along the Monitoring Lines in the Hunter, Newcastle and Western Coalfields

The histogram of maximum observed total tensile and compressive strains measured anywhere along the monitoring lines, at any time during or after mining, is provided in Figure 3.

It can be seen from the above figure, that 50 % of the monitoring lines have recorded maximum total tensile strains of 10 mm/m, or less, and 75 % of the monitoring lines have recorded maximum total tensile strains of 20 mm/m, or less. 43 % of the monitoring lines have recorded maximum compressive strains of 10 mm/m, or less, and 60 % of the monitoring lines have recorded maximum compressive strains of 20 mm/m, or less.

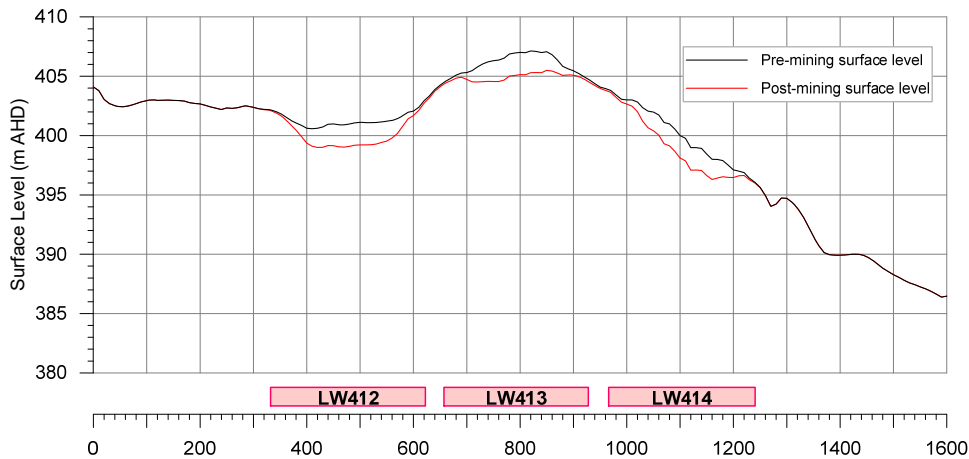
Figure 5 Surface Levels along Saddlers Creek Road

Saddlers Creek Road will experience the full range of subsidence movements from the extraction of Longwalls 412, 413 and 414. The potential impacts on Saddlers Creek Road, are expected to include cracking, stepping and rippling of the road surfaces. The road may also experience ponding and redirection of surface flow. The below graphs depict the pre-mining and predicted post-mining surface levels and grades along Saddlers Creek Road in Figure 5 and Figure 6 respectively. It can be seen in Figure 6 that the maximum changes in grade along the road will occur near the edges of each of the extracted longwalls. There is an increased likelihood of ponding where post-mining grades are reversed or near zero grade.

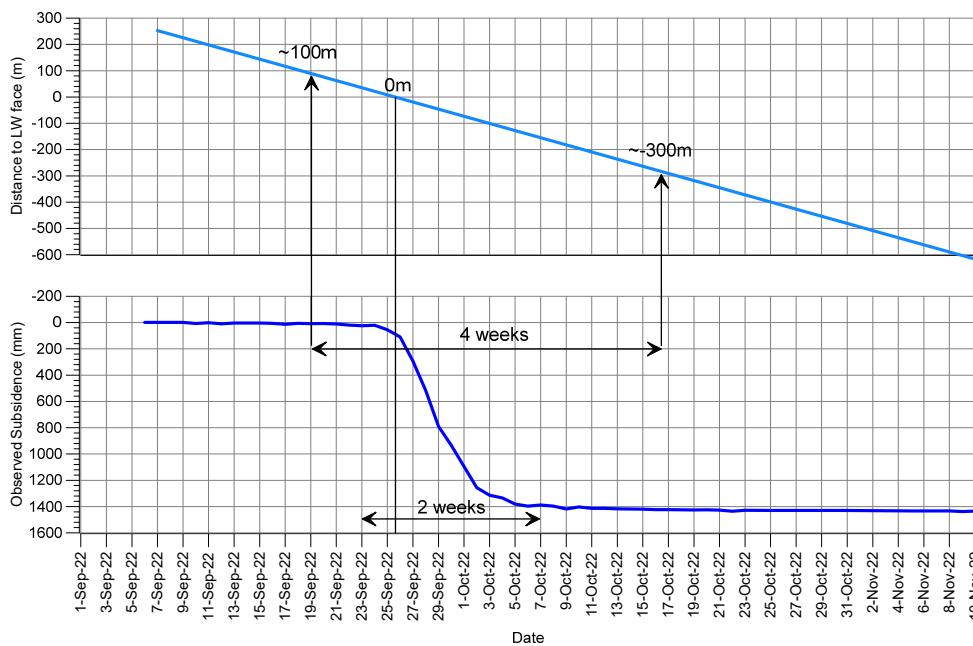
Figure 7 Development of vertical subsidence during Longwall 401

The expected duration of active subsidence beneath Saddlers Creek Road with the extraction of each longwall panel is dependent on the rate of extraction, however based on rates of extraction at MCO the most active period of vertical subsidence is approximately 2 weeks at a single location. A monitoring site above previously extracted Longwall 401 provides an example of the expected duration of active subsidence, since panel geometry and depth of cover are similar to those beneath Saddlers Creek Road. A plot of the development of vertical subsidence and the distance to the longwall face at the monitoring site during the extraction of Longwall 401 is shown in Figure 7.

The plot shows the most active subsidence period to be approximately 2 weeks, with additional minor subsidence occurring from approximately 100 m prior to the face passing beneath the monitoring site, to approximately 300 m beyond the monitoring site, over a total of approximately 4 weeks.

It is noted that the estimated duration of 4 weeks is based on a single location. Saddlers Creek Road follows a curved route and is angled to the longwall alignment, therefore the duration may be longer since the longwall face will extract for some distance directly beneath the road. The management period should be implemented from when the longwall face is approximately 100 m before the road, to approximately 300 m beyond the road.
