**UG4 LONGWALLS 409 TO 414  
BUILT FEATURES  
MANAGEMENT PLAN  
TELSTRA**

Document	Version	Issue Date	Status	Author
MCO_BFMP_TELSTRA	3	April 2026	Approved	MCO

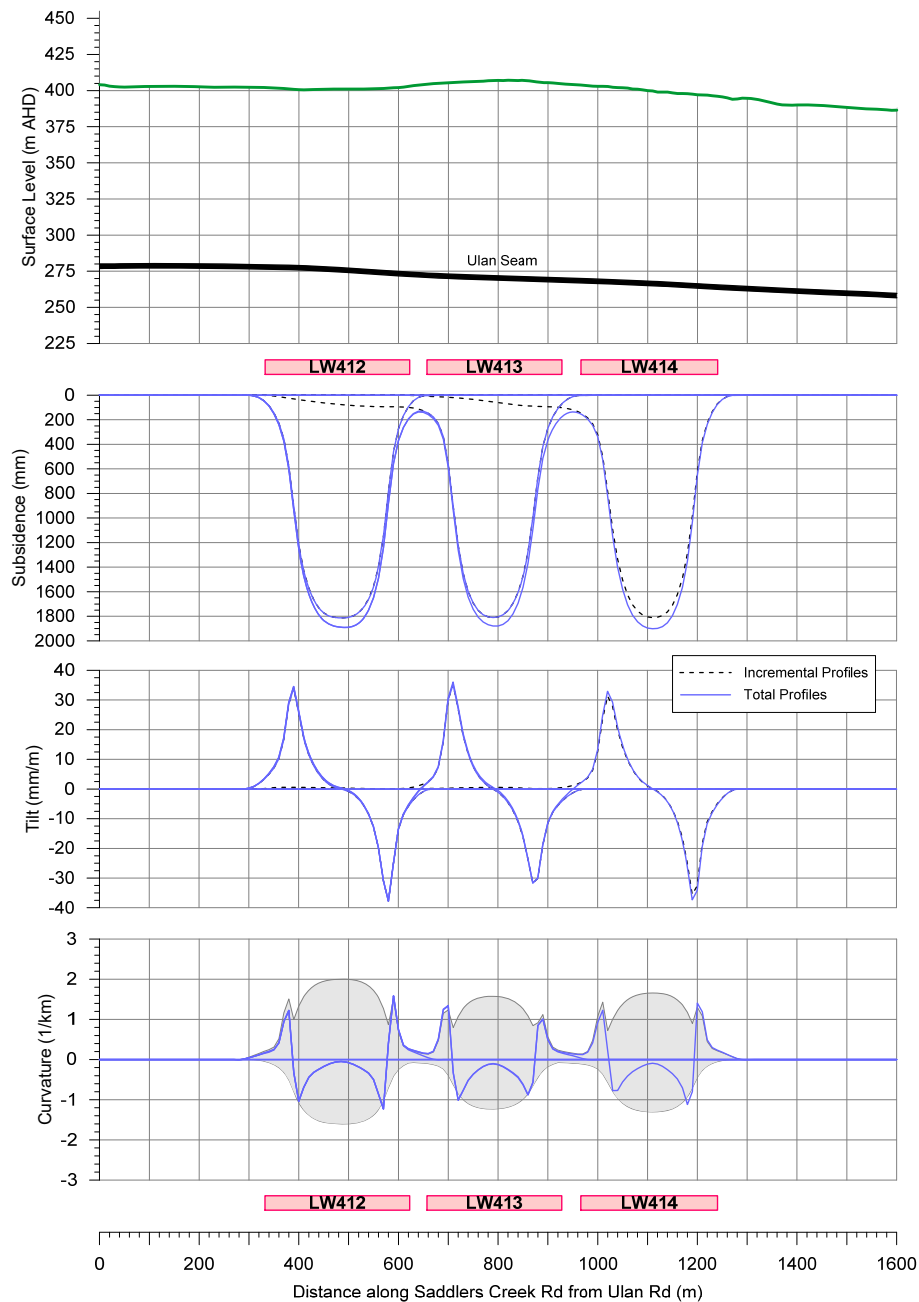
The copper cables along Saddlers Creek Road will be mined beneath by Longwalls 412 to 414. The predicted profiles of vertical subsidence, tilt and curvature along the copper cable, resulting from the extraction of Longwalls 409 to 414, are shown in Figure 1. The predicted incremental profiles due to the extraction of each of the longwalls, are shown as dashed black lines. The predicted total profiles after the extraction of each of the longwalls based on the Extraction Plan Layout, are shown as solid blue lines.

**Figure 1 Predicted Profiles of Conventional Subsidence, Tilt and Curvature for the Telstra copper cables along Saddlers Creek Rd**

A summary of the maximum predicted values of total conventional subsidence, tilt and curvature for copper cables along Saddlers Creek Road, resulting from the extraction of Longwalls 409 to 414 for the Extraction Plan Layout, is provided in Table 1. The predicted tilts provided in this table are the maxima after the completion of all the longwalls. The predicted curvatures are the maxima at any time during or after the extraction of the longwalls.

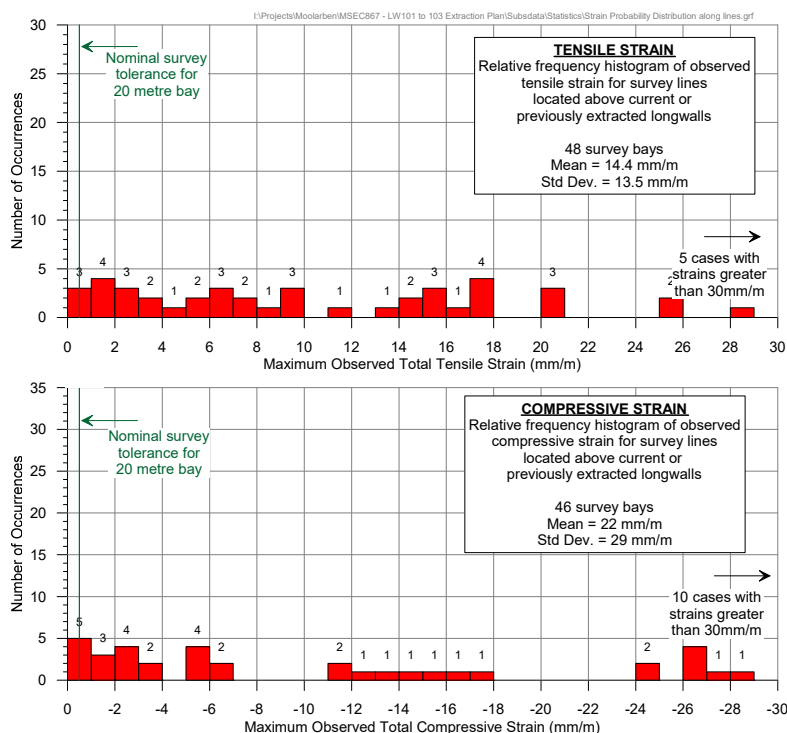
The histogram of maximum observed total tensile and compressive strains measured anywhere along the monitoring lines, at any time during or after mining, is provided in Figure 2.

**Figure 2 Distributions of Measured Maximum Tensile and Compressive Strains Anywhere along the Monitoring Lines in the Hunter, Newcastle and Western Coalfields**

It can be seen from the above figure, that 24 of the 48 monitoring lines (i.e. 50 %) have recorded maximum total tensile strains of 10 mm/m, or less, and that 36 monitoring lines (i.e. 75 %) have recorded maximum total tensile strains of 20 mm/m, or less. Also, 20 of the 46 monitoring lines (i.e. 43 %) have recorded maximum compressive strains of 10 mm/m, or less, and that 28 of the monitoring lines (i.e. 60 %) have recorded maximum compressive strains of 20 mm/m, or less.

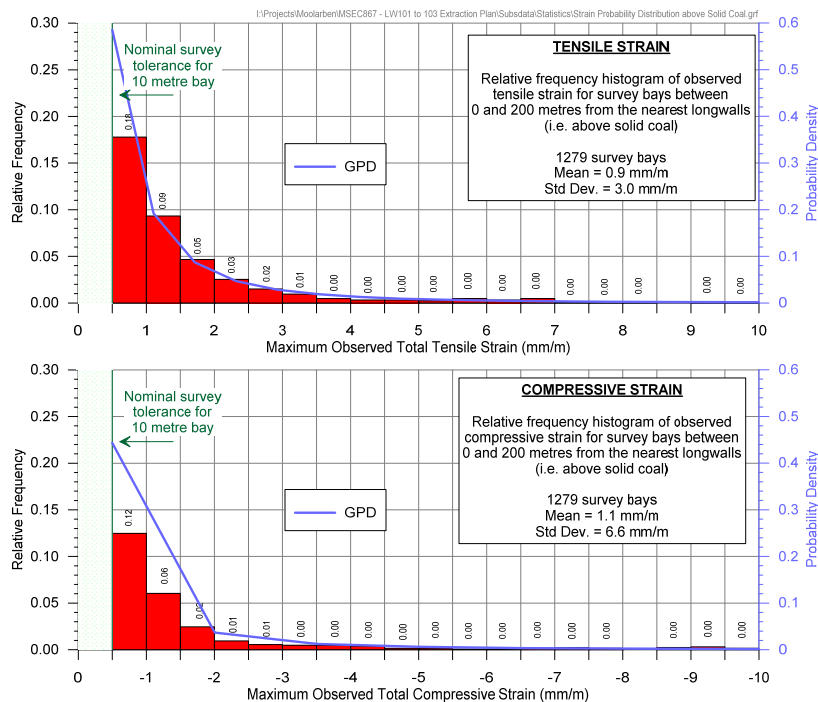
The histogram of the maximum observed tensile and compressive strains measured in survey bays above solid coal is provided in Figure 3. The probability distribution functions, based on the fitted Generalised Pareto Distribution (GPD), have also been shown in this figure.

**Figure 3 Distributions of the Measured Maximum Tensile and Compressive Strains in the Hunter, Newcastle and Western Coalfields for Survey Bays located above Solid Coal within 200 m of the nearest longwall**

The 95 % confidence levels for the maximum total strains that the individual survey bays *above solid coal* experienced at any time during mining are 3.3 mm/m tensile and 3.0 mm/m compressive. The 99 % confidence levels for the maximum total strains that the individual survey bays above solid coal experienced at any time during mining are 9.2 mm/m tensile and 14.4 mm/m compressive.
