## Mount Thorley Warkworth

### Monthly Obtained Data Summary

**Environment Protection Licence 1376**

February 2017

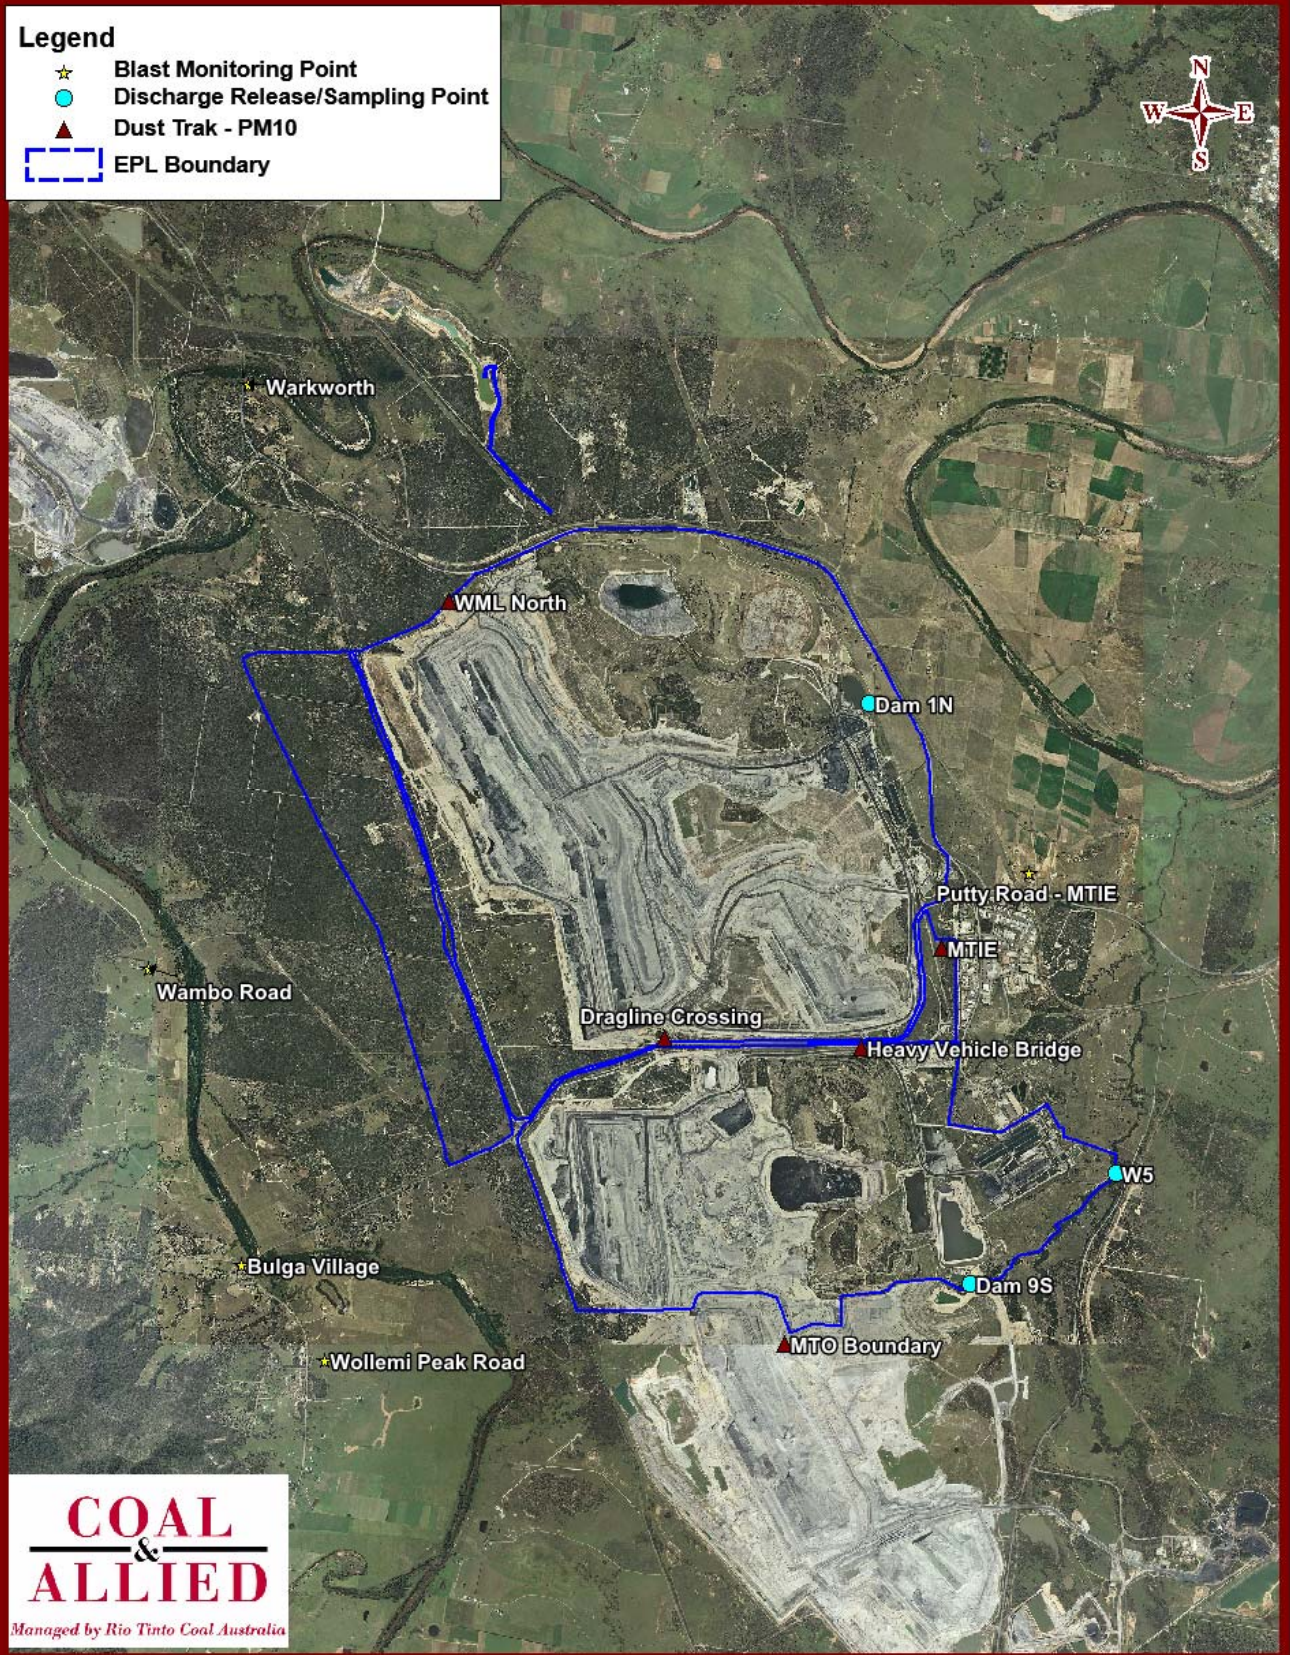
**Figure 1 : Mount Thorley Warkworth Environmental Monitoring Locations**

**Mount Thorley Warkworth**  
Environmental Monitoring Locations

- ☆ Blast Monitoring Point
- Discharge Release/Sampling Point
- ▲ Dust Trak - PM10
- ▭ EPL Boundary

To monitor regional air quality, MTW operates and maintains a network of 5 Particulate Matter <10µm (PM10) Monitors (DustTrak II) on mine owned land surrounding the mining operations. The location of these monitors can be found in Appendix A – MTW Monitoring Location Plan.

The location of these sampling points can be found in Appendix A – MTW Monitoring Locations Plan

The location of these monitors can be found in Appendix A – Mount Thorley Warkworth Environmental Monitoring Locations.
