Monthly Environmental Monitoring Report

Yancoal Mount Thorley Warkworth

July 2021

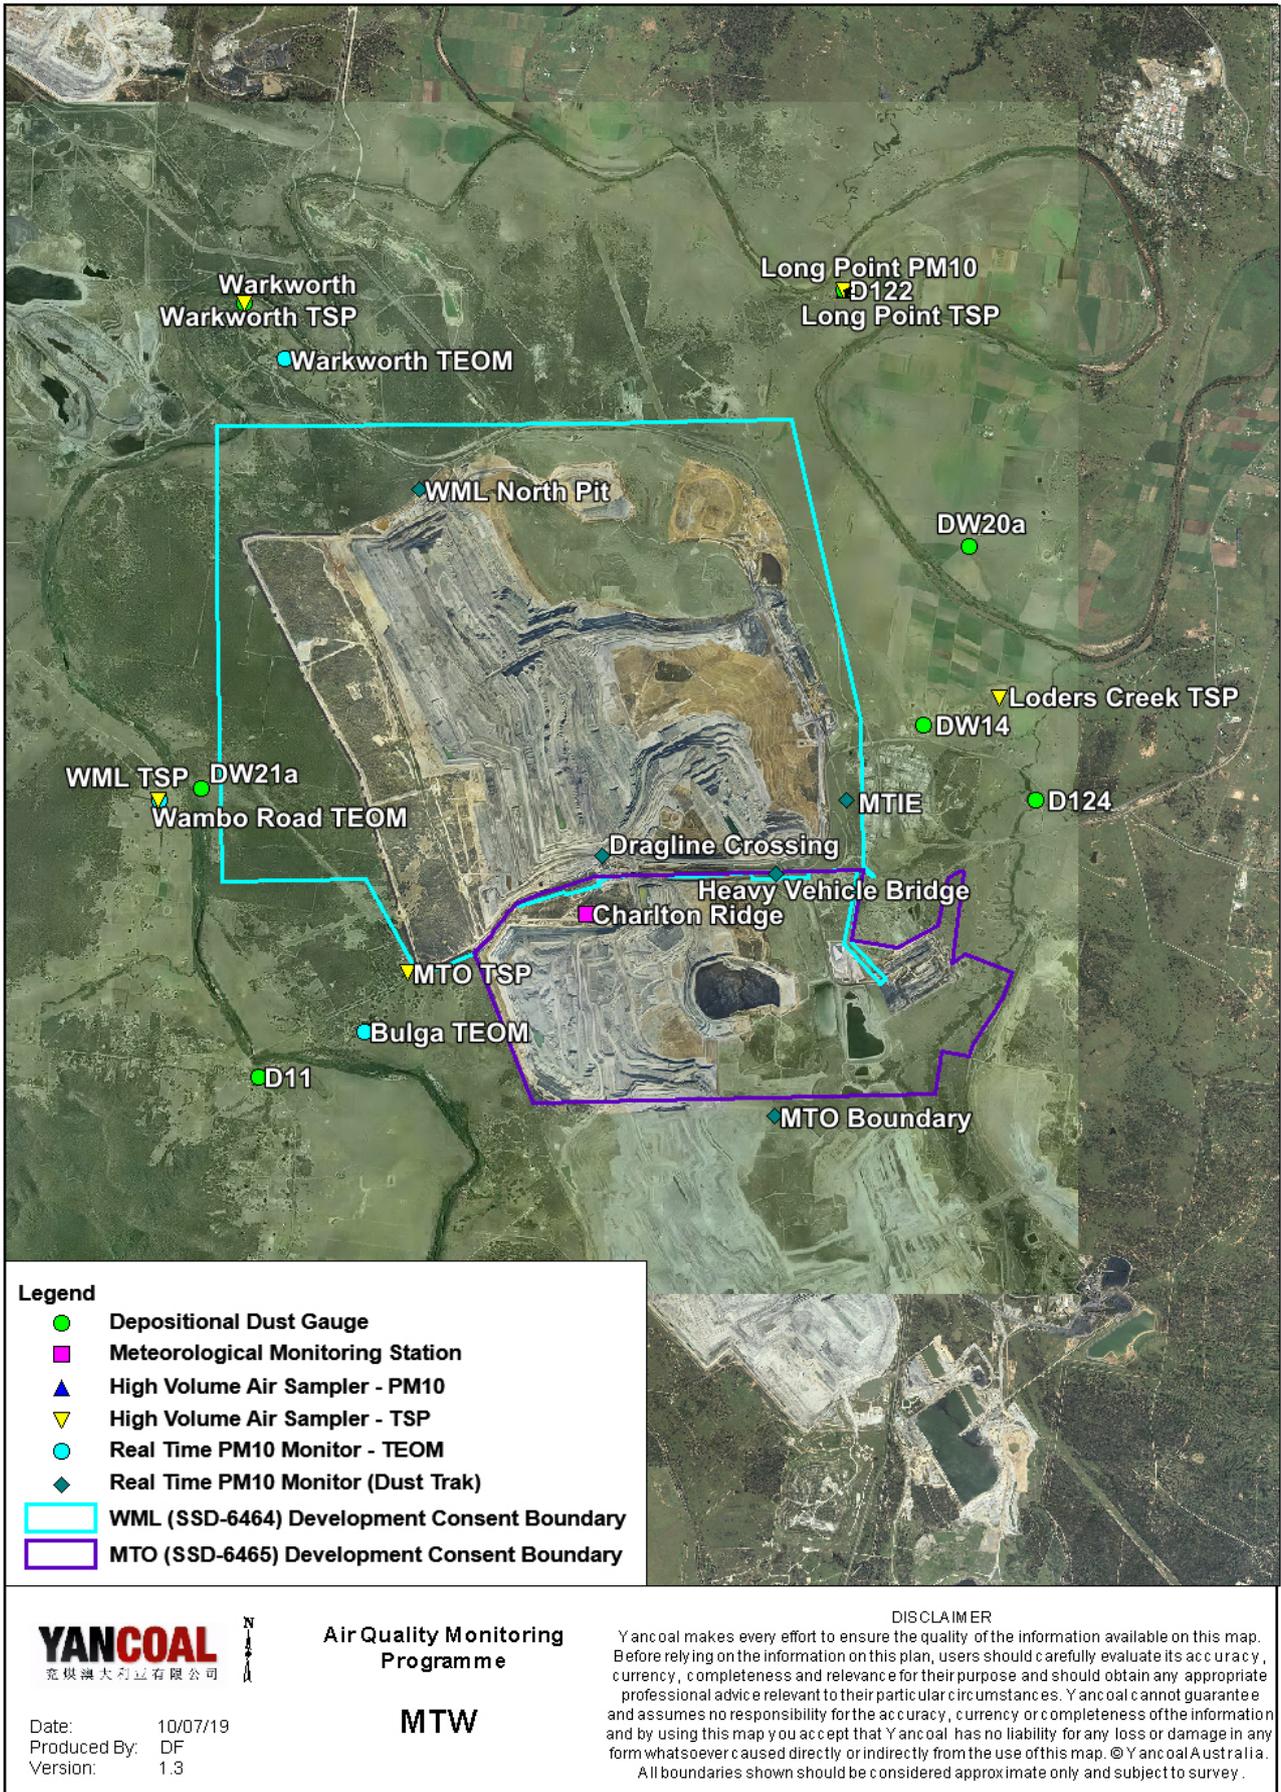
Figure 3: Air Quality Monitoring Locations

Meteorological data is collected at MTW’s ‘Charlton Ridge’ meteorological station (refer to **Figure 3: Air Quality Monitoring Locations**).

Suspended particulates are measured by a network of High Volume Air Samplers (HVAS) measuring Total Suspended Particulates (TSP) and Particulate Matter <10µm (PM₁₀). The location of these monitors can be found in **Figure 3**. Each HVAS

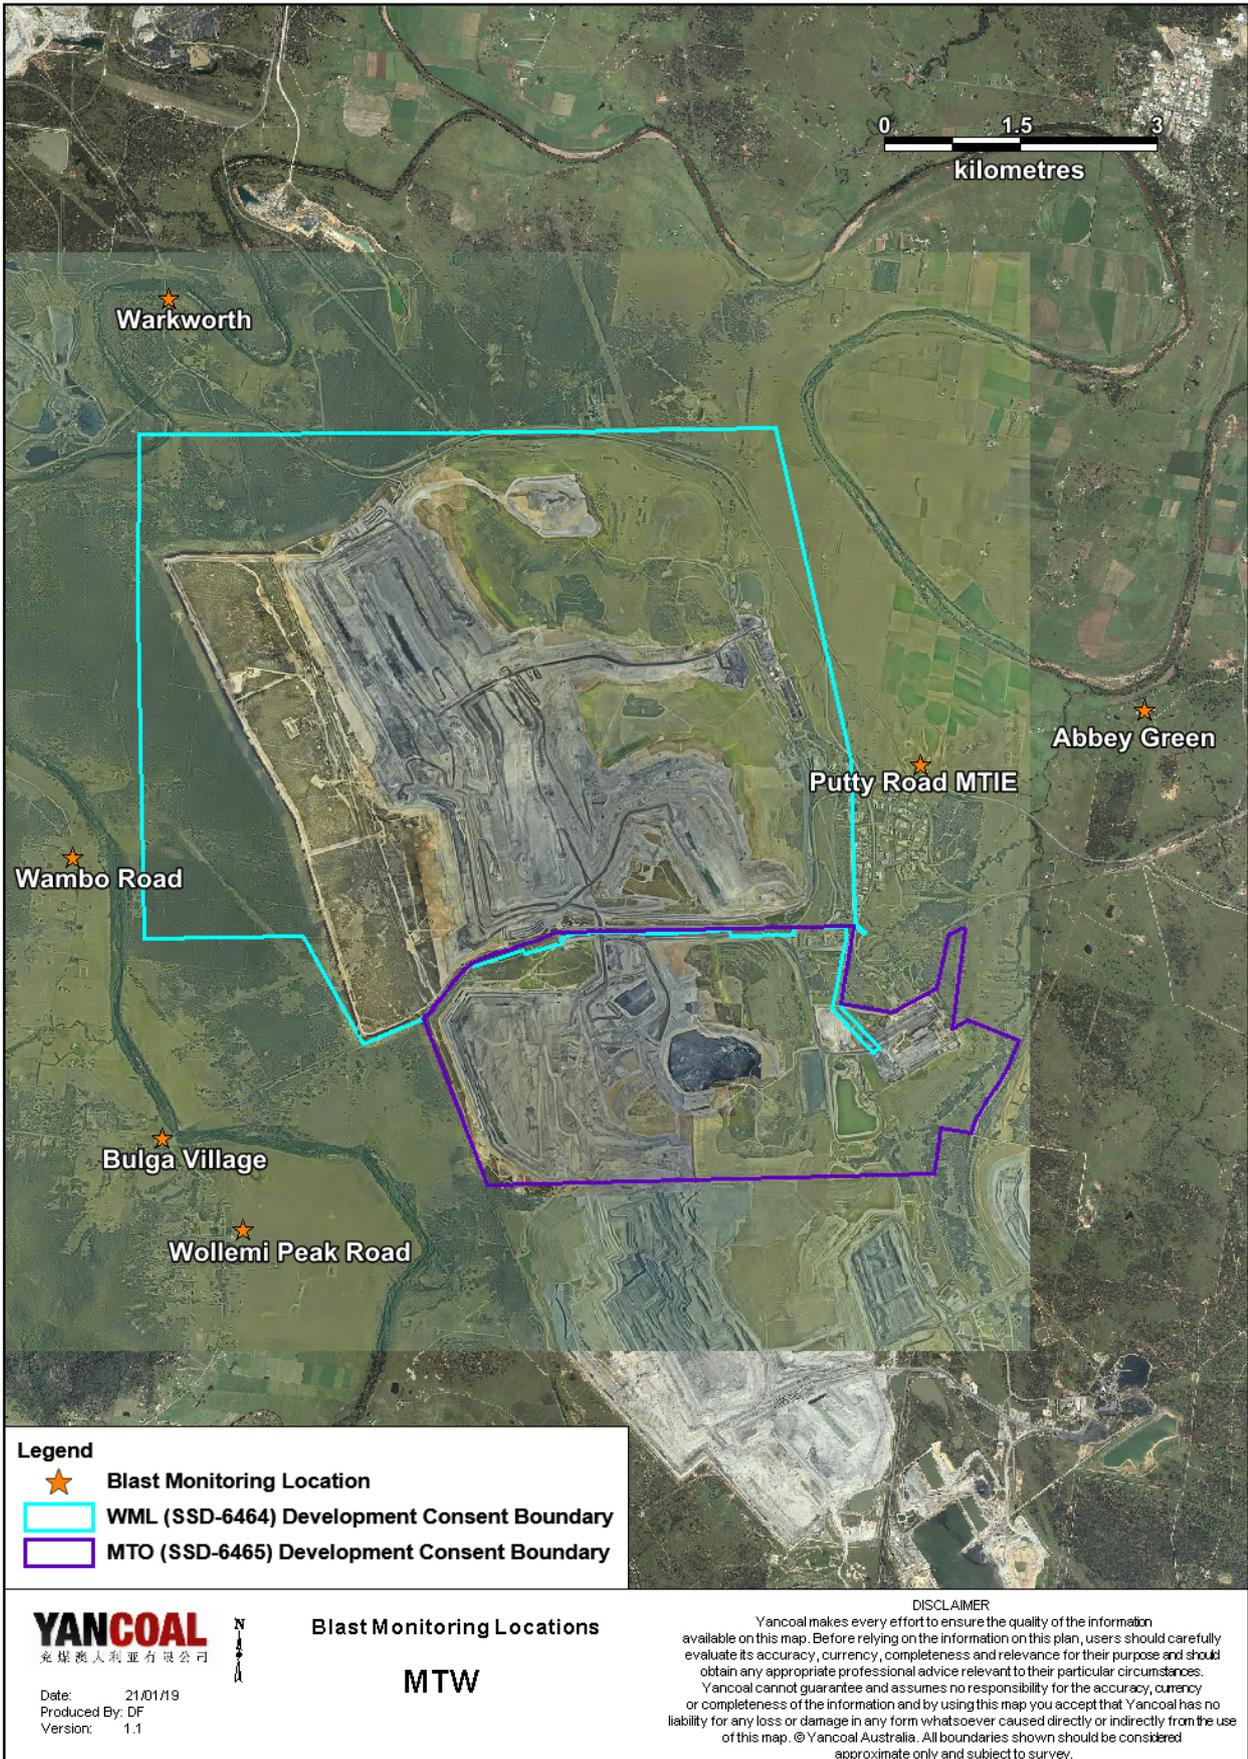
Figure 15: MTW Blast Monitoring Location Plan

MTW have a network of six blast monitoring units. These are located at nearby privately owned residences and function as regulatory compliance monitors.

The location of these monitors can be found in **Figure 15**.

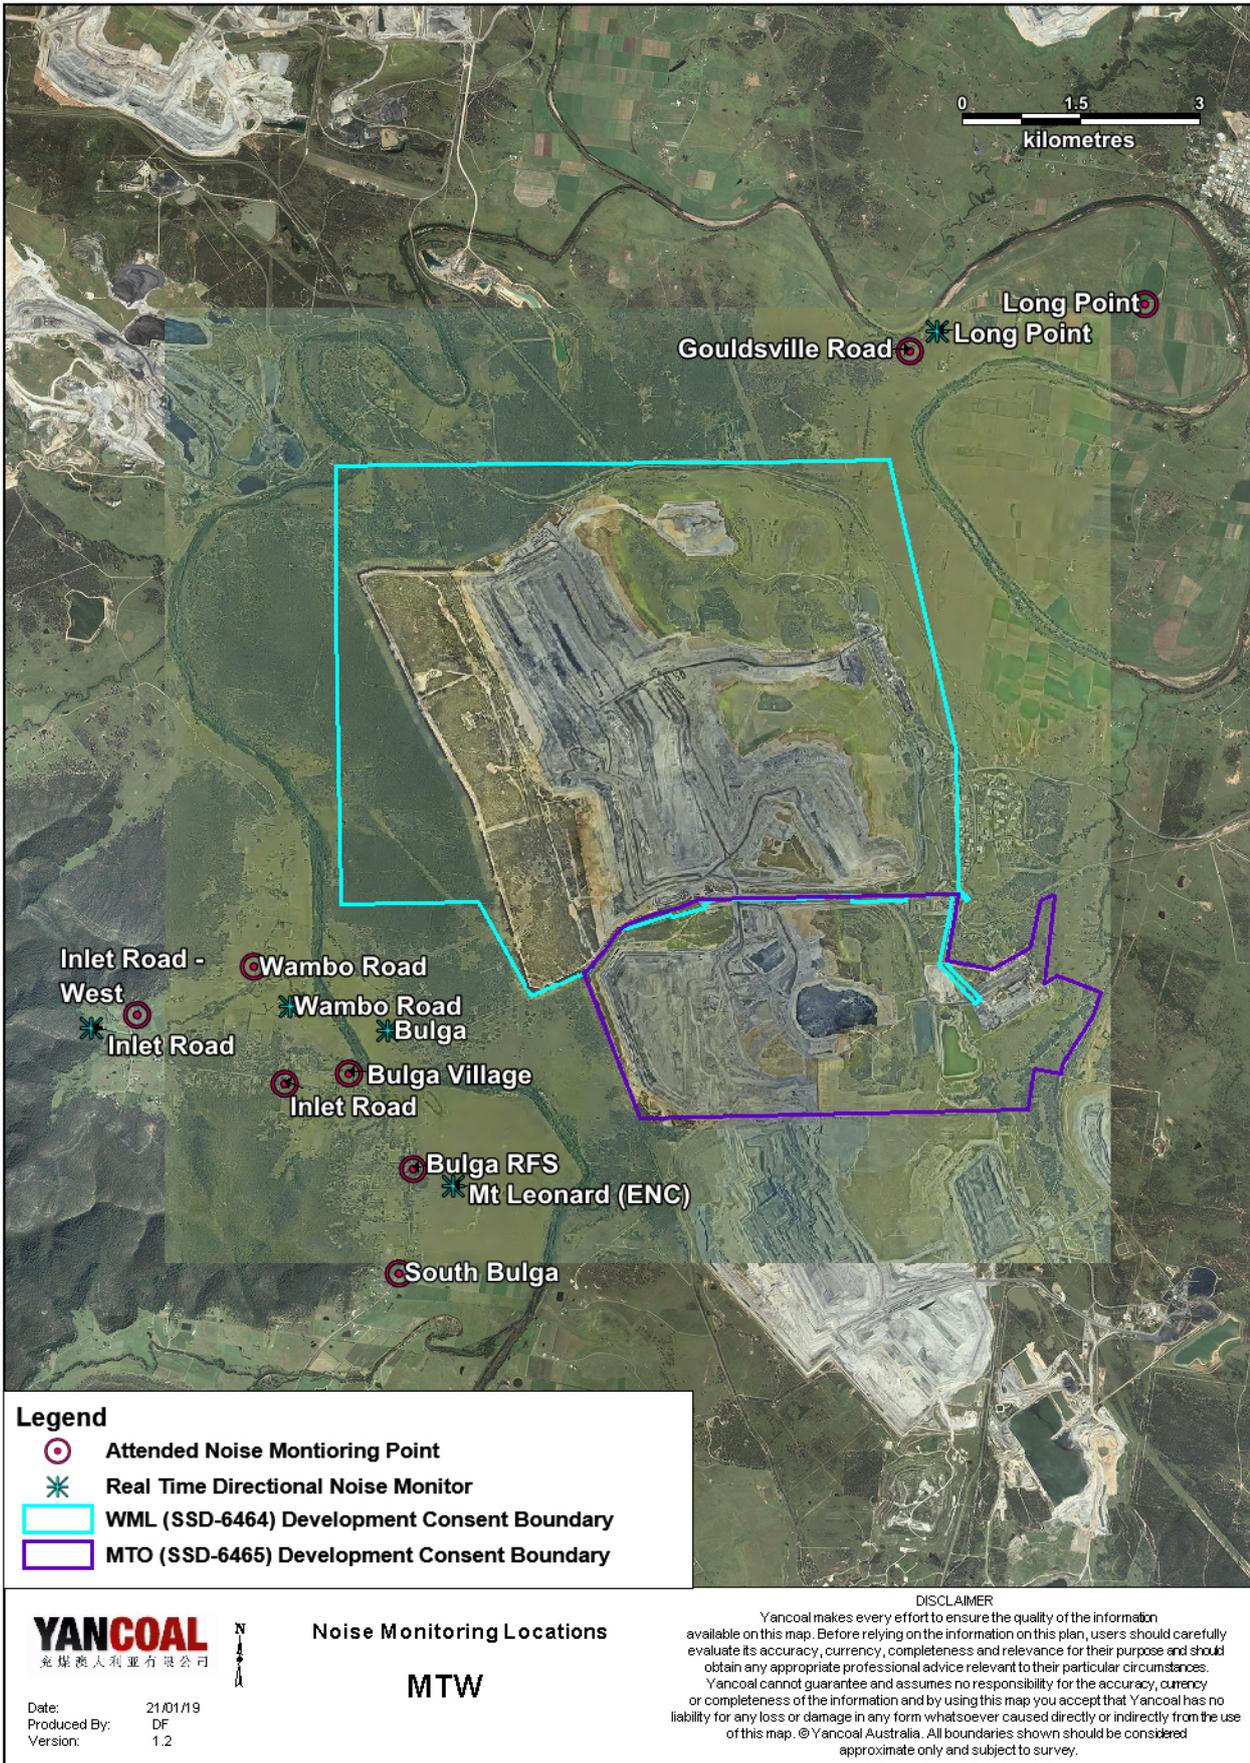
Figure 16: Noise Monitoring Location Plan

Routine attended noise monitoring is carried out in accordance with the MTW Noise Management Plan. A review against EIS predictions will be reported in the Annual Review. The purpose of the noise surveys is to quantify and describe the acoustic environment around the site and compare results with specified limits. Real time noise monitoring also occurs at five sites surrounding MTW. Noise monitoring locations are displayed in **Figure 16**.
